# **SEPTEMBER 1983**

**OCEAN ENGINEERING** AND CONSTRUCTION PROJECT OFFICE CHESAPEAKE DIVISION NAVAL FACILITIES ENGINEERING COMMAND WASHINGTON, D.C. 20374

FPO-1-83 (25)

CHESNAVFACENGCOM REPORT FPO-1-83(25), "PWC YOKOSUKA FLEET MOORINGS INSPECTION REPORT",

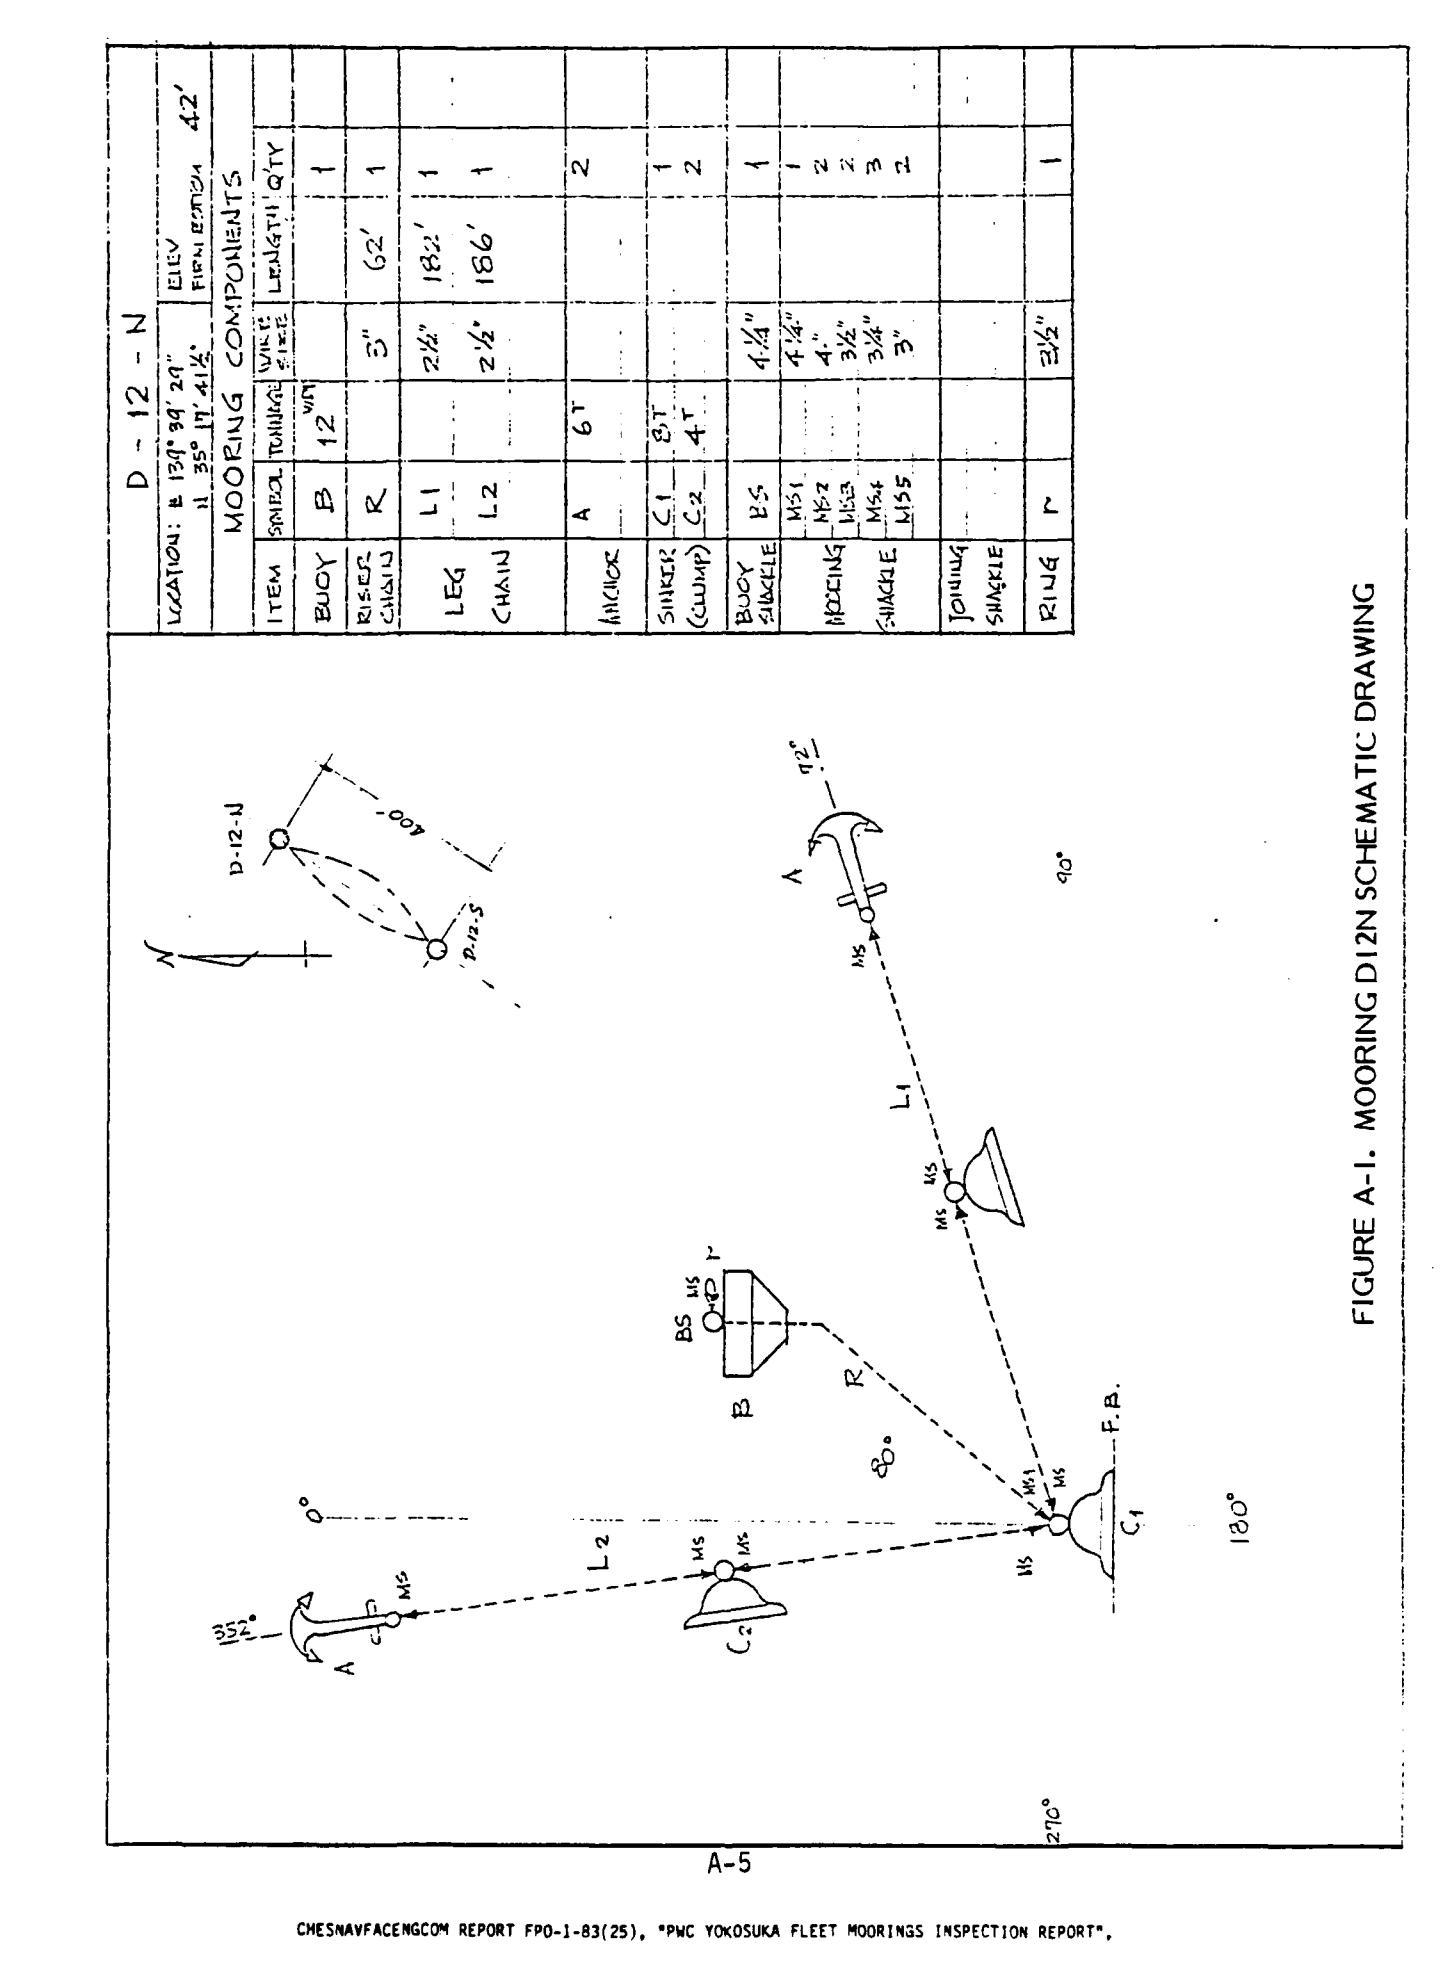
This is a large Japanese-built drum-type buoy with a hawsepipe. The buoy was fiberglass coated, but the fiberglass is badly chipped. The hull of the buoy below the waterline is covered with several inches of heavy marine growth. The top of the riser measured greater than 90 percent of its original wire diameter but is moderately rusted. The chafing rail is badly dented.

This mooring is in good condition.

As-built information contained in Figure A-1 reveals that the legs of this mooring were 2-1/2 inch wire diameter when installed. A class A mooring requires ground legs of 2 3/4-inch diameter. Therefore, recommend that this mooring be reclassified from a class A to a class B mooring.

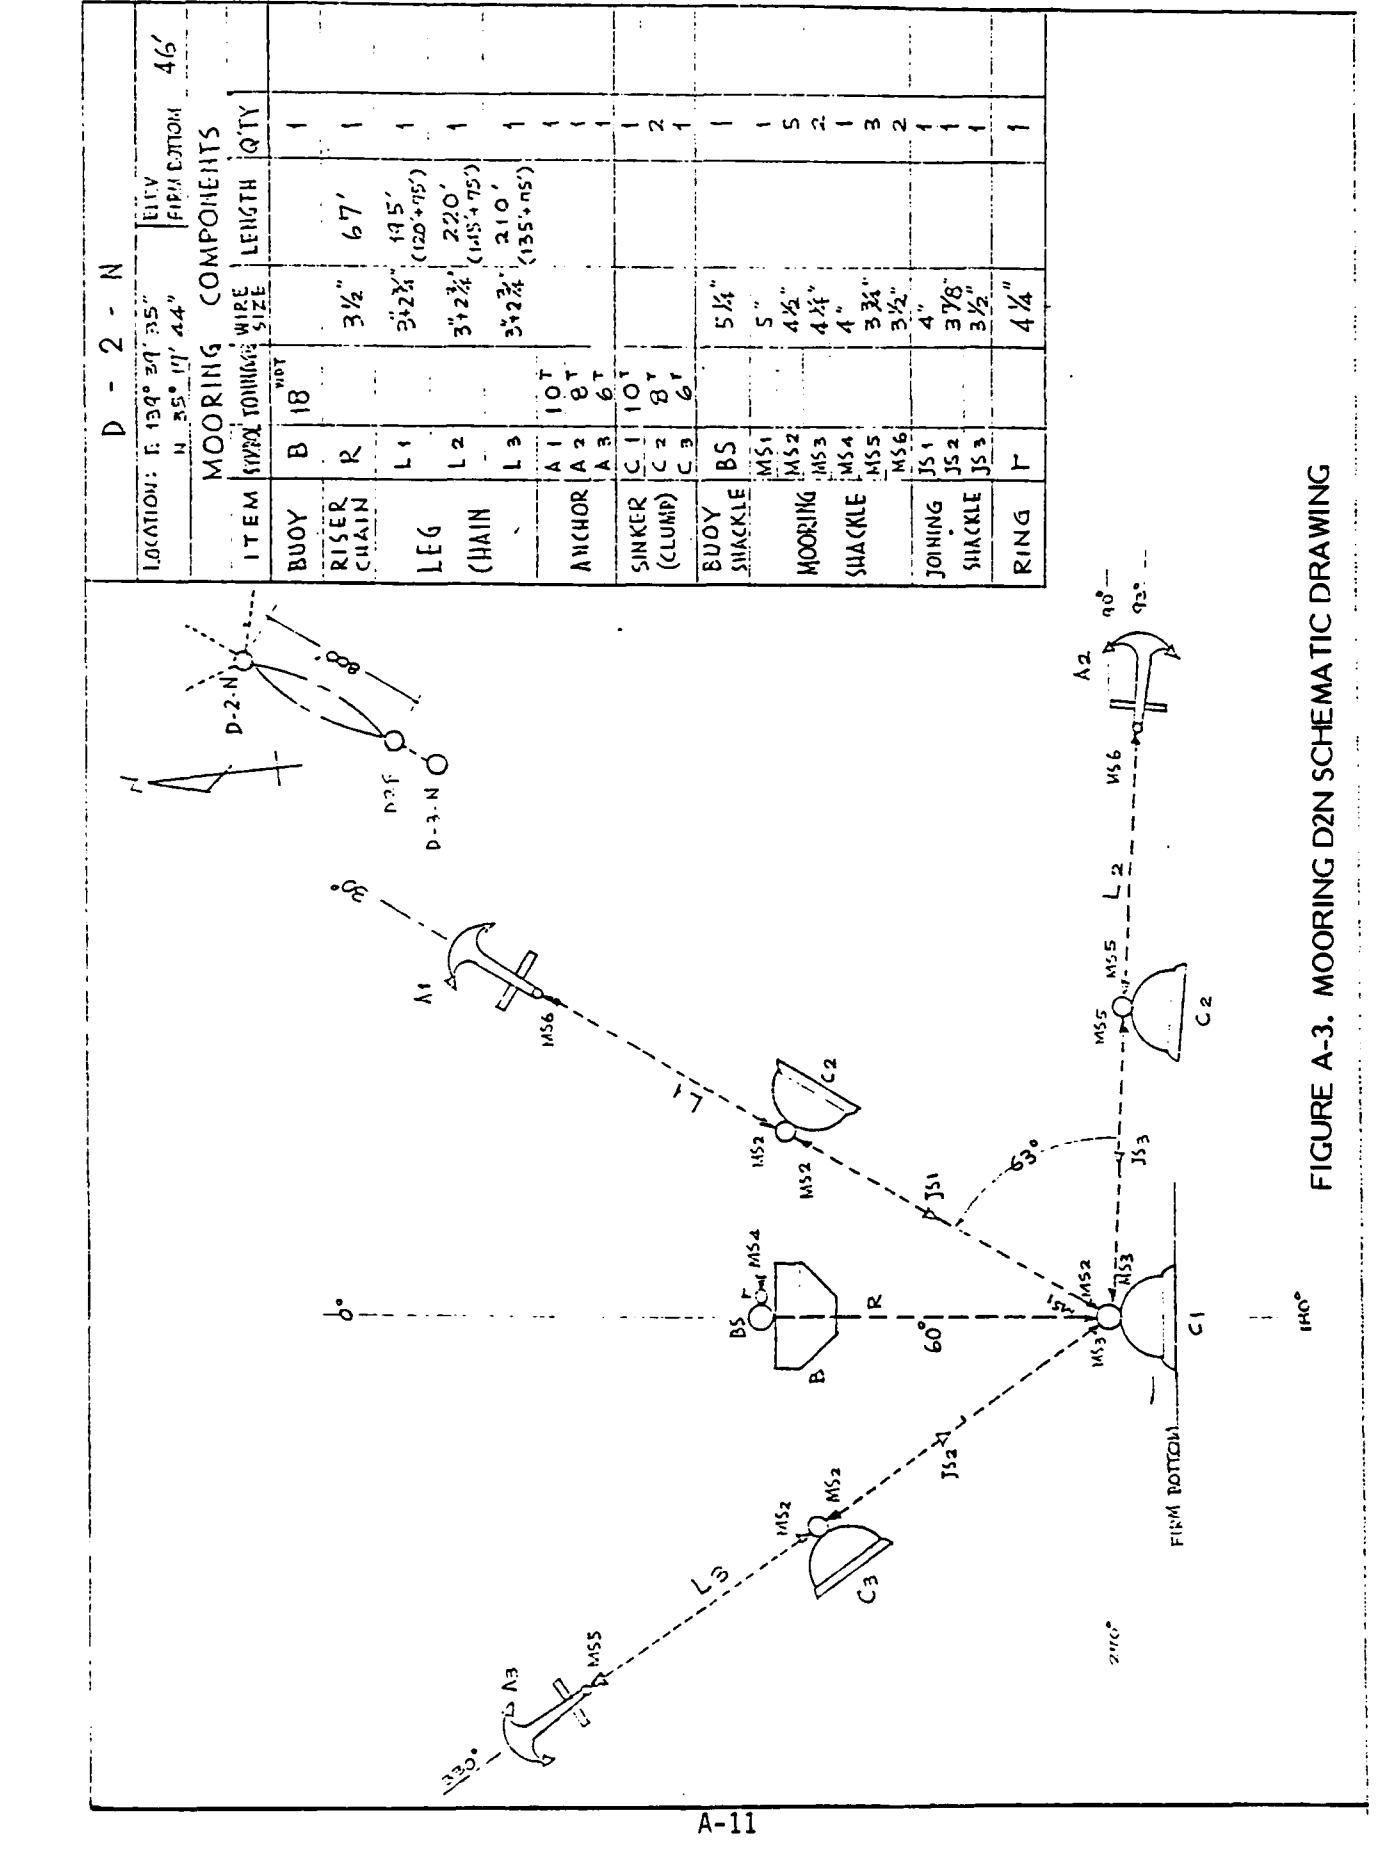
This is a large Japanese-built drum-type buoy with a hawsepipe. The buoy is fiberglass coated. There is some light rusting of the top deck plate under the fiberglass and a medium amount of rust streaking of the side plating. The galvanized pipe chafing rail is rusted and flaking badly. A heavy coating of marine growth covers the buoy bottom below the water line.

This mooring is in fair condition.

The worn condition of the riser chain of this mooring would dictate that this mooring be downgraded to a class A mooring. The ground leg diameters of 2 3/4 inches (Figure A-3) are also satisfactory for a class A mooring. However, this is part of a bow/stern mooring system and its classification should not exceed that of its sister mooring. Since mooring D2S can meet only the requirements of a class C mooring, recommend that this mooring be reclassified to a class C mooring.

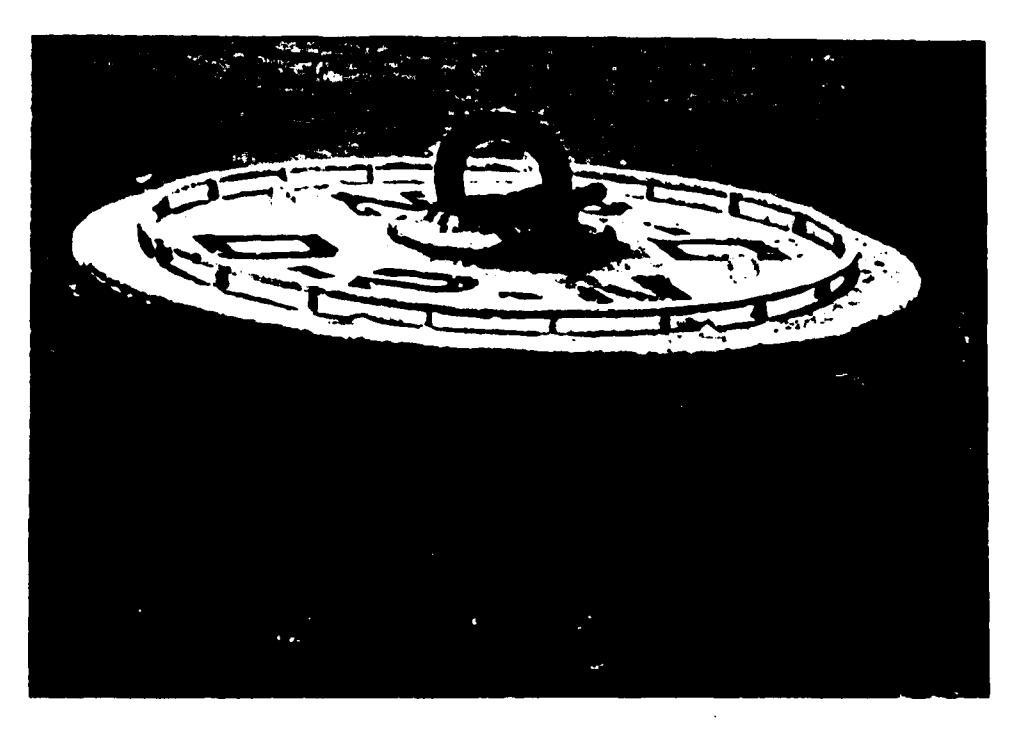
**Typical Rust Bleeding Underneath the Fiberglass**

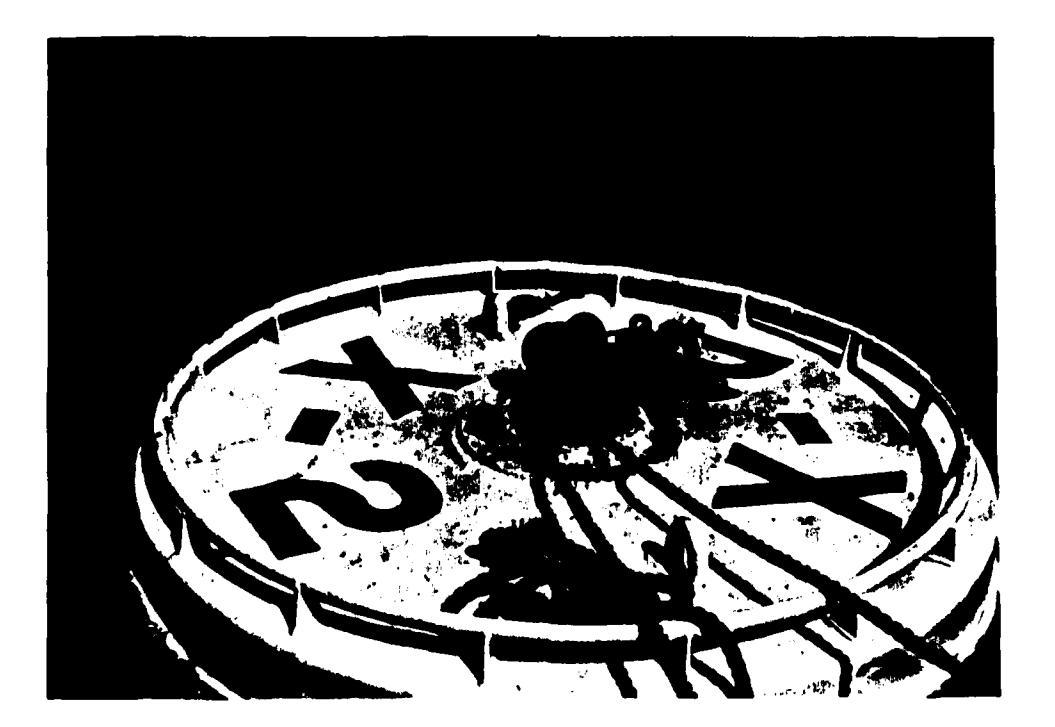
**Buoy X-2. Excellent Condition**
