DIEGO GARCIA FLEET MOORINGS INSPECTION REPORT

FP0-1-82(21)

OCEAN ENGINEERING AND CONSTRUCTION PROJECT OFFICE CHESAPEAKE DIVISION NAVAL FACILITIES ENGINEERING COMMAND WASHINGTON, DC 20374

30 SEPTEMBER 1982

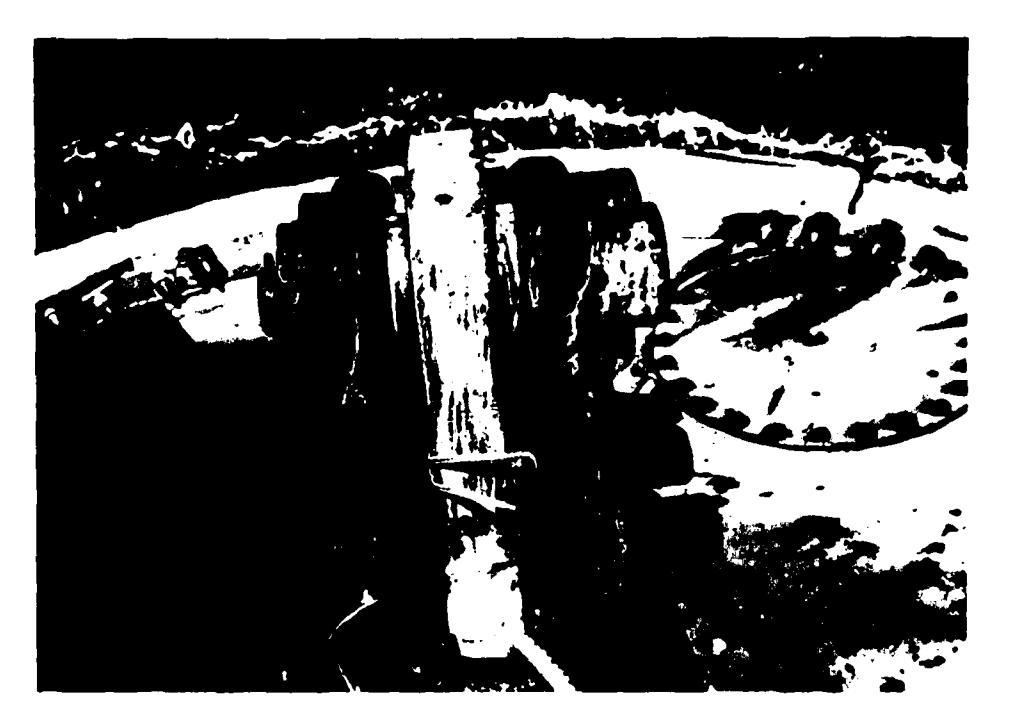
Rusted shackles and top deck plating of Buoy 11 NW.

Due to the deteriorated condition of the mooring buoys, it is recommended that the upper portion of each buoy be scraped, cleaned, and properly repainted, using specified/authorized materials, as soon as practical. Delays in refurbishing these buoys can only lead to further deterioration. Excessive delays in maintenance actions could lead to the requirement for replacement of the buoys. Both the northern and southern mooring dolphins should be overhauled by removing from the water and replacing all deteriorated chain and connecting hardware.

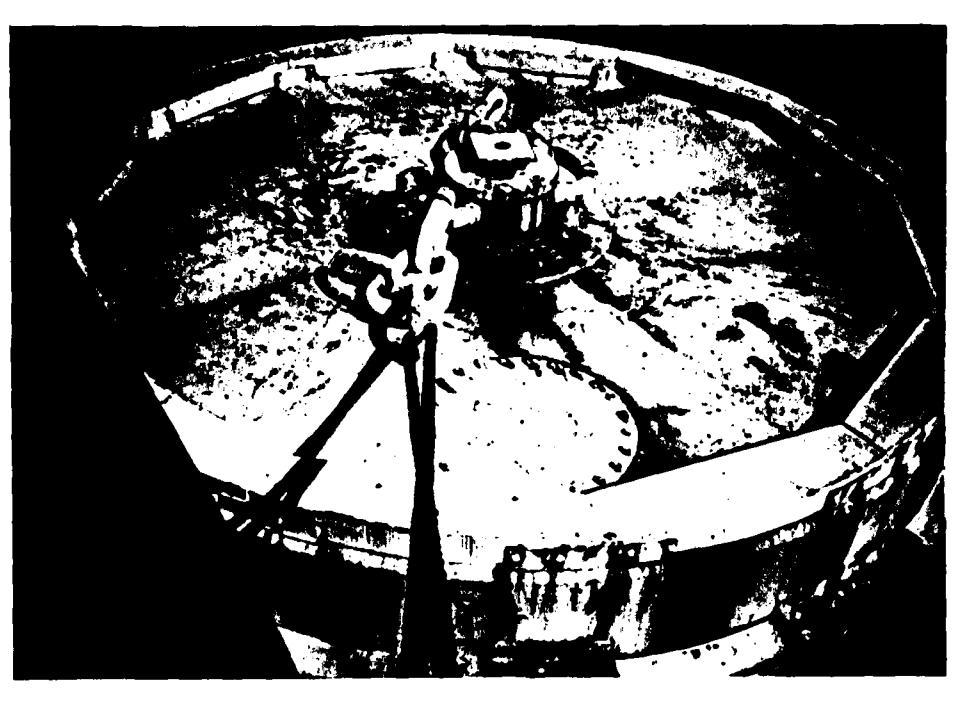
Top of Buoy 7N. Best condition of all buoys inspected.
