This report contains the results of the inspection of the fleet mooring located near Gaeta, Italy. A CHESNAVFACENGCOM-assigned Engineer-in-Charge and divers from Underwater Construction Team One conducted the inspection during the period 15-24 September 1983.

## NAVAL SUPPPORT ACTIVITY NAPLES

## (GAETA) FLEET MOORING UNDERWATER

#### INSPECTION REPORT

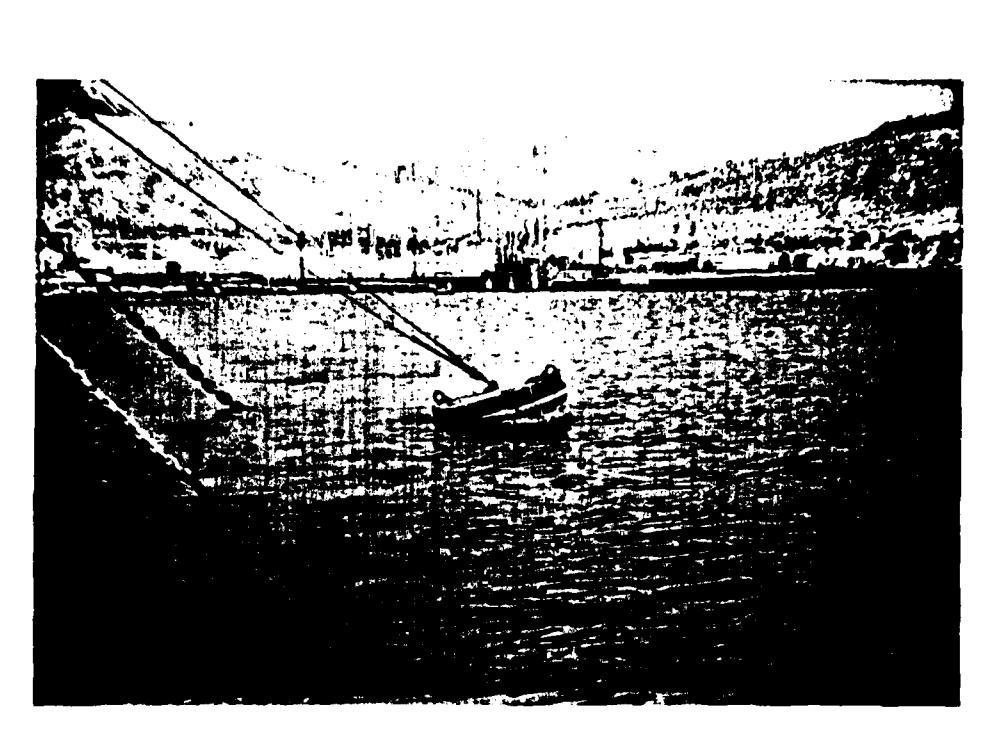
BOW MOORING. NOTE THE STEEP HAWSER ANGLE

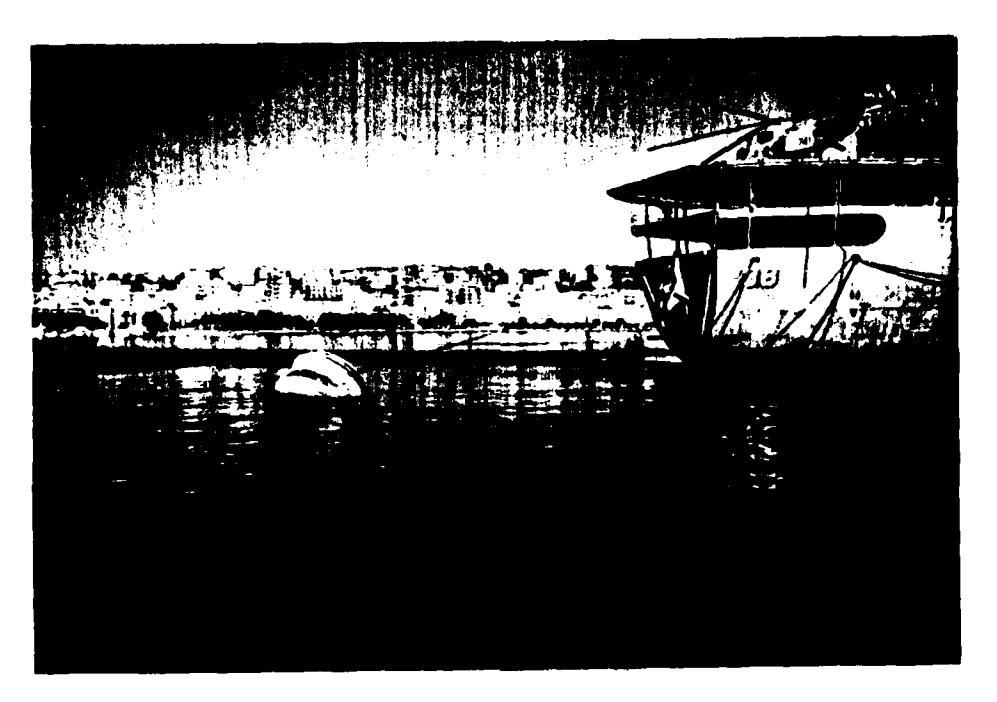
STERN MOORING UNDER LOAD

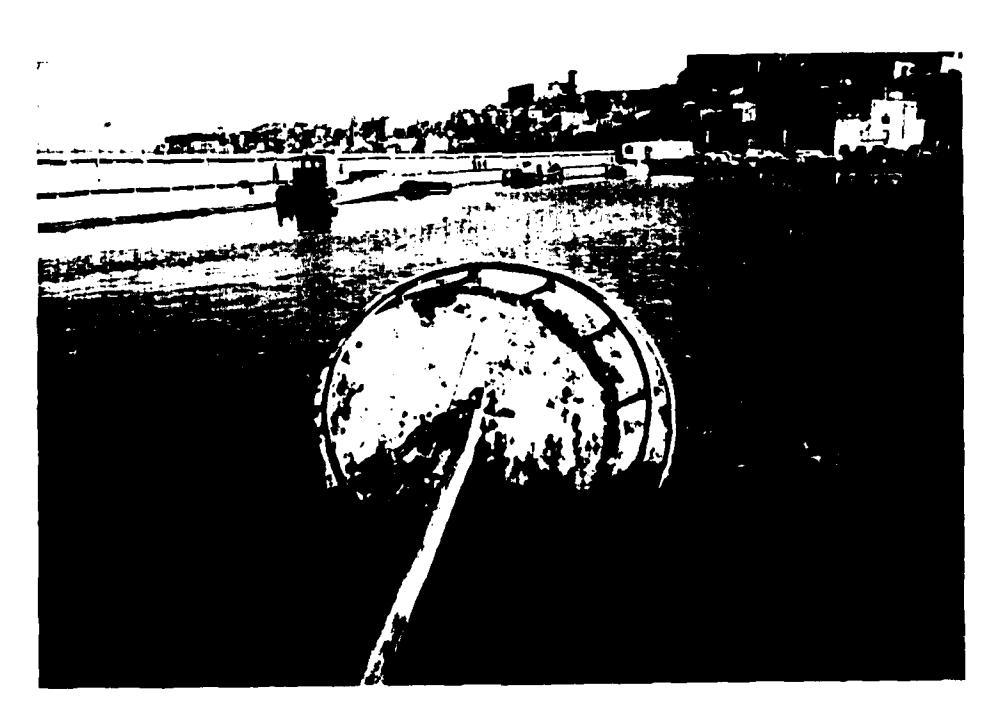
STERN MOORING UNDER LOAD

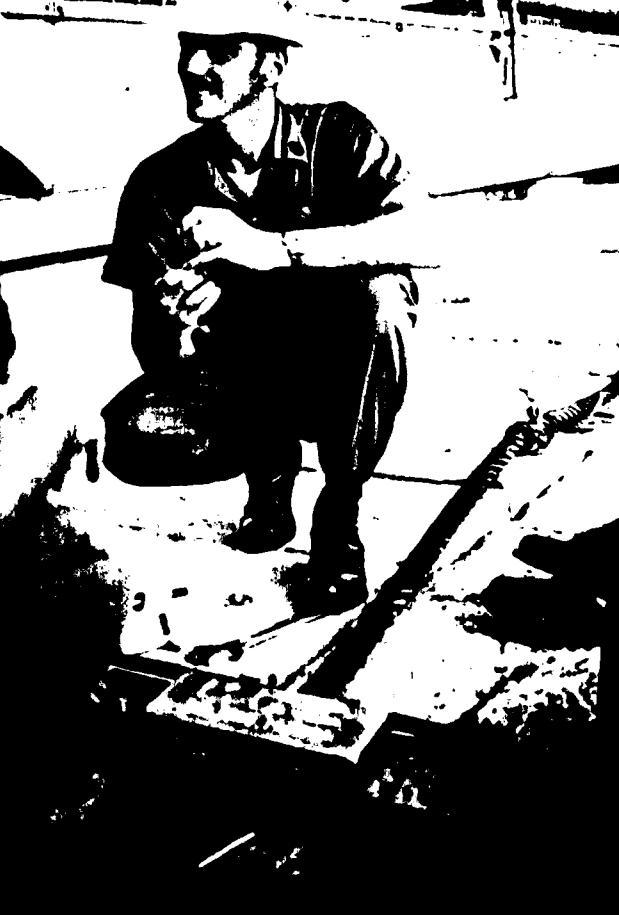
BOW MOORING. NEW SOUTHERN LEG 1 3/4" WIRE ROPE ANCHOR PENDANT WITH A 25-POUND ZINC ANODE ATTACHED. ANNEX D

A 25-pound anode was mounted on each of the northern and southern anchor pendants, below the swage fitting which connects the anchor pendant to the equalizer chain. The 1/2-inch continuity wire was continued down from the chain and attached to each zinc anode. A schematic drawing of the cathodic protection system is depicted in Figure B-1.

UCT One divers replaced the upper 50-foot section of the southern leg's anchor pendant. After removal of the damaged section, it was packed for shipment to the Naval Civil Engineering Laboratory (Attn: Mr. James Miller L42) for failure analysis. Shipment of the new anchor pendant from the United States to Gaeta took one week.
