Chena River Lakes Project Fairbanks, Alaska

Overview of Tanana River monitoring and research studies near Fairbanks, Alaska

OVERVIEW OF TANANA RIVER MONITORING AND
RESEARCH STUDIES NEAR FAIRBANKS, ALASKA
(with Appendices)

Prepared by
U.S. Army Cold Regions Research and Engineering Laboratory
Hanover, New Hampshire

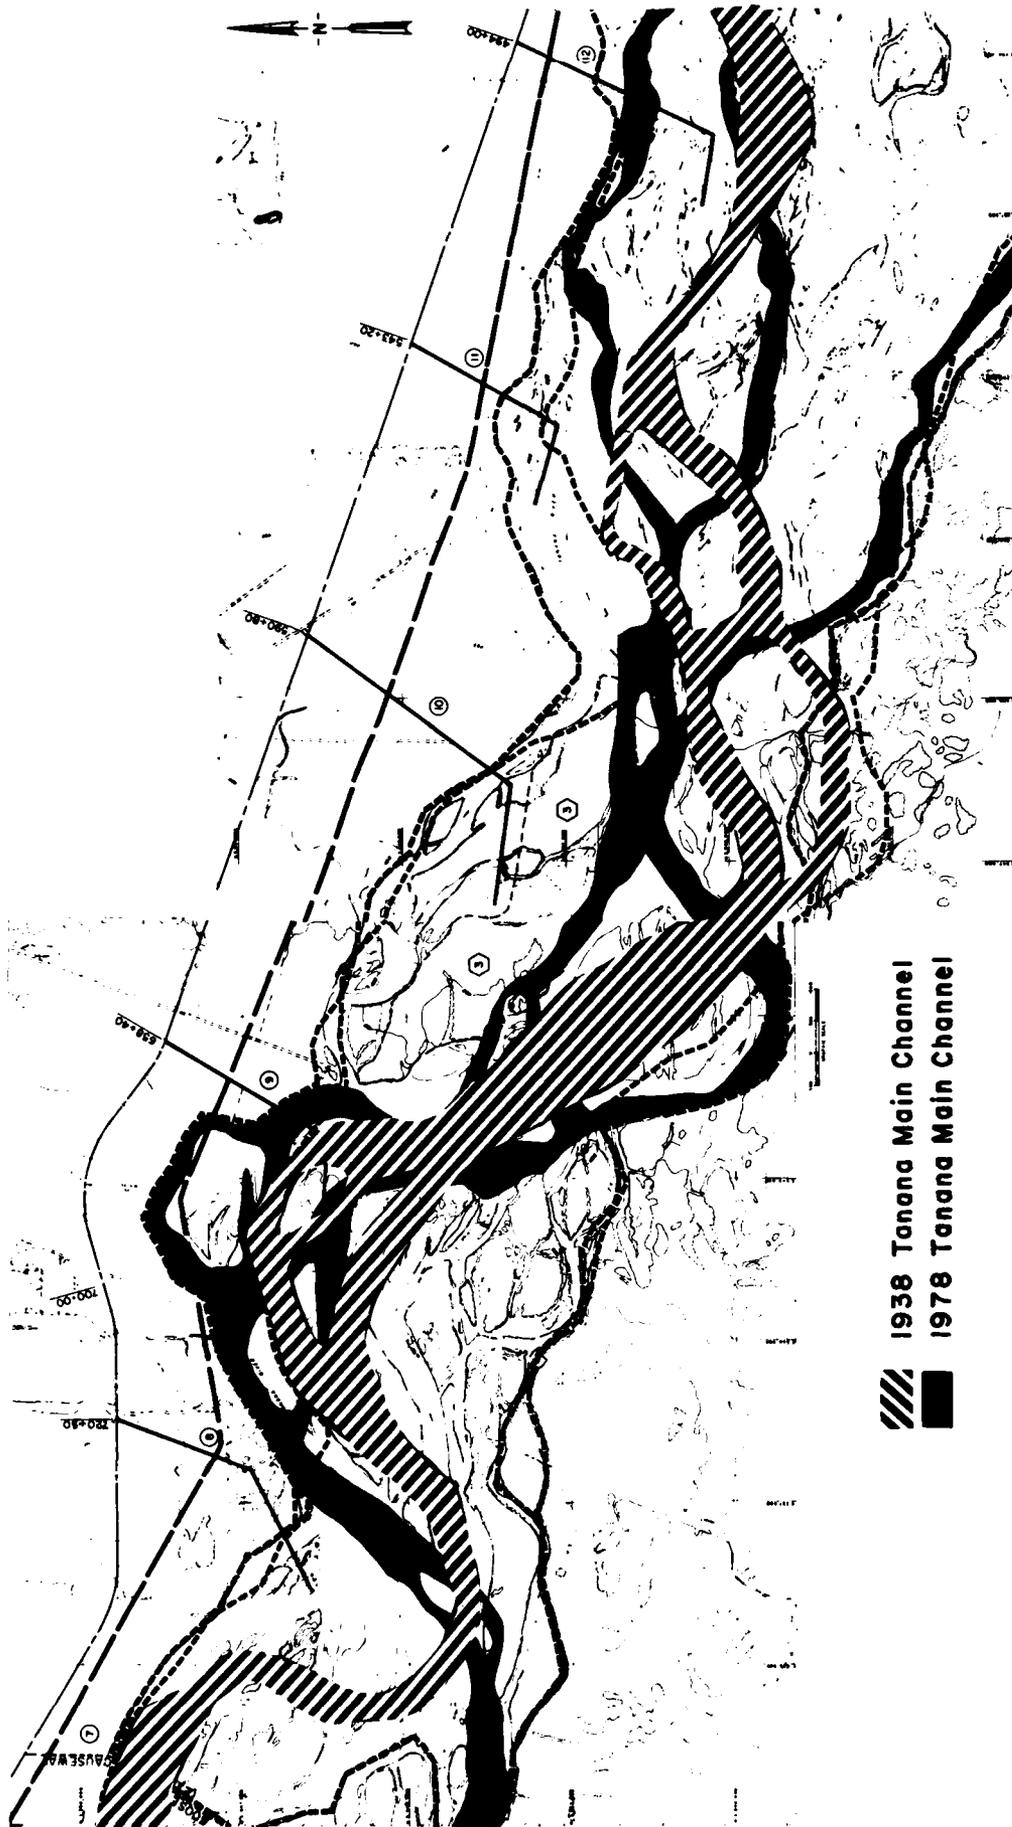
Figure 5.1. Apparent downstream migration of main channel loops upstream of Goose Island, 1938-1978.

1,200 ft in a 40-year period, an average rate of about 30 ft per year (Figure 5.1).

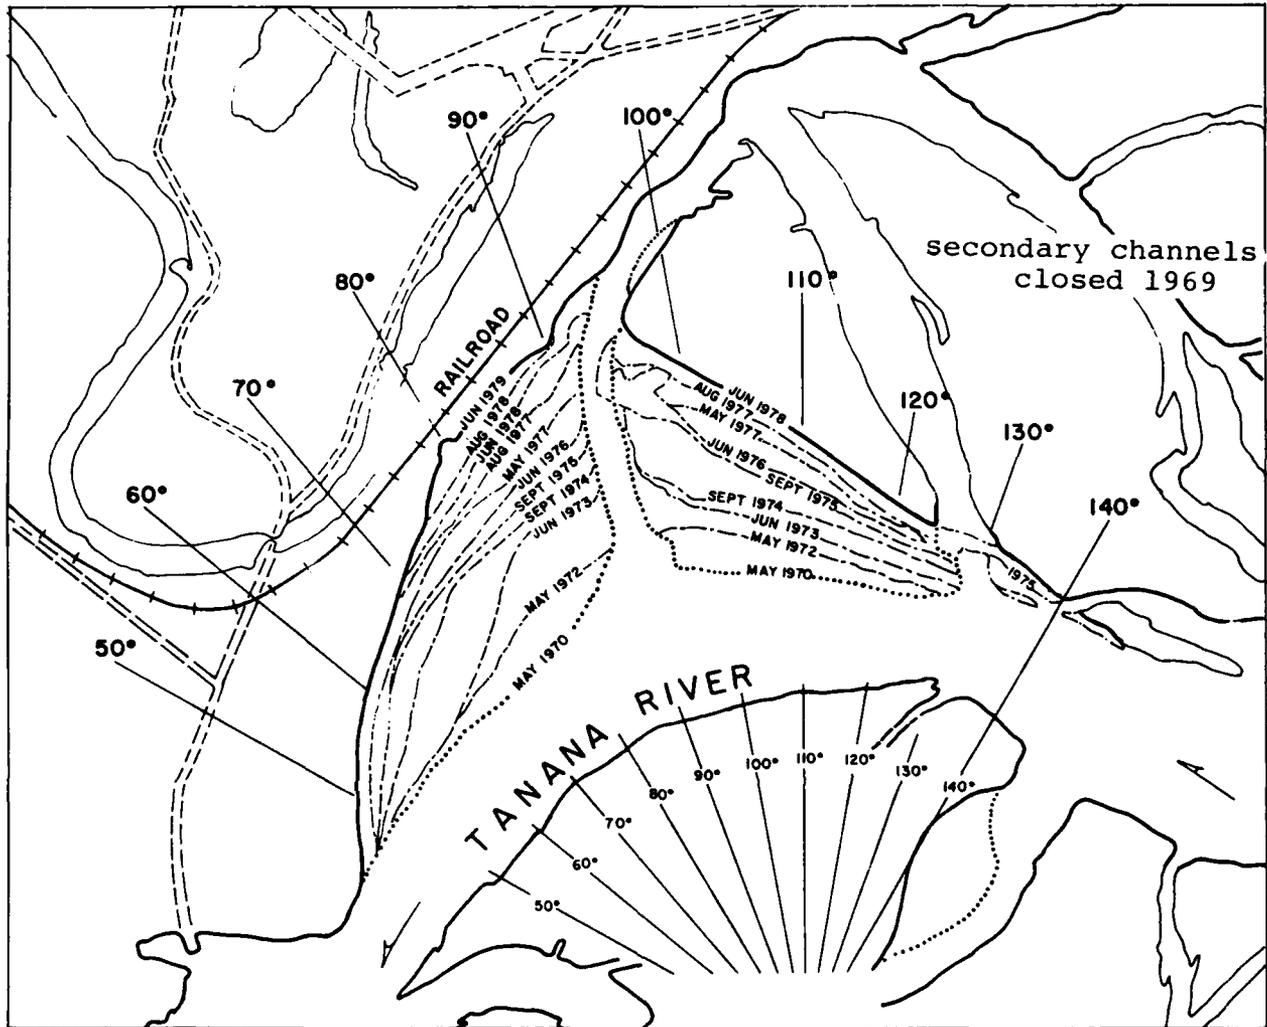
Figure 5.2. Bank recession, 1970-79, in Bend A, Phase III area. Based on D.M. 27 (Corps of Engineers, 1979).

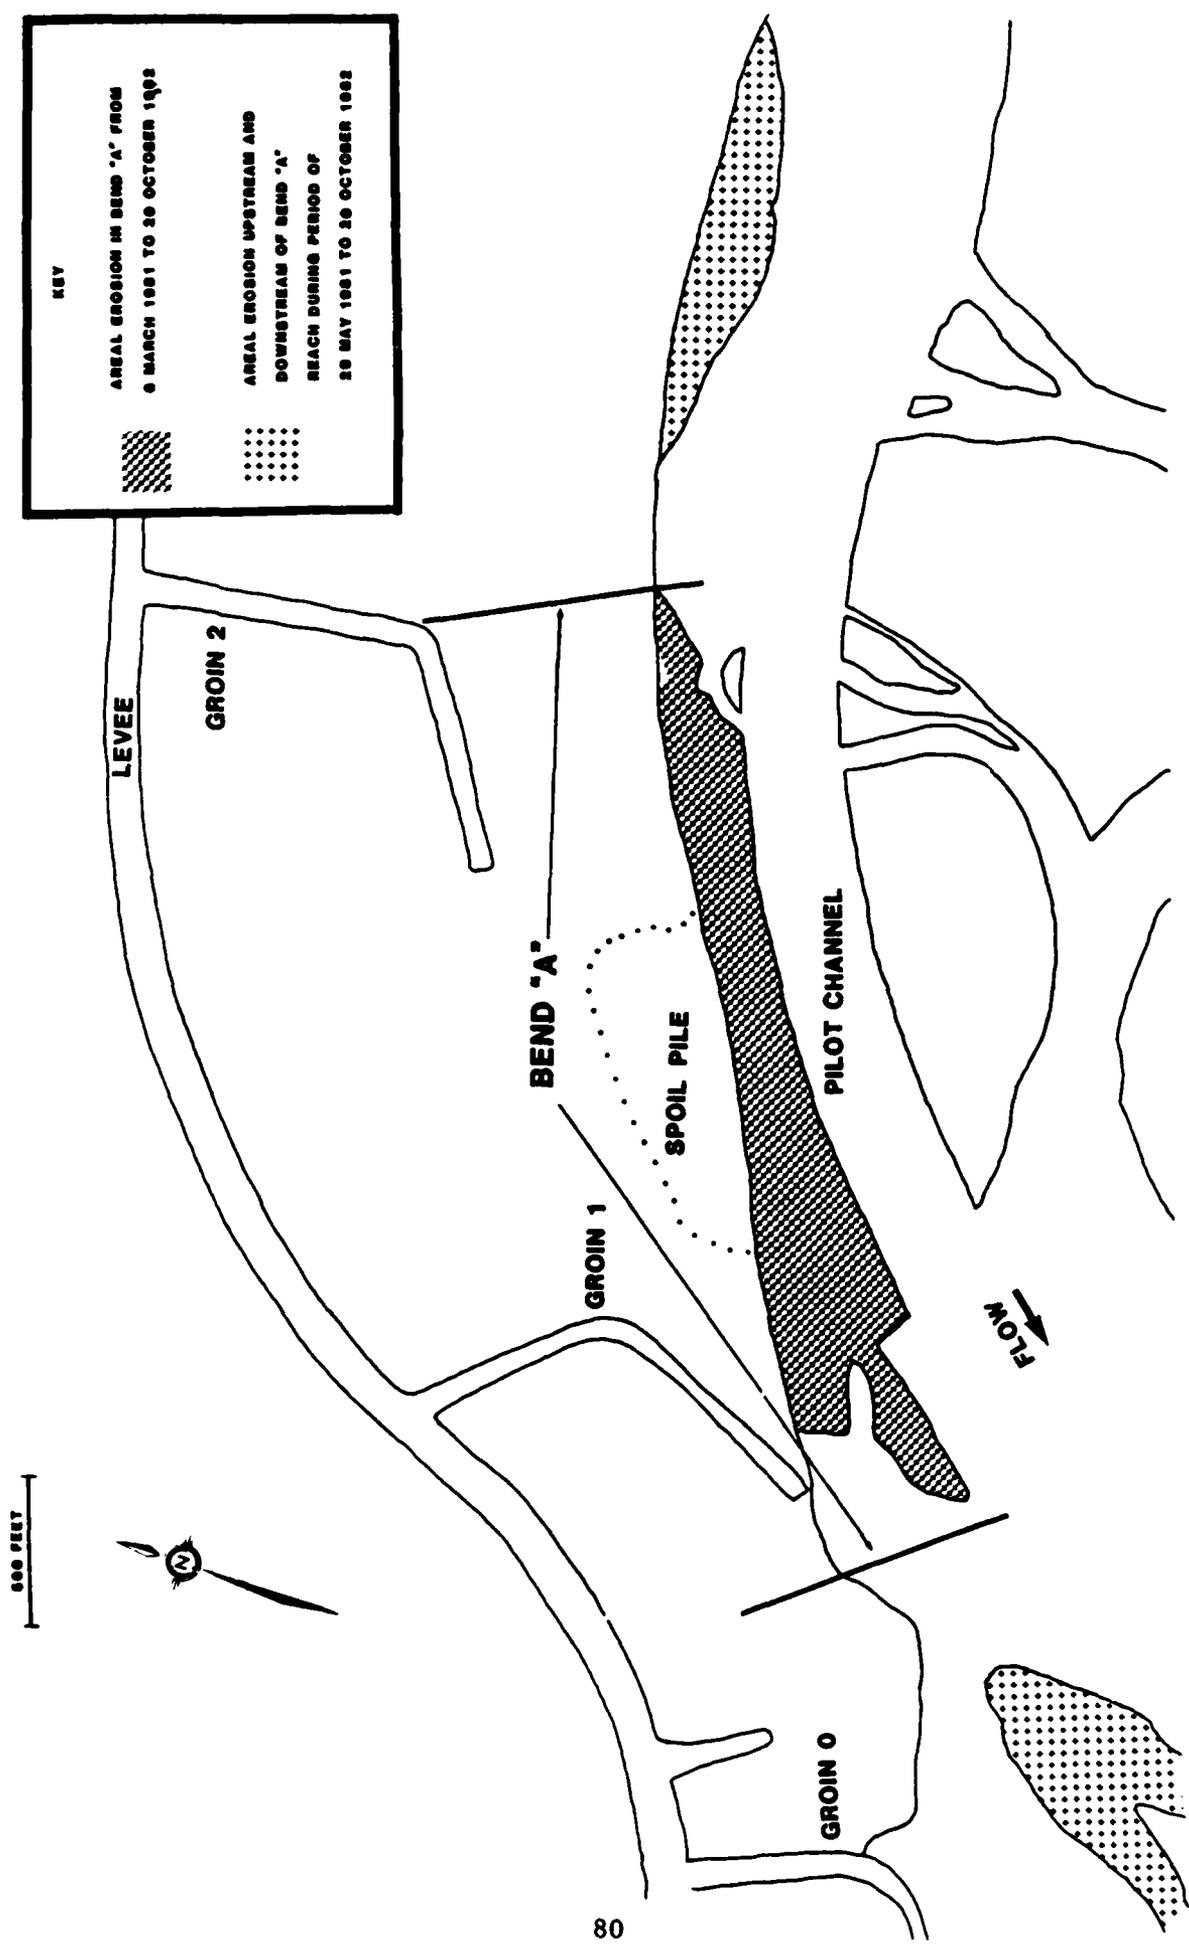
Figure 6.3. Bend A post-construction areal erosion.

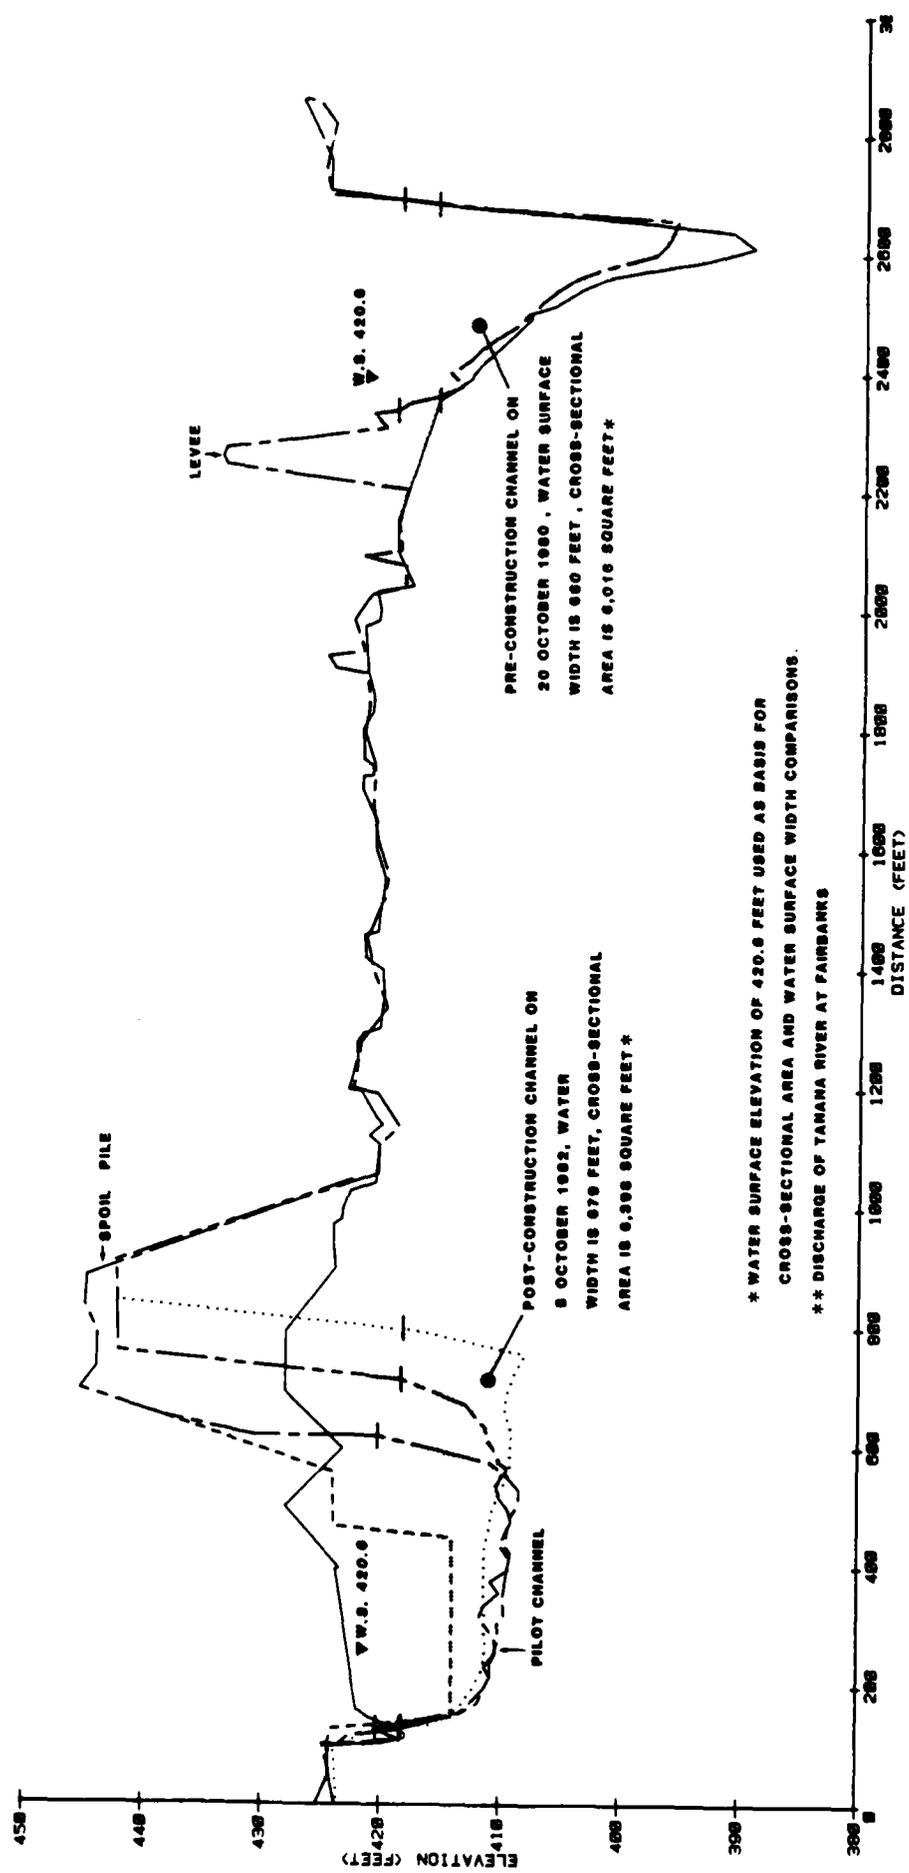
Figure 6.4. Comparison of cross-sectional changes at cross section 4A.

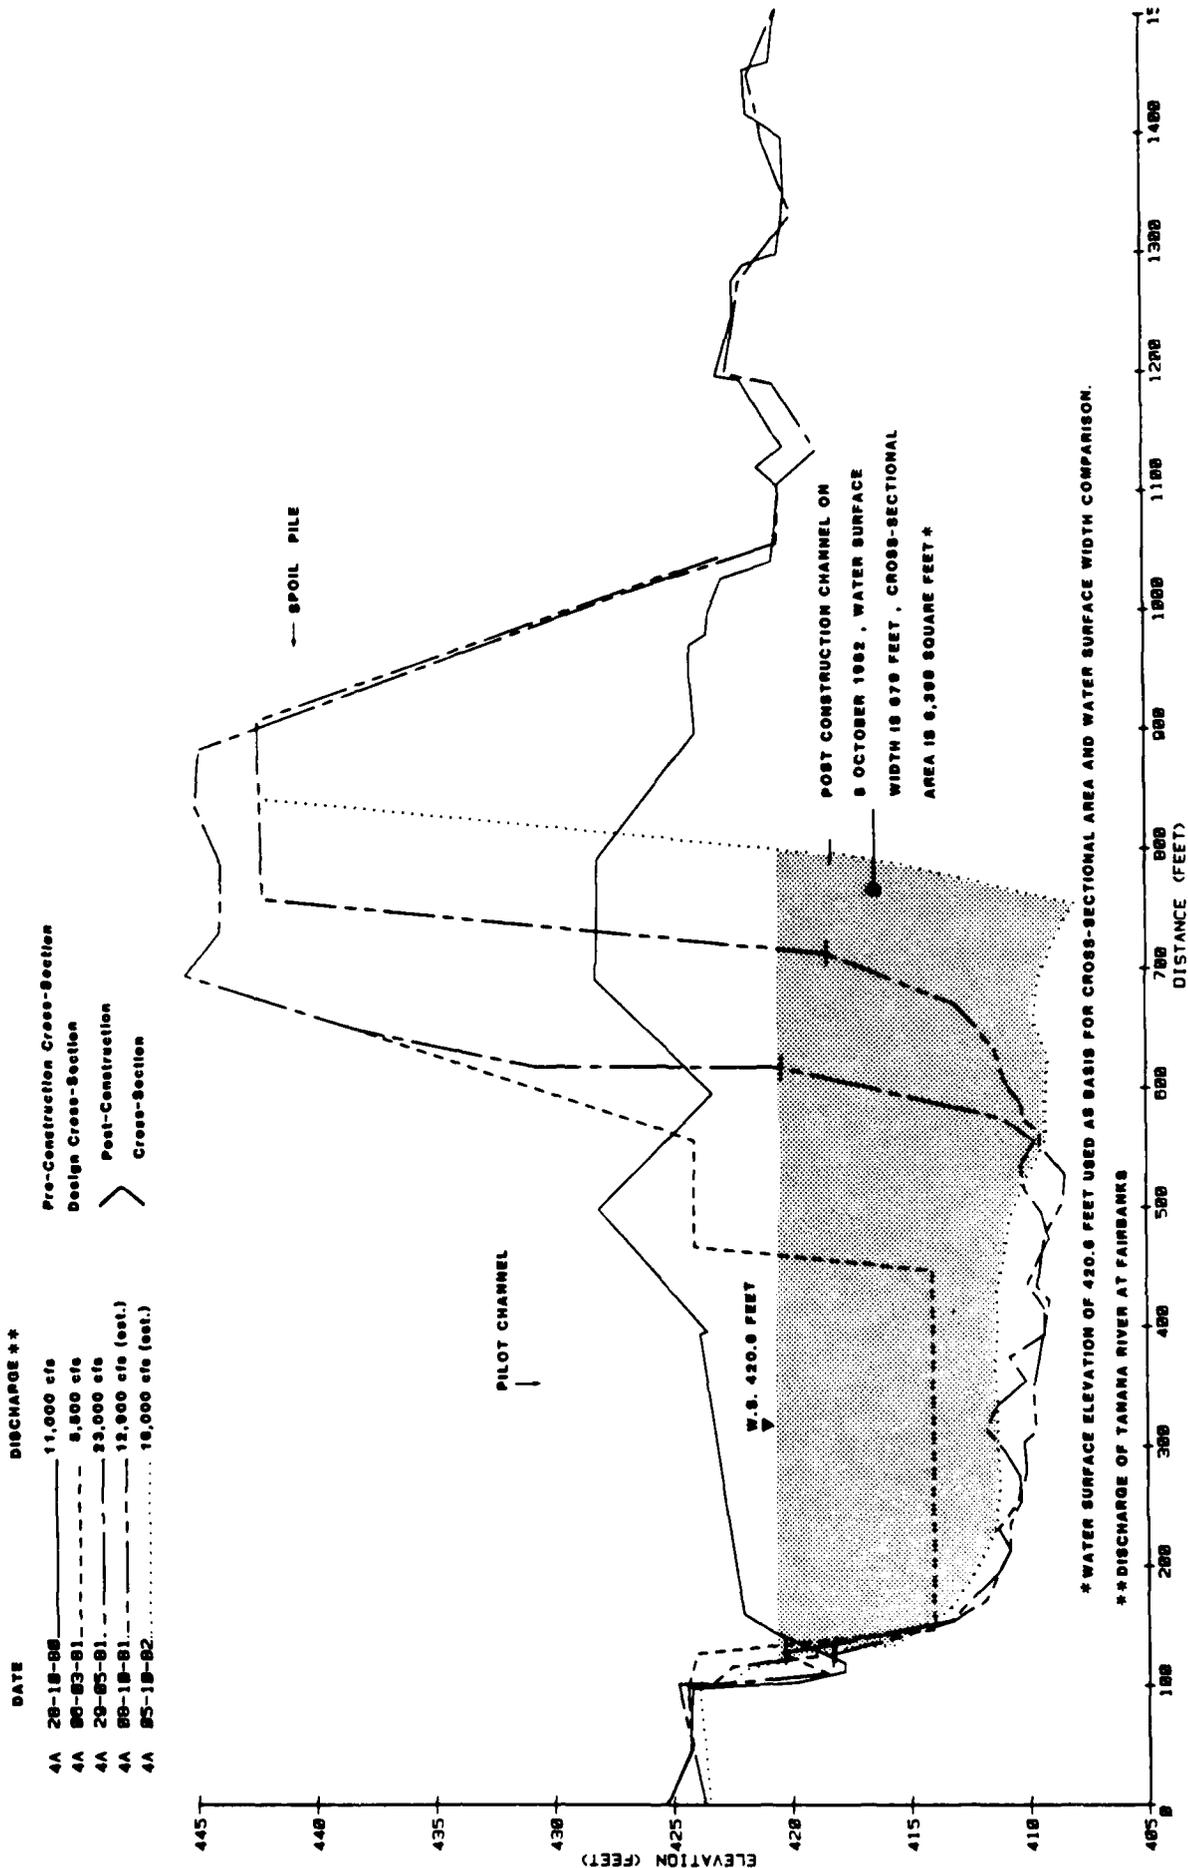
Figure 6.5. Detail of cross-sectional changes at Pilot Channel and spoil pile, cross section 4A.

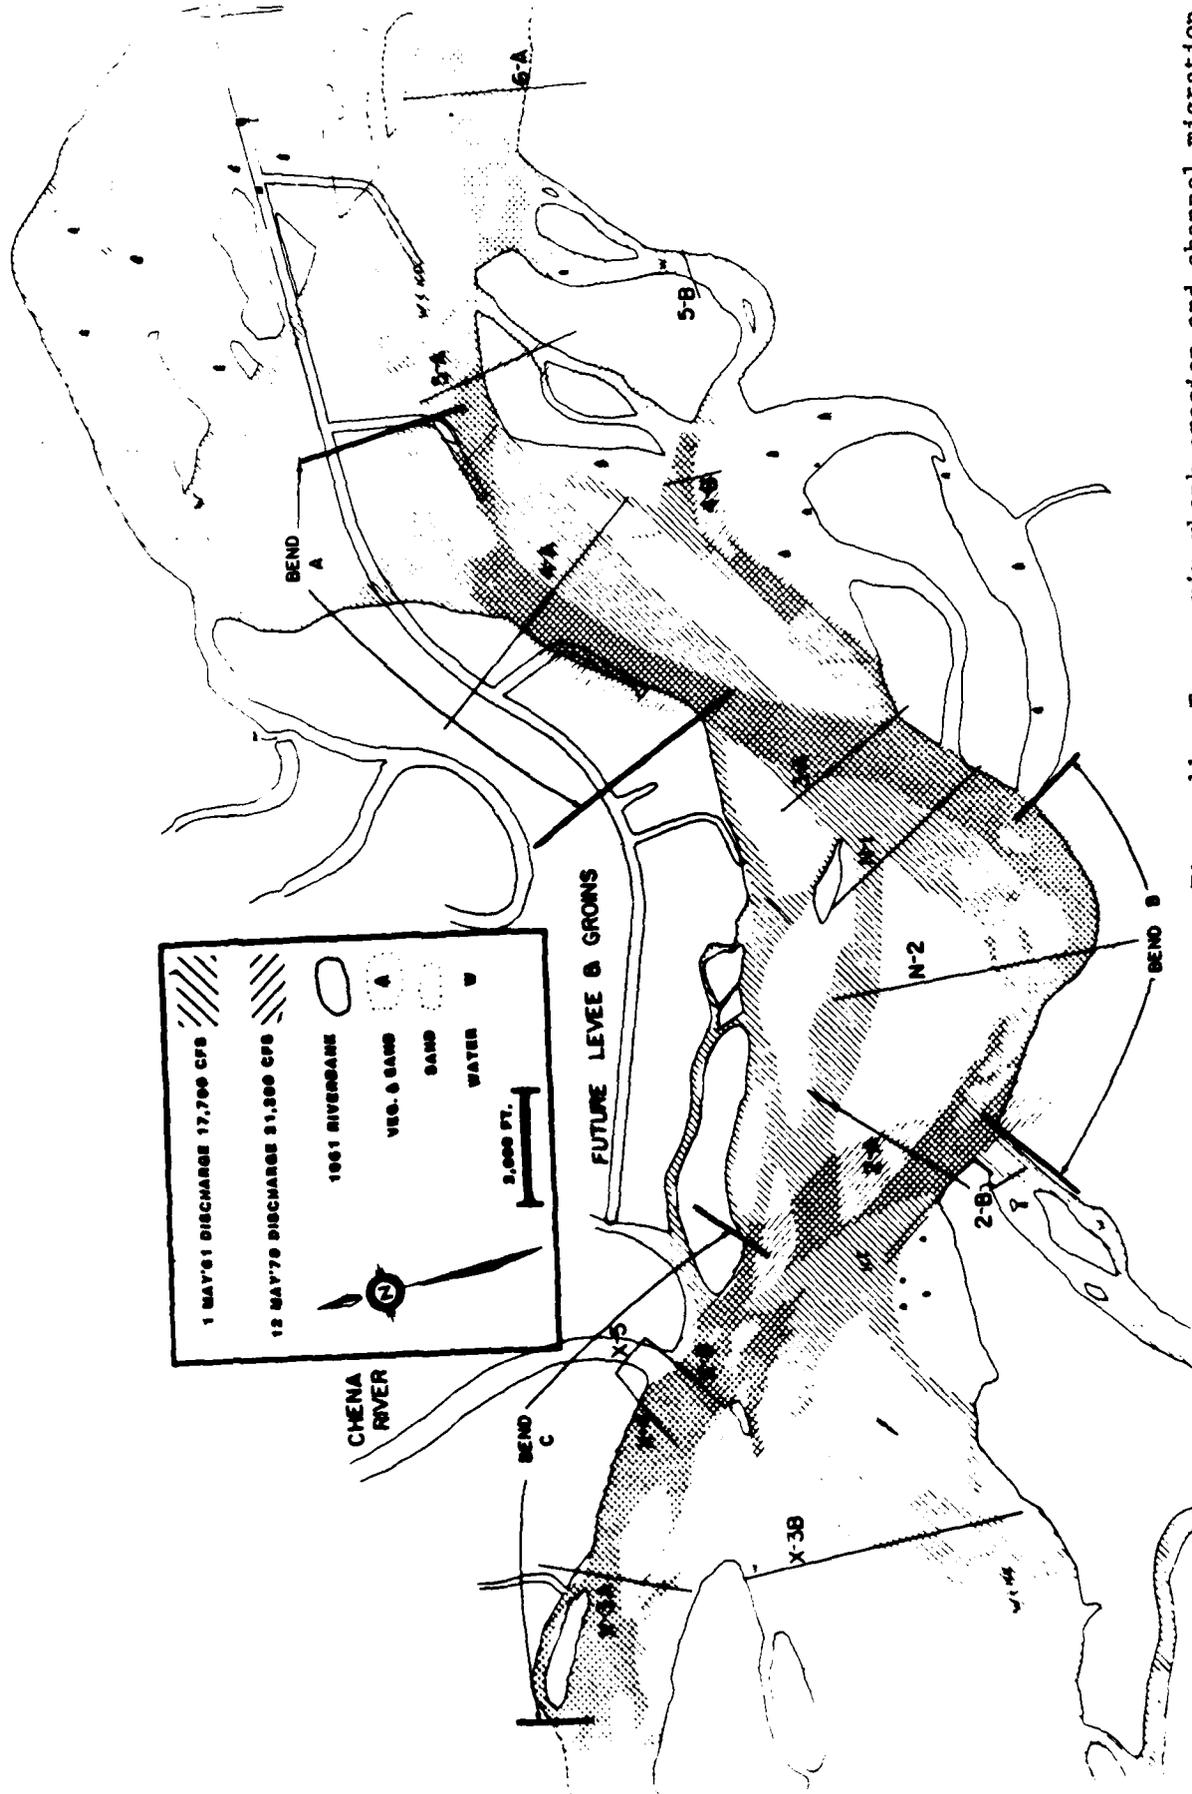
Figure 11. Tanana riverbank erosion and channel migration from 29 May 1981 to 20 October 1981.

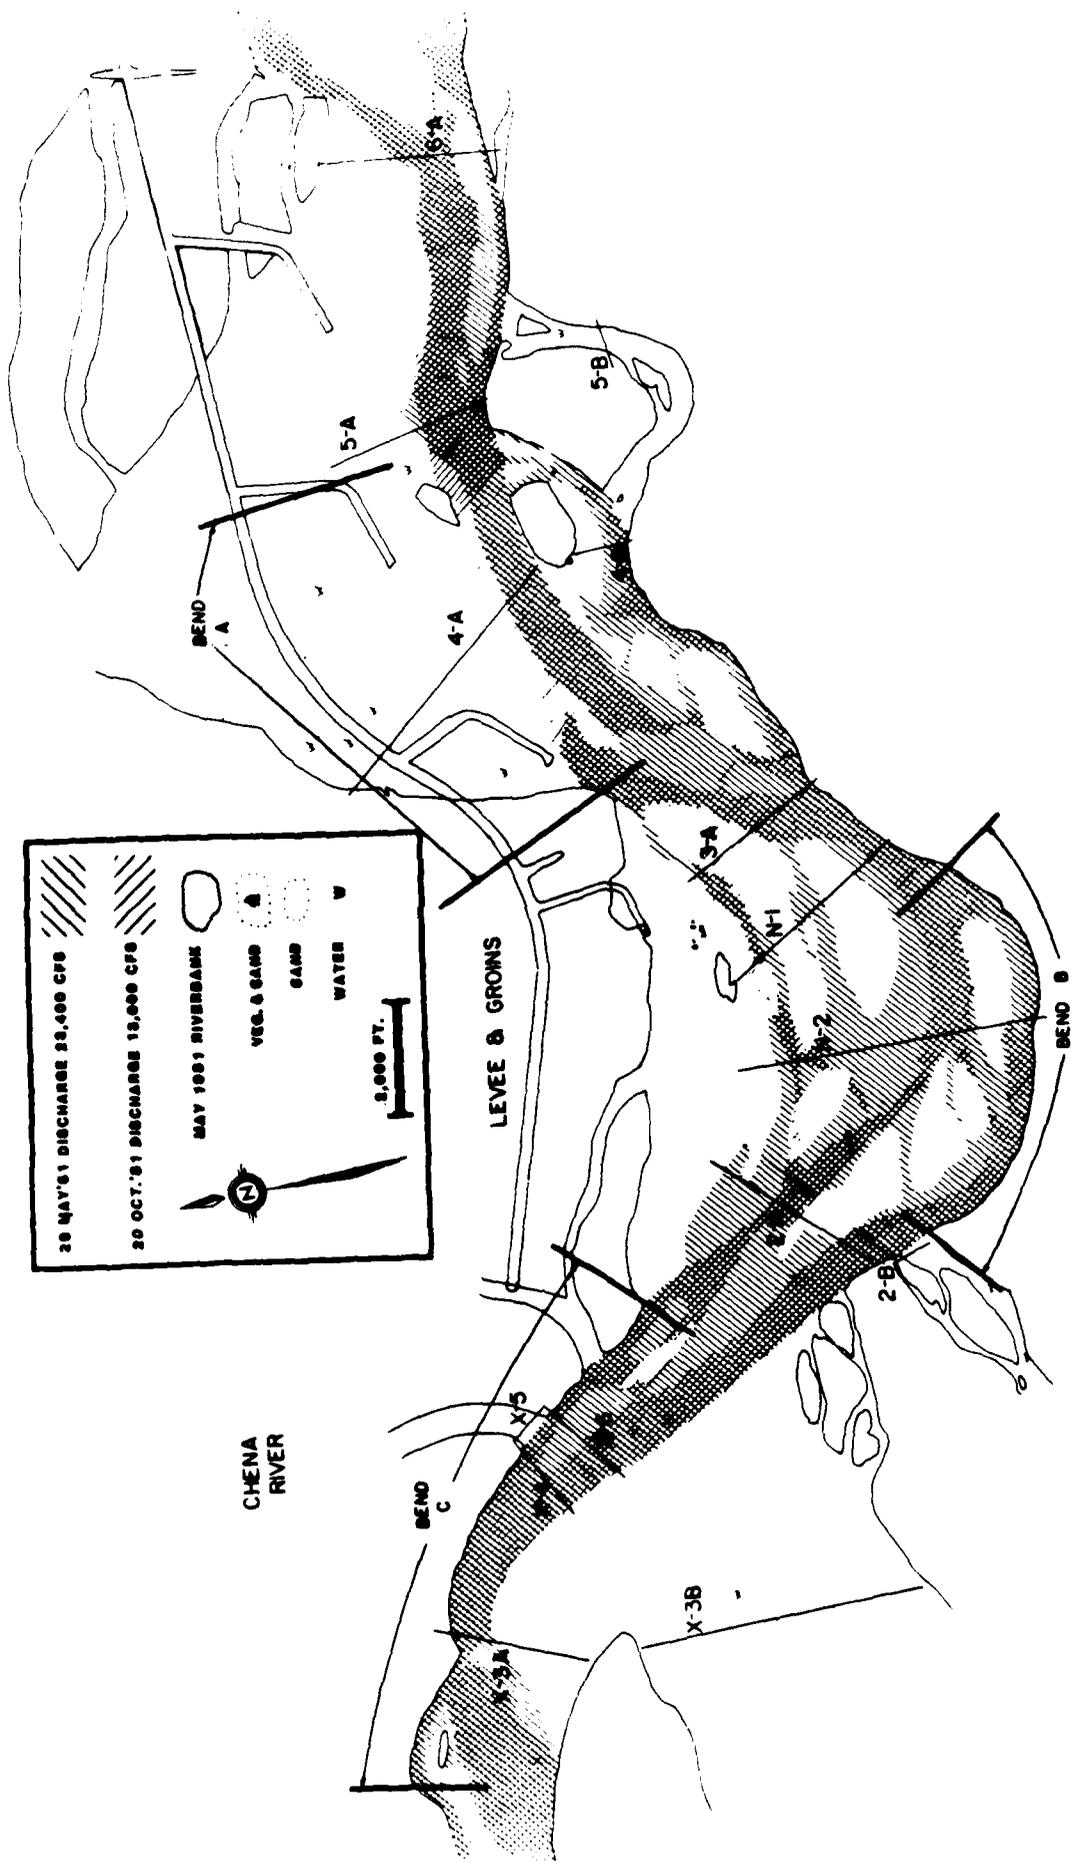
Figure 13. Tanana riverbank erosion and channel migration from 29 May 1981 to 20 October 1981.

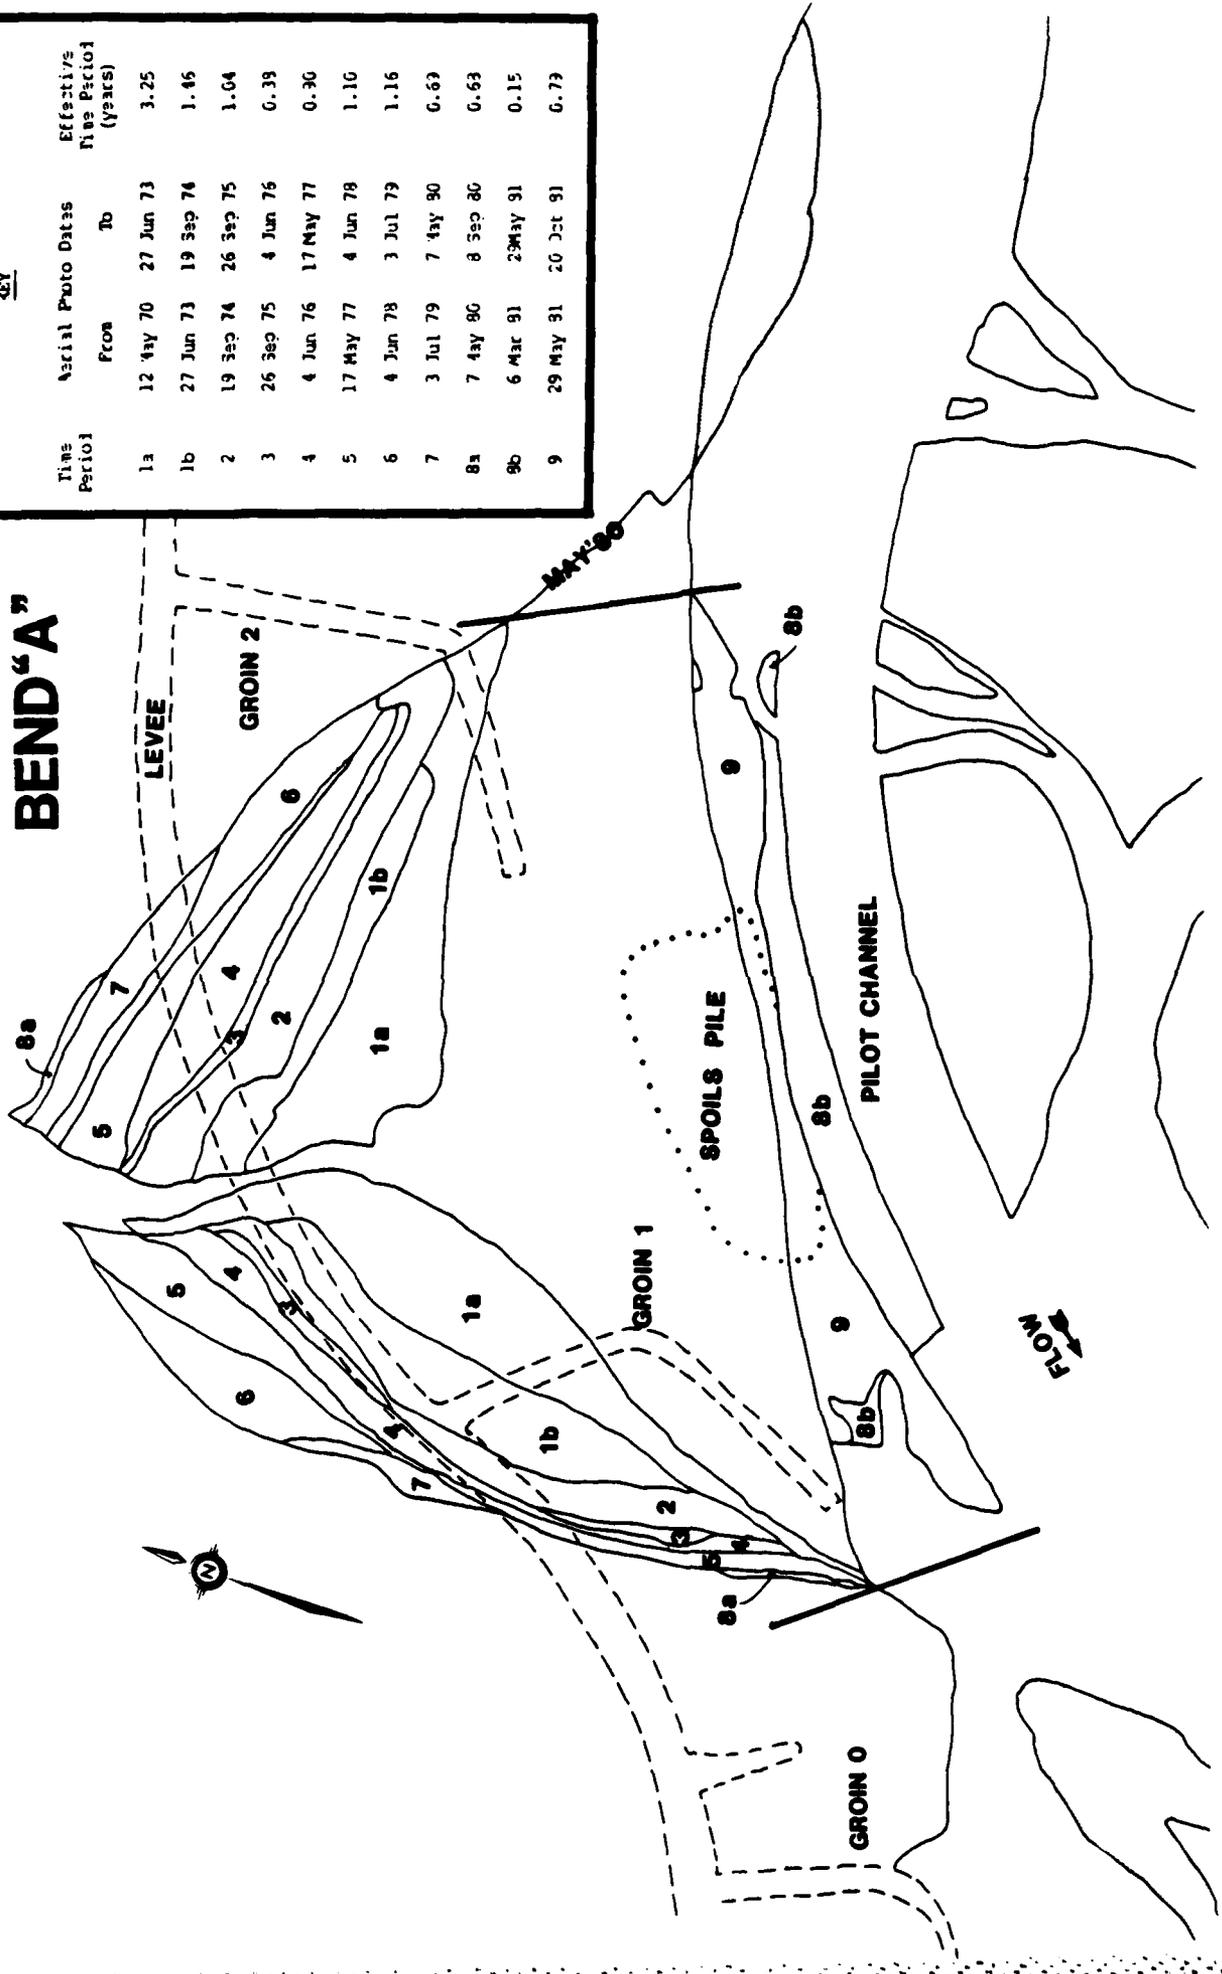
Figure 14. Riverbank erosion detail, Bend A, 12 May 1970 to 20 October 1981.

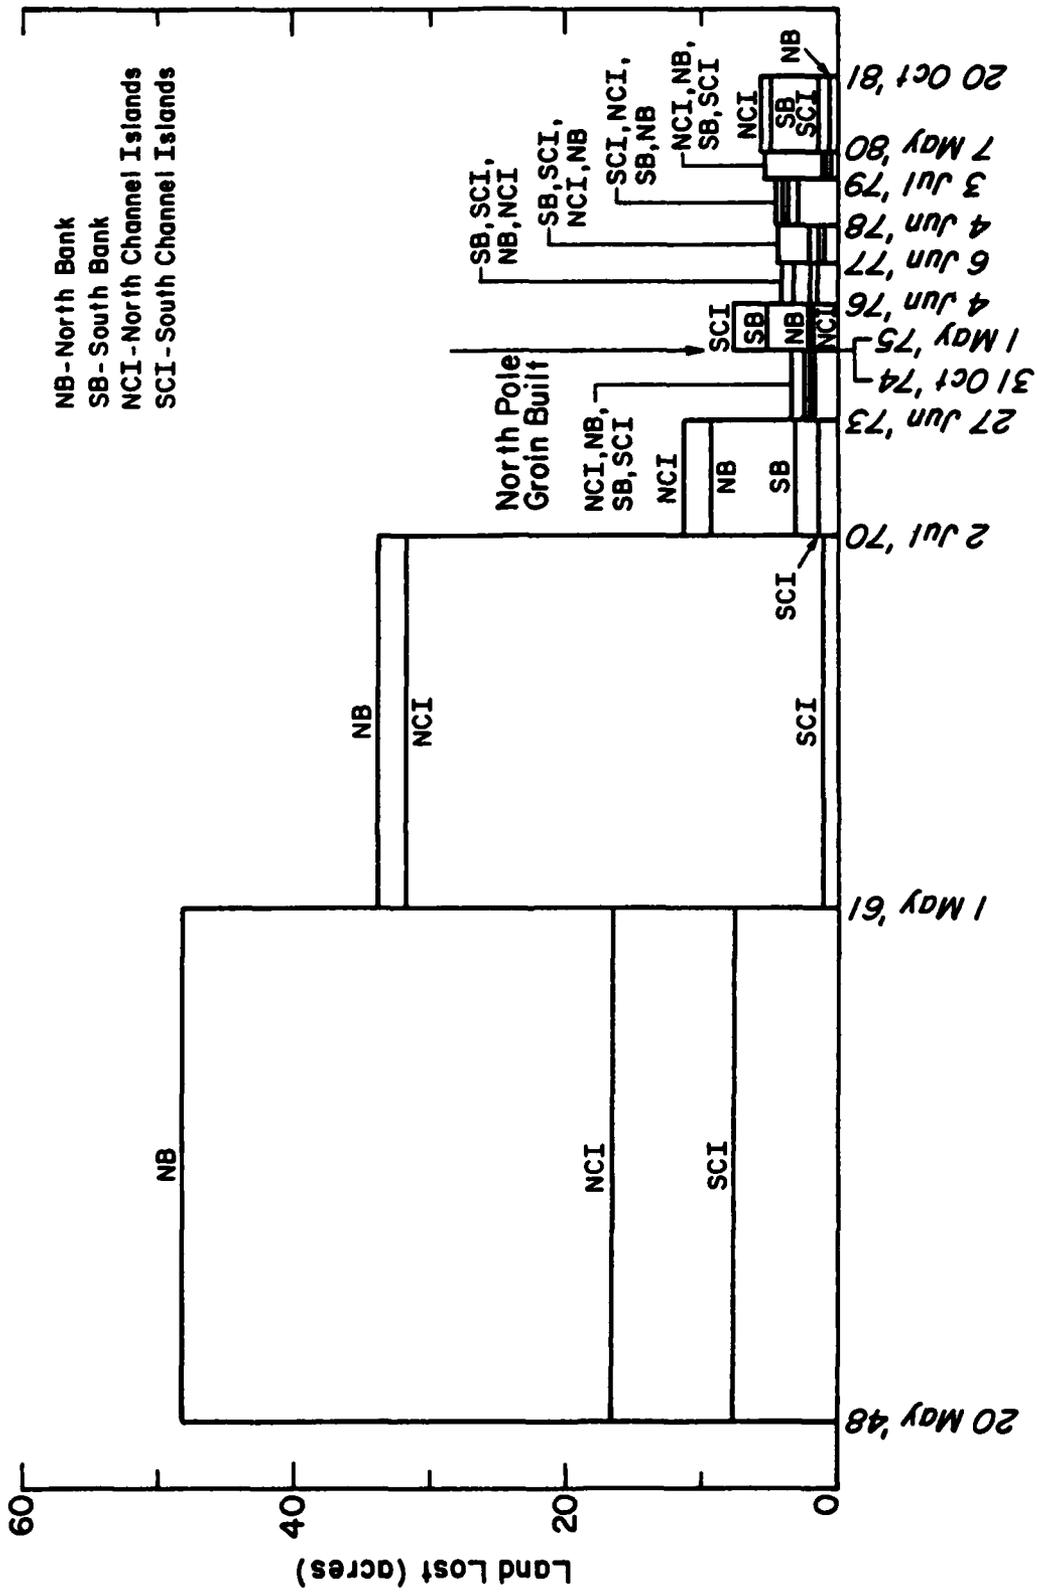
Figure 5. Land lost in the North Pole groin area.

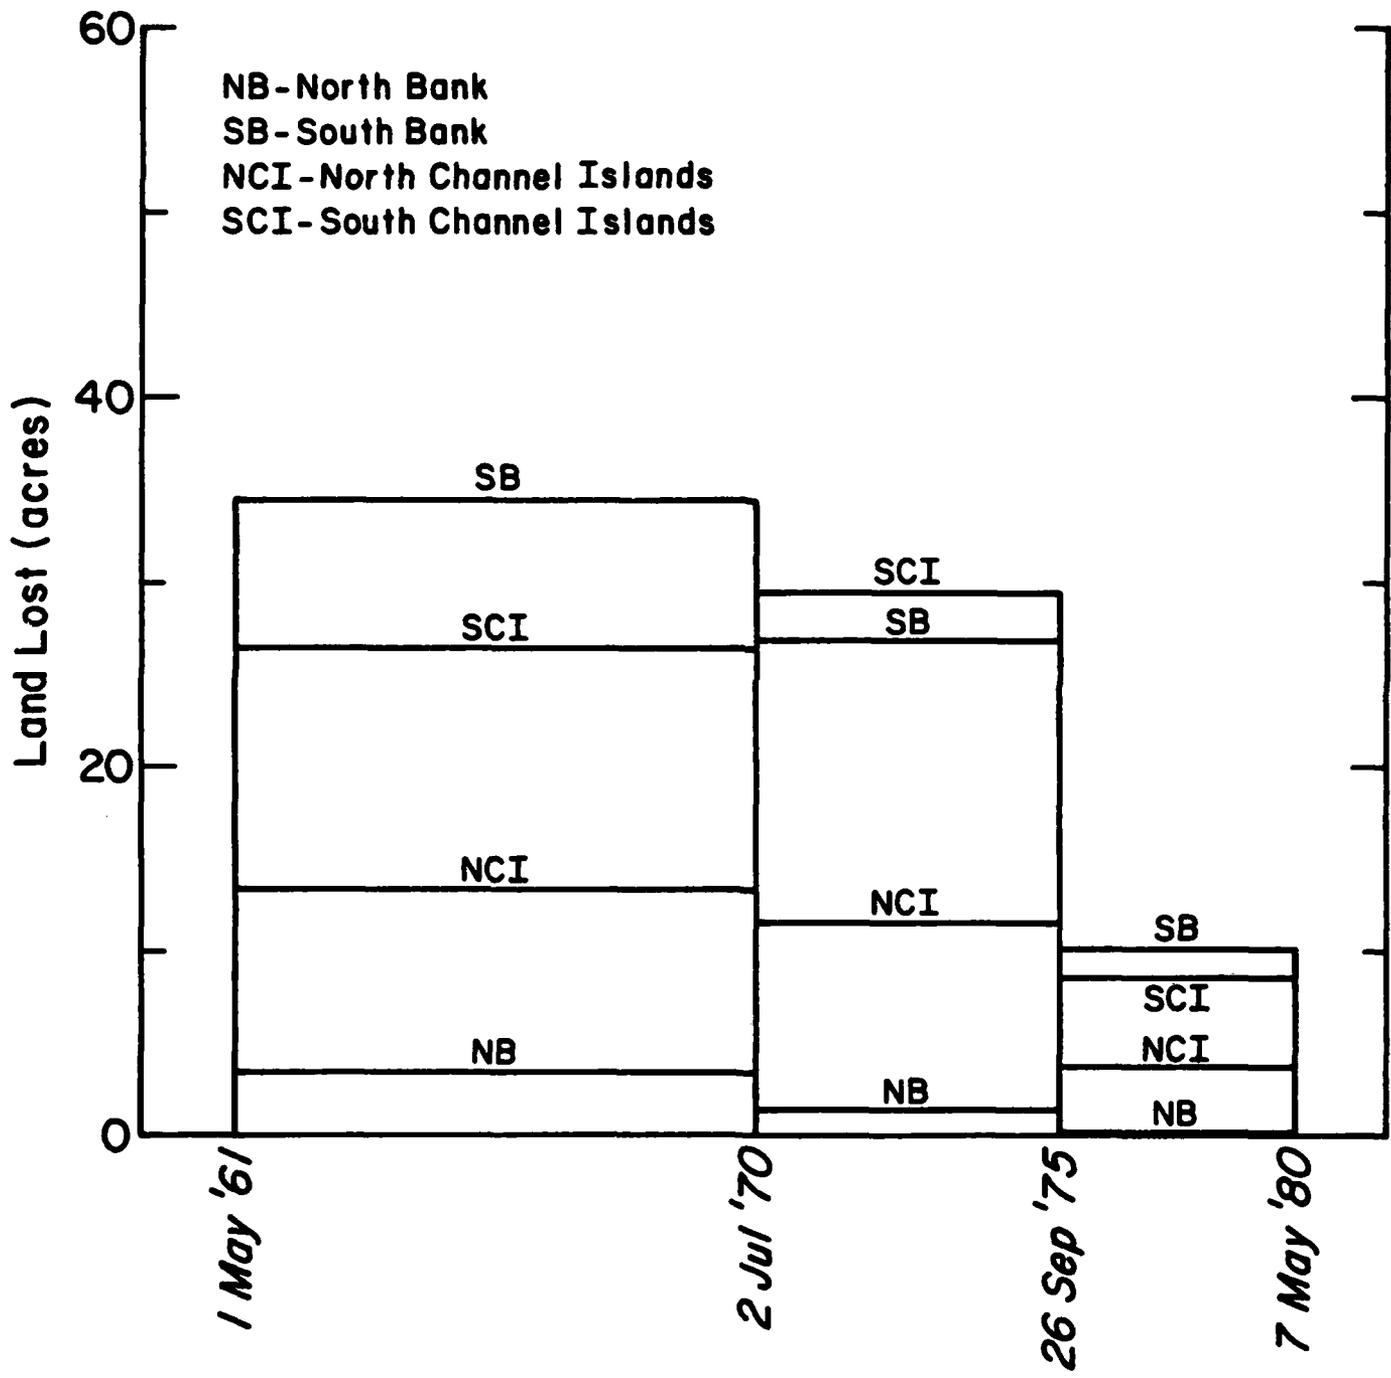
Figure 15. Land lost in the area upstream of the North Pole groin.

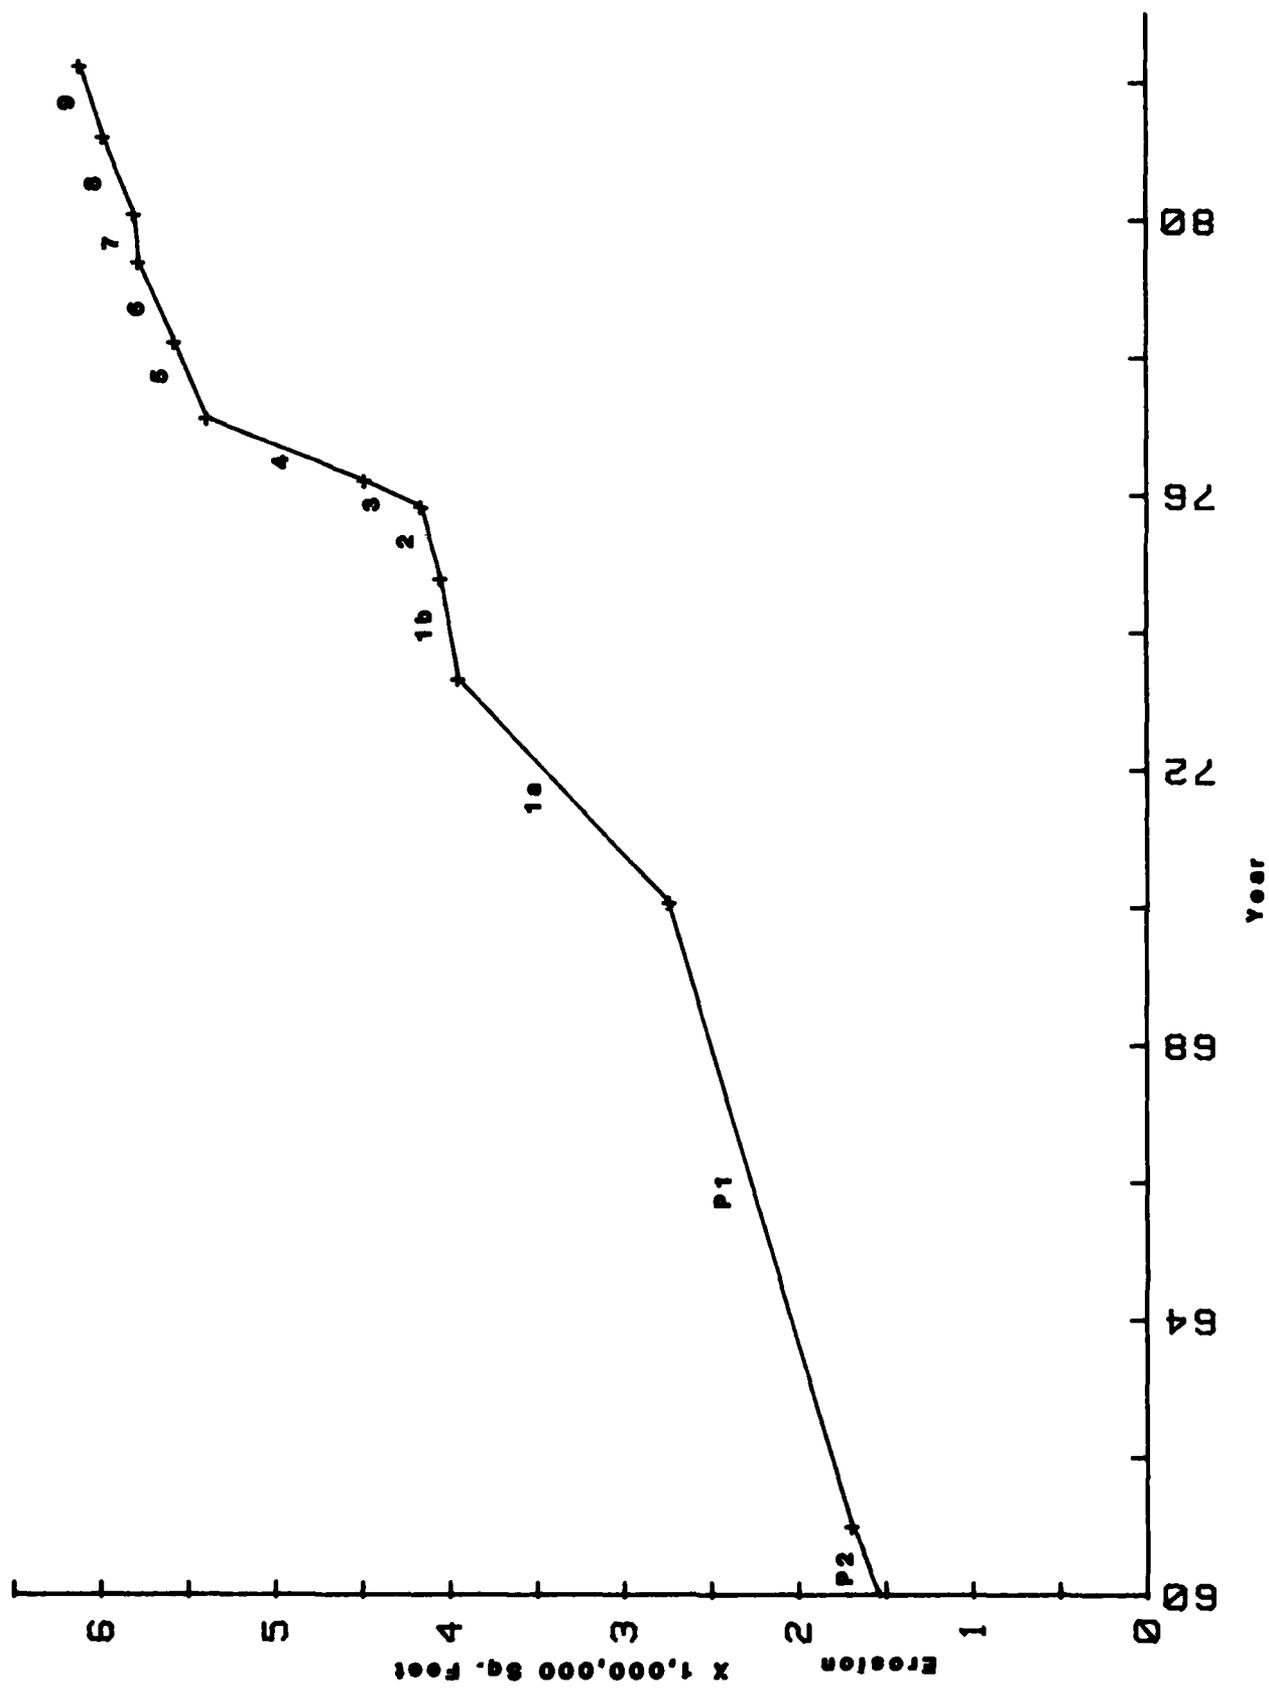
Figure 4. North bank cumulative erosion.
