Chena River Lakes Project Fairbanks, Alaska

Overview of Tanana River monitoring and research studies near Fairbanks, Alaska

OVERVIEW OF TANANA RIVER MONITORING AND
RESEARCH STUDIES NEAR FAIRBANKS, ALASKA
(with Appendices)

Prepared by
U.S. Army Cold Regions Research and Engineering Laboratory
Hanover, New Hampshire

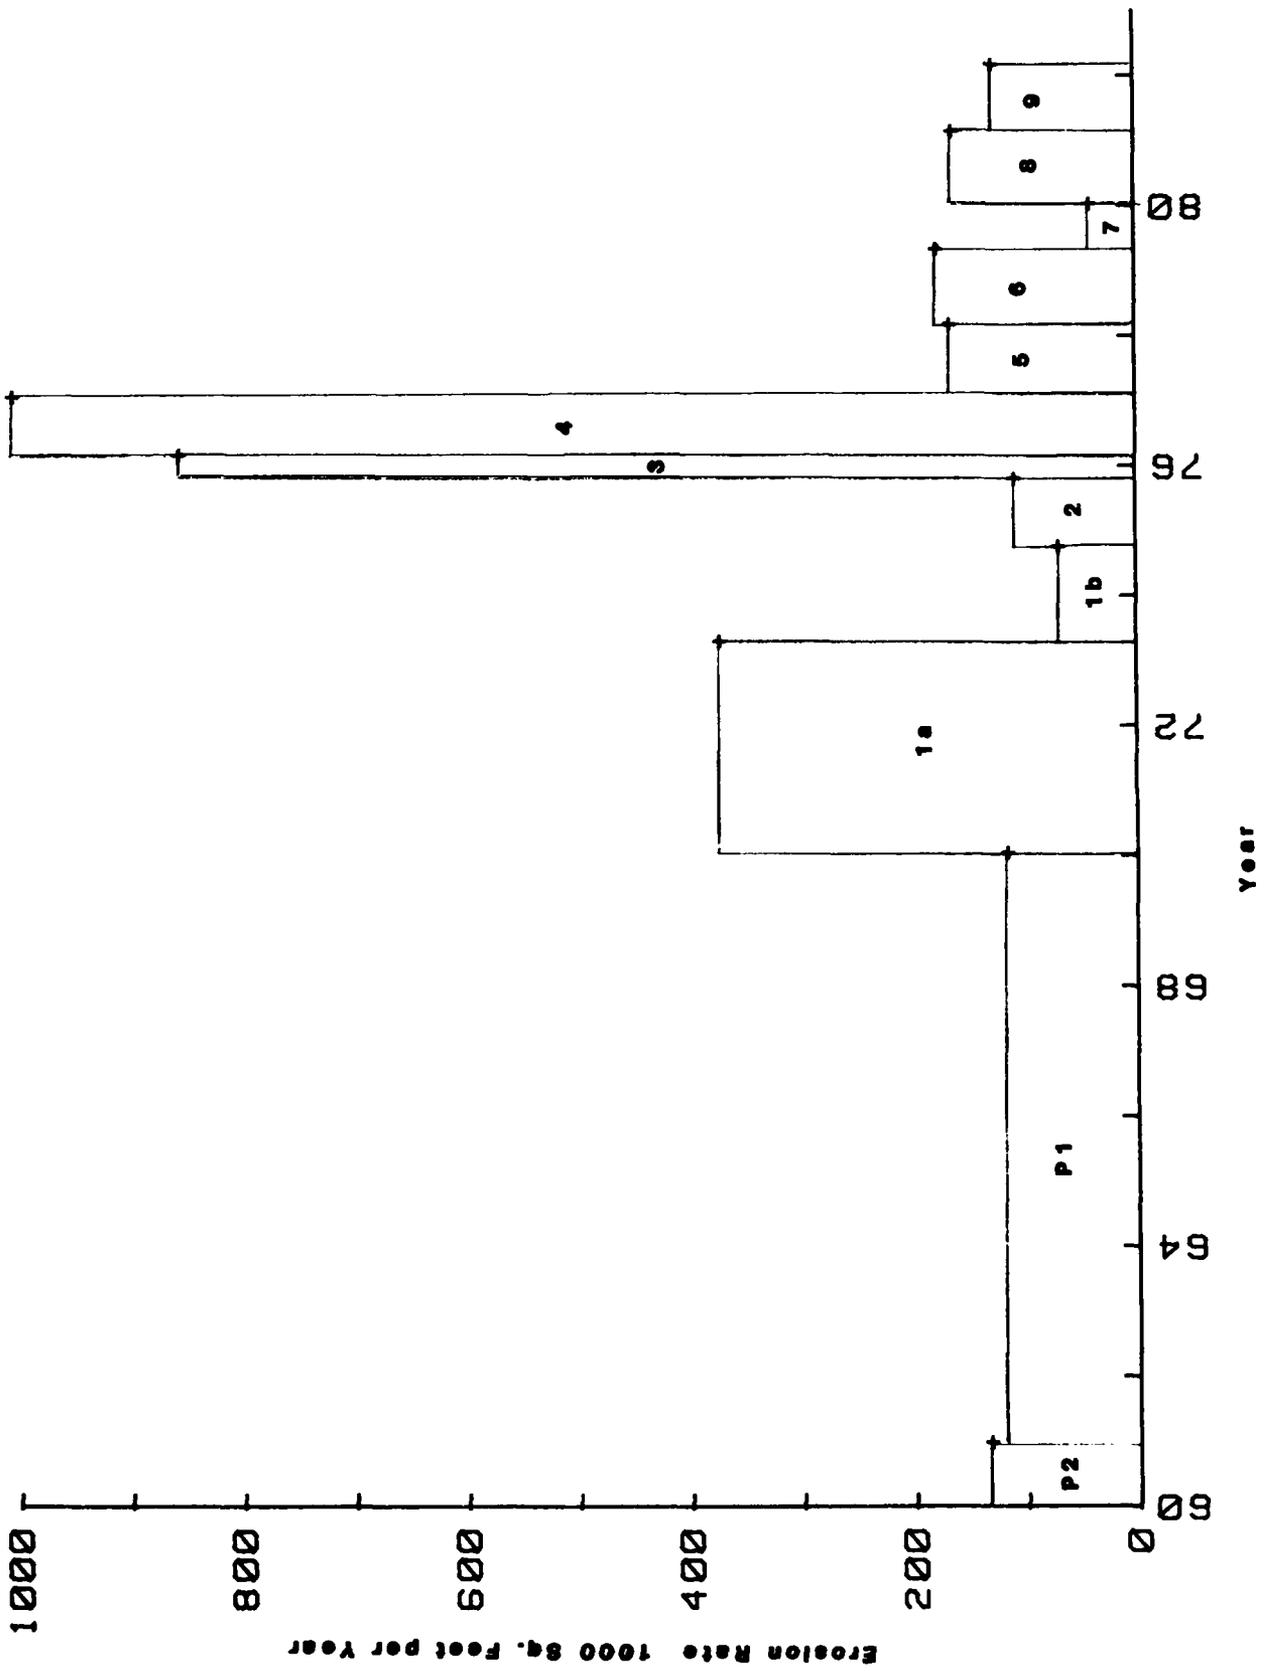
Figure 5. North bank erosion rates.
