PRELIMINARY MATERIAL TESTING OF CERAMIC AND WOOD

May 1986

Final Report

4. PERFORMING ORGANIZATION REPORT NUMBER(S) AFWL-TN-85-47			5. MONITORING ORGANIZATION REPORT NUMBER(S)			
6a. NAME OF PERFORMING ORGANIZATION Air Force Weapons Laboratory		6b. OFFICE SYMBOL (If applicable) NTAOP		7a. NAME OF MONITORING ORGANIZATION		
6c. ADDRESS (City, State and ZIP Code) Kirtland Air Force Base, NM 87117			7b. ADDRESS (City, State and ZIP Code)			
8a. NAME OF FUNDING/SPONSORING ORGANIZATION		8b. OFFICE SYMBOL (If applicable)		9. PROCUREMENT INSTRUMENT IDENTIFICATION NUMBER		
8c. ADDRESS (City, State and ZIP Code)			10. SOURCE OF FUNDING NOS.			
			PROGRAM ELEMENT NO. 64747F	PROJECT NO. 1209	TASK NO. 15	WORK UNIT NO. 01

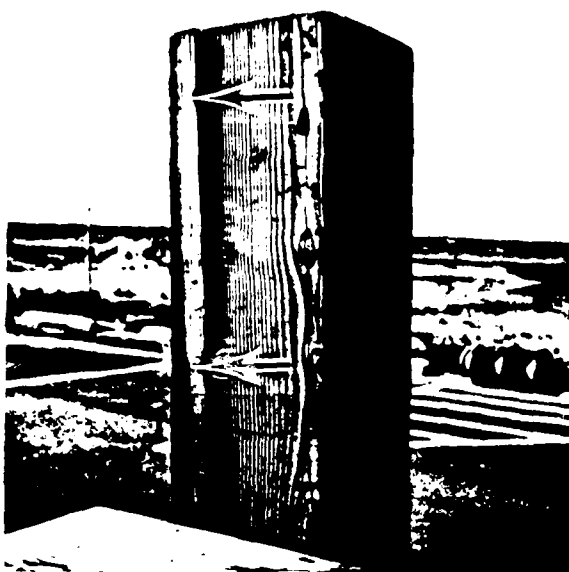
The flashovers tracked on the surface of the wood and through the split rings. Voltages just above flashover value caused no structural damage.

One pulser shot was made at 120 kV charge voltage (nominal 1.5 MV output). This shot caused considerable structural damage as a 1 by 1-in shard was ejected (Fig. 3).

(a) Damage to upper part of post.

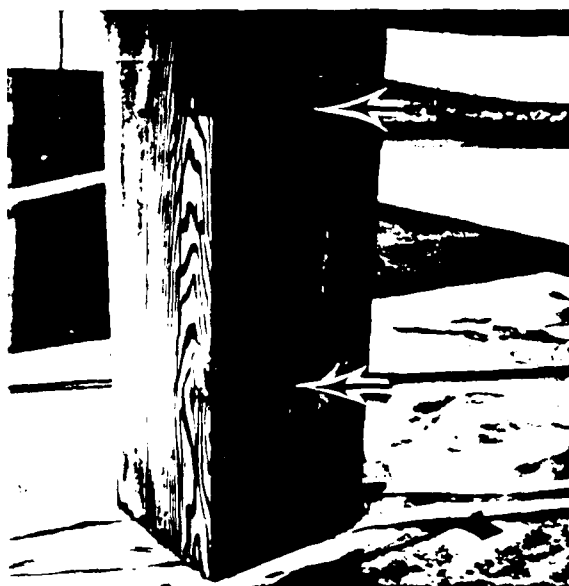
(b) Damage to lower part of post.
