MISCELLANEOUS PAPER CERC-86-8

STABILITY TEST OF MODIFIED REPAIR OPTIONS FOR SAN PEDRO BREAKWATER LOS ANGELES, CALIFORNIA

Coastal Model Investigation

July 1986 Final Report

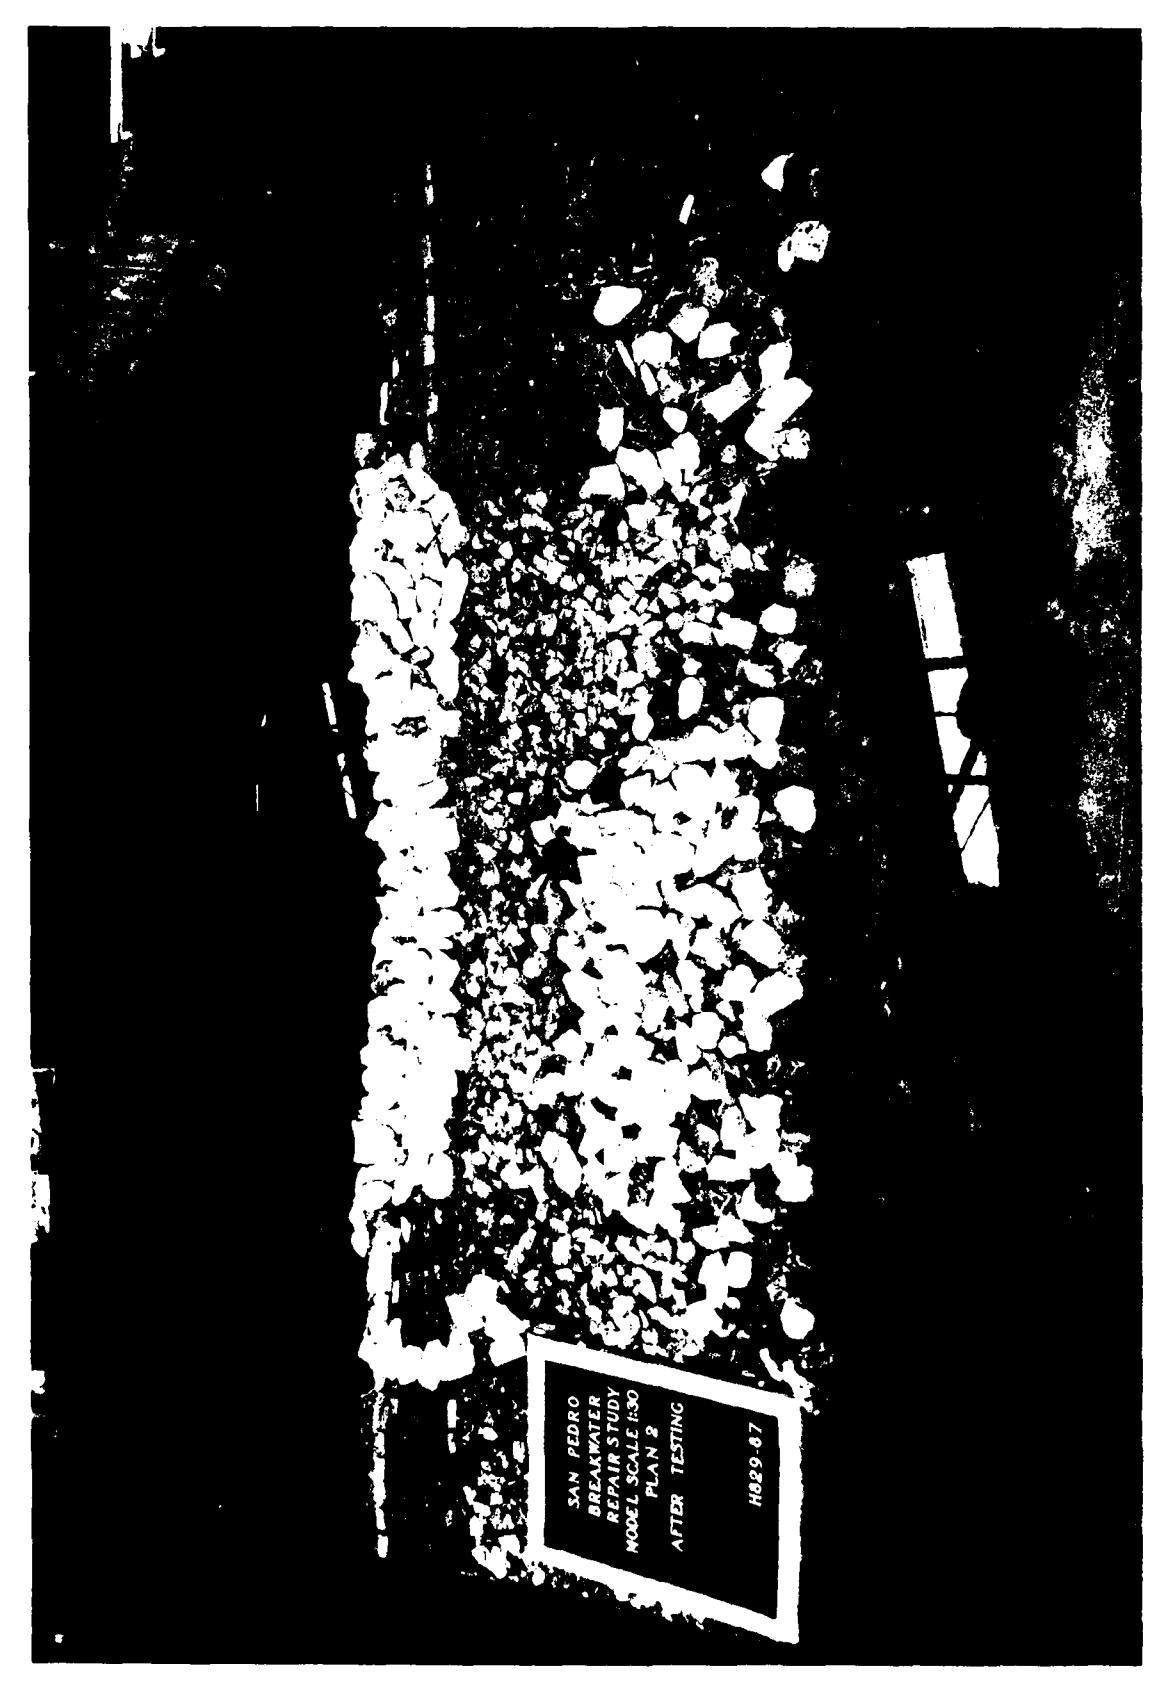
15. Plan 2 (Photos 5-8 and Plate 5) was constructed in the same manner as Plan 1 except 13- to 20-ton stone was added to the sea side of the repair section. This stone was painted blue in the model so it could be differentiated from the stone used to represent the 1983 repair section (7- to 20-ton stone). The stone appears black in the photographs. The toe of the additional stone was placed 25 ft seaward from the toe of the 1983 repair. This distance is approximately 50 ft when measured horizontally from the center line of the breakwater. The 13- to 20-ton stone transitioned into the 7- to 20-ton stone while maintaining a maximum crest elevation of +13 ft mllw. It was hoped that flattening the slope and moving the toe into deeper water would increase the stability of the section. Stone placed along the toe on the 1V on 3H slope of the base mound appeared to be very vulnerable to wave attack. In fact, it was difficult to place the toe stone during construction as it tended to roll downslope. The test section was subjected to Hydrograph A (Table 1). Damage to the new stone section was initiated during Step 1 (6-sec. 8-ft waves, 0-ft mllw) and originated at the toe. Continued wave attack at the 0-ft mllw caused severe damage to the added stone in the rubblemound section; however, the additional stone protected the stone representing the 1983 repair. Testing at the +8 ft swl caused extensive damage to the stone from the 1983 repair with damage initiating at Step 6 (6-sec, 14-ft

waves) and progressing with continued wave attack. Damage to the existing granite stone was also initiated during attack of 6-sec, 14-ft waves at the +8 ft swl. Wave attack during Step 8 (11-sec, 16-ft waves) caused significant damage to the granite stone, and extensive damage was done during Step 10 (22-sec, 16-ft waves) with this section failing completely. The additional stone added some reserve stability to the rubble-mound section and there was more stone left after testing than for Plan 1. Testing was stopped after Step 10 of Hydrograph A, because it was determined unnecessary to continue after complete failure of the existing granite block sections had taken place.

Harbor-side view of Plan 2 after subjection to Hydrograph A. Angle of wave attack = 90 deg Photo 8.

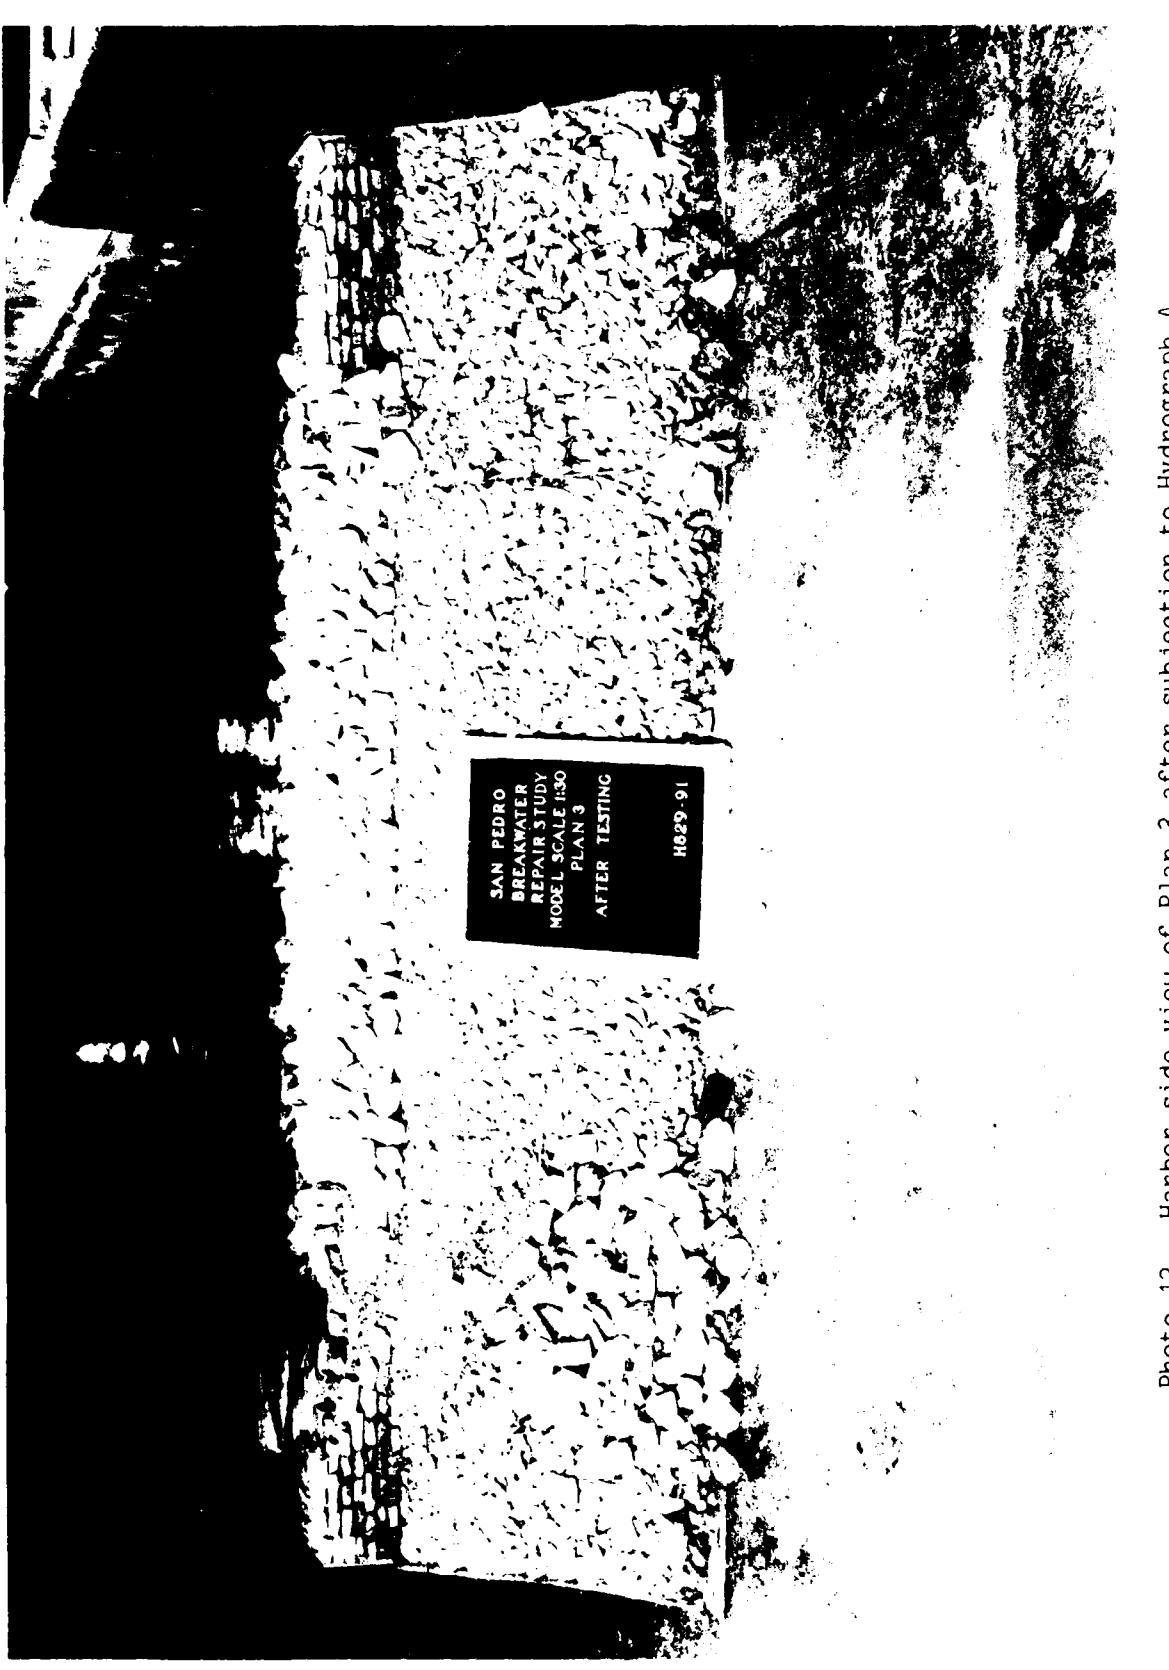
16. Plan 3 (Photos 9-14 and Plate 6) was similar to Plan 2 except a trench was excavated along the toe of the added 13- to 20-ton stone. The trench was about 7 ft wide and 3.5 ft deep, i.e., wide enough to allow a 20-ton stone to be placed inside at a depth of approximately one-half that of the stone. After the 13- to 20-ton stones were placed in the trench, voids between the stones were backfilled with material left from the excavation. A total of 478 7- to 20-ton stones and 246 13- to 20-ton stones were placed in the model. The test section was subjected to Hydrograph A. Wave attack at the 0-ft swl caused minor damage to the rubble-mound section with the first stones being displaced during attack of the 6-sec, 12-ft waves (Step 2). Most of the movement occurred in the transition areas. Wave attack at this swl caused no damage to the existing granite stone sections, and only one stone was displaced from the area representing the 1983 repair. During wave attack at the +8 ft swl. several additional stones were randomly displaced throughout the rubble-mound section, but the total damage to this area was still minor. Damage to the existing granite block stone was initiated during Step 6 (6-sec, 14-ft waves) and became extensive during Step 8 (11-sec, 16-ft waves). This area of the structure failed completely. Testing was stopped after completing Step 8 of Hydrograph A. The test section was rebuilt and subjected to Hydrograph B with similar results. Damage was initiated during Step 5 (8-sec, 16-ft waves, 0-ft mllw) for the 13- to 20-ton stone and during Step 8 (6-sec, 14-ft waves. +8 ft mllw) for the existing granite block sections. Damage to the existing granite block sections was significant during Step 9 (8-sec, 16-ft waves, +8 ft mllw) with these sections failing completely during tests at the +8 ft swl. Hydrograph B was run to completion with the rubble-mound section sustaining only minor damage except in the transition areas where stone was lost after the existing granite block sections had failed

Harbor-side view of Plan 3 after subjection to Hydrograph A. Angle of wave attack = 90 deg Photo 12.

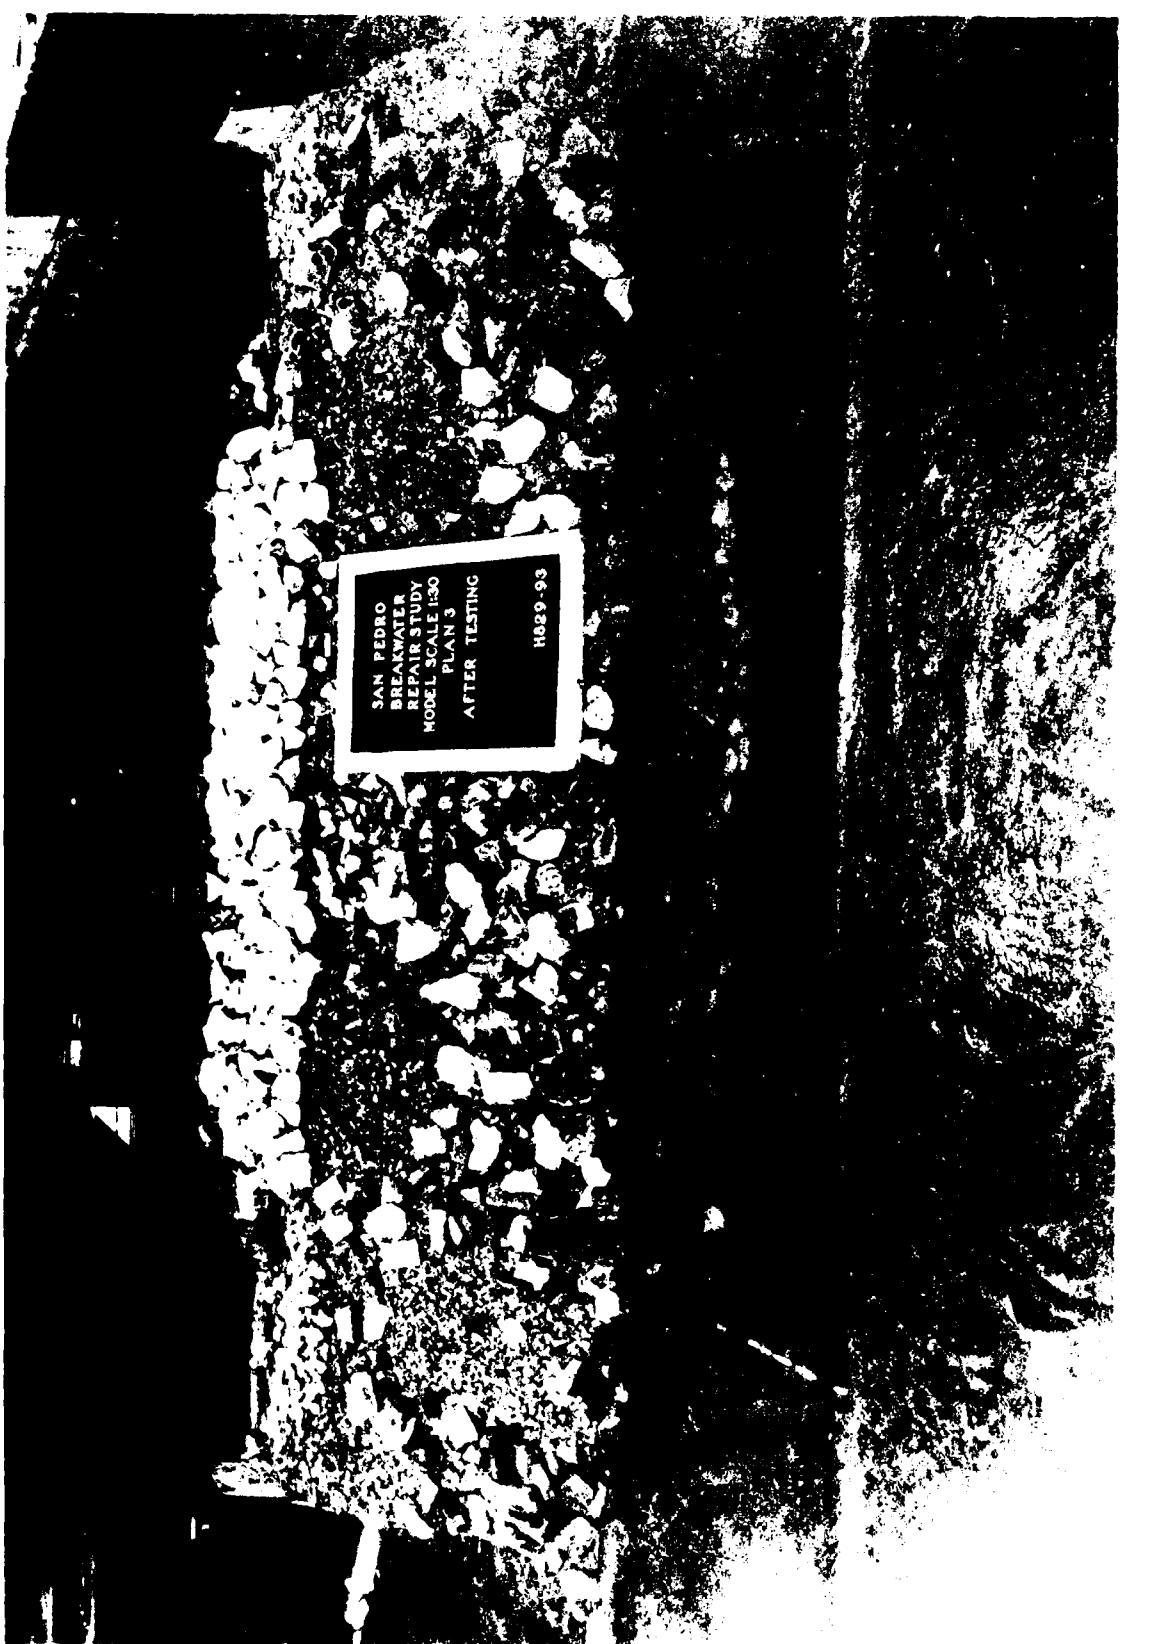
completely. Based on these test results, it can be concluded that Plan 3 offers a repair option that is more stable than the original breakwater.

Photo 14. Harbor-side view of Plan 3 after subjection to Hydrograph B. Angle of wave attack = 90 deg

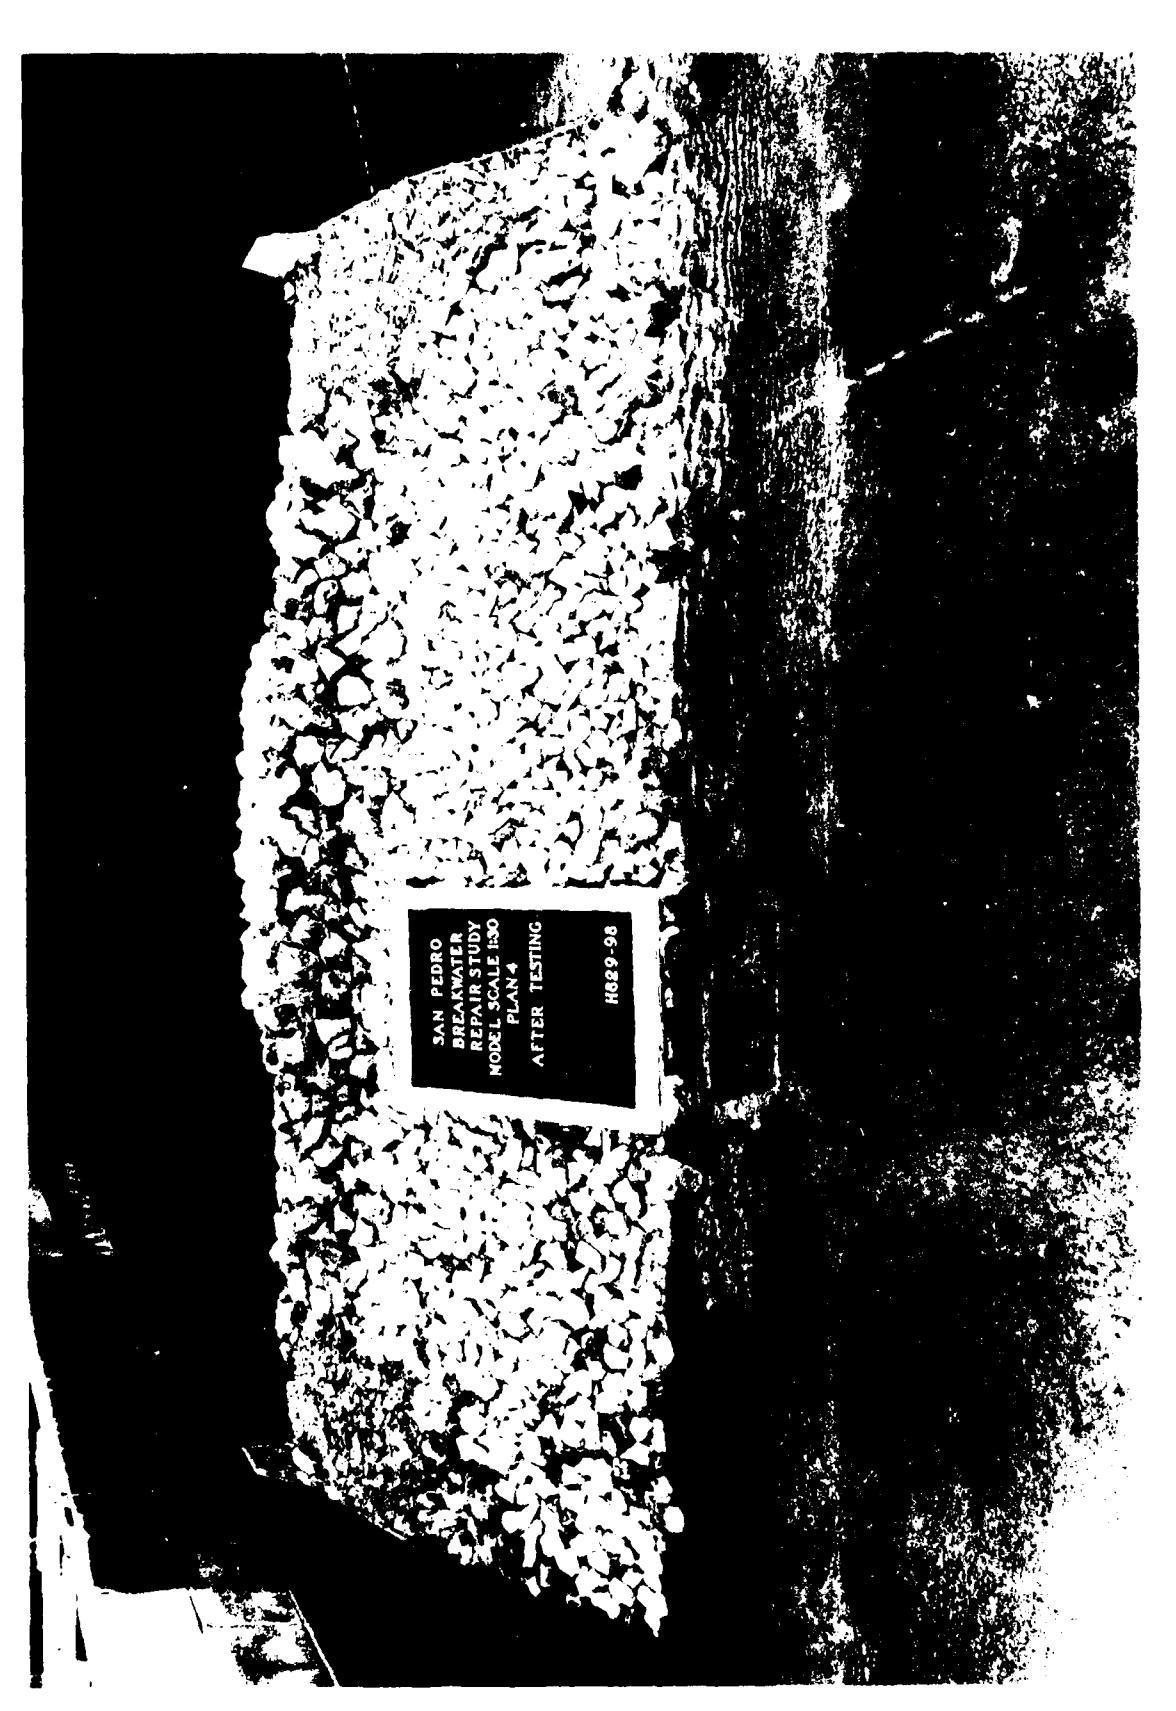
17. Plan 4 (Photos 15-18 and Plates 7-8) was the same as Plan 3 except the toe stone on the sea side of the repair section was buttressed with two layers of 3- to 4-ton angular stone rather than being placed in a trench. Placement of the 3- to 4-ton stone started at the toe of the base mound, -47 ft contour, and then continued upslope to the point where the 13- to 20-ton stone started. The 3- to 4-ton stone bordered the 13- to 20-ton stone in the transition areas (see Plate 8). A total of 475 7- to 20-ton stones, 245 13- to 20-ton stones, and 1,746 3- to 4-ton stones were placed in the model. The test section was subjected to Hydrograph B. Wave attack at the 0-ft swl caused minor damage to the 3- to 4-ton stone with most of the smaller stone in the transition areas being displaced. The 3- to 4-ton stone along the toe of the 13- to 20-ton stone remained stable. Wave attack at the 6 ft swl caused minor damage to the 13- to 20-ton stone with most damage occurring during attack of 8-sec, 16-ft waves; displacement was concentrated in the transition areas. Damage to the existing granite block sections was initiated during Step 9 (8-sec, 16-ft waves, +8 ft mllw) with these sections failing completely during Step 10 (11-sec, 16-ft waves, +8 ft mllw). Wave attack at the +8 ft swl caused minor damage to the rubble-mound section because of overtopping. Hydrograph B was run to completion with some additional damage occurring in the transition areas where stone was lost after the existing granite block sections had failed completely. Based on these test results, it can be concluded that Plan 4 offers a repair option that is more stable than the original breakwater but less stable than Plan 3.

Photo 17. Searside view of Plan 4 after subjection to Hydrograph B. $\hat{n}_{n\xi}$ le of wave attack = 90 deg

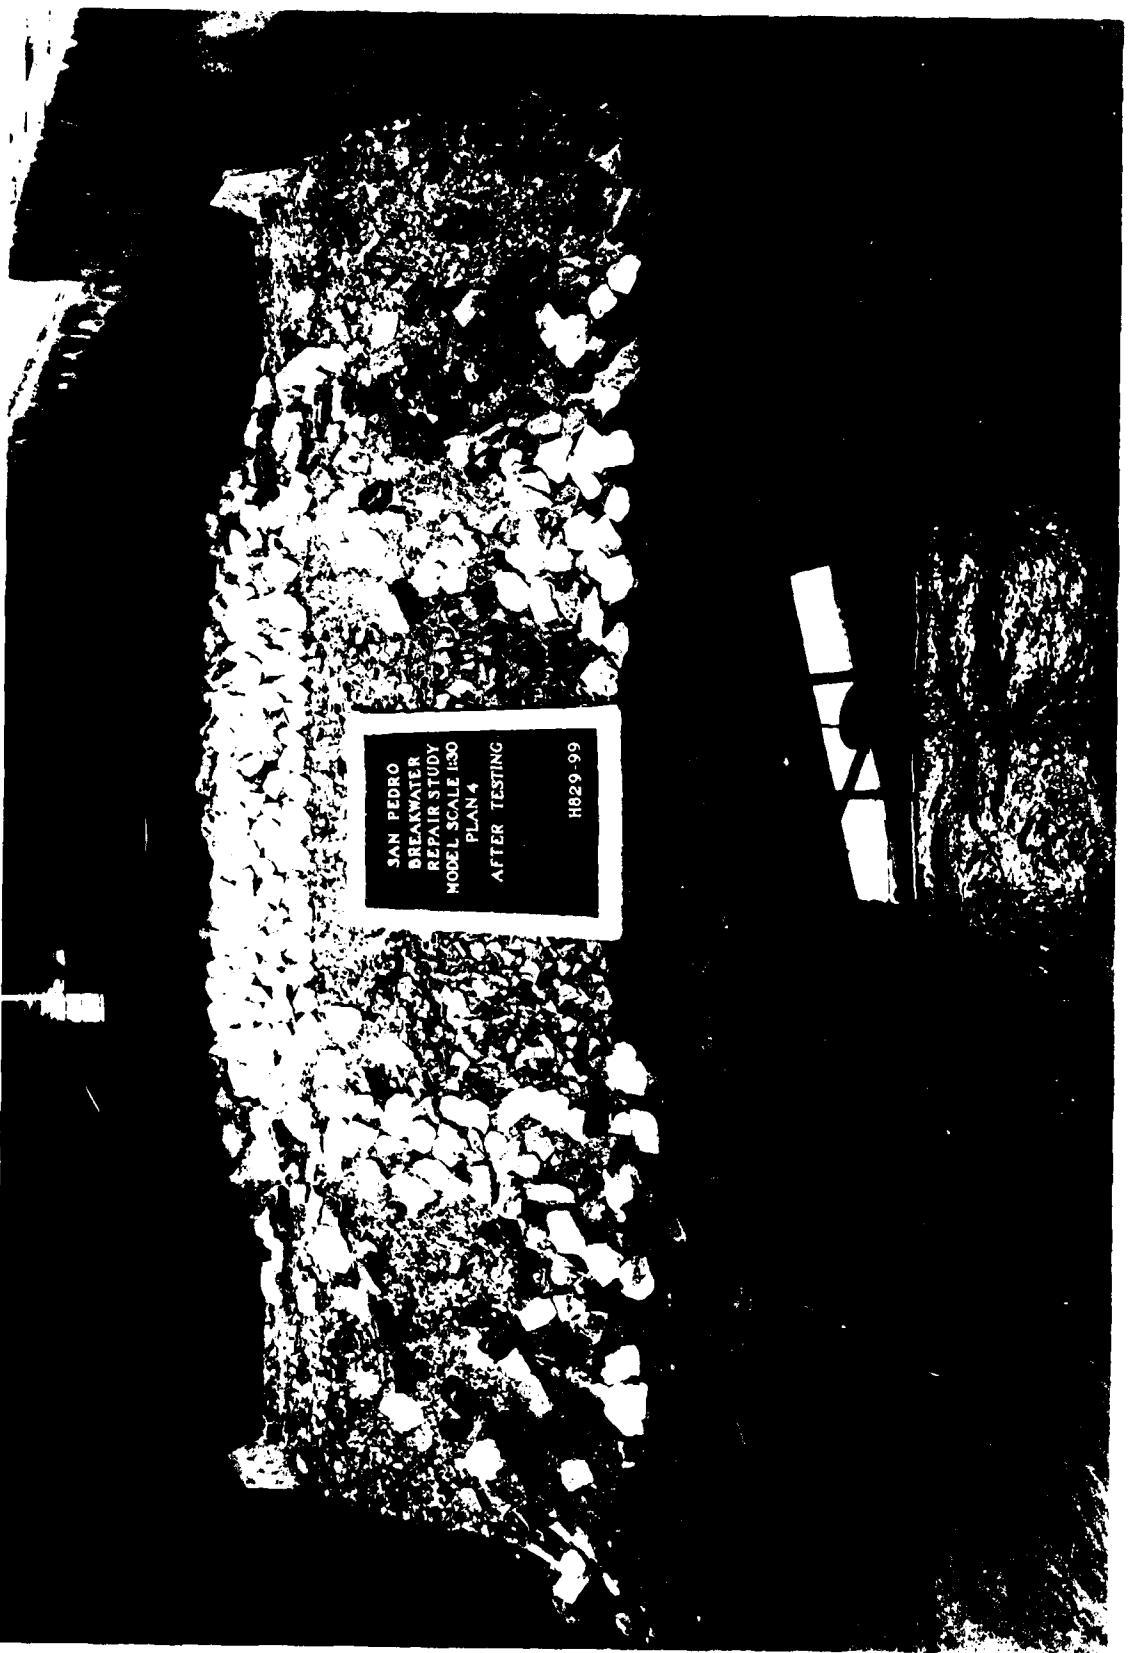
Harbor-side view of Plan 4 after subjection to Hydrograph B. Angle of wave attack = 90 deg Photo 18.

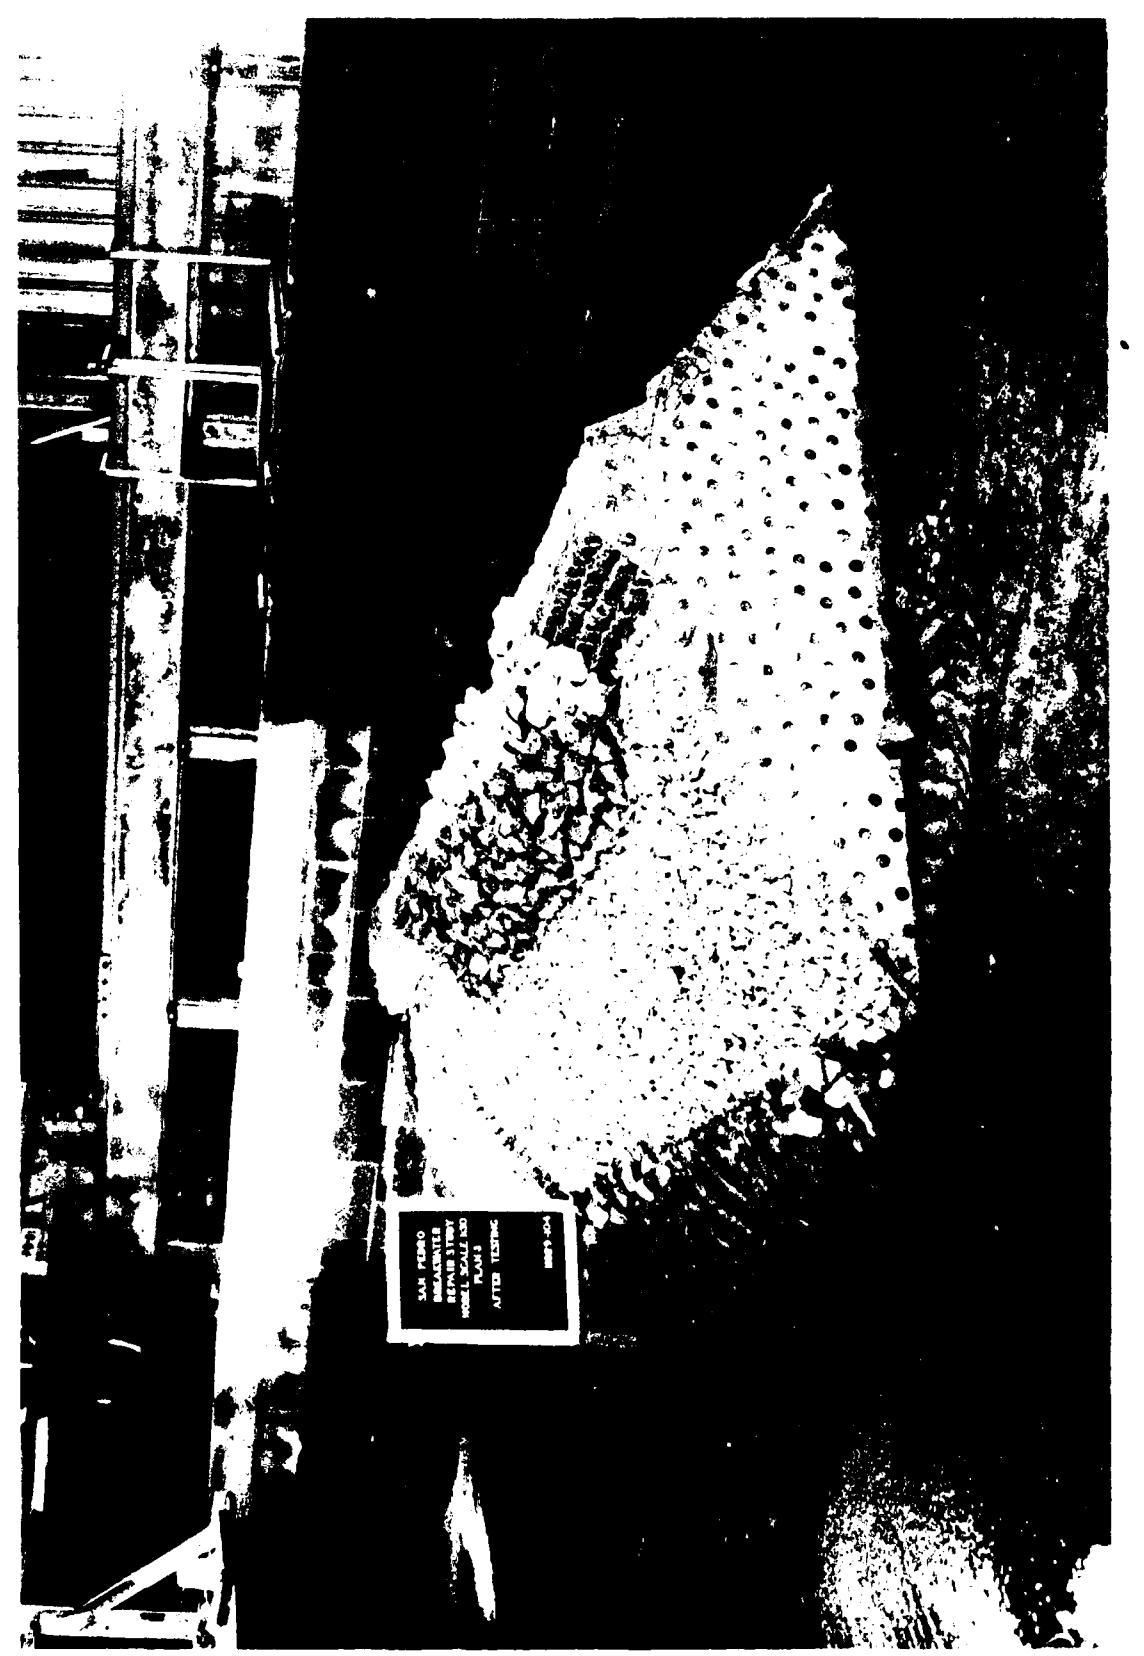
18. Plan 3 (Photos 19-22 and Plate 6) was selected for testing at wave direction 2 because it appeared to be the best alternative based on constructability and economic considerations. As requested by representatives of SPL, the granite block sections were wired in place so the stability of the repair section could be checked independent of the original structure. The test section was subjected to Hydrograph B. Wave attack at the 0-ft mllw caused slight movement as the stone shifted and then nested after construction. Testing at the +6 ft mllw caused minor damage to 13- to 20-ton stone at the seaward (left) transition and slight damage to 13- to 20-ton stone at the shoreward (right) transition. There was also minor damage, caused by overtopping, of the 7- to 20-ton stone on the harbor side of the structure. Wave attack at the +8 ft swl caused moderate damage to the harbor-side 7- to 20-ton stone. Most of the waves overtopped the structure at this swl and there was minimum wave energy concentrated in the sea-side transition areas. There was slight change in the damage level as the hydrograph was run to completion. Based on these test results, it can be concluded that Plan 3 offers a more stable repair option for both wave directions 1 and 2 than the original breakwater. There was minor damage to the 13- to 20-ton stone at the seaward transition during testing from wave direction 2, but the structural integrity of this area remained intact. It appears that if there was a greater duration of long-period waves than tested at the +8 ft mllw level the 7- to 20-ton stone on the harbor side of the structure might be lost; however, the original granite block sections would fail before this happens.

Sea-side view of Plan 3 after subjection to Hydrograph B. Angle of wave attack = 45 deg Photo 21.

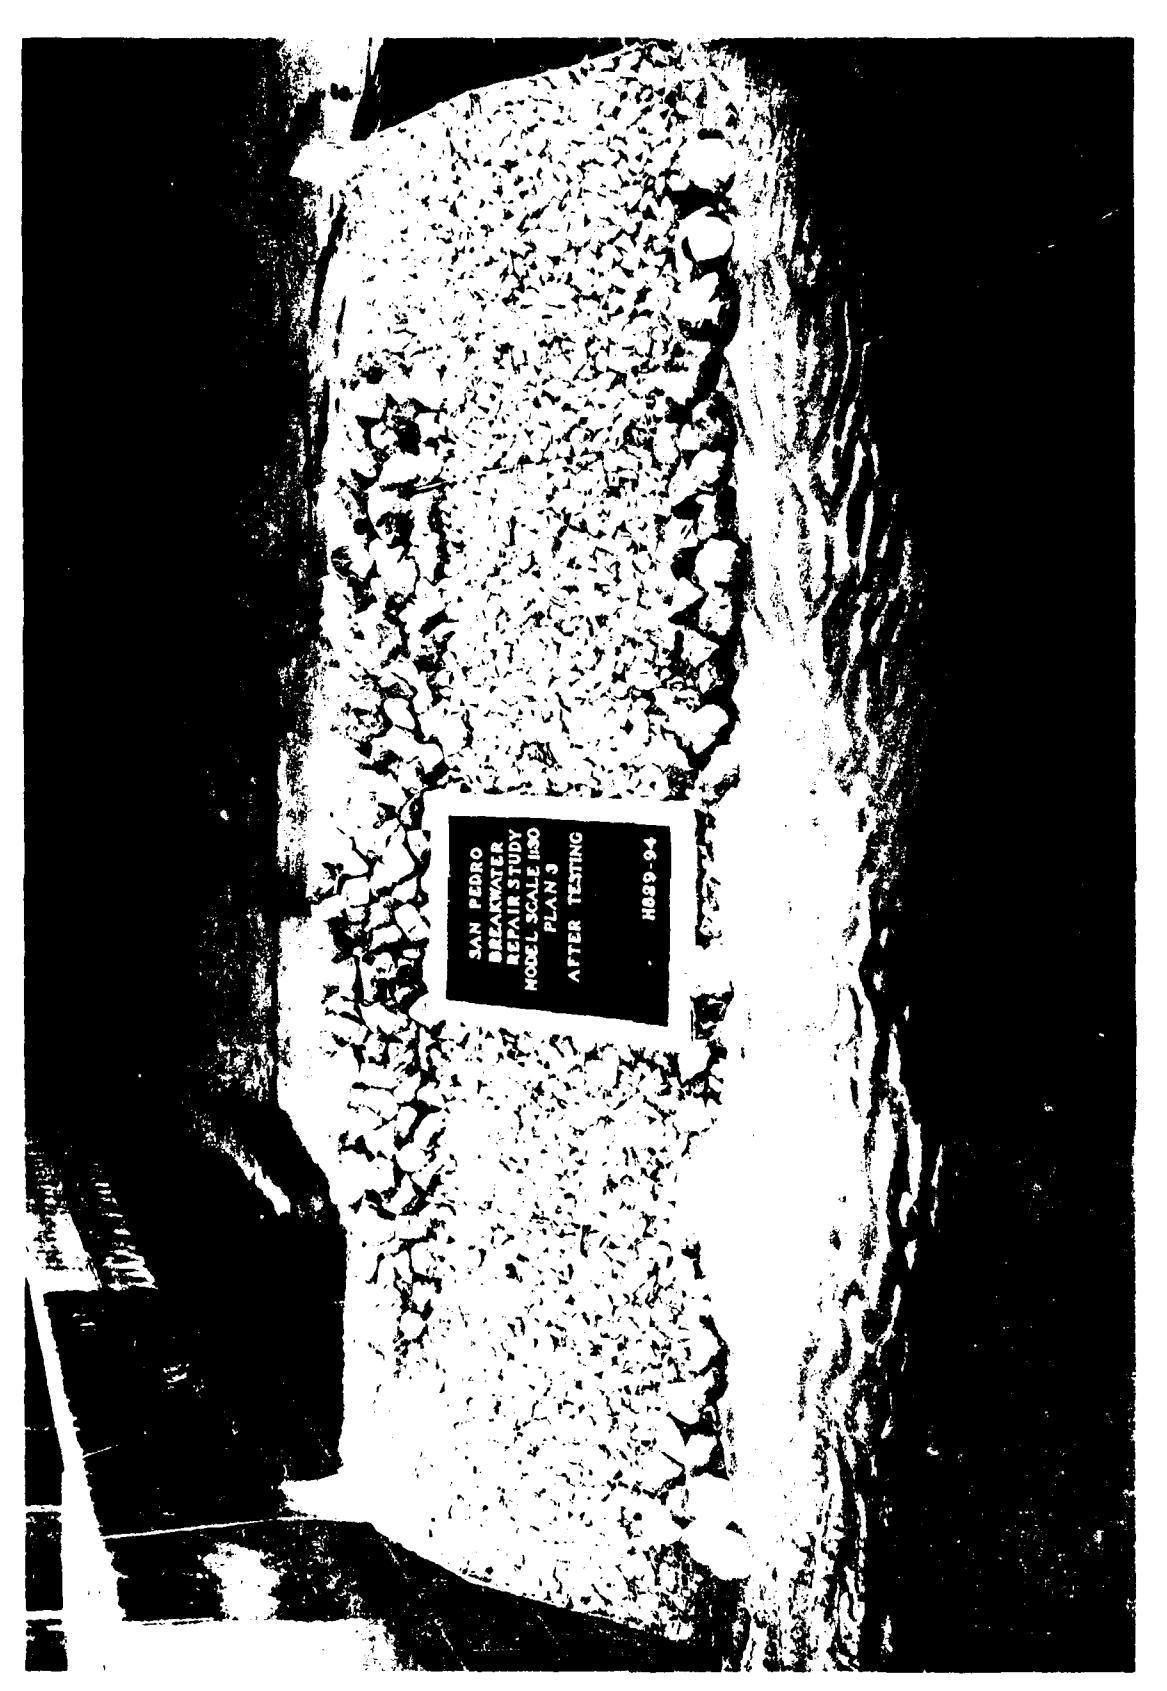
20. Plan 3 (Plate 6) was tested to determine its margin of safety for both wave directions 1 and 2. Safety factor tests (Table 2) of Plan 3 were initiated as an extension of Hydrograph B (Table 1). For wave direction 1, damage progressed throughout the safety factor tests; however, failure was not complete at the conclusion of tests (Photos 23 and 24). Damage was concentrated in two areas, near the transitions and the harbor side of the repair section. Wave overtopping caused displacement of the 7- to 20-ton stone on the harbor side of the structure with the largest amount of dislocation occurring during attack of 8-sec, 20-ft waves. Original granite blocks had

Photo 23. Sea-side view of Plan 3 after factor of safety tests. Angle of wave attack = 90 deg

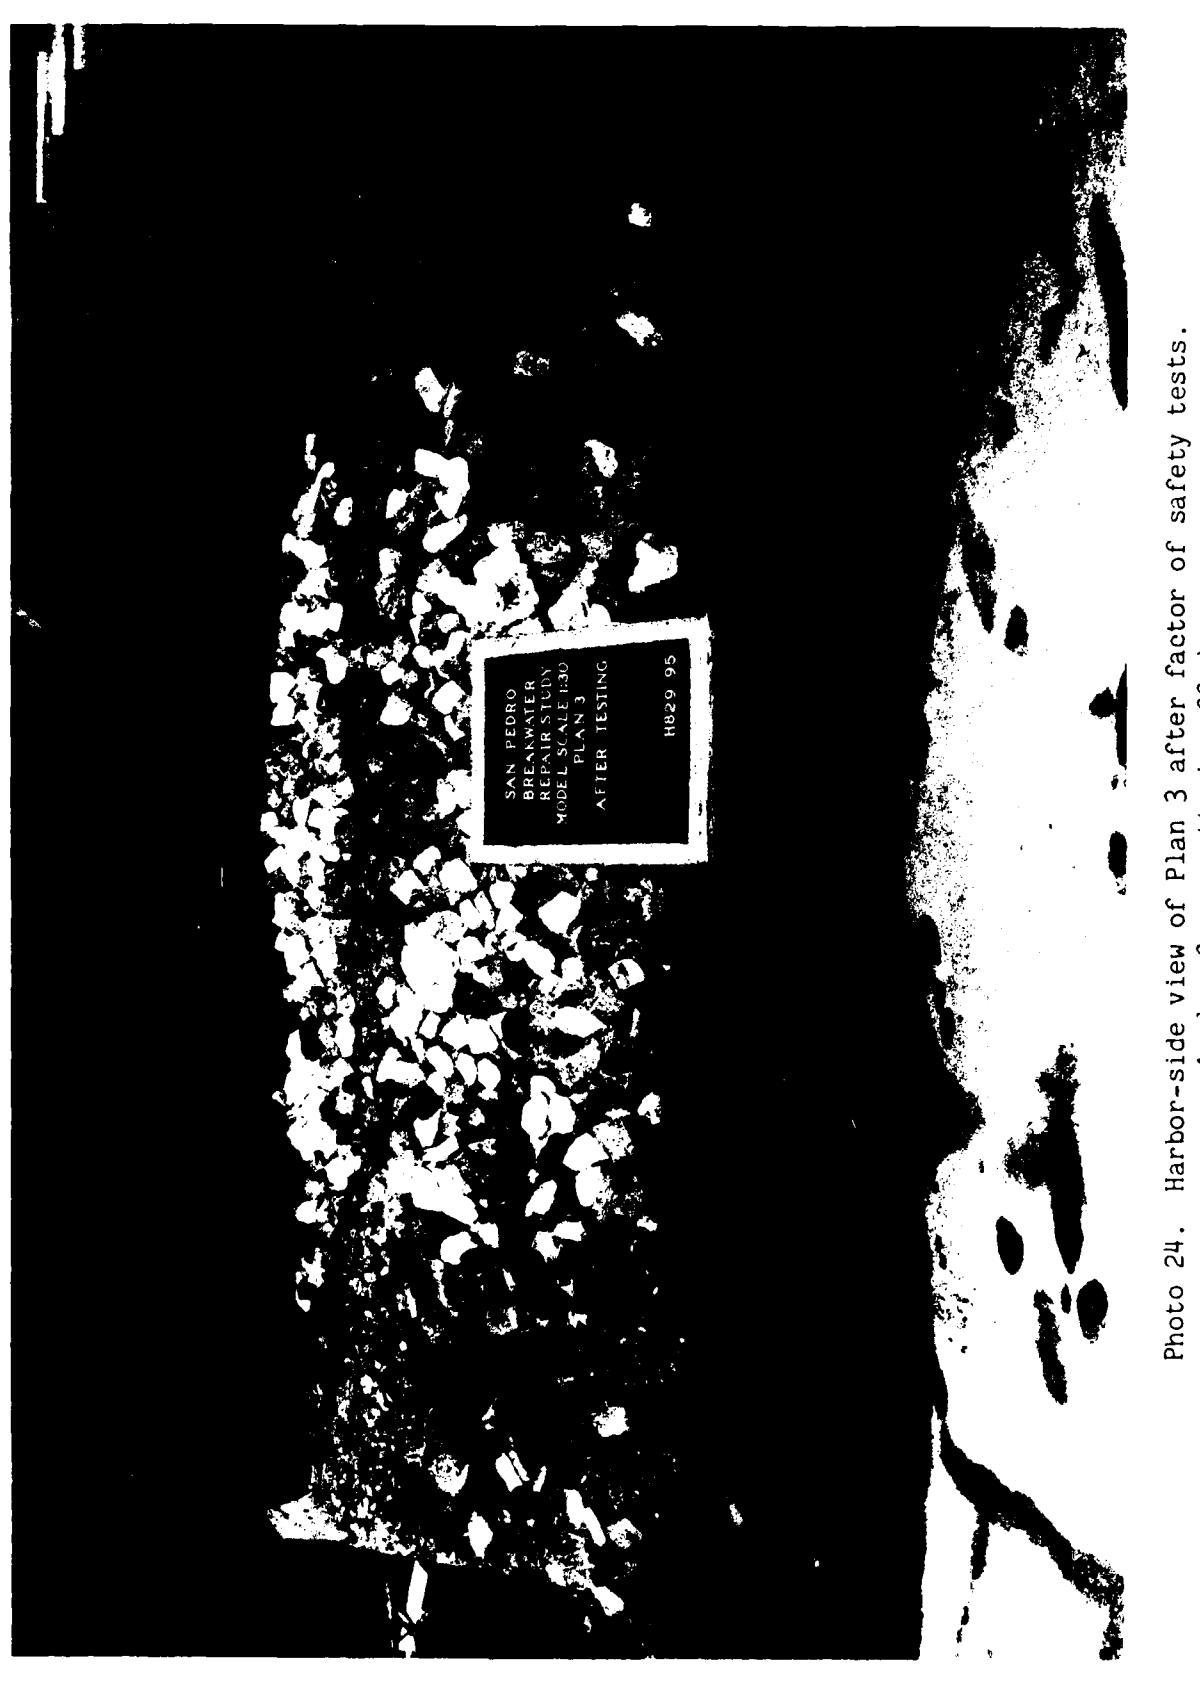
Photo 24. Harbor-side view of Plan 3 after factor of safety tests. Angle of wave attack = 90 deg

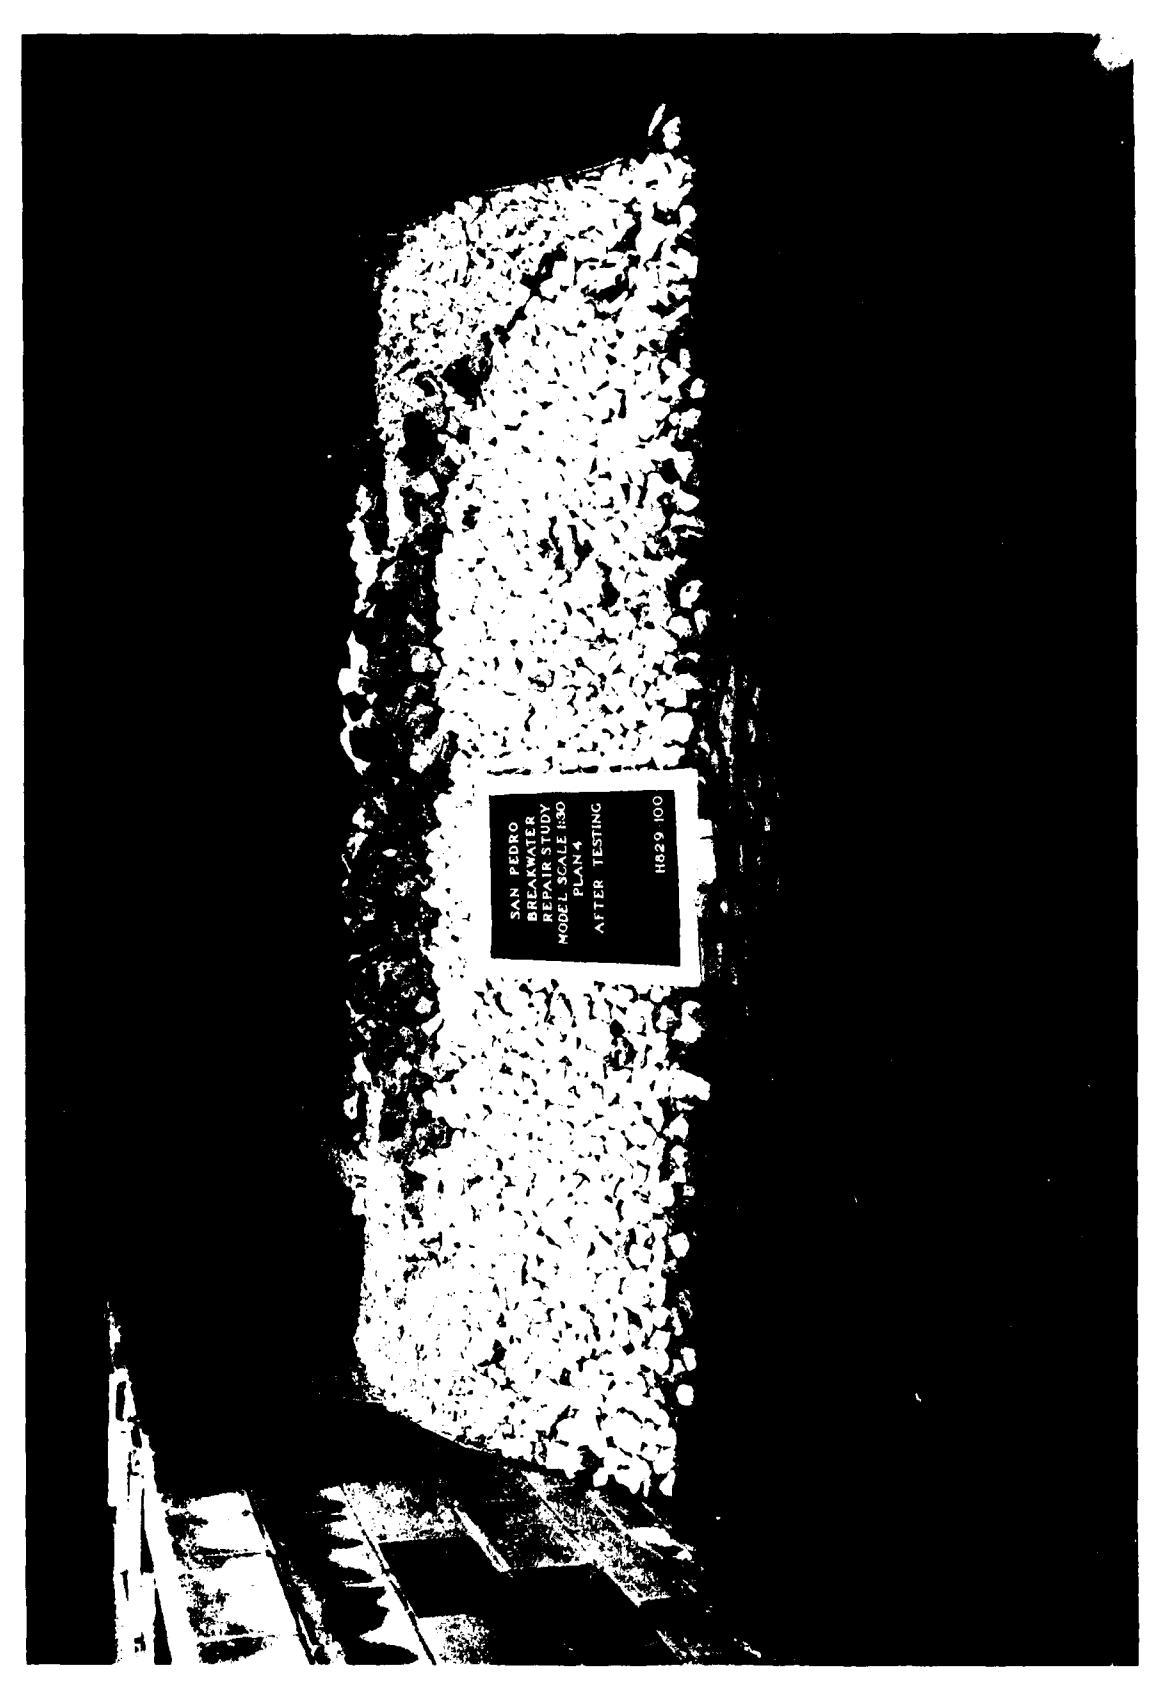
23. Results of safety factor tests (Photos 27 and 28) show Plan 4 has sufficient resiliency to withstand waves in excess of design height without experiencing complete failure and confirms the conclusion from previous tests that Plan 4 exhibits a response similar to but slightly less than Plan 3 for wave direction 1.

Photo 27. Sea-side view of Plan 4 after factor of safety tests. Angle of wave attack = 90 deg C T T L L L L L L L
