FIBERGLASS MATERIAL  
SPECIFICATION TEST SUPPORT

U.S. COAST GUARD  
DEPARTMENT OF TRANSPORTATION

September 27, 1985

Battelle has conducted a preliminary investigation for the U.S. Coast Guard to establish an information baseline into possible causes for the blistering of gel coat laminates on boats.

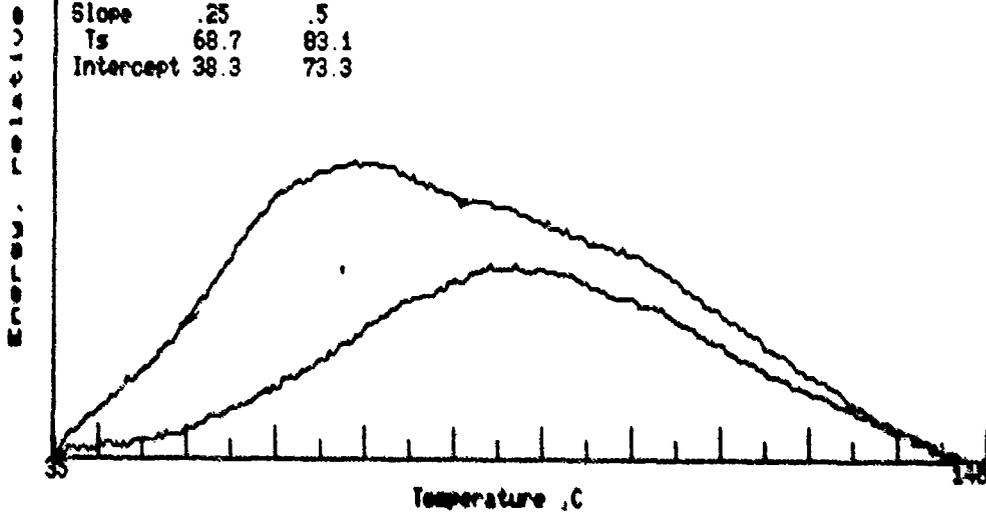
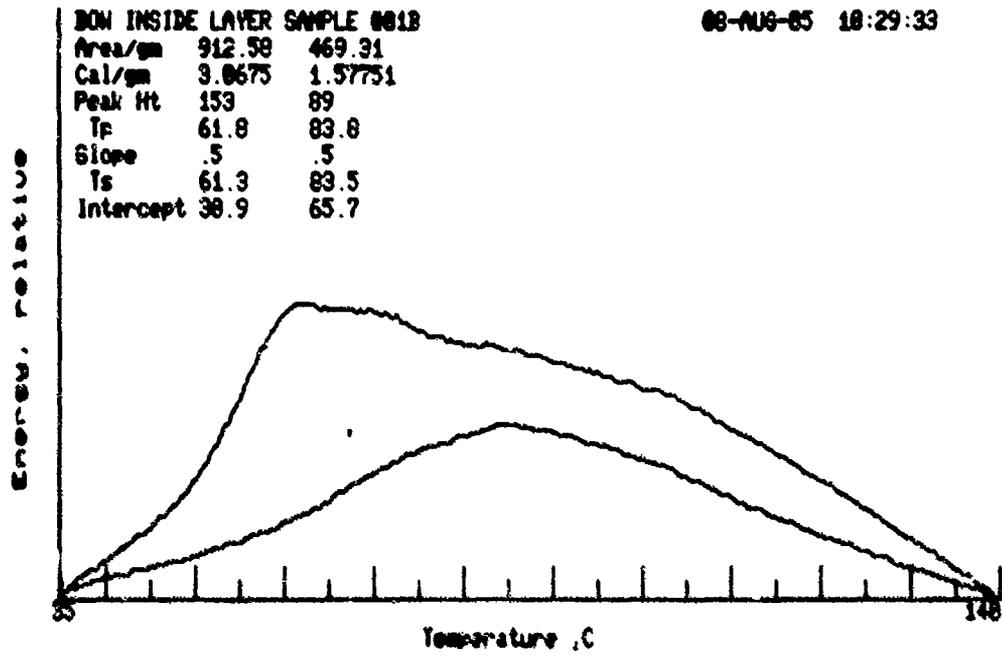
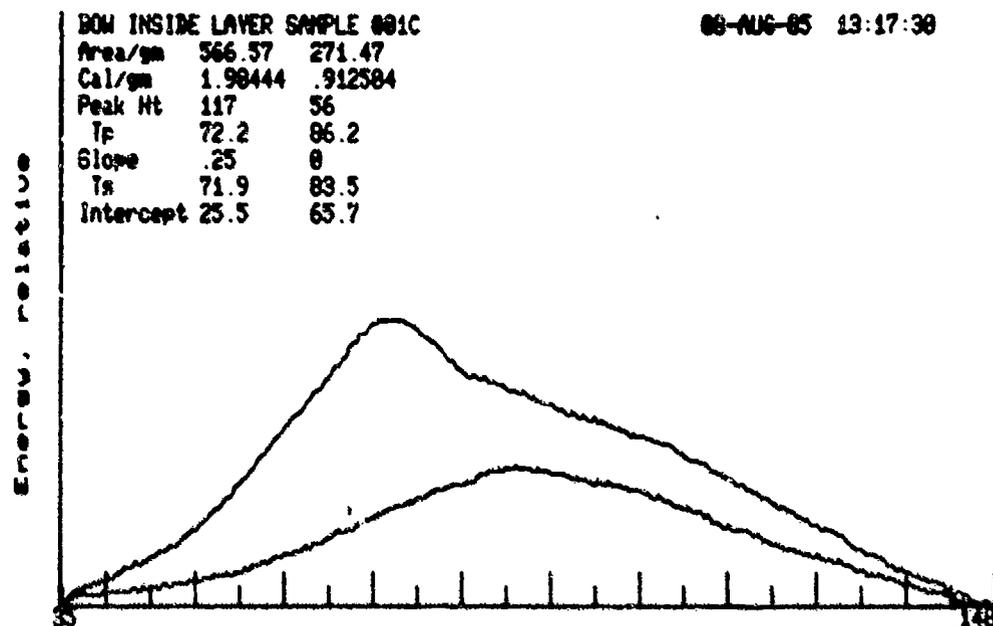
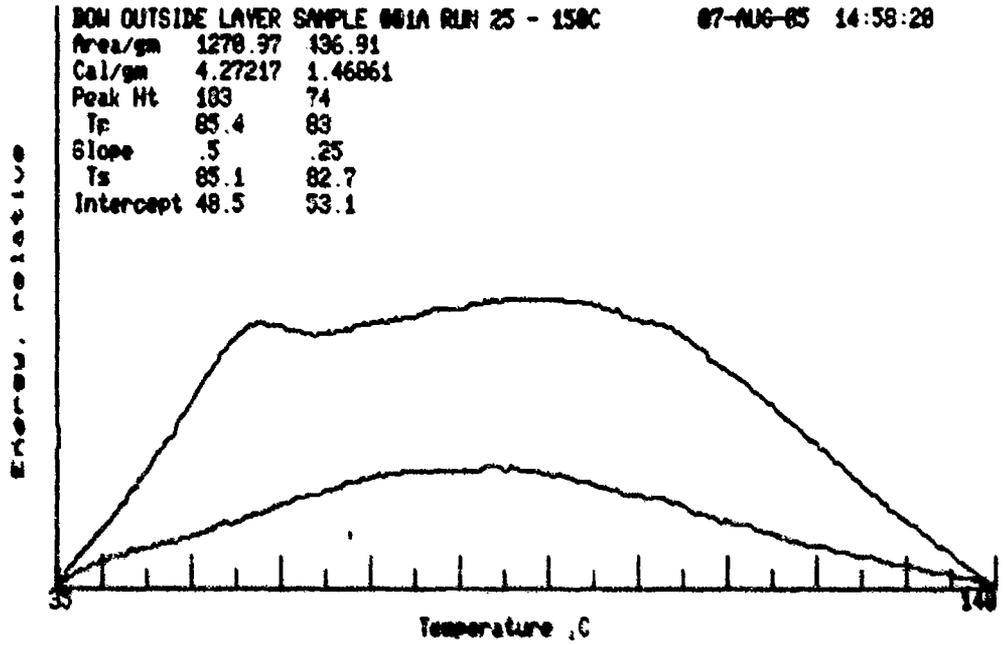
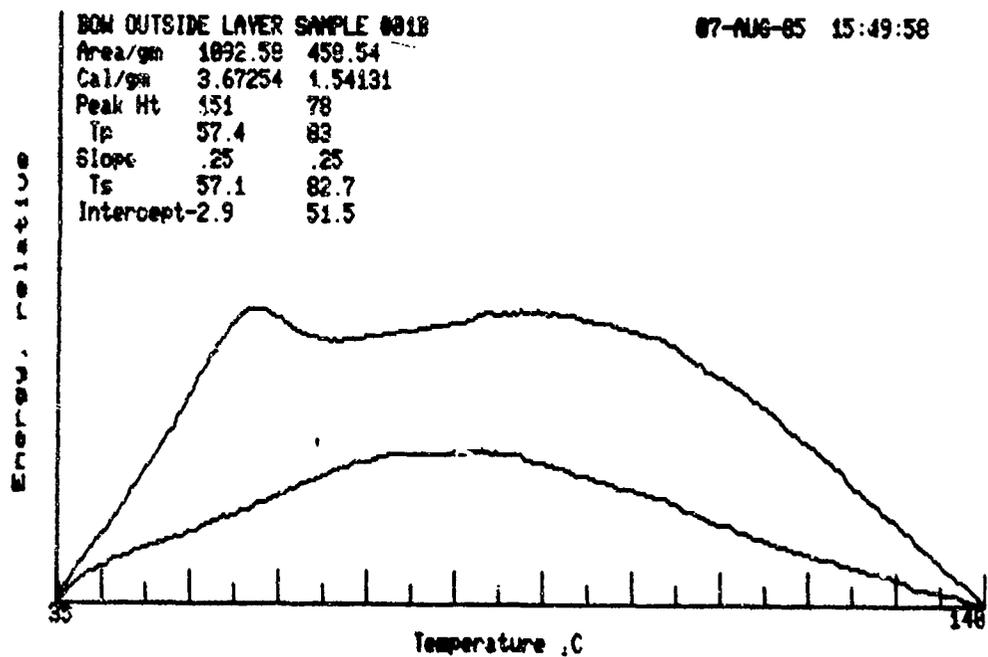
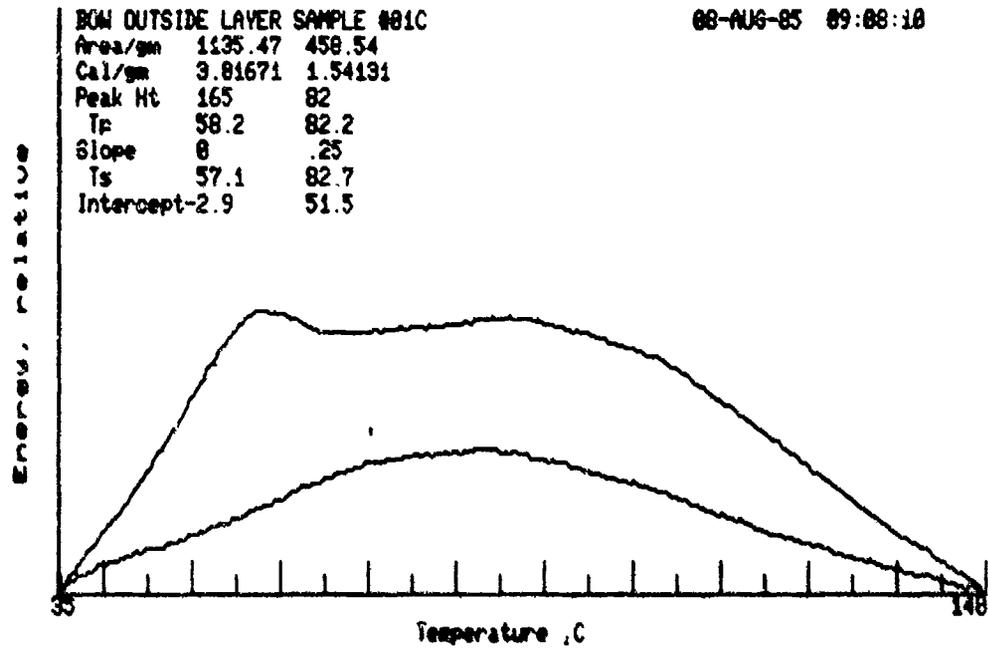
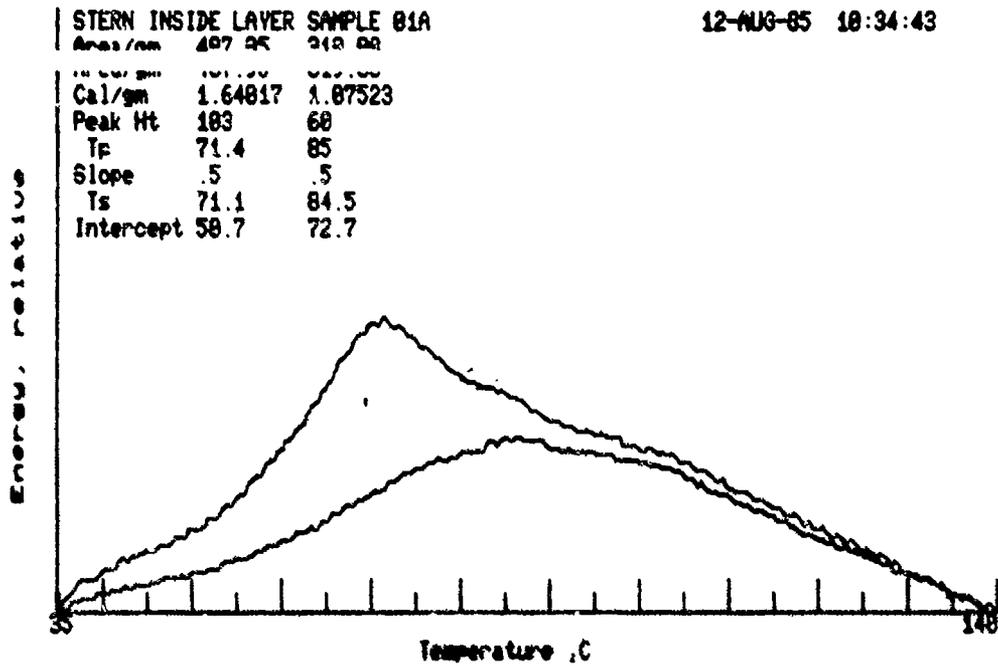
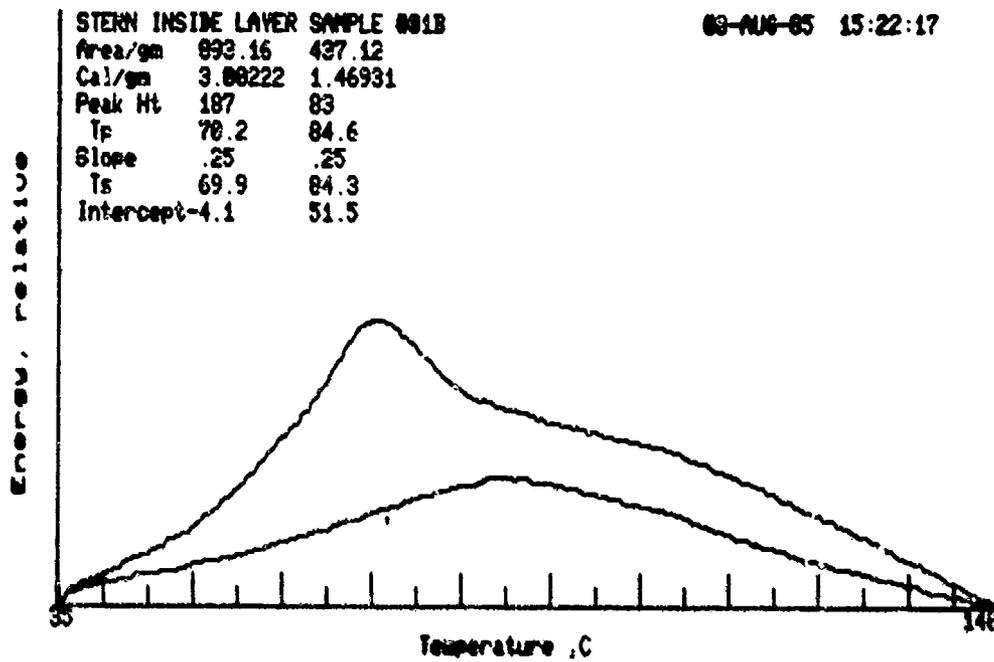
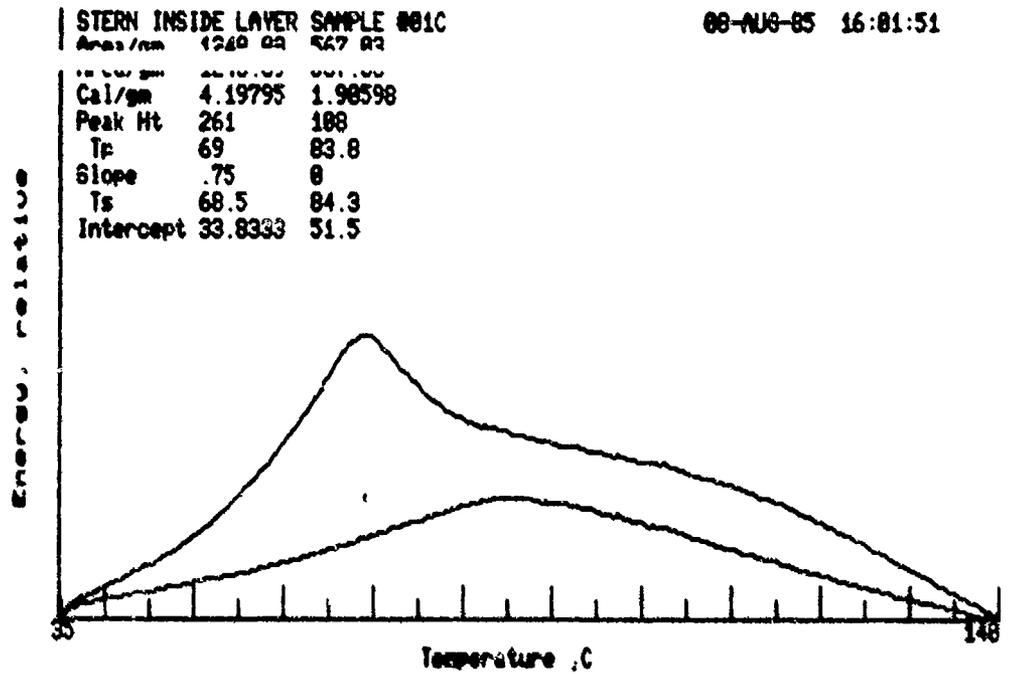
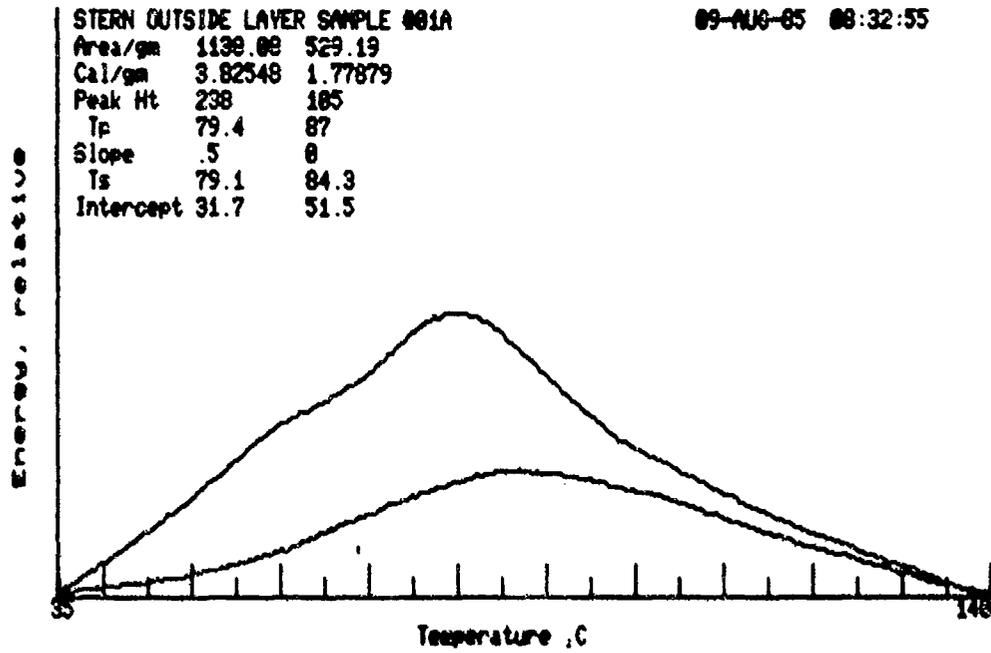
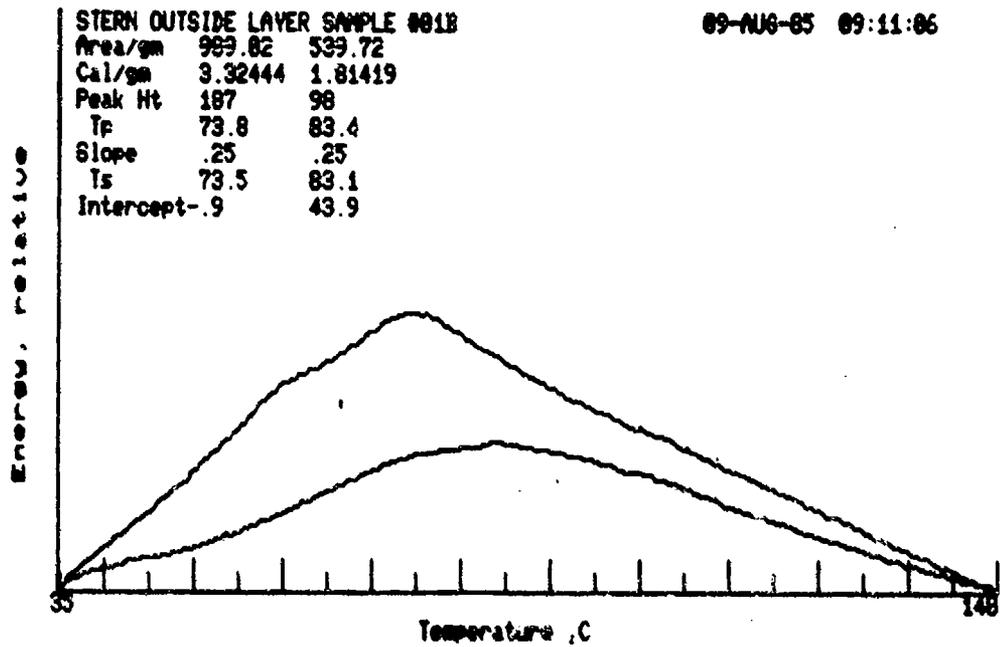
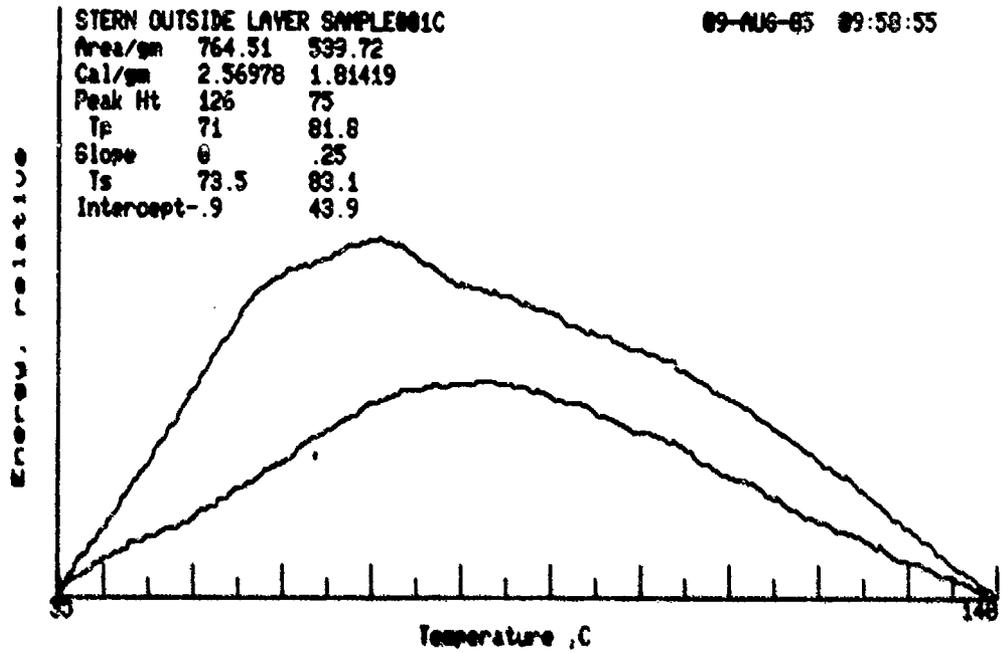
of the curing process, thus identifying the probable cause of blistering of these samples as undercuring.

- (1) Conduct a parametric cure grid to determine the critical factors associated with blistering. This would elucidate the factors and interrelationship of factors most responsible for deficient interlaminar cures. Factors should include all formulation variables, time, temperature, and humidity, processing variables, etc.

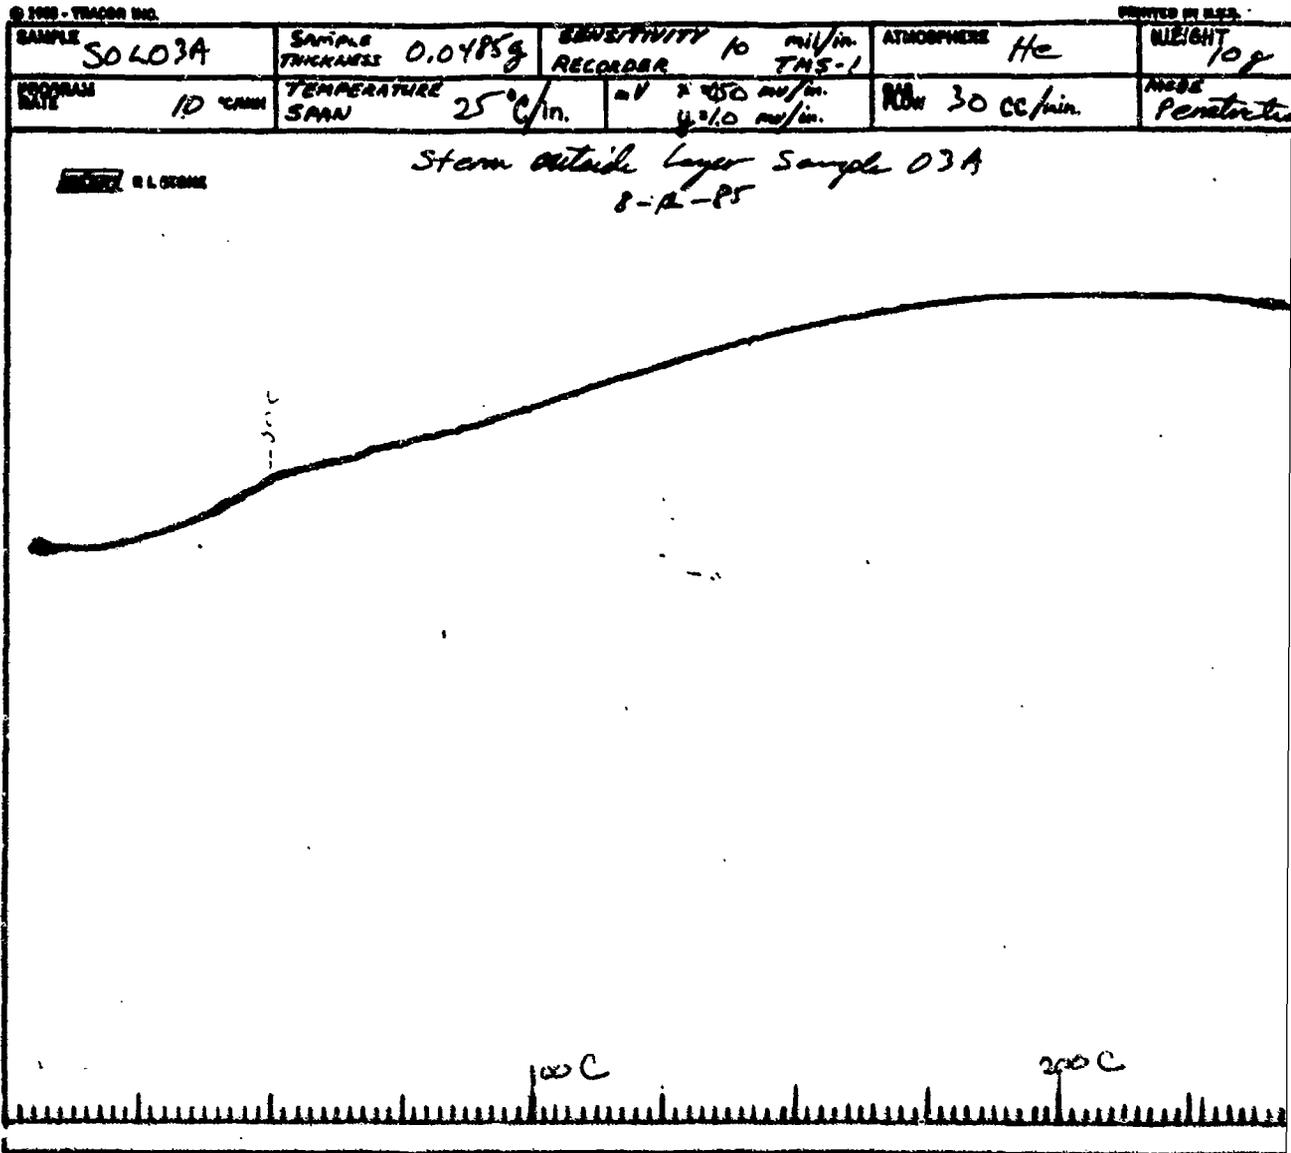
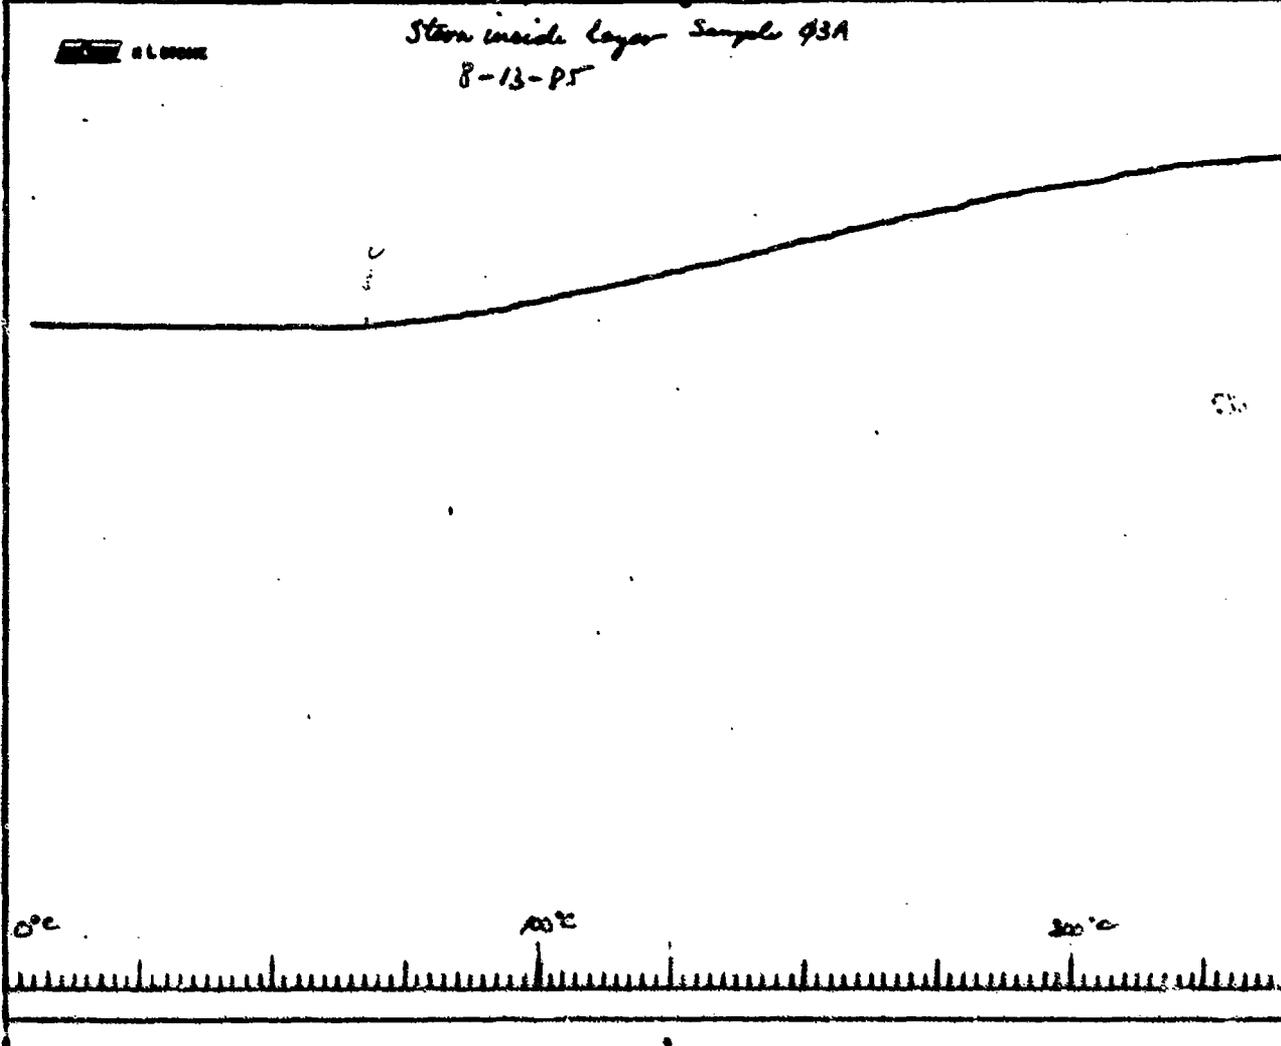
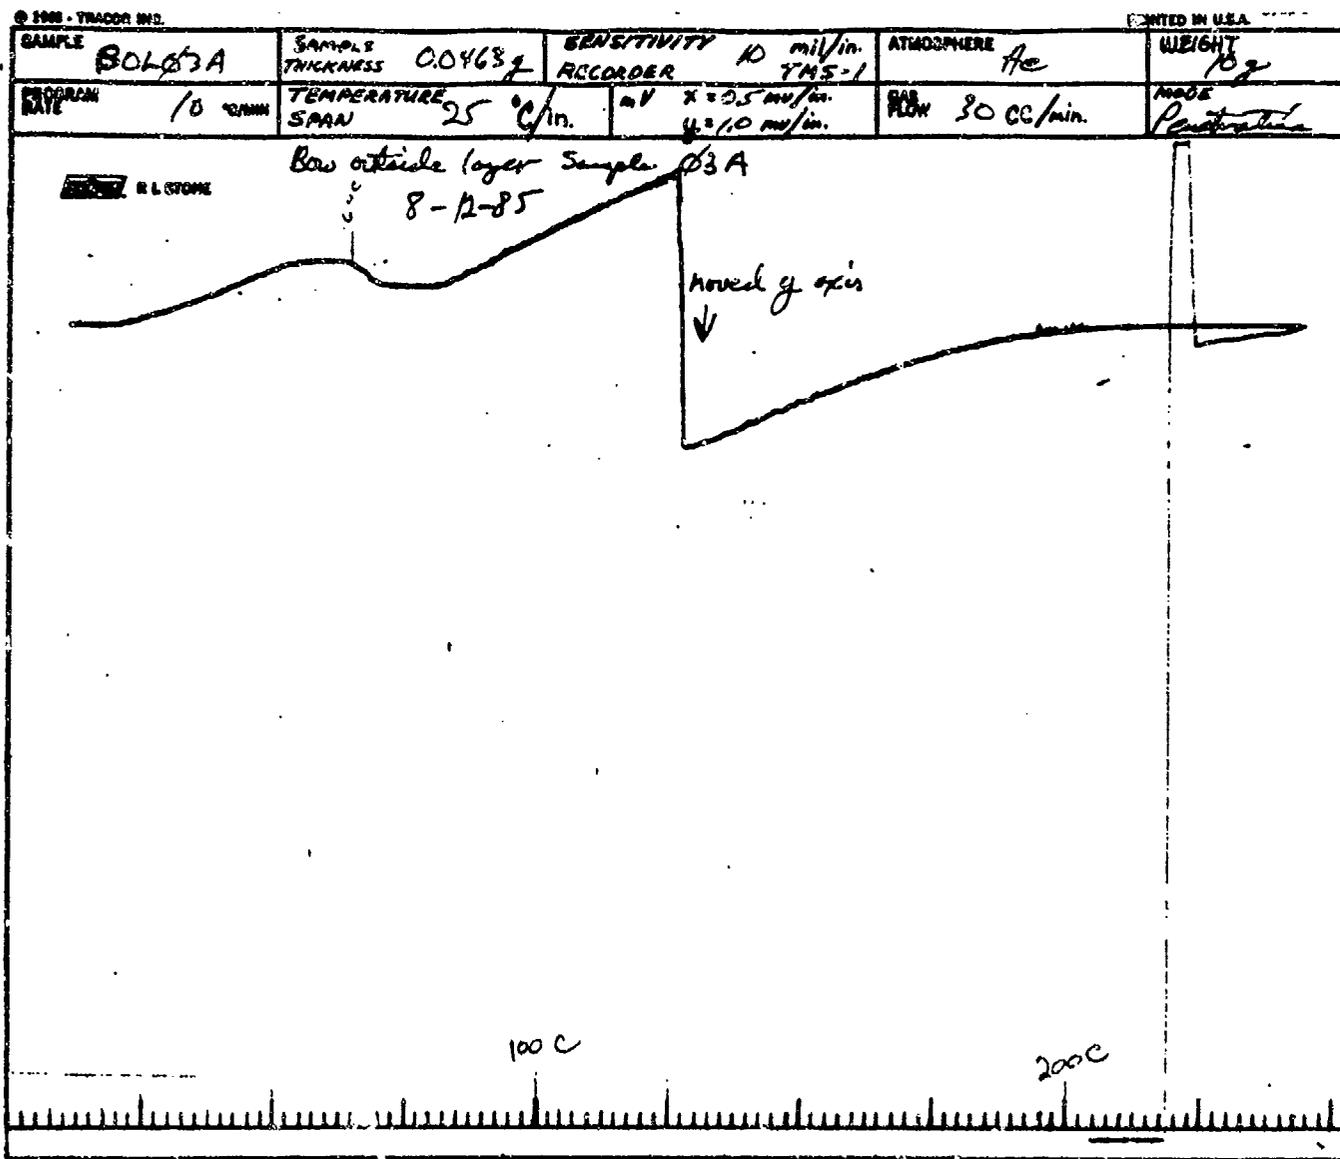
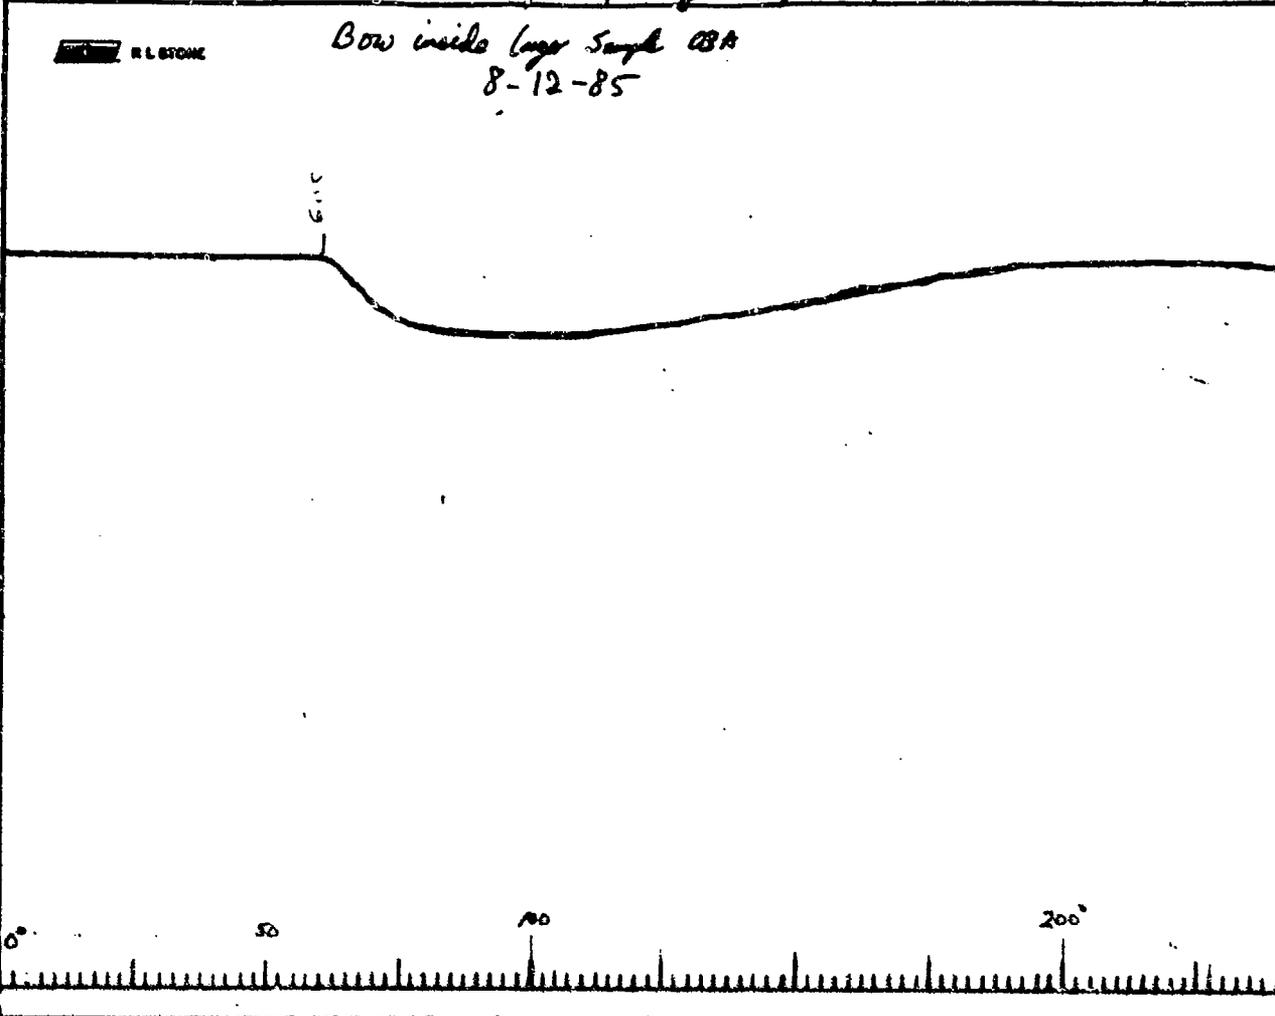
IMA data support the contention that the samples are not homogeneous in nature, thus pointing to variability in fabrication and cure. Non-homogeneity will cause concerns beyond cosmetic problems and may ultimately result in loss of structural integrity.
