THE DESIGN, DEVELOPMENT AND FABRICATION  
OF AN ORGANIC COMPOSITE SHIPPING CONTAINER  
FOR THE FULL UP POWER PACK (FUPP) (U)

CONTRACT DAAE07-88-C-R049

APRIL 1990

Carl H. Luther  
General Dynamics  
Land Systems Division  
P.O. Box 2094  
Warren, MI 48090

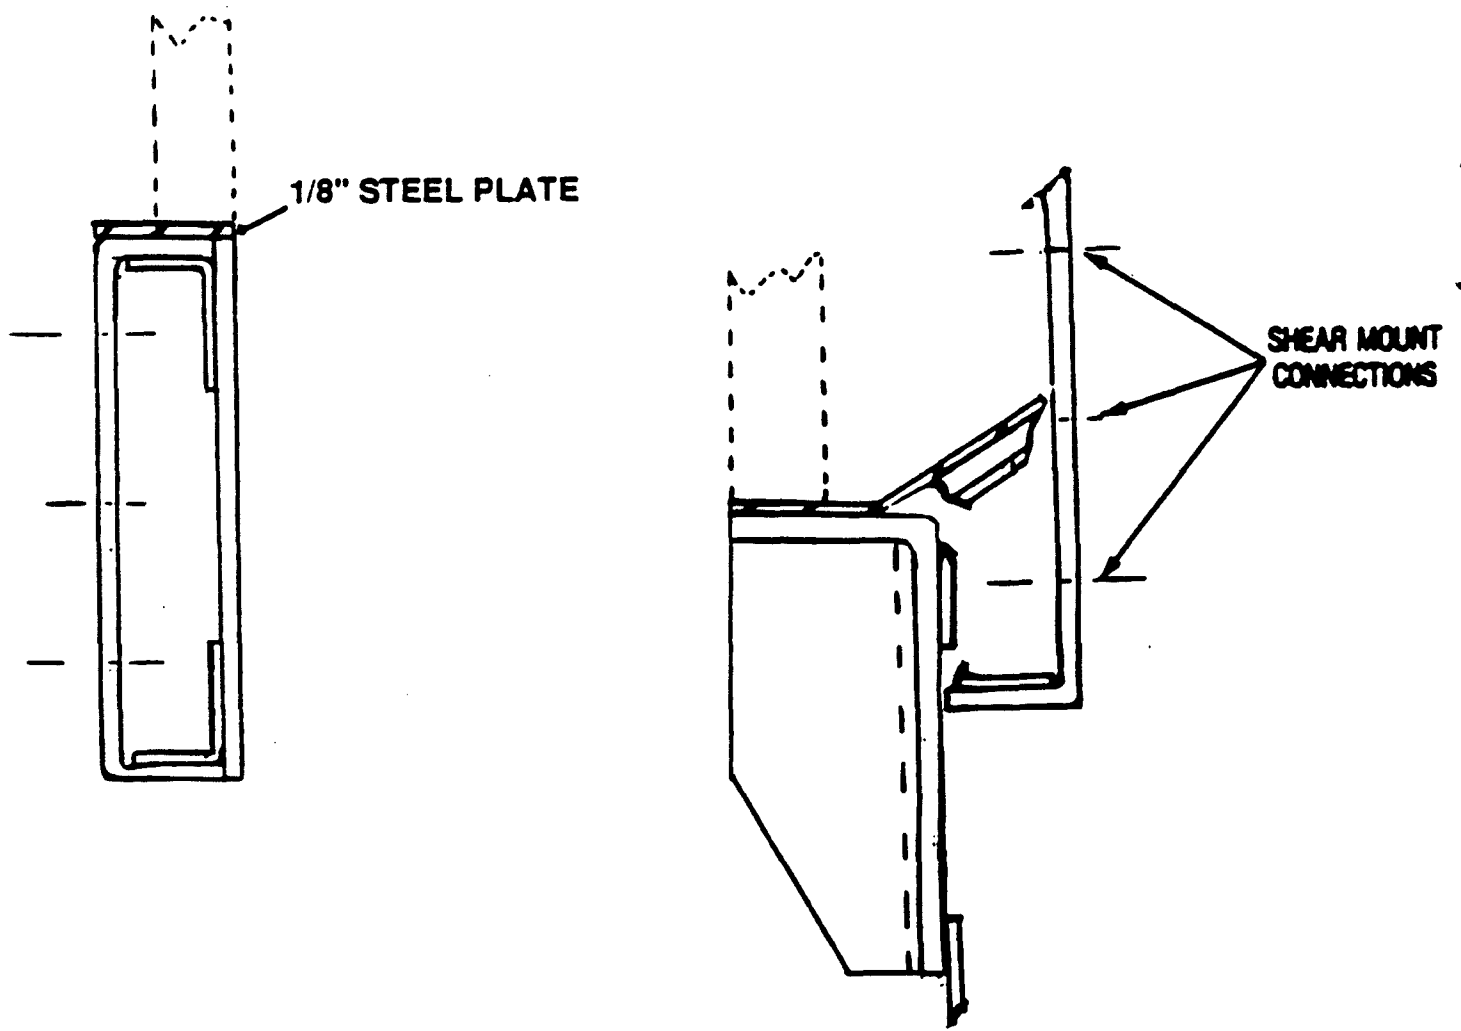
Figure 6-2. Inner Frame Pultruded Joint Failure

Initial design of the inner isolation frame utilized pultruded E-glass/polyester channels. During drop testing, there was a joint failure which was traced to excessive flange bending. The inner frame was redesigned out of 6061-T6 aluminum and has successfully passed all tests.

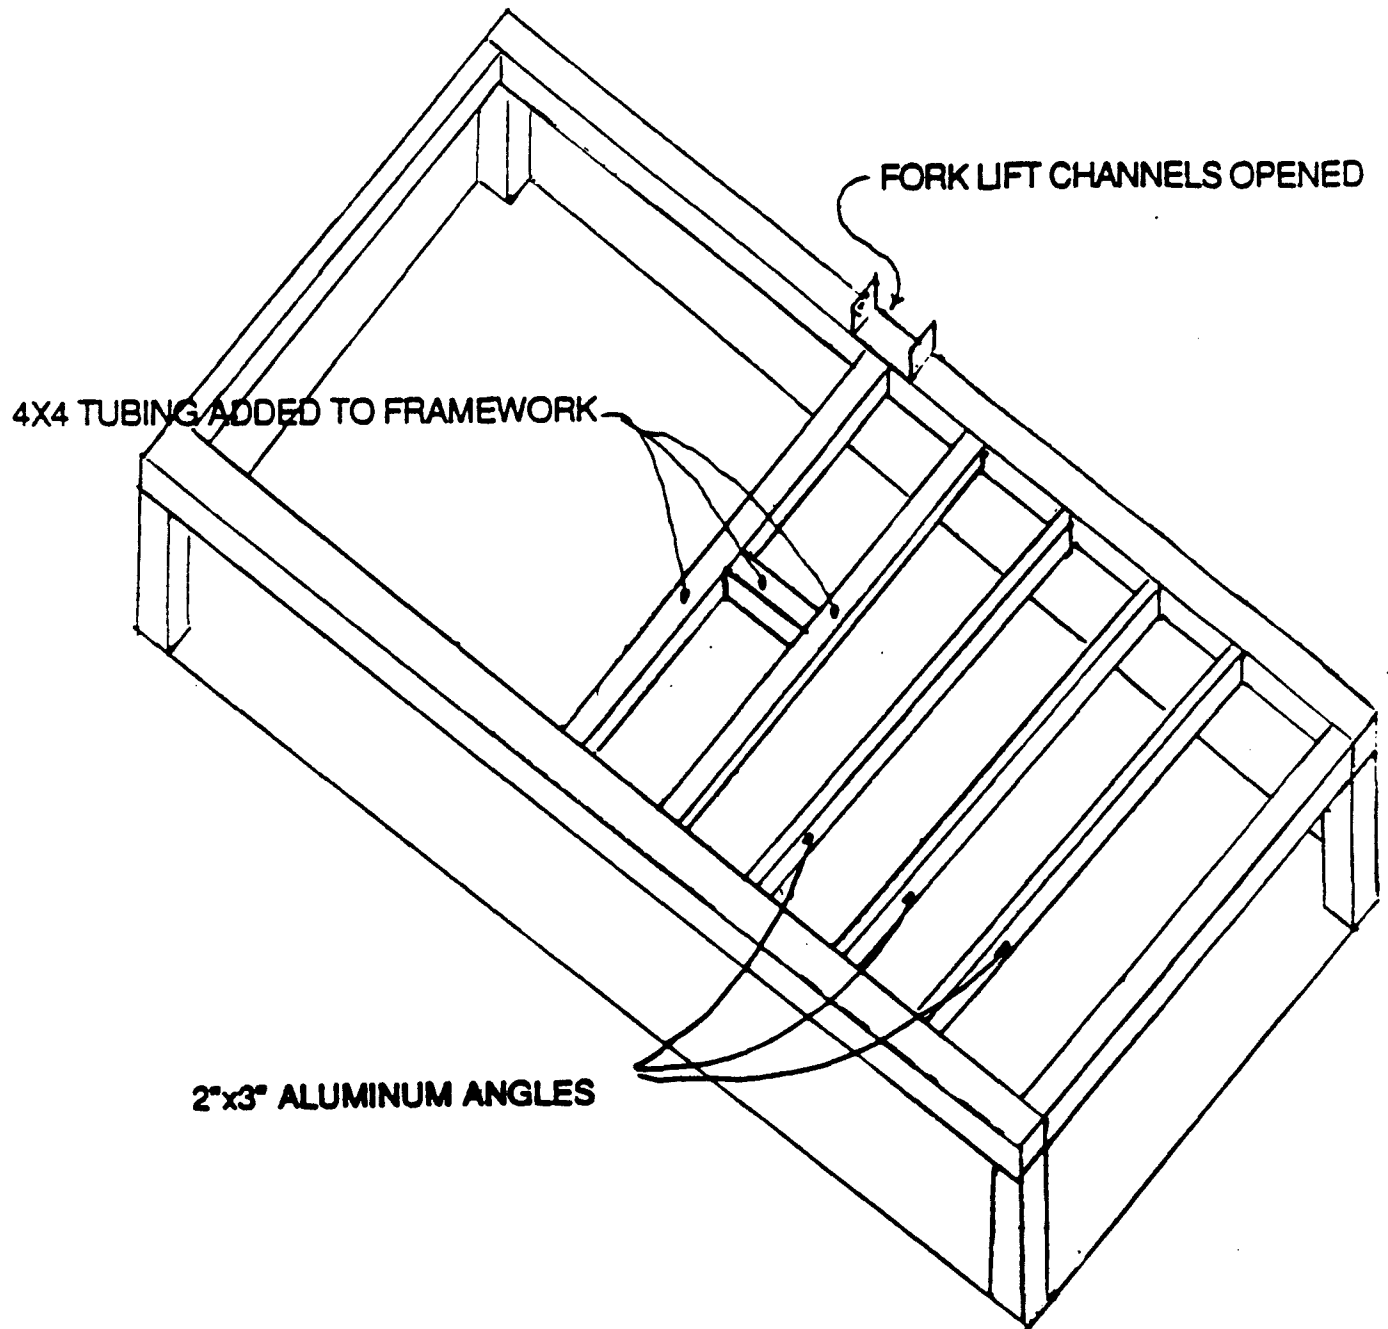
Figure 6-4. Redesign of Bottom Tub

**CONCERN : EXCESSIVE DEFLECTION OF BOTTOM DURING PRESSURIZATION AND FORK LIFT CONDITIONS**

6.3.1 Composite Tub. The basic wall construction is 2/10 in. Cofab glass cloth/flame retardant polyester resin. Inside, radii are kept at 5/8 in. to allow extruded square aluminum tubing to nest as closely as possible to the corners. The horizontal flanges are 1/2 in. thick to allow adequate strength in the bolted joint. This 1/2 in. extends 3.5 in. inches down the vertical wall to form an integral angle stiffener around the perimeter. Initial design of the tub floor had minimal stiffening in an attempt to minimize weight. However, excessive deflections were noted during pressure testing so additional aluminum stiffeners were bolt/bonded to the 2/10 in. composite panel. These were 2" x 3" x 1/4" 6061-T6 extrusions. Test results have proven the validity of this redesign.

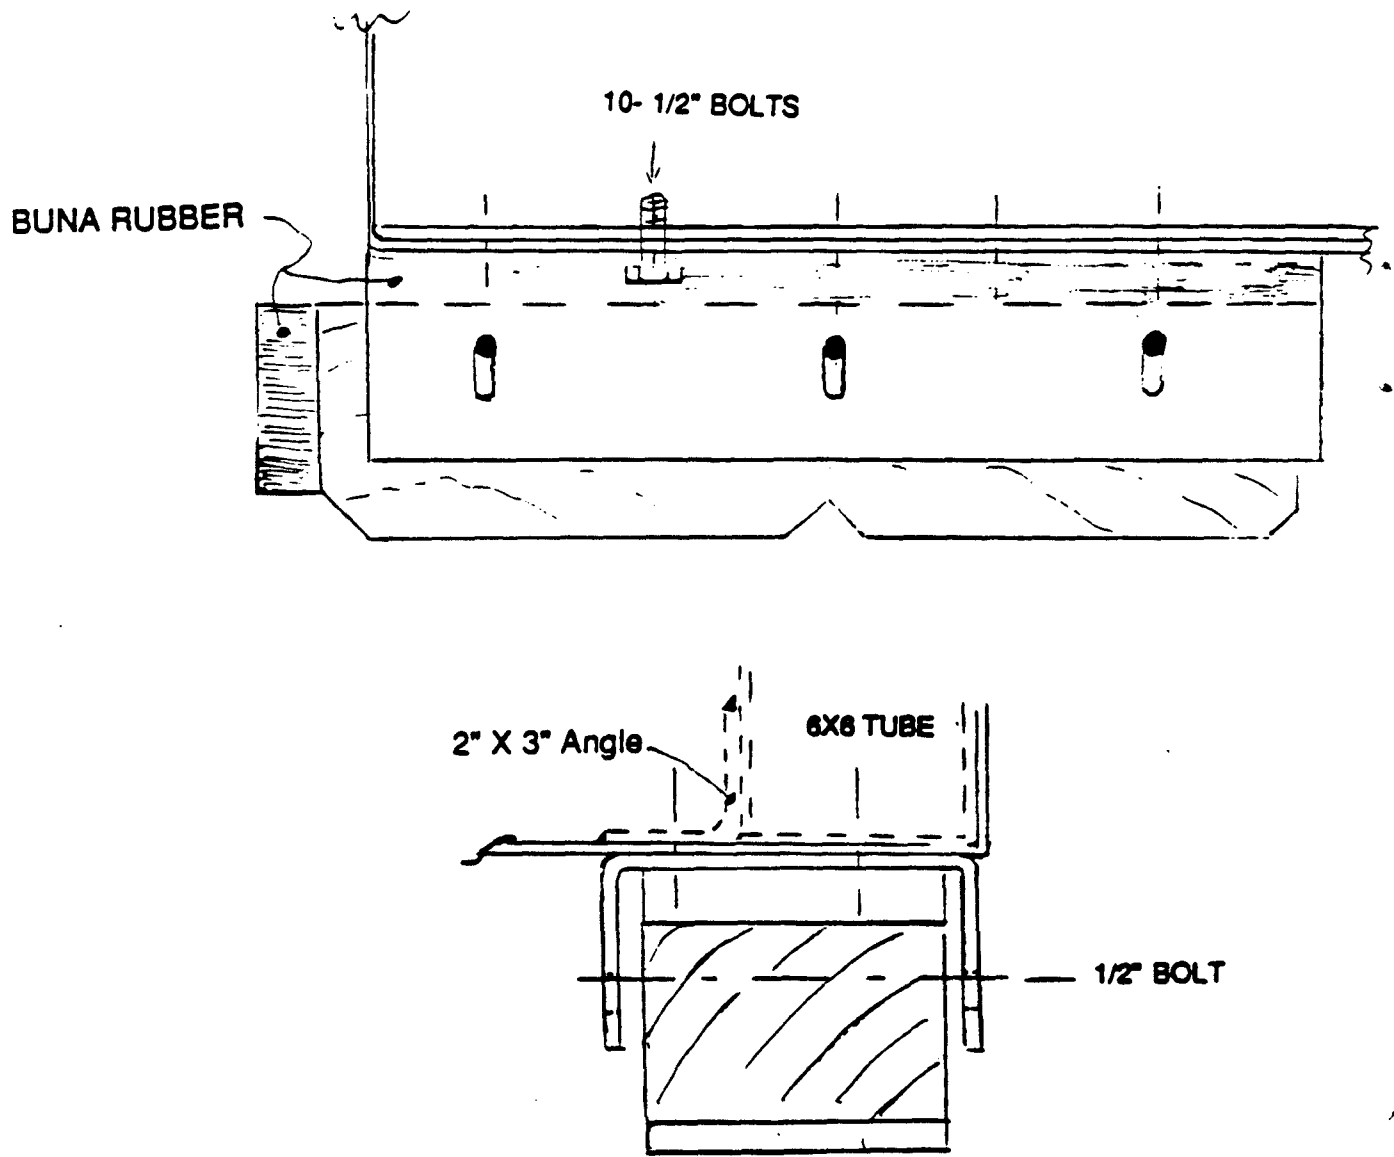
Figure 6-5. Skid Mount

The bottom tub is subject to drop and pendulum impact testing, the most severe condition being pendulum impact. The critical region for this condition is the skid mount attachment. This area was beefed up after failure of the initial concept. All Margins of Safety are now positive. Stress analysis is presented in Figure 7-3.

The redesign of the skid mount attachment region required adding in a 2" x 3" x 1/4" 6061-T6 aluminum angle to the inside of the composite tub at each of the four corners. This is shown in Figure 6-5. In addition, ten 1/2 in. steel bolts were used at each corner to react the impact load from the skid directly into the tub reinforcement tubes. Pliogrip adhesive was also used at the interface. This attachment minimized loading on the thin (2/10 in.) composite floor. There were no failures in subsequent testing.

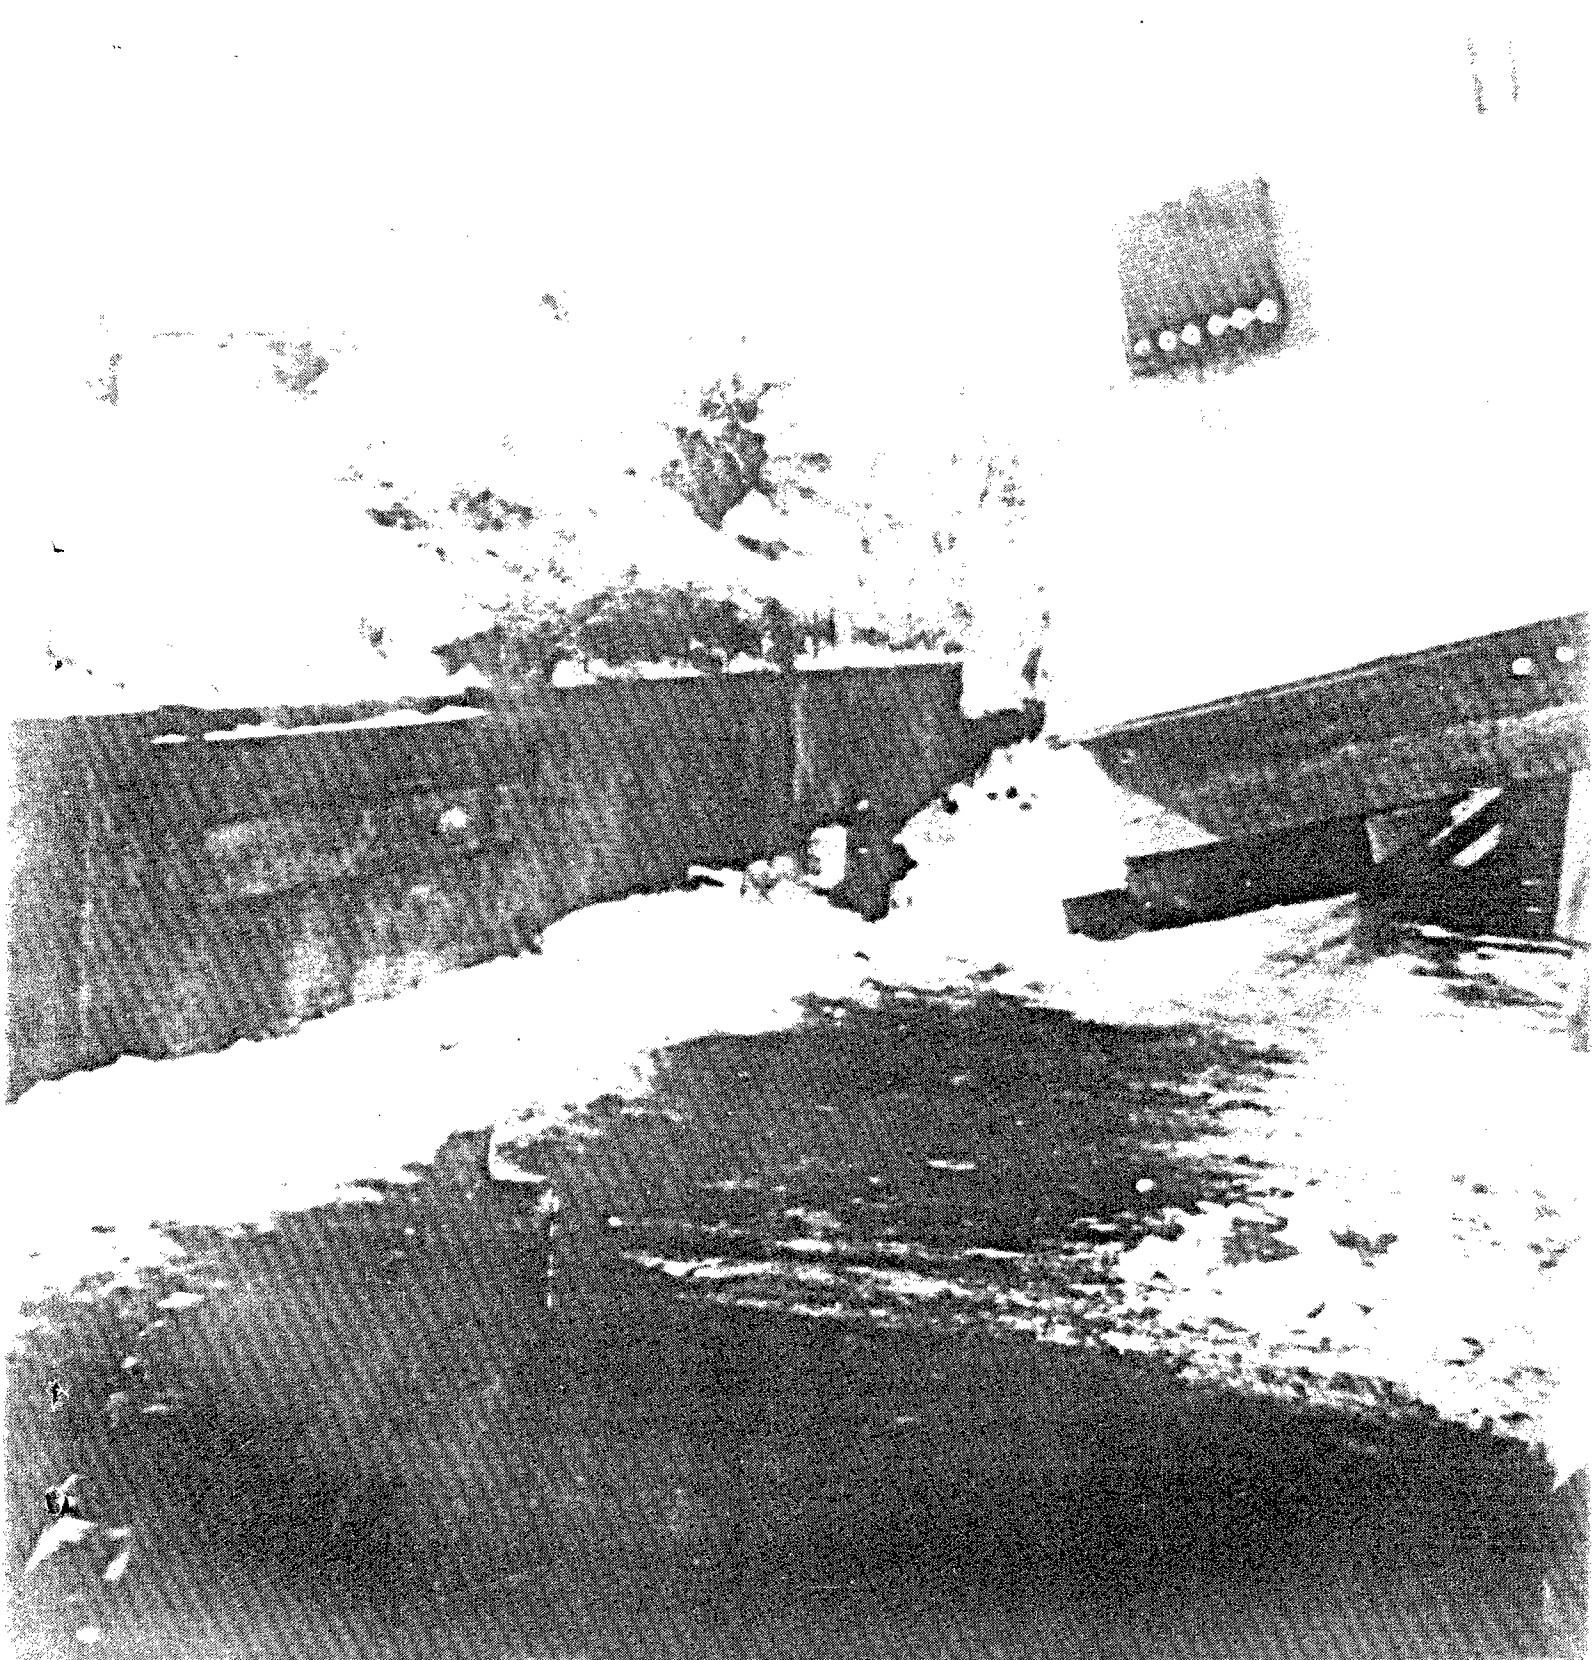
PENDULIM IMPACT (AFT END)

2.11.3 Prior to performing the tests specified in 2.9 it was observed that the skid brackets were coming free from the bottom section of the container. It was decided that we would proceed with the pendulum impact tests in 2.9. During these tests the skid brackets were totally broken away from the bottom section of the container.
