AD-A231 442 SSC-337 (PART 1)

SHIP FRACTURE MECHANISMS INVESTIGATION

SHIP STRUCTURE COMMITTEE

1990

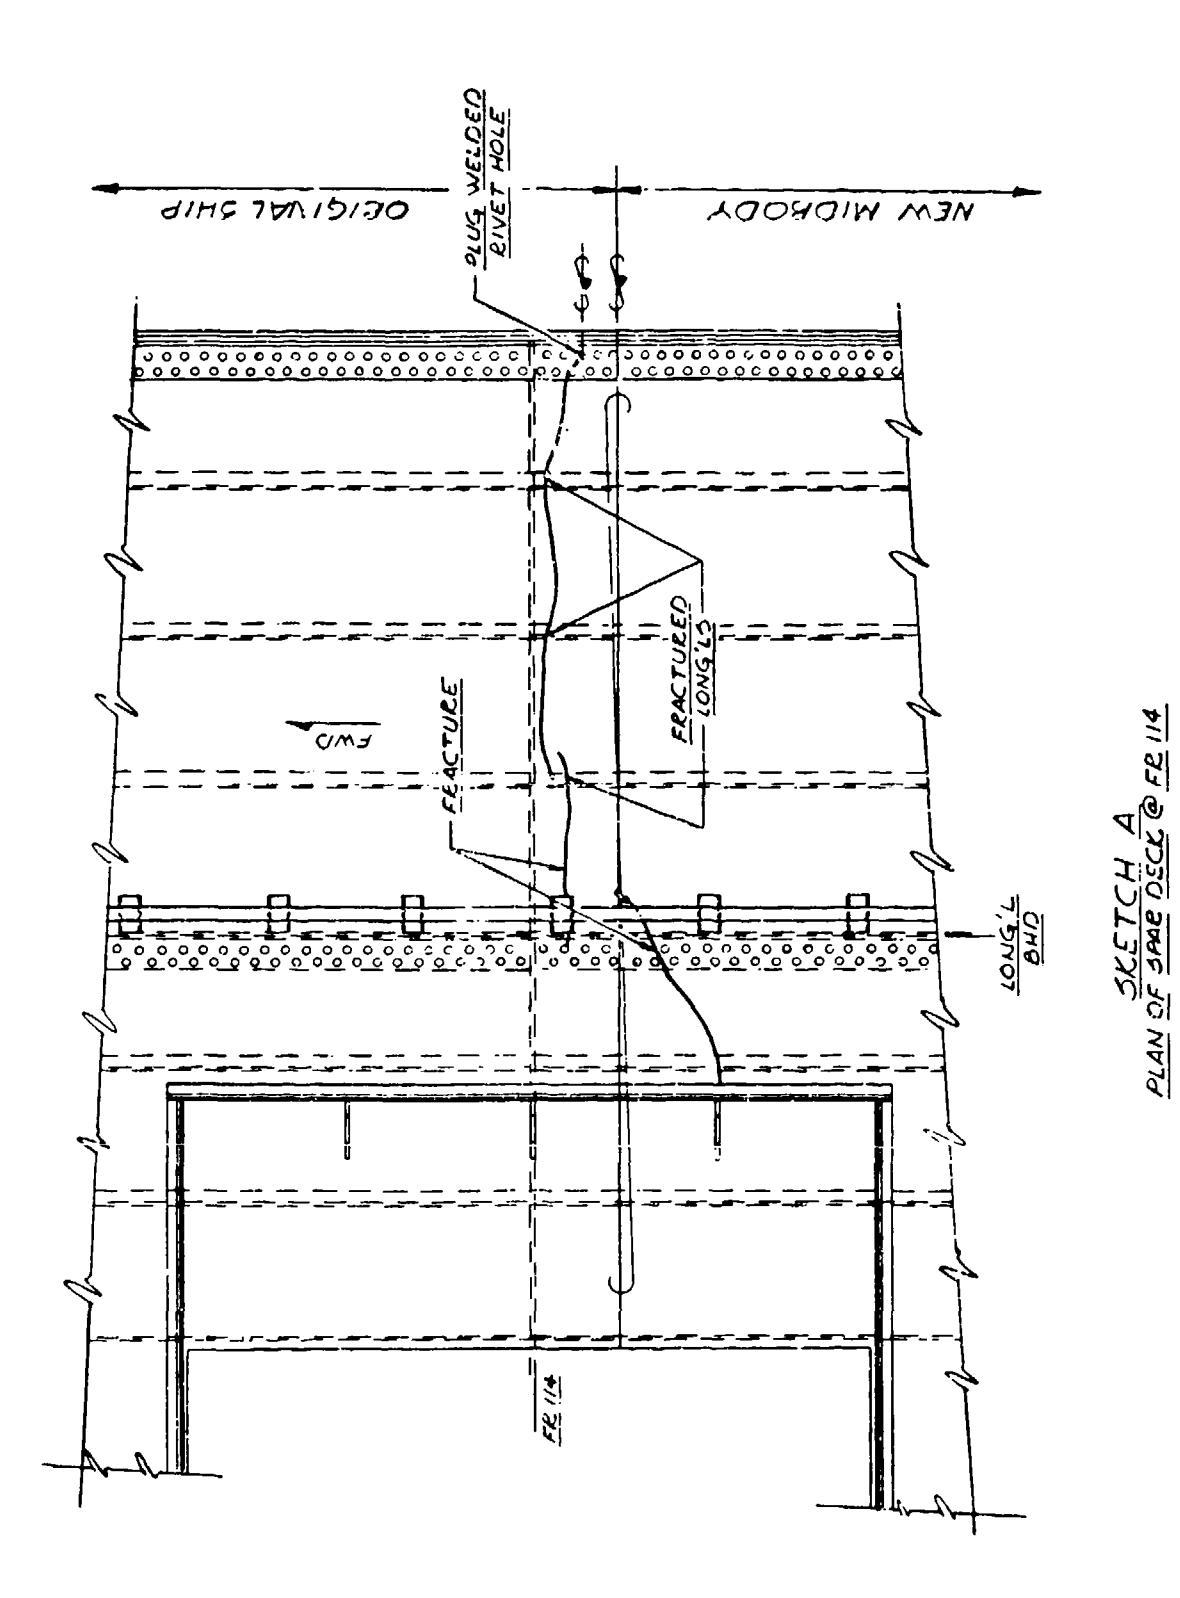
Fracture path on the $s_{\vec{\mu}}ar$ deck of the Great Lakes bulk carrier Figure 3-2

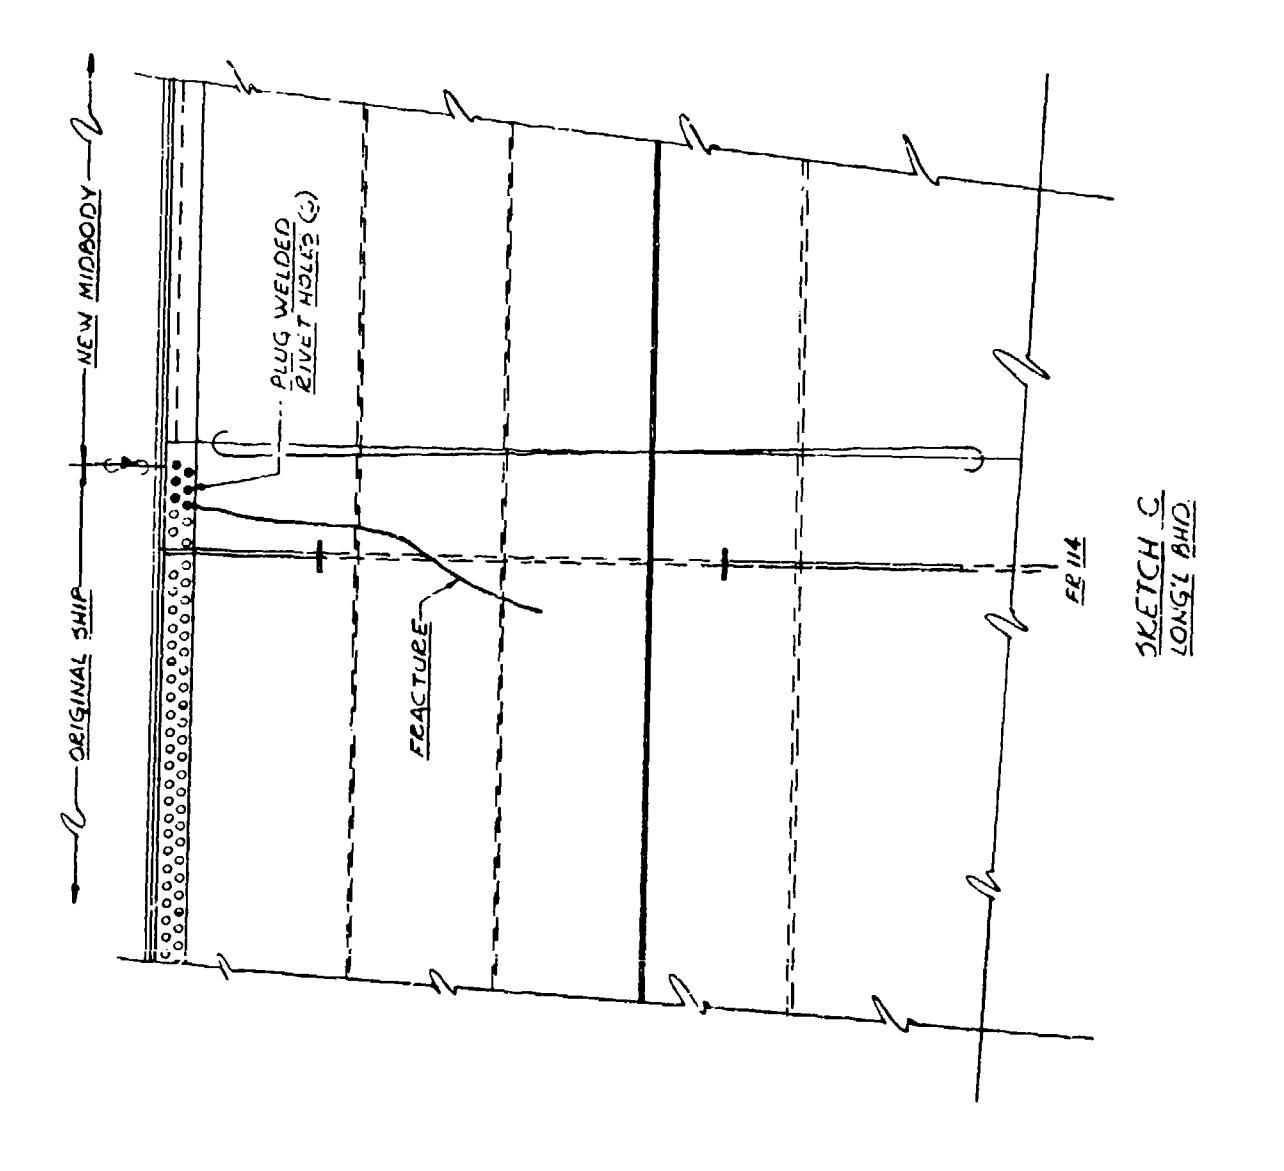
Figure 3-4 Fracture path in the longitudinal Bulkhead of the Great Lakes Bulk Carrier

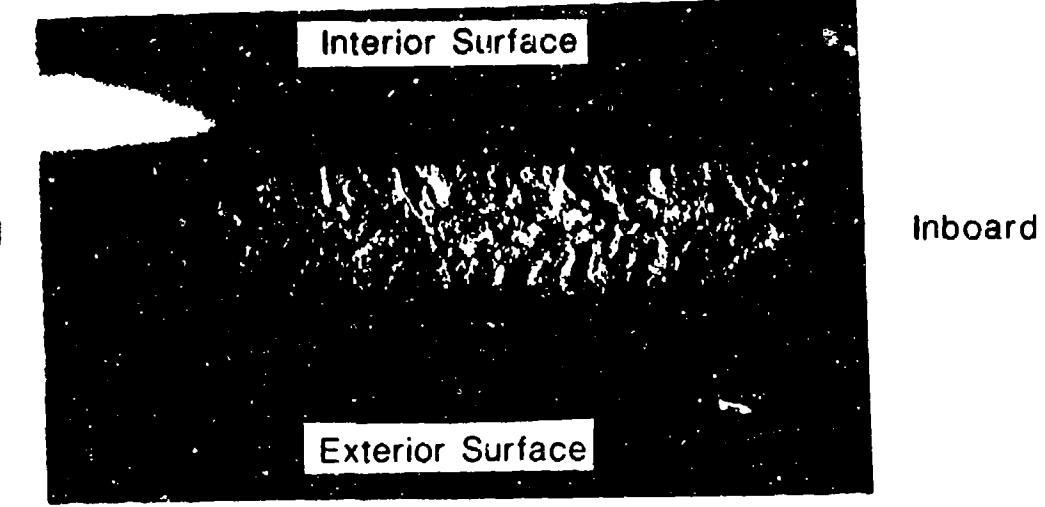
Figure 3-7a Example of chevron markers on the surface of Piece no. 1, indicating generally brittle fracture. Surface not completely flat, but markers are accentuated by oblique lighting.

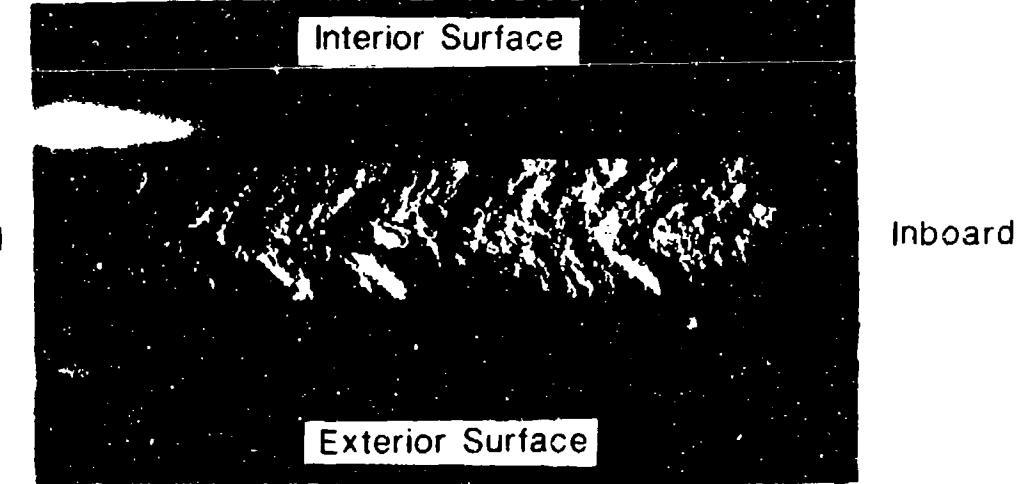
Figure 3-7b Fracture surface of Piece no. 1, oblique lighting. Somewhat more surface texture than seen in Figure 7a indicating increasing ductility in the fracture process, however no shear lip present.

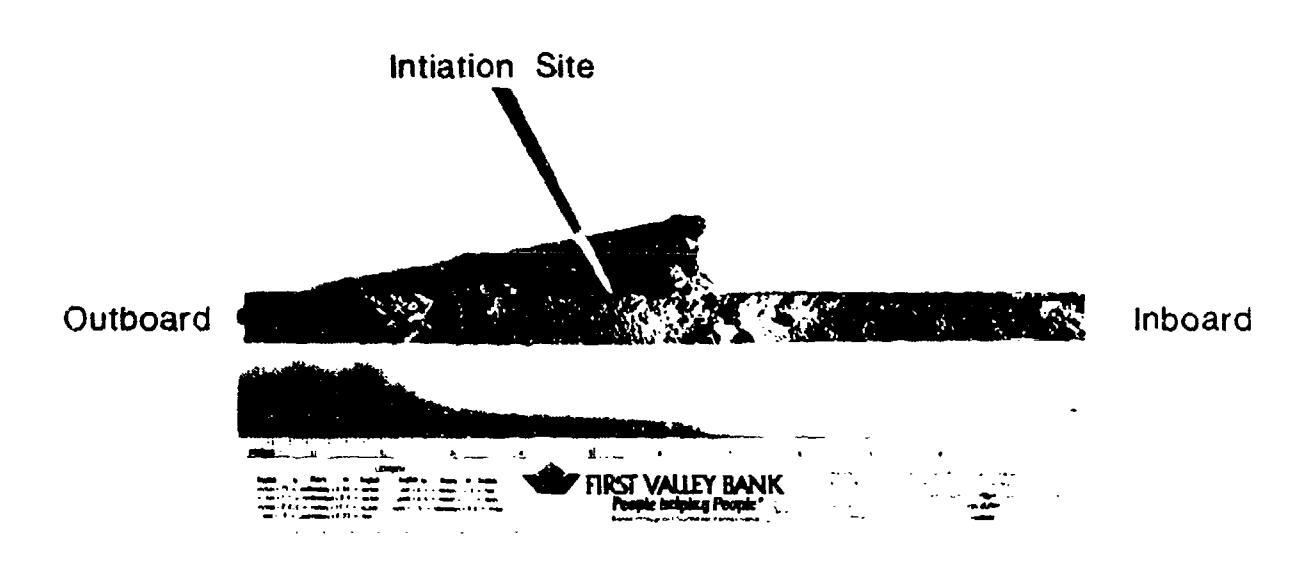
Figure 3-9 Piece no. 6. Fracture initiation site in deck at channel but: weld.

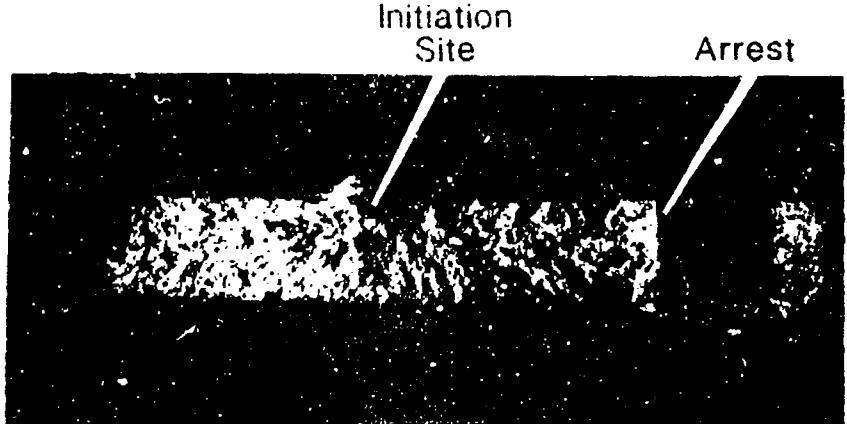
- Up- Toward Main deck
- Figure 3-10 Piece no. 3 (top of longitudinal bulkhead) initiation site showing crack entering Piece no. 3 through weld of angle to Piece no. 3. Crack goes to rivet hole on right and down the bulkhead to left.

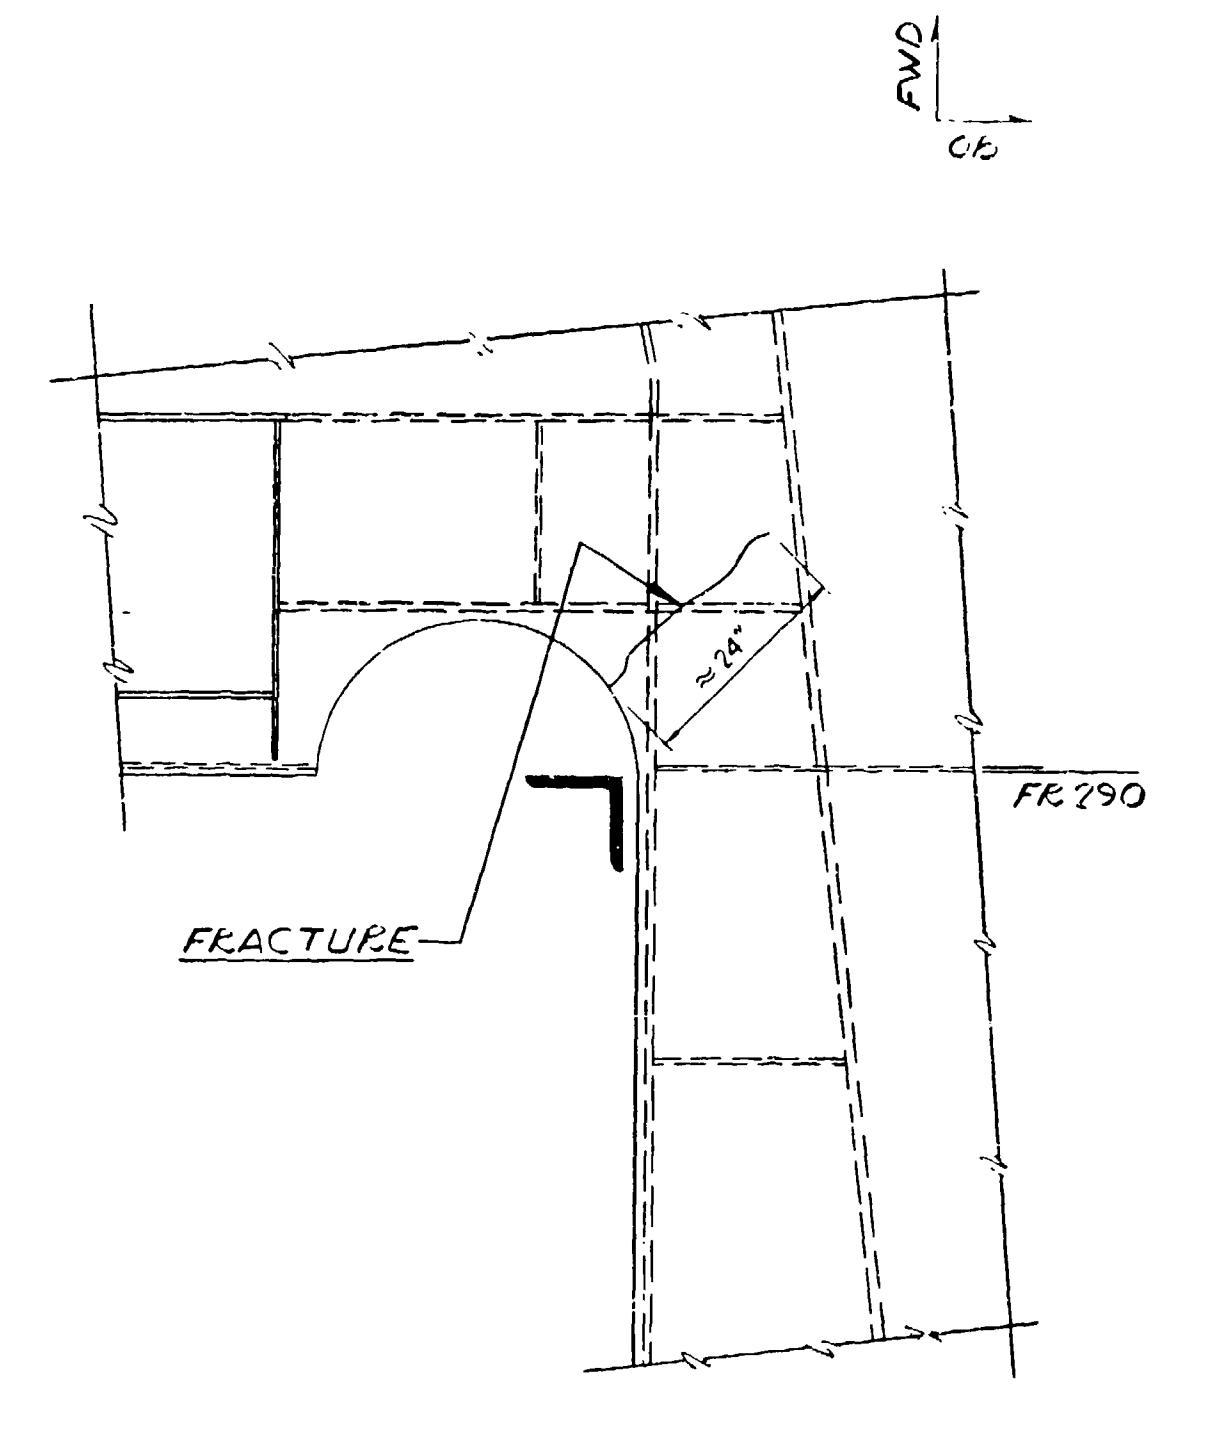
Figure 3-16 Fracture of the forward hatch cutout on the high speed containership during the second winter season

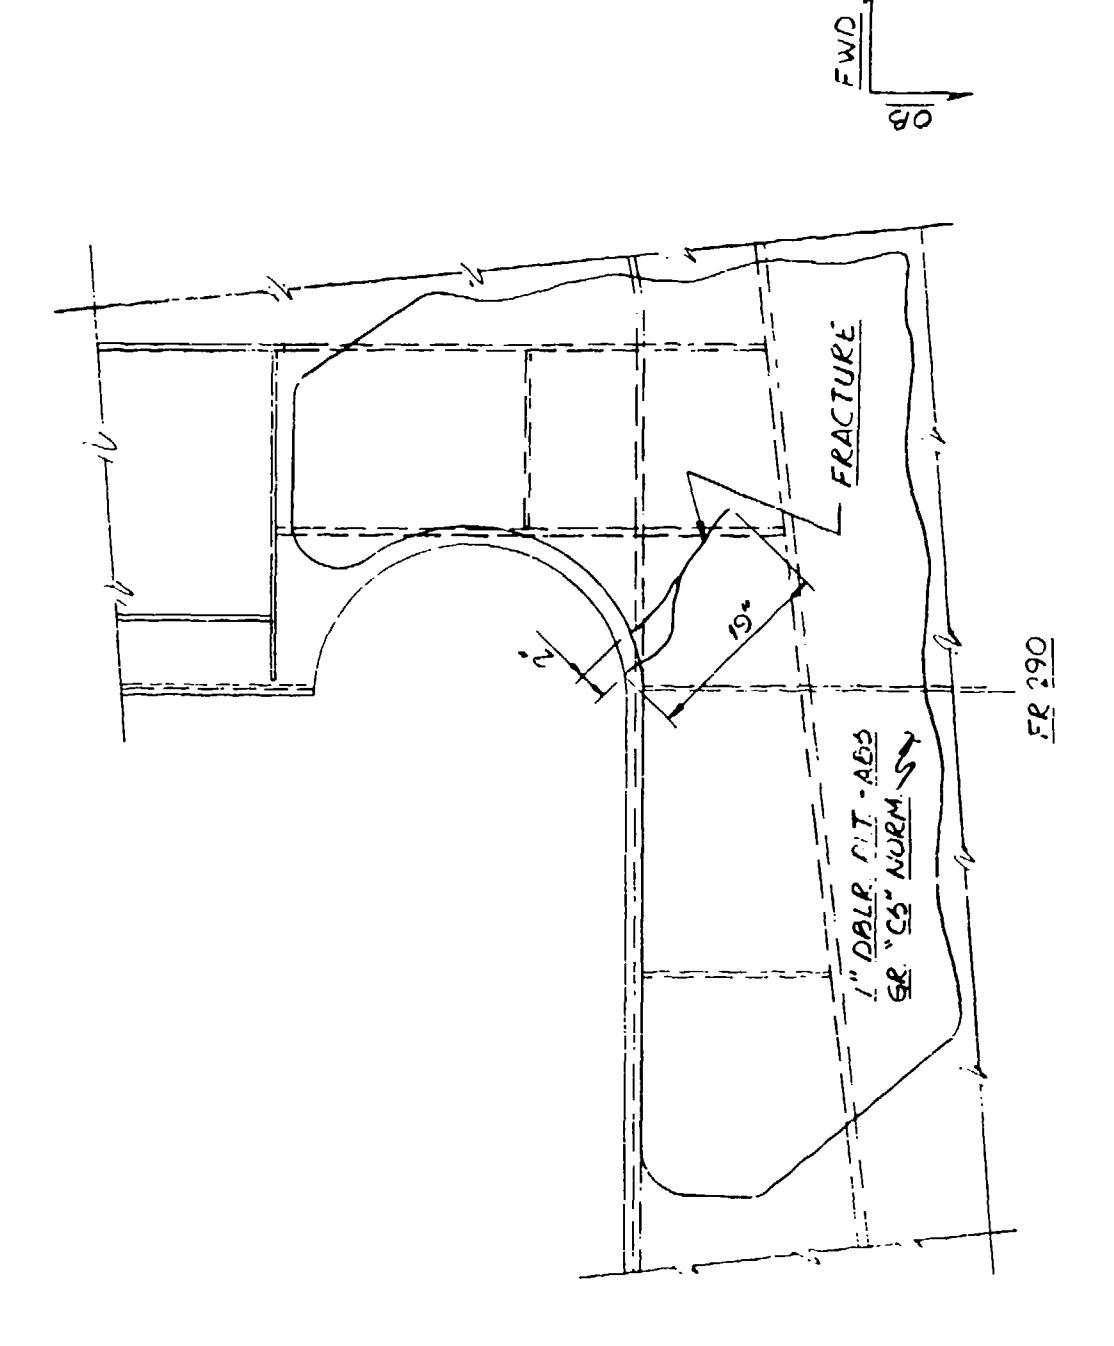
Figure 3-17 Fracture in the deck and doubler plate at the forward hatch cut out prior to 5/75

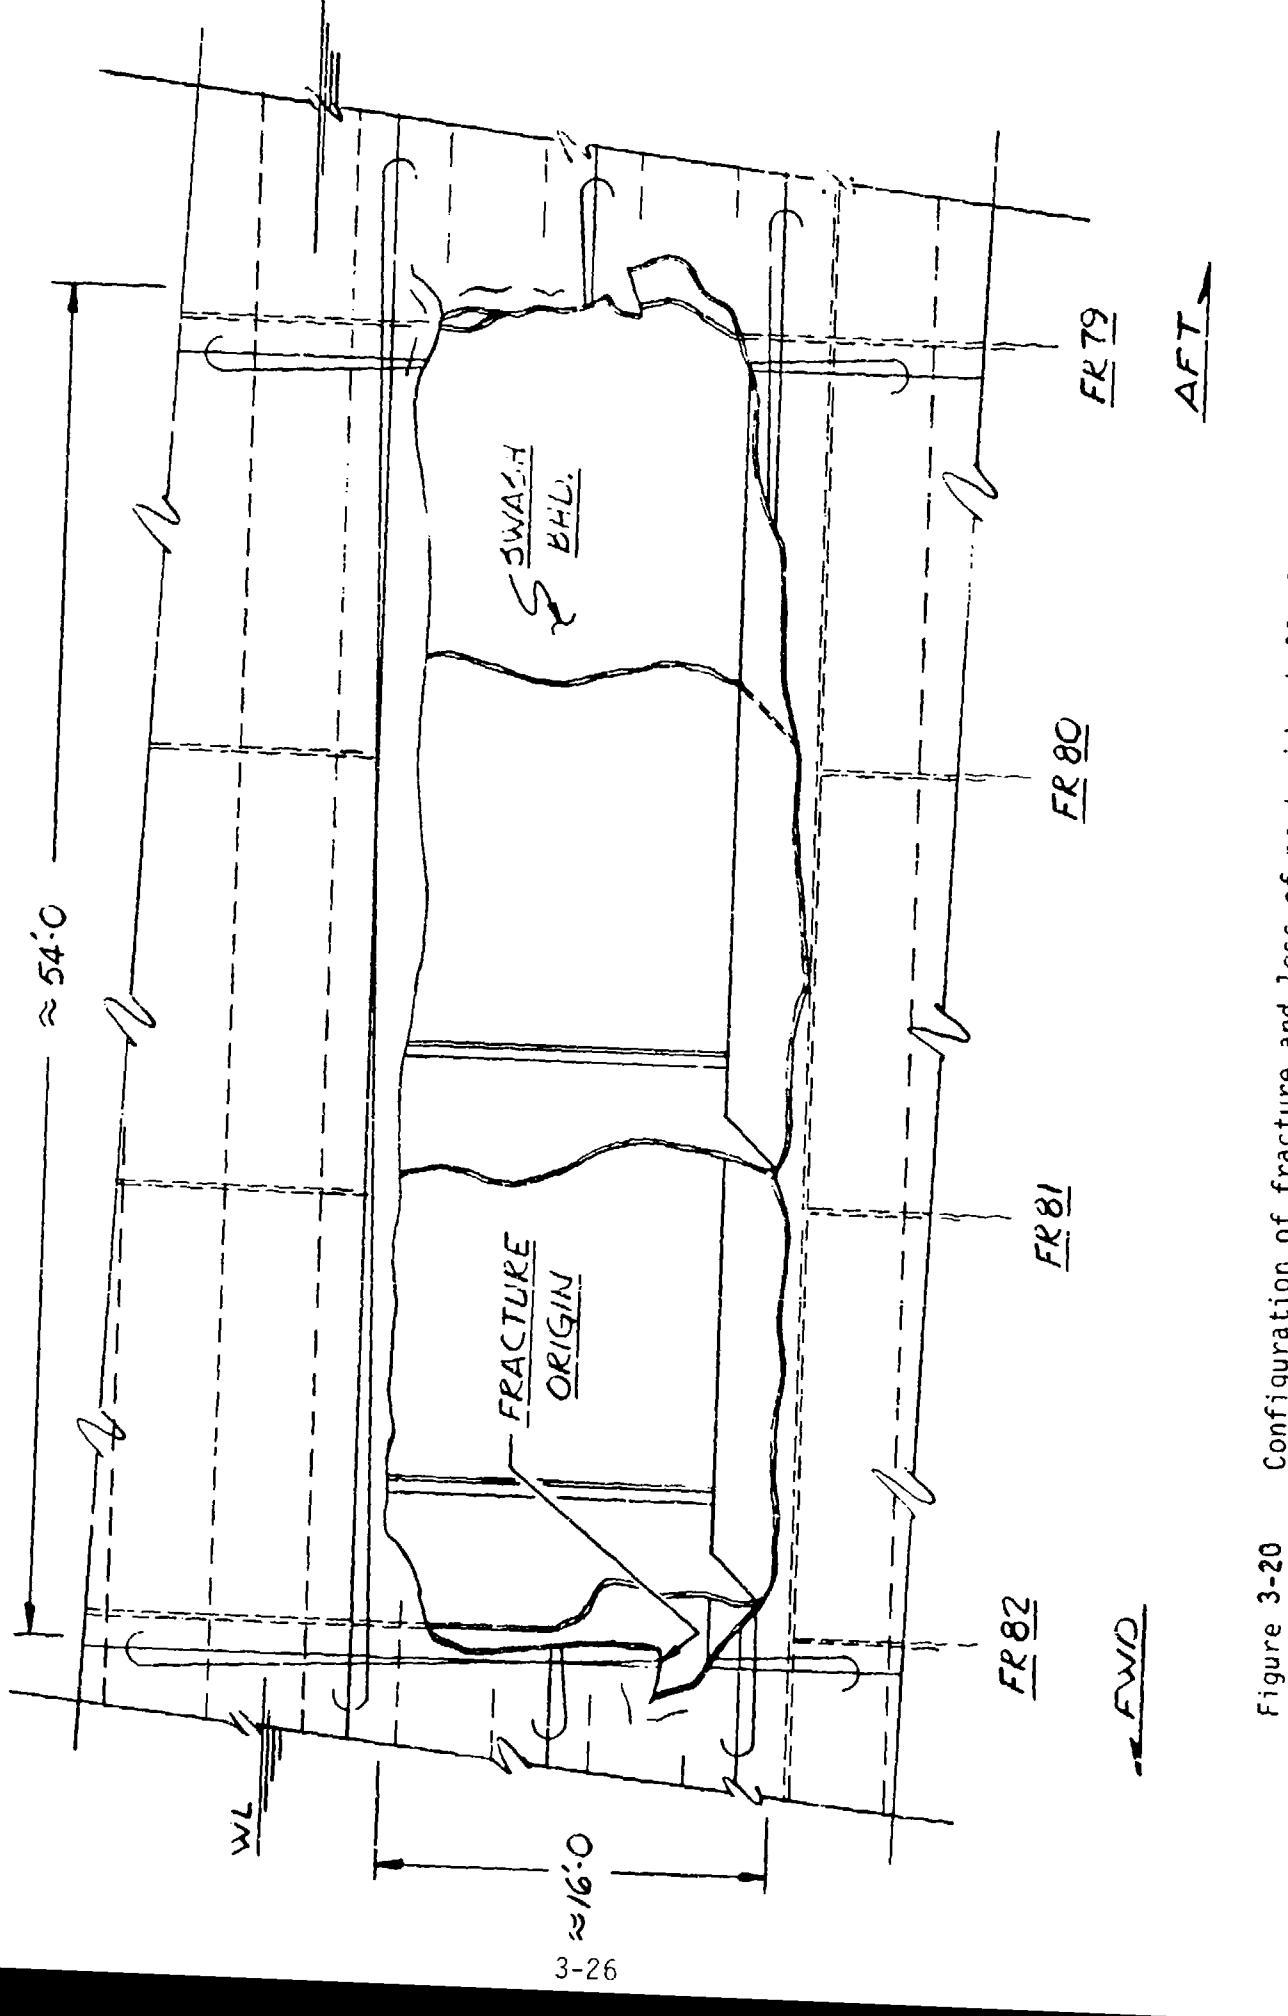
Configuration of fracture and loss of port side shell plating on the tanker

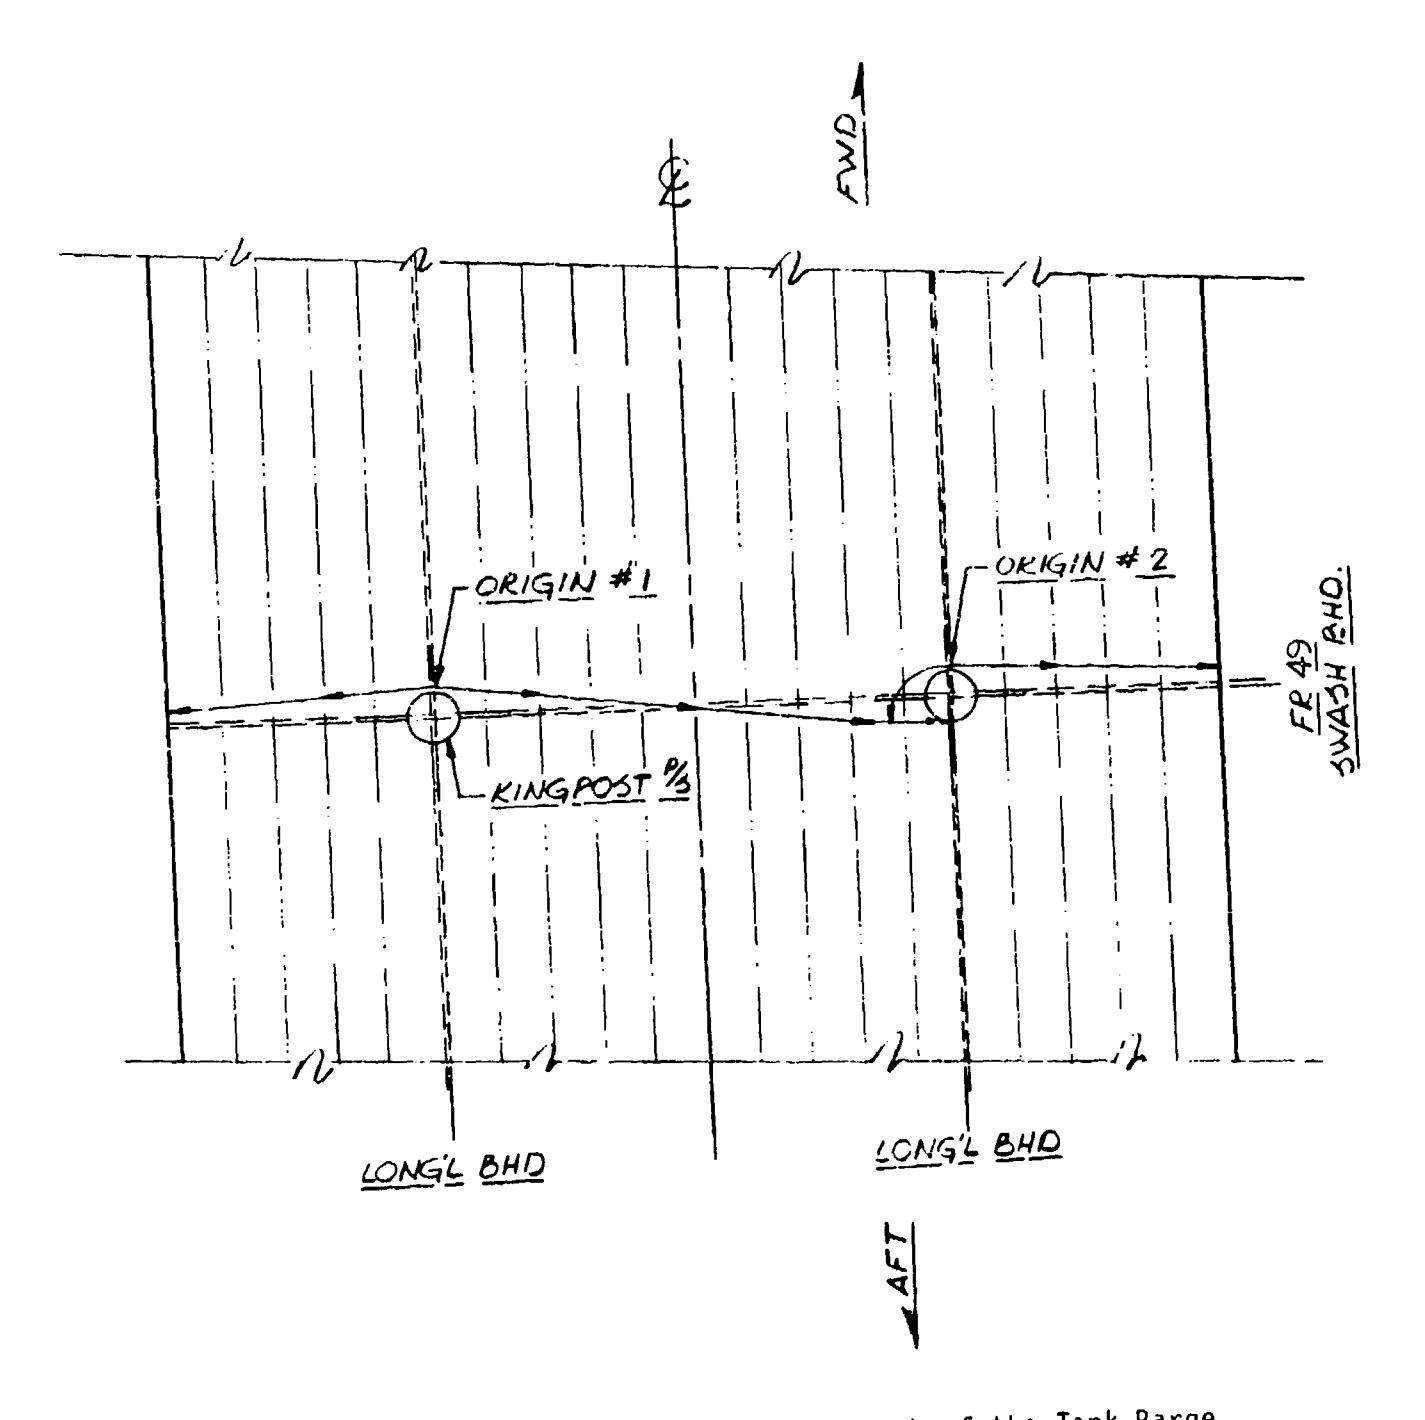
The fracture of the barge was generally in the vicinity of Frame 49, which is 42'-6" aft of the midpoint of the barge. The fracture extended completely across the main deck, down the side shell port and starboard, and across approximately 46 percent of the bottom plating. The configuration of the fracture path across the main deck is shown in Figure 3-21. The fracture originated at the base of a king post on the deck above the port longitudinal bulkhead. The king post was welded to a base plate doubler ring which was centered directly over the intersection of the transverse swash bulkhead at Frame 49

Figure 3-21 Fracture Path on the Main Deck of the Tank Barge

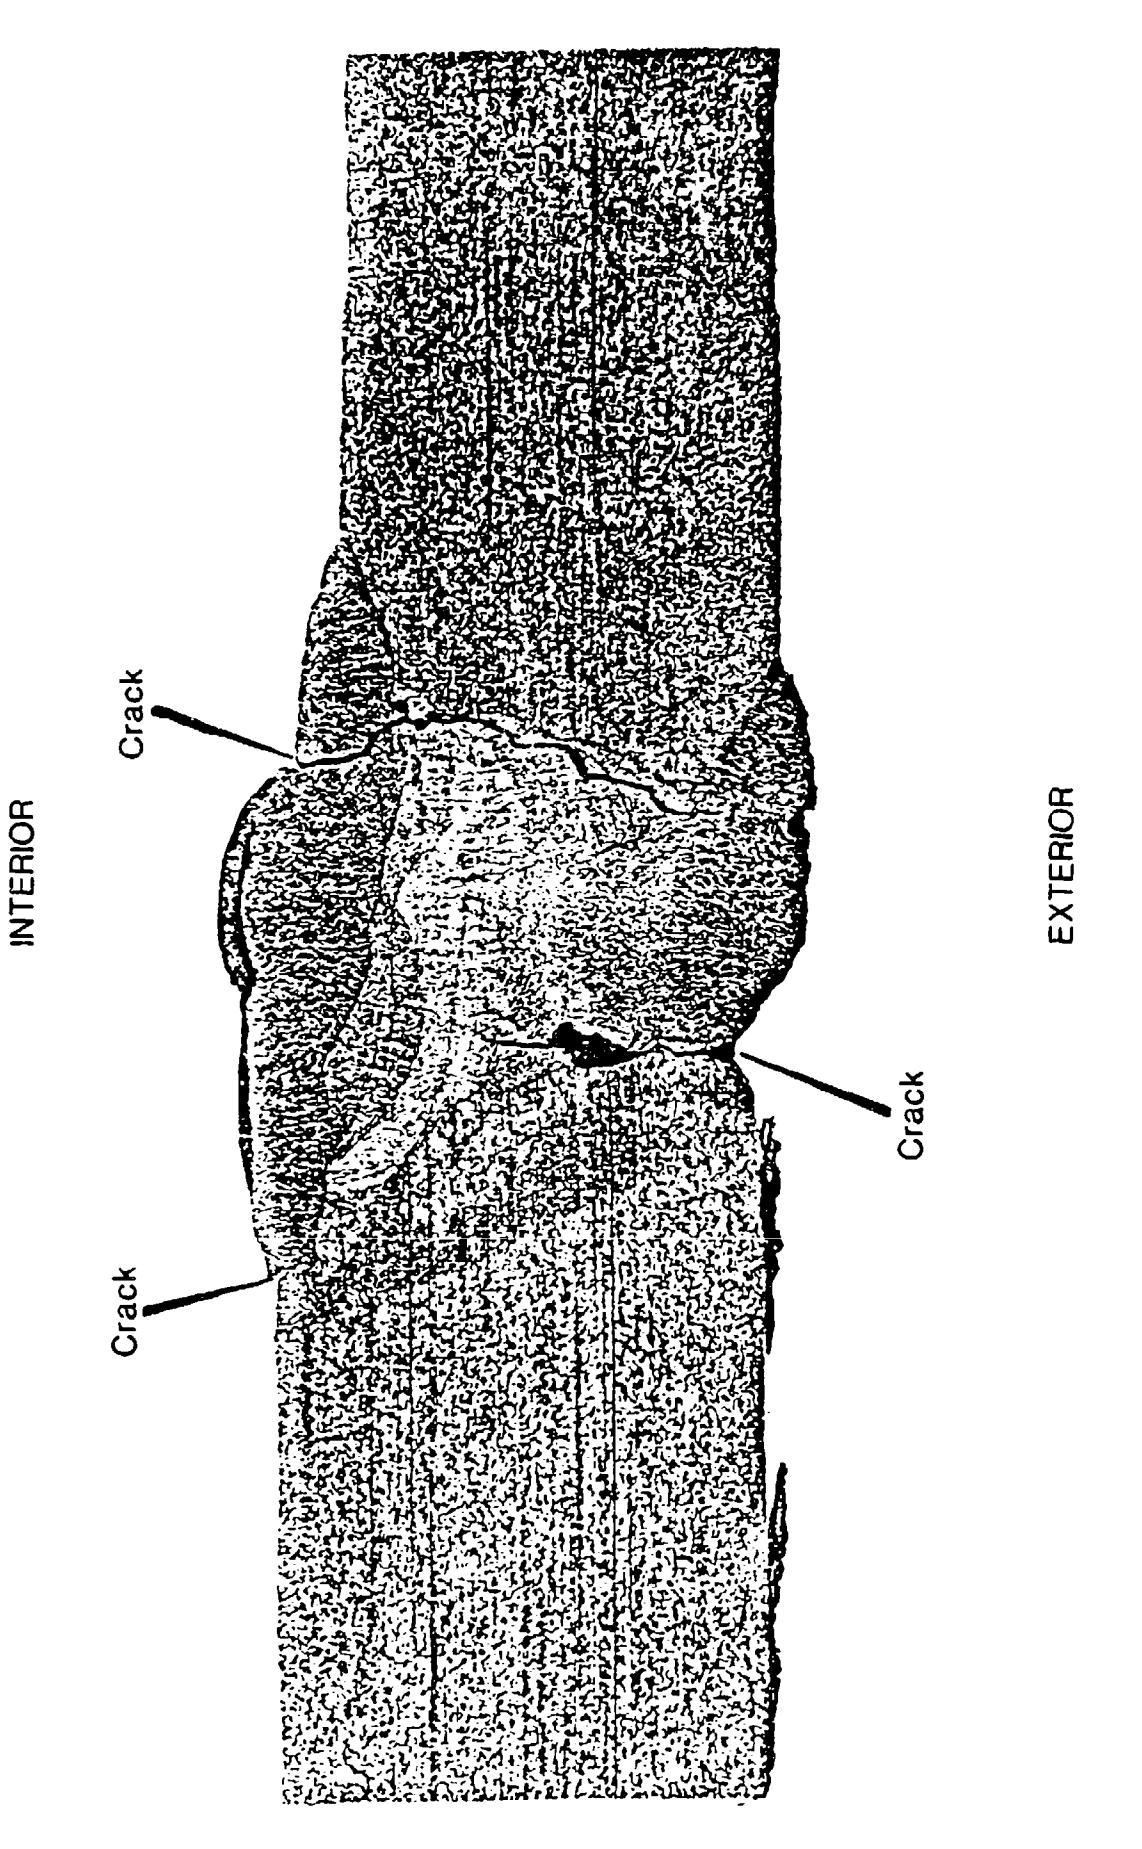
Figure 3-26 Weld Detail Used on the Converted Containership Showing Corrosion Fatigue Cracks

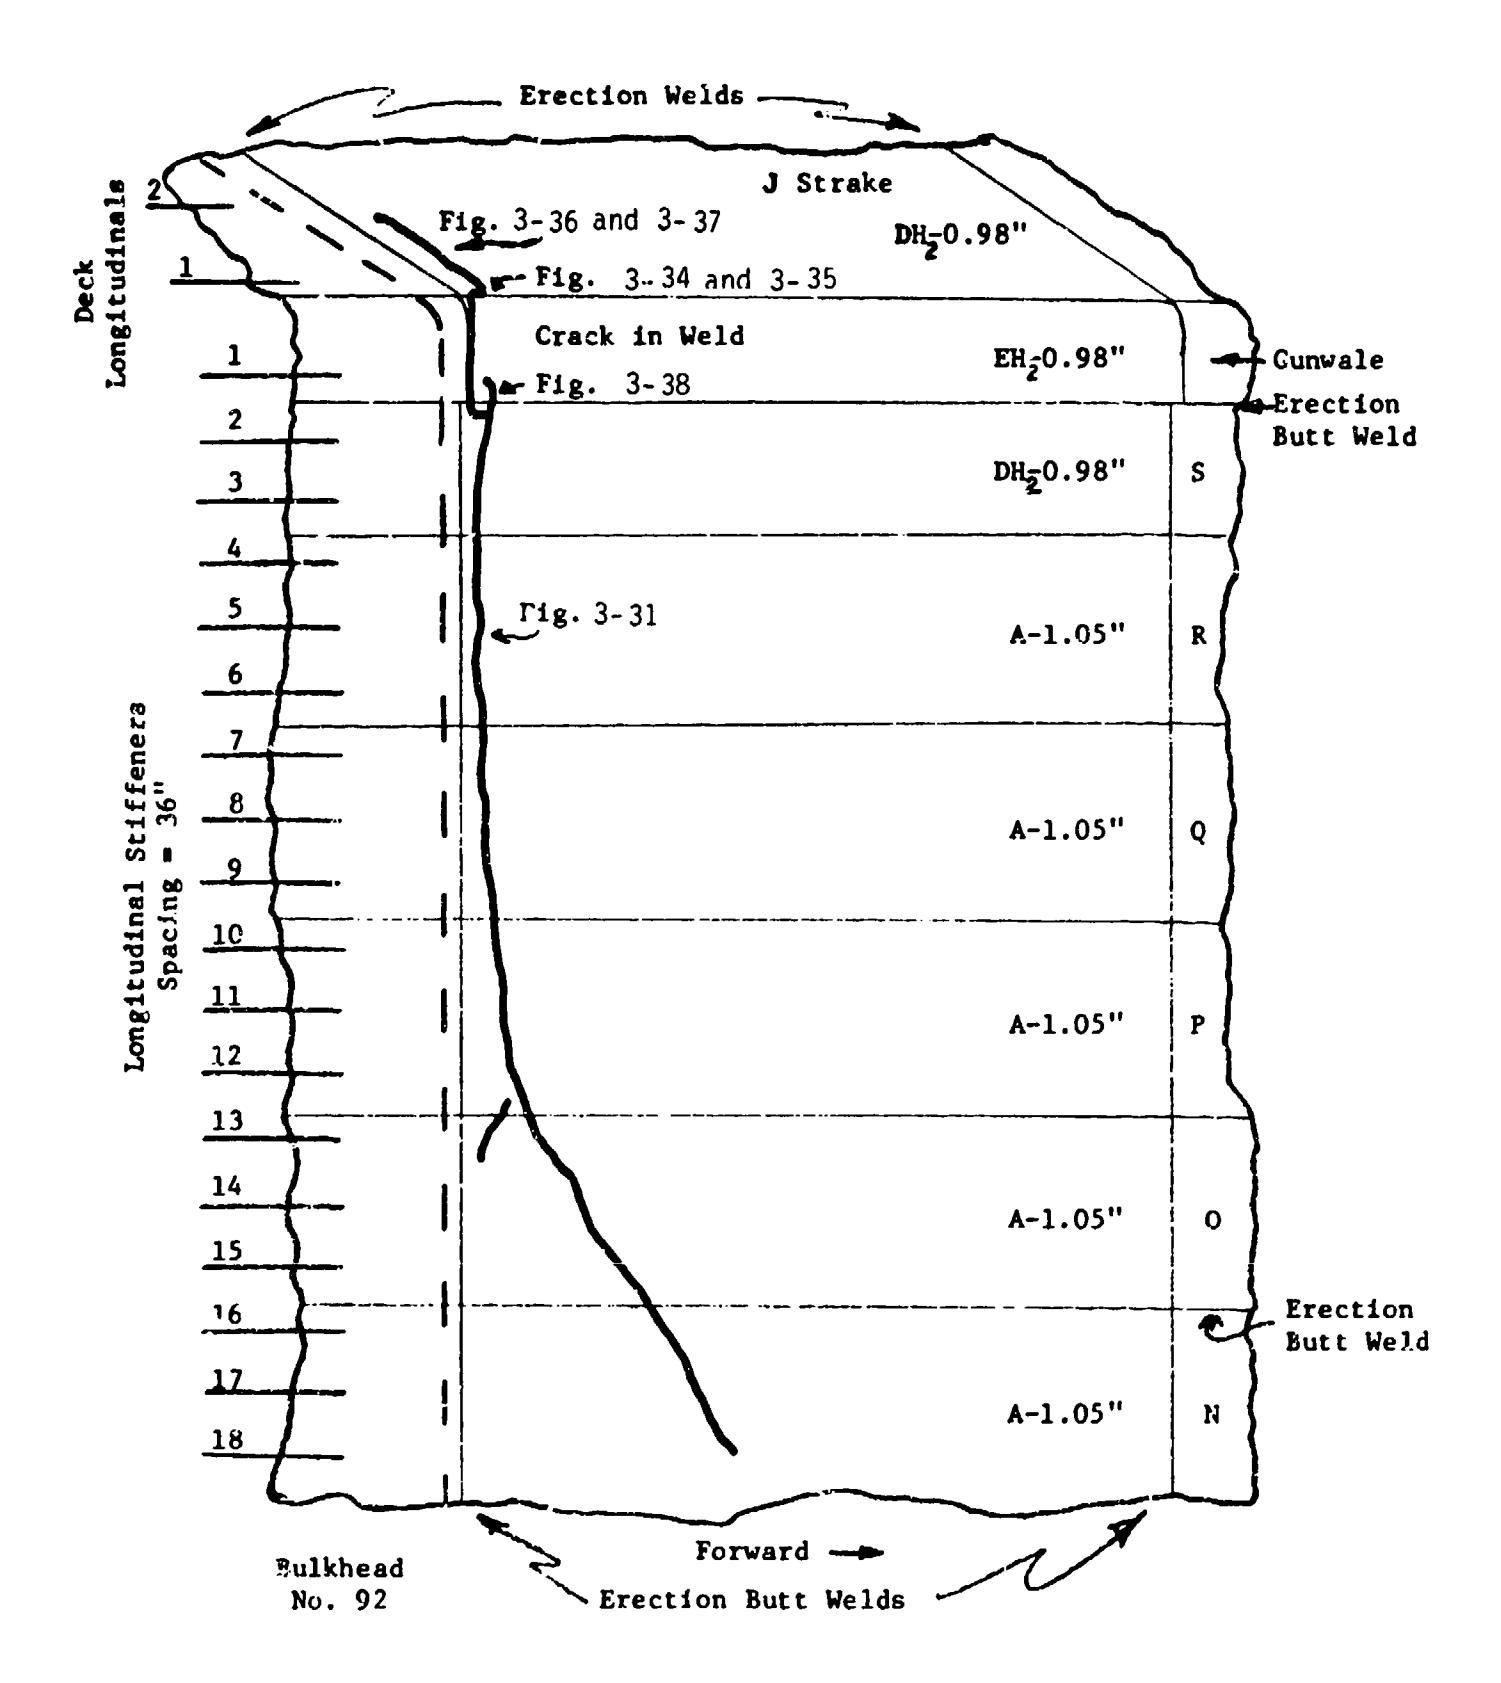
Figure 3-29 General View of Shell Fracture No. 3 Wing Tank Starboard

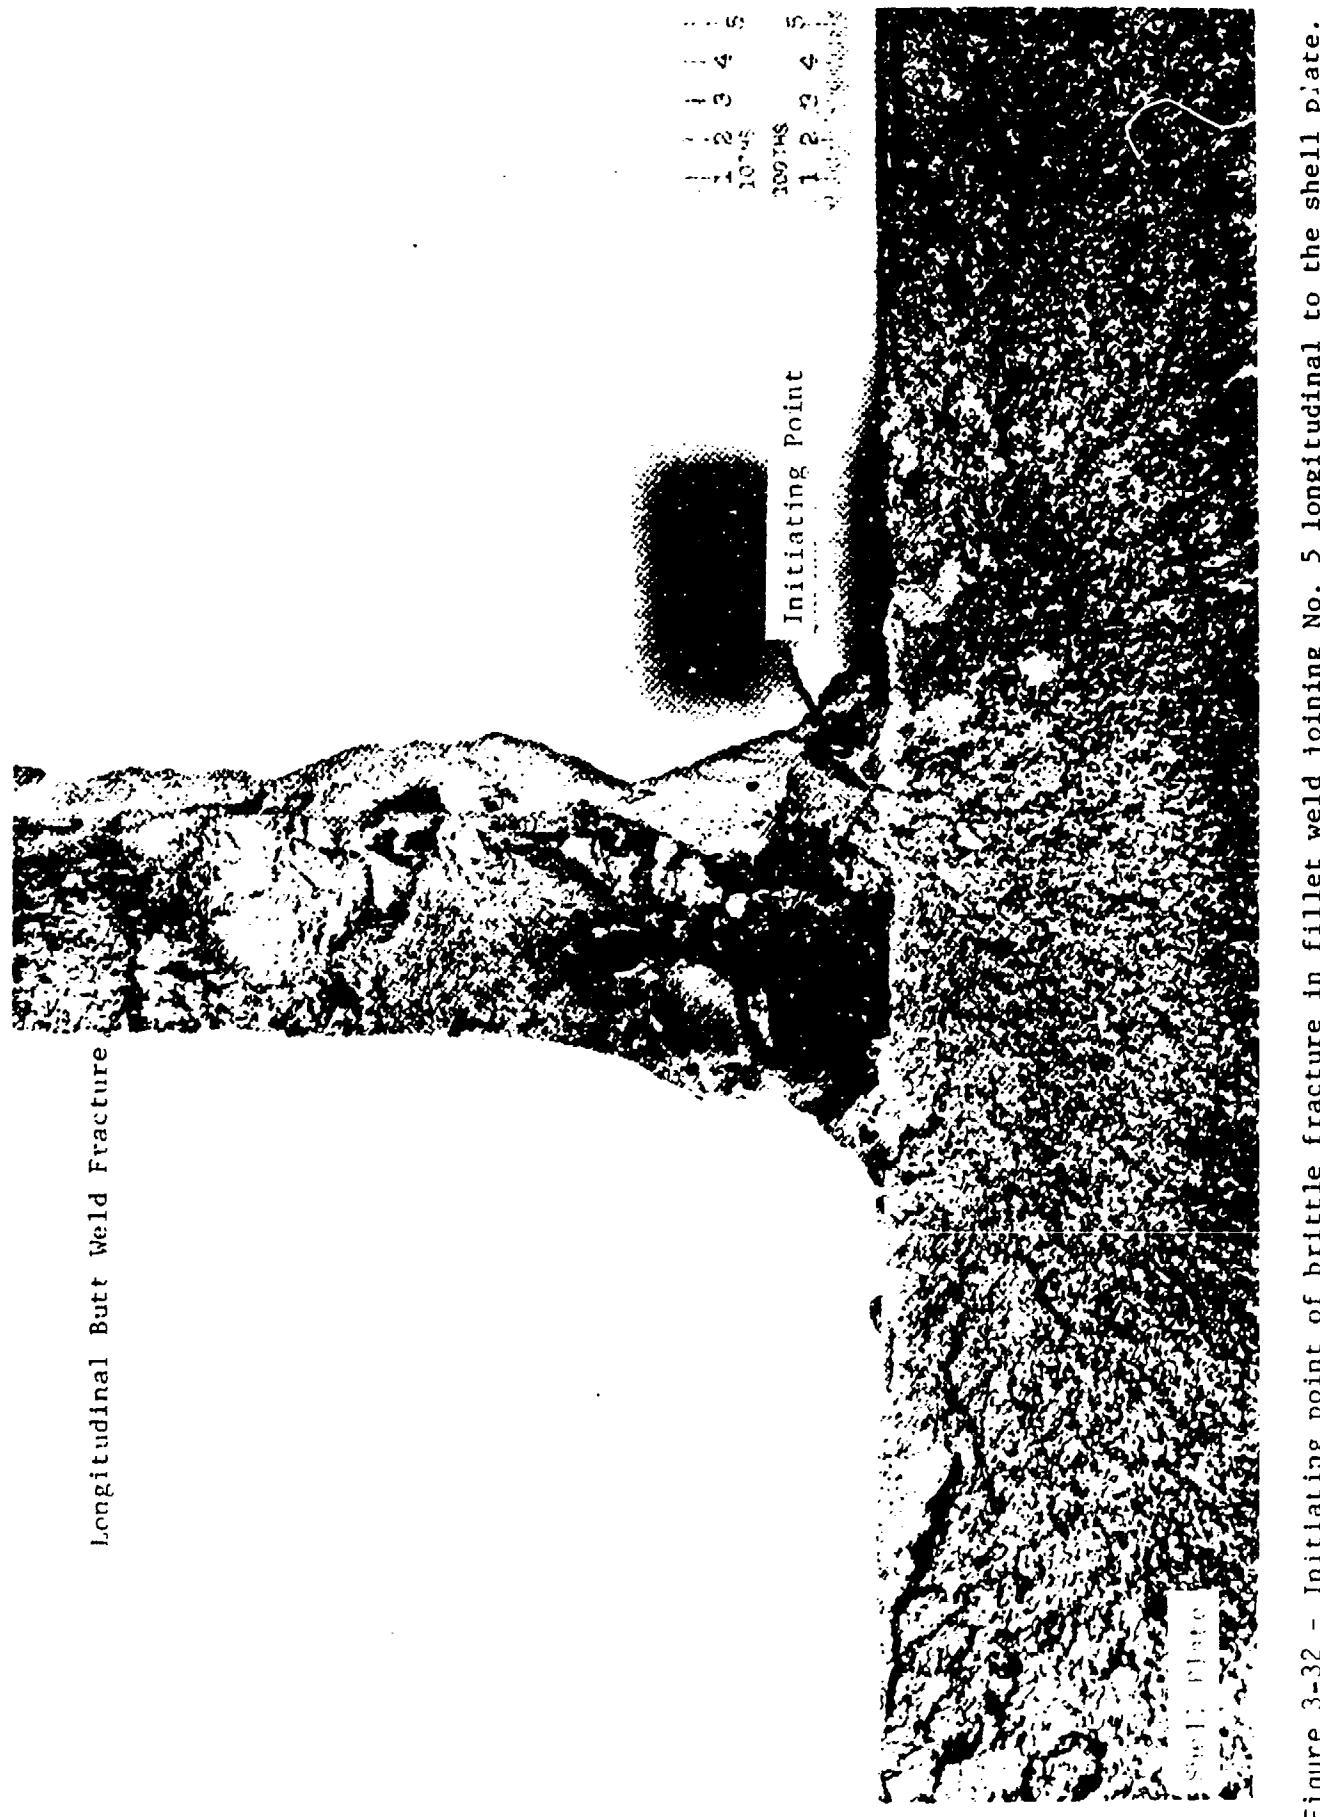
Figure 3-32 - Initiating point of brittle fracture in fillet weld joining No. 5 longitudinal to the shell plate. Specimen No. 3908; Magn. 2x.
