AD-A231 442 SSC-337 (PART 1)

SHIP FRACTURE MECHANISMS INVESTIGATION

SHIP STRUCTURE COMMITTEE

1990

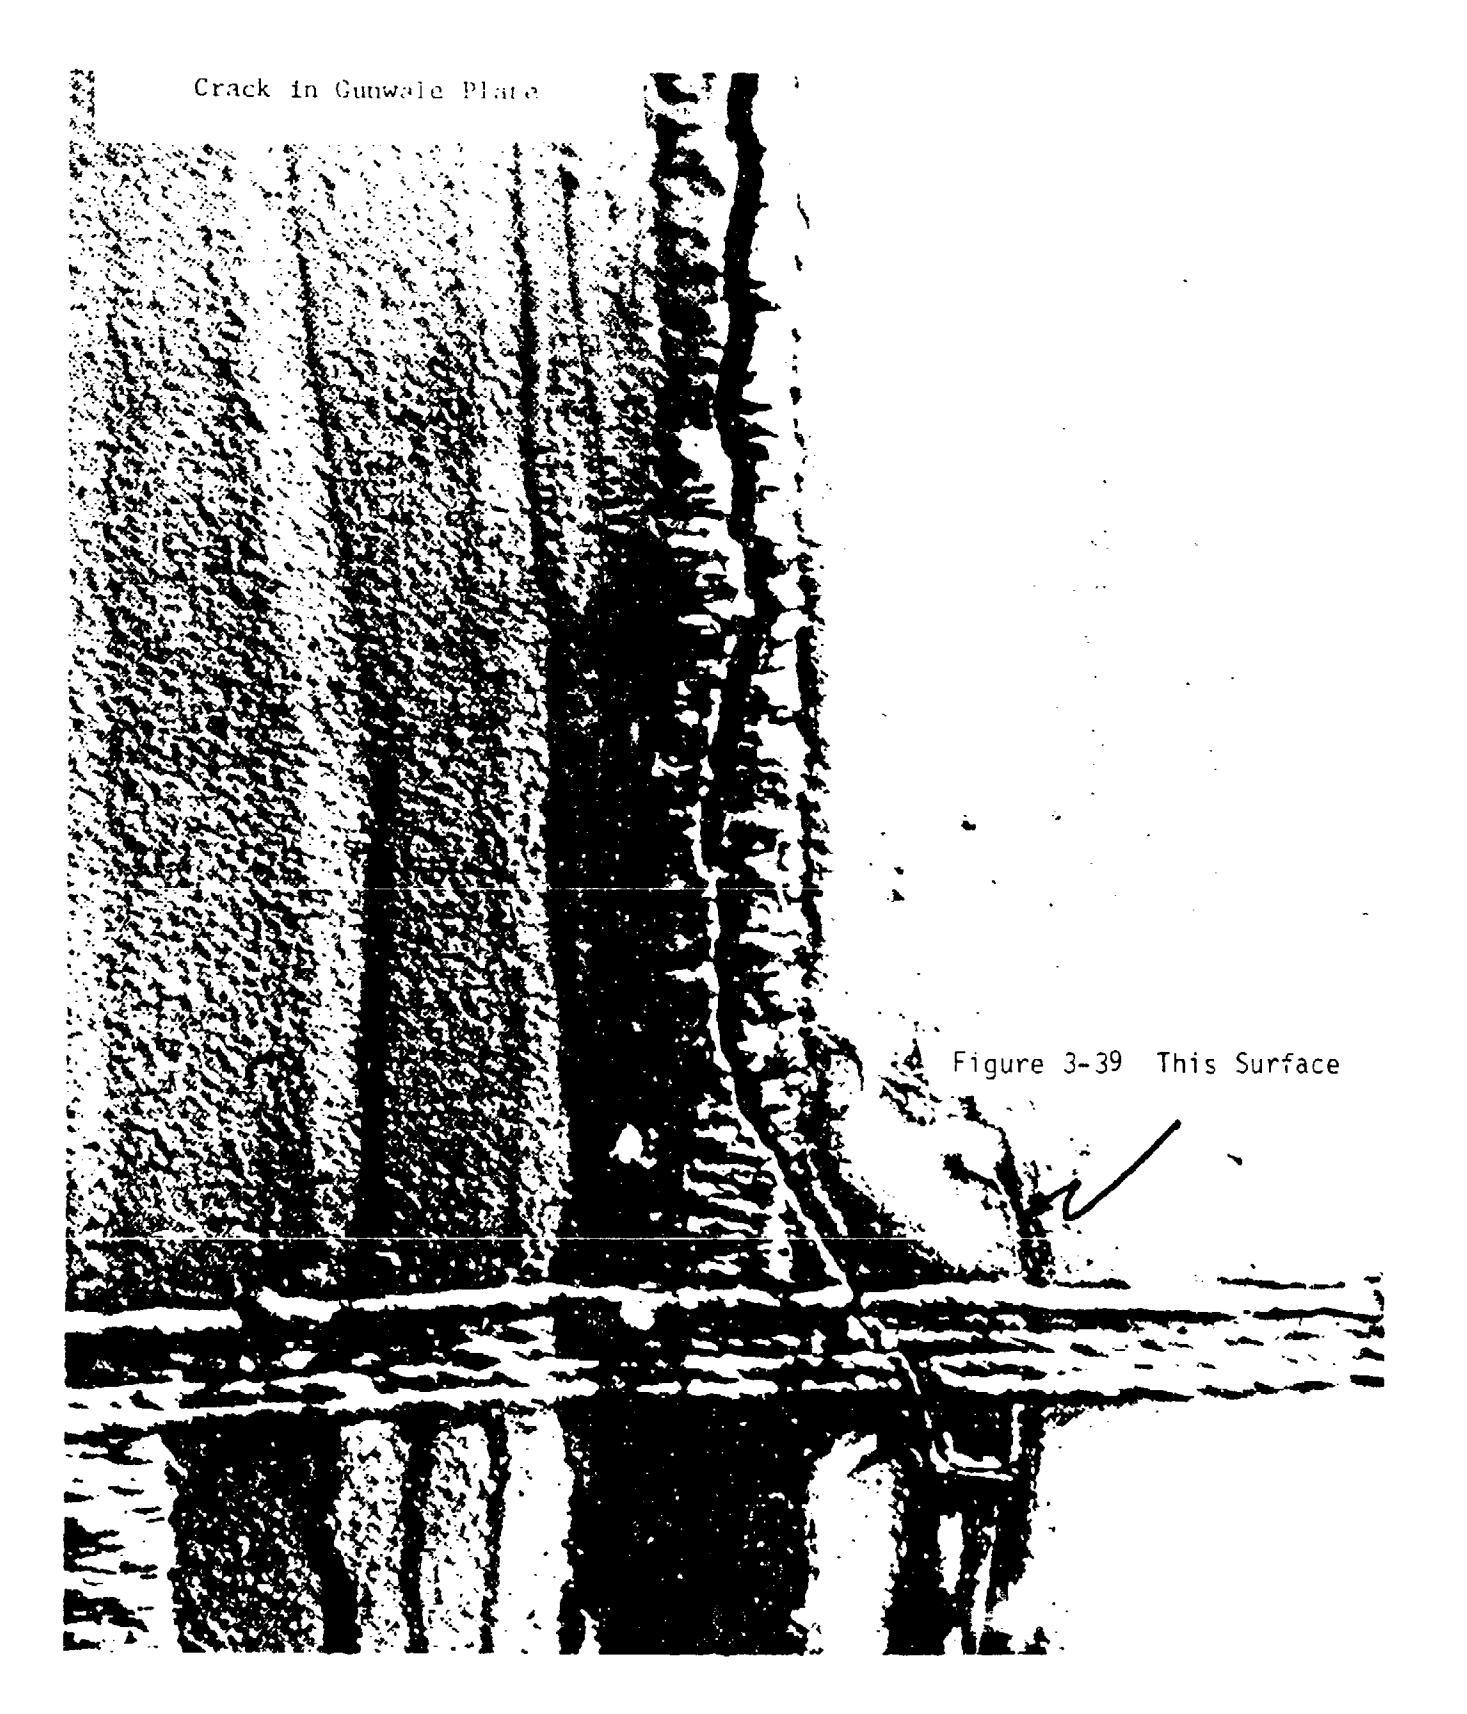
Figure 3-38 - Junction of main side shell fracture with the fracture through the weld of the genwale plate.

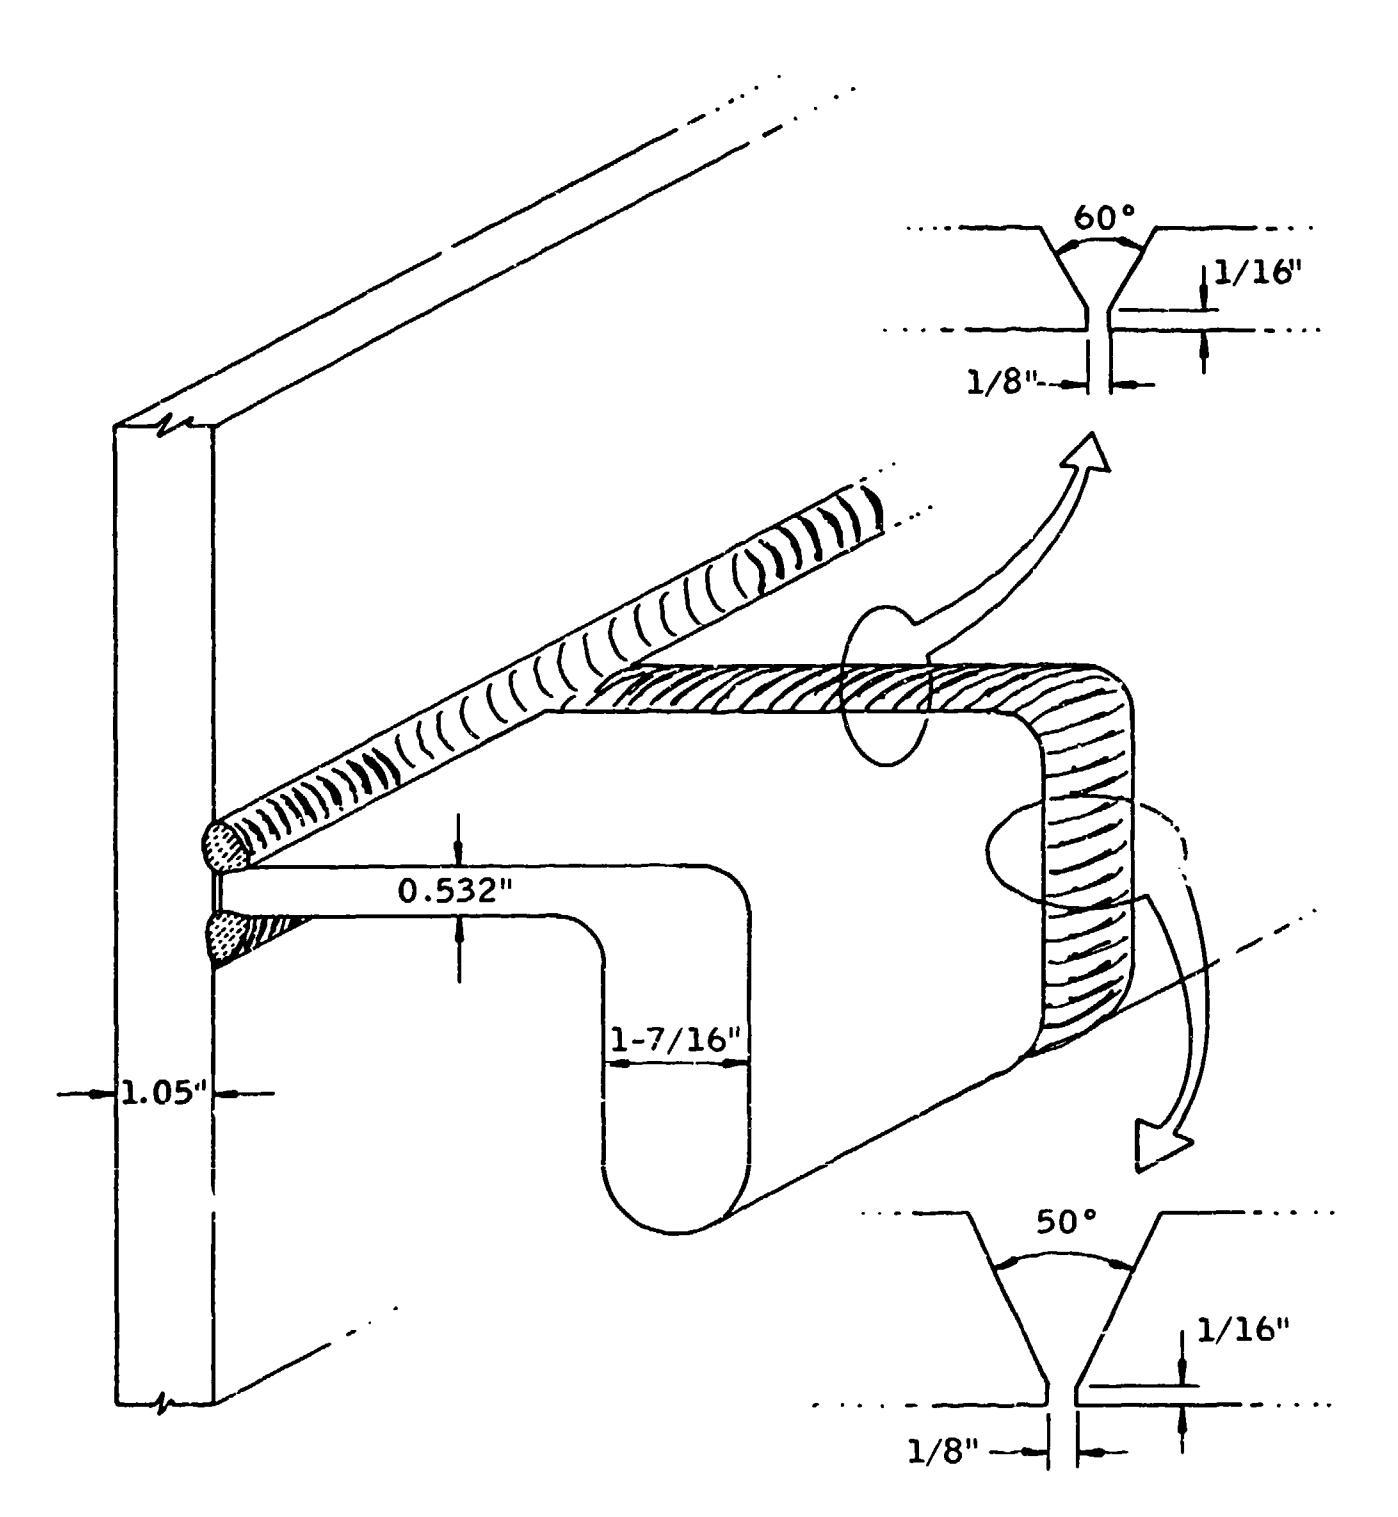
The fillet weld joining the longitudinals to the shell plate was not made in the correct sequence in addition to being of poor quality. The actual weld detail is shown in Figures 3-32, 3-42, and 3-43. In Figures 3-37 and 3-42 it is obvious that the back welding of the butt weld has been laid on top of the fillet weld. On Figure 3-42 the same can be seen for the V'd side of the butt weld. To illustrate this more clearly a section was taken through line A-B in Figure 3-43. This is shown on Figure 3-44. The grain structure clearly illustrates that the butt weld was made over, and hence after, the fillet weld. Also note the almost total lack of fusion of the fillet welds. The effect of this welding sequence is to promote cracking of the butt weld. By

Figure 3-40 Weld details as reported by the builder for butt and fillet welds on the longitudinals. Fillet weld is stopped short of butt. V'd side is welded complete, starting at shell plate and welding around to toe of flange. Opposite side is back-chipped and welded. Fillet weld to the shell is then completed.

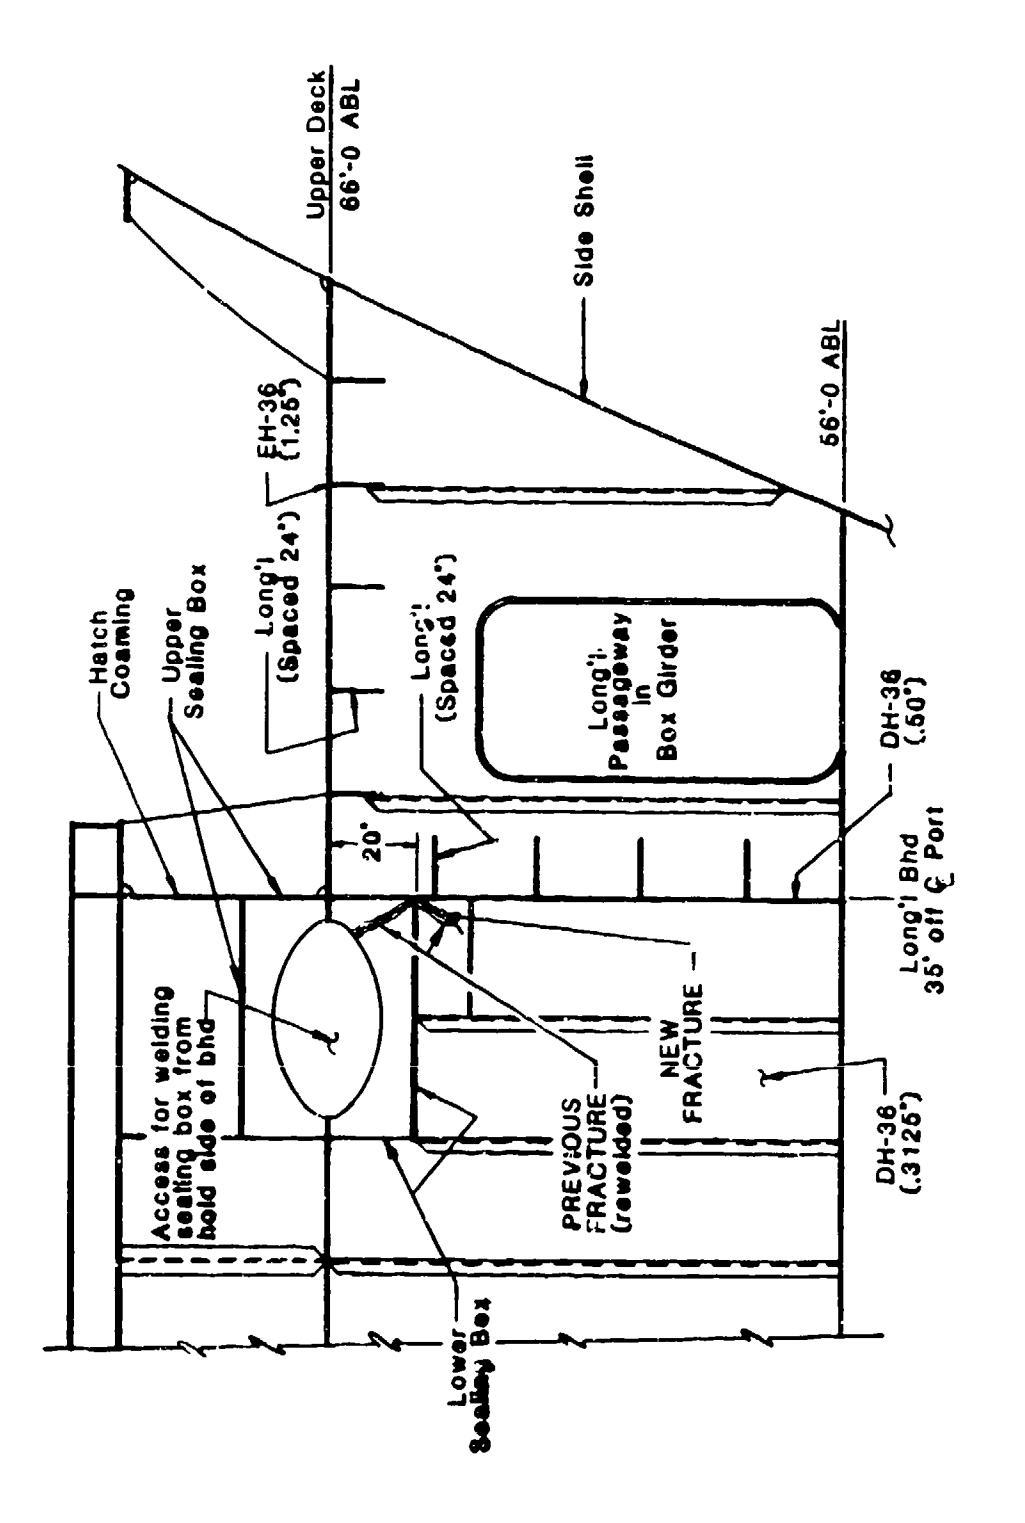
Figure 3-48 Fractured Transverse Bulkhead of a Containership

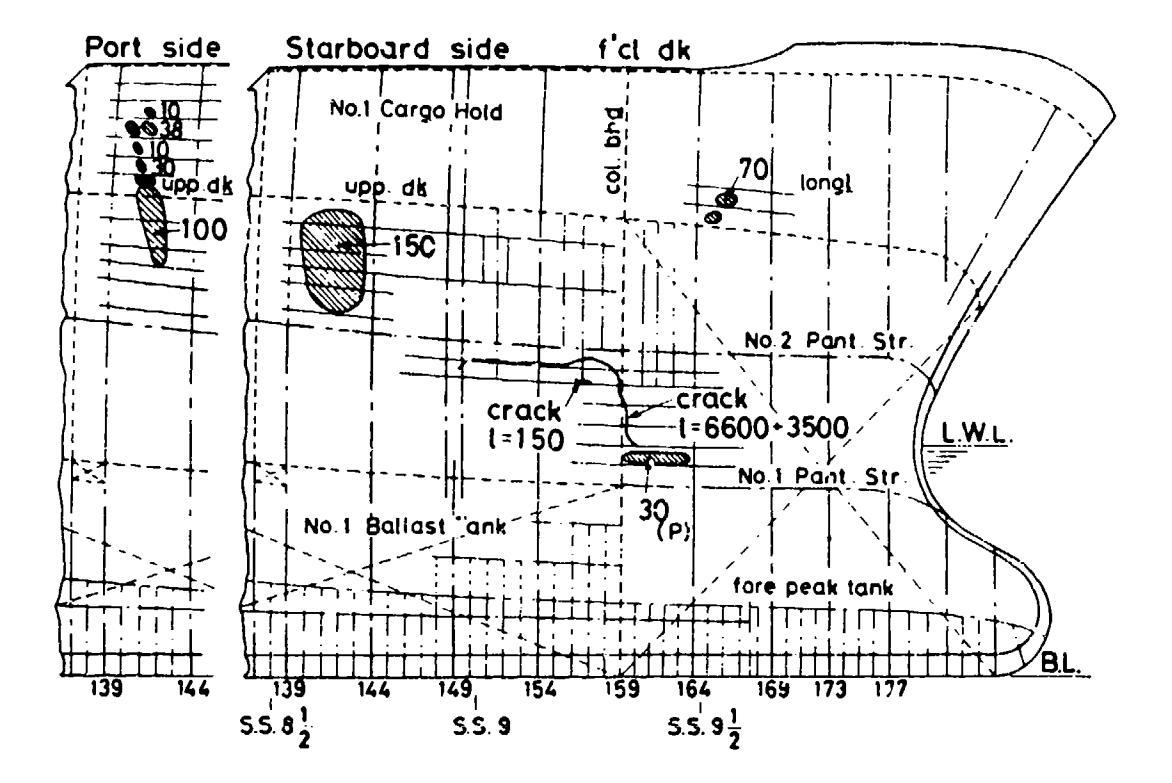
Figure 3-53 Shell Expansion and Fracture Location in the Containership Flare

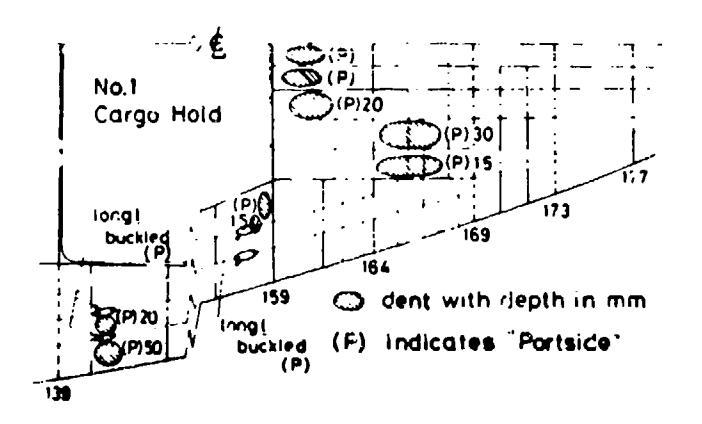
Figure 3-54 Deck Buckling in the Deck of the Containership Bow

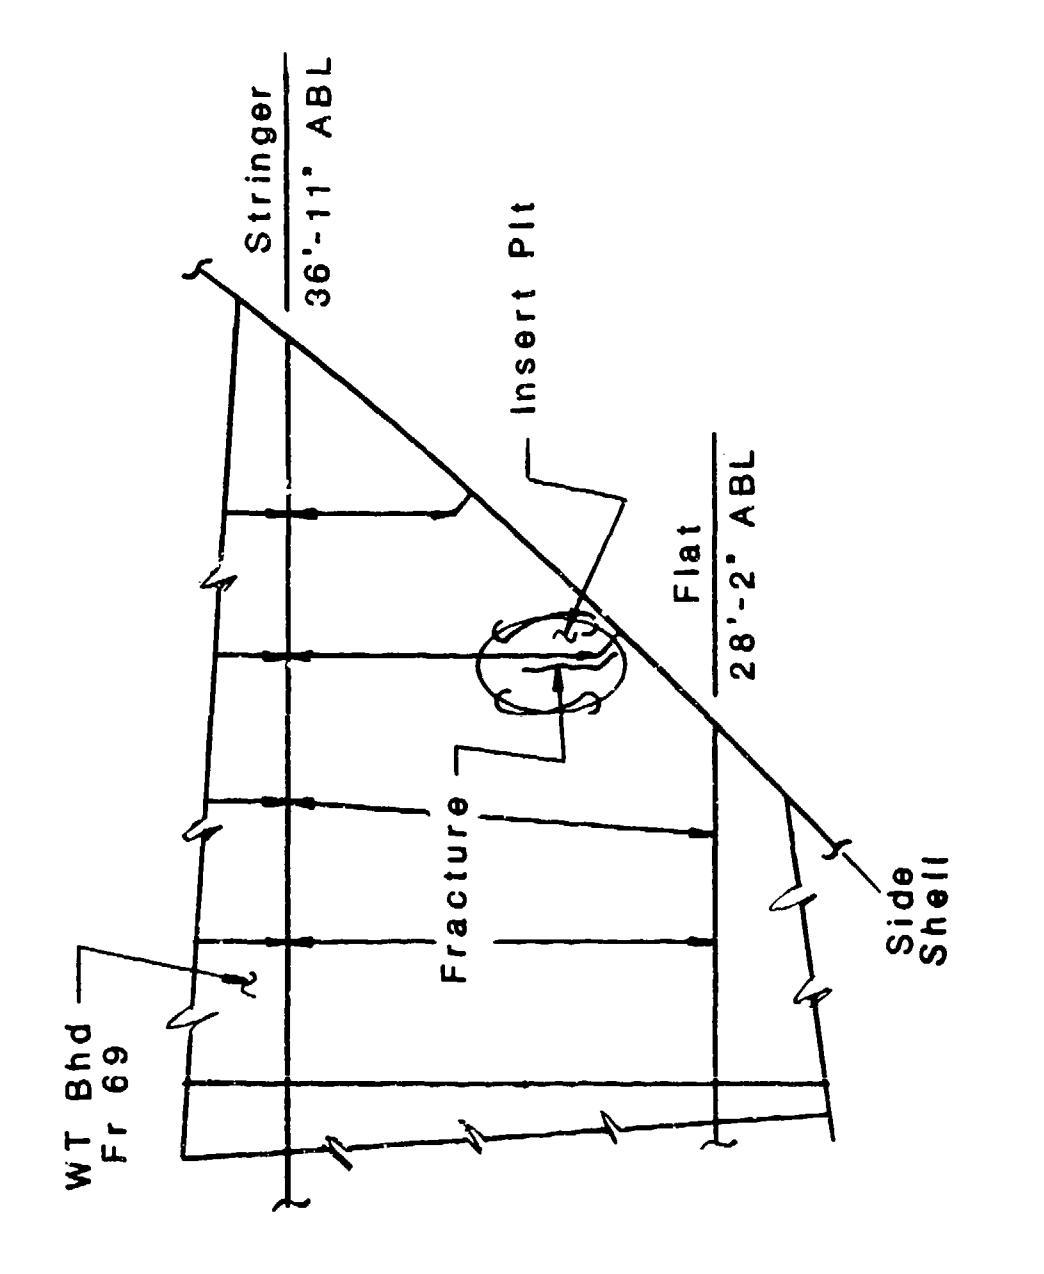
Figure 3-59 Fracture on the Transverse Bulkhead of a Tanker

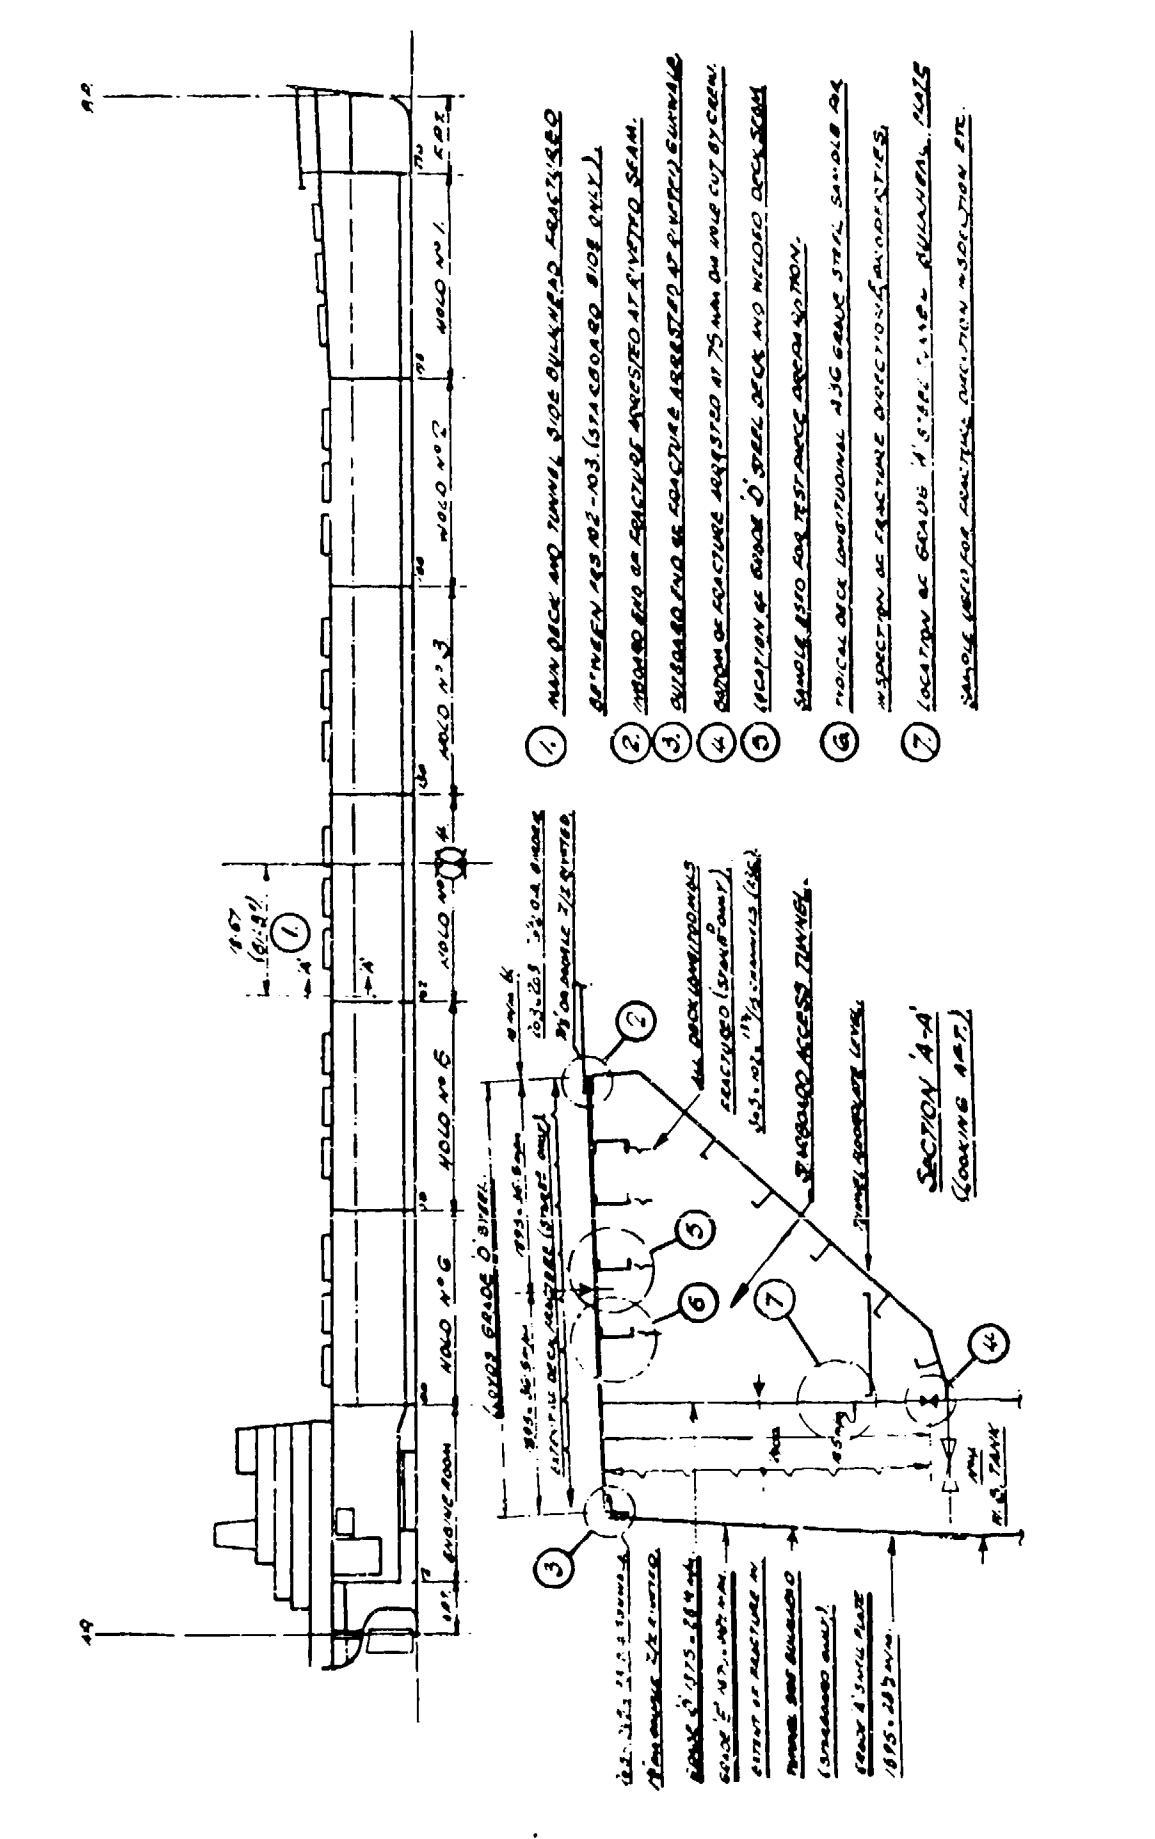
Figure 3-62 Profile and Structural Section of the Great Lakes Bulk Carrier Maindeck Fracture
