1. AGENCY USE ONLY (Leave Blank)	2. REPORT DATE December 1990	3. REPORT TYPE AND DATES COVI Final	ERED			
4. TITLE AND SUBTITLE	L		5. FUNDING NUMBERS			
Rehabilitation of Military ' Fort Carson, CO	Training Areas Damaged t	by Tracked Vehicles at	FEAP

REHABILITATION OF MILITARY TRAINING AREAS DAMAGED BY TRACKED VEHICLES AT FORT CARSON, CO

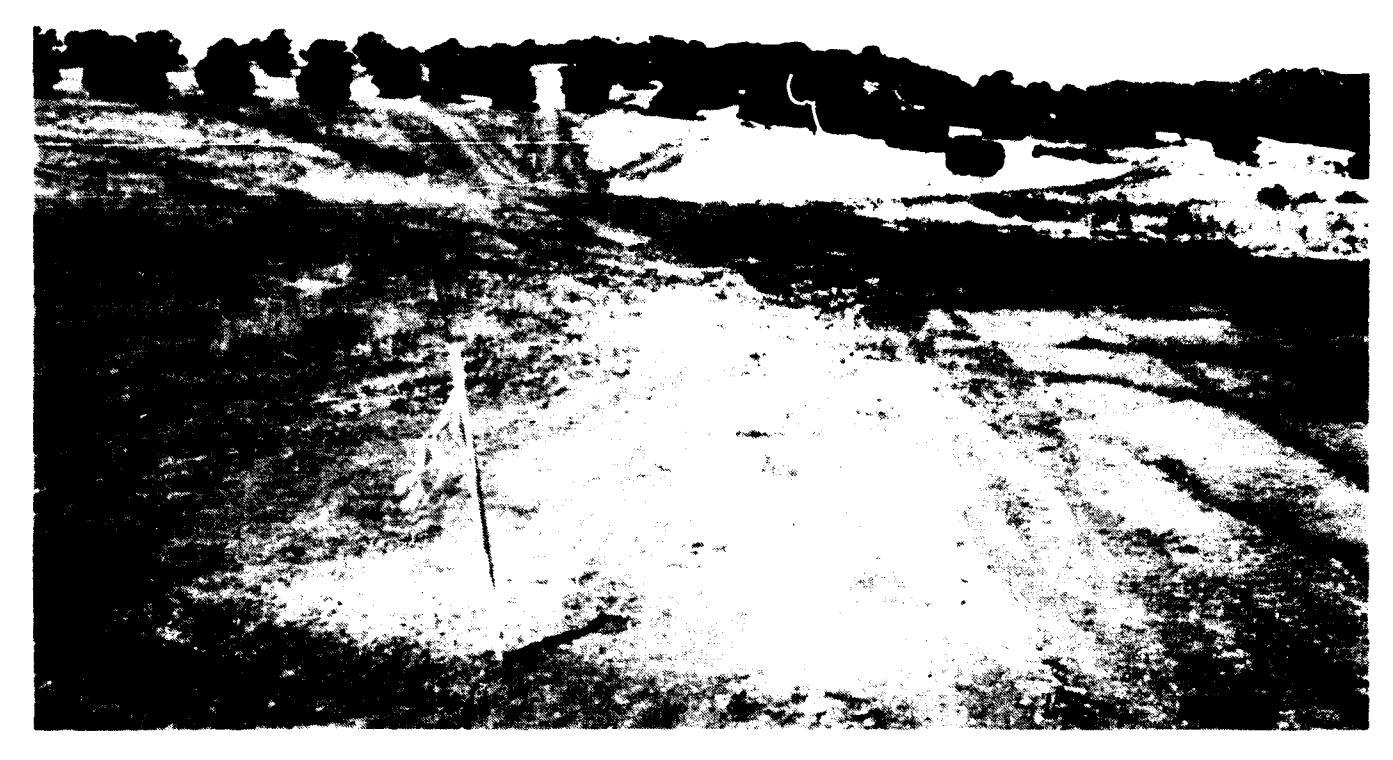
Trends, Field Observations, and Photographic Documentation. The 1986 data (Table 6) confirm the consistent trend toward higher grass cover on treated areas that was observed in the field in 1984 and 1985 but was not statistically significant in 1985. The 1986 increases in grass and litter on the untreated areas (Table 6) suggest that rest alone may be beneficial, but the quality of cover developing on the untreated areas (mostly weedy forbs and loose litter) is lower than that on the treated areas (more grasses and rooted litter). These trends and field observations are documented in Figures 4 through 8, which represent a time series of views of the east slope of the FEAP site from just before rehabilitation work in April 1984 (Figure 4) to July 1986 (Figure 8). The photos show four central roads (tank trails) with a severely damaged pinyon-juniper woodland in the background (see Figure 2 for a map of this area). In Figure 4.

Figure 4. View of the east slope of the FEAP site before rehabilitation work in April 1984.

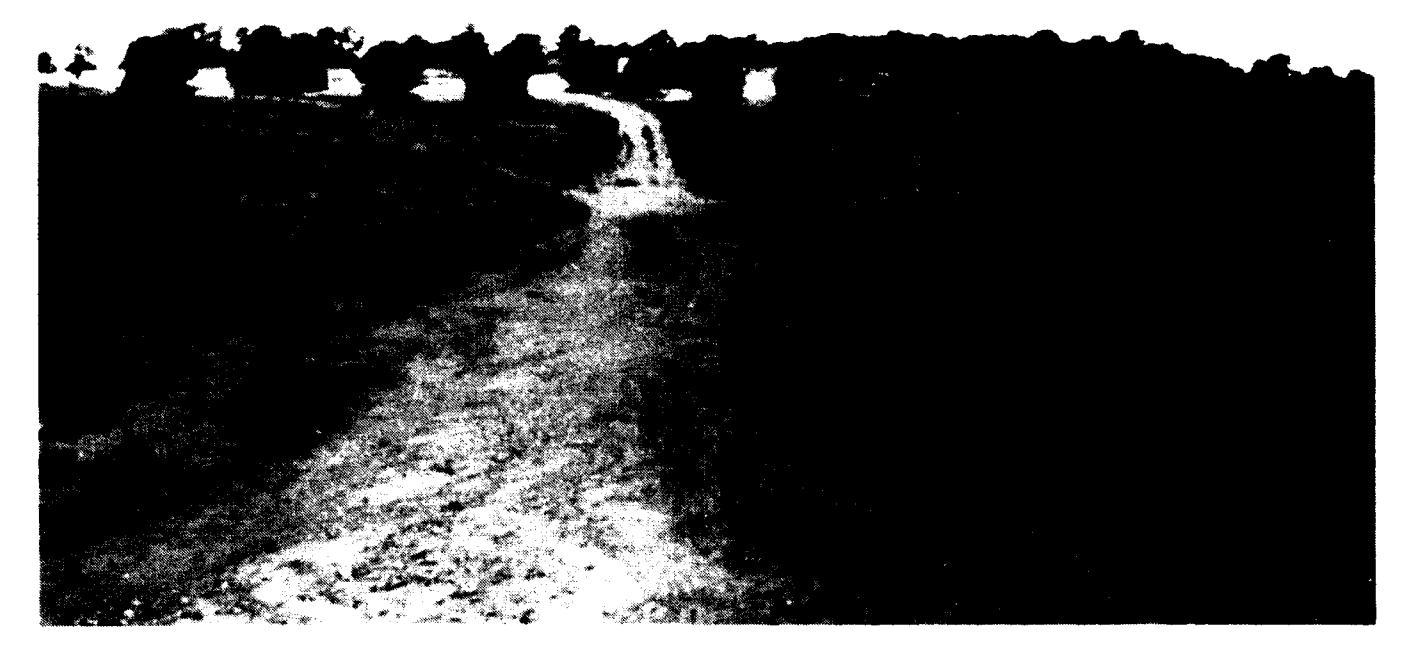
Figures 6 through 8 are monitoring photographs taken in July of 1984, 1985, and 1986, respectively. The July 1984 photo (Figure 6) shows conspicuous growth of grasses and some weedy forbs on the treated areas (two roads on the right and right foreground) and predominantly weedy growth (mostly dark green kochia plants) on the untreated areas (two roads on the left and left foreground). In July 1985 (Figure 7), the site vegetation is alive and vigorously growing due to above-normal precipitation in the spring and early summer of 1985. Extensive growth of large weeds is responsible for the darker color of the two untreated roads on the left. An erosion gully that has deepened considerably since 1984 is just in front of the monitoring crew member at the edge of the untreated road. The locations of the two treated roads on the right side are difficult to discern, but they have somewhat more weedy growth than the adjacent

Figure 6. View of the east slope of the FEAP site in July 1984.

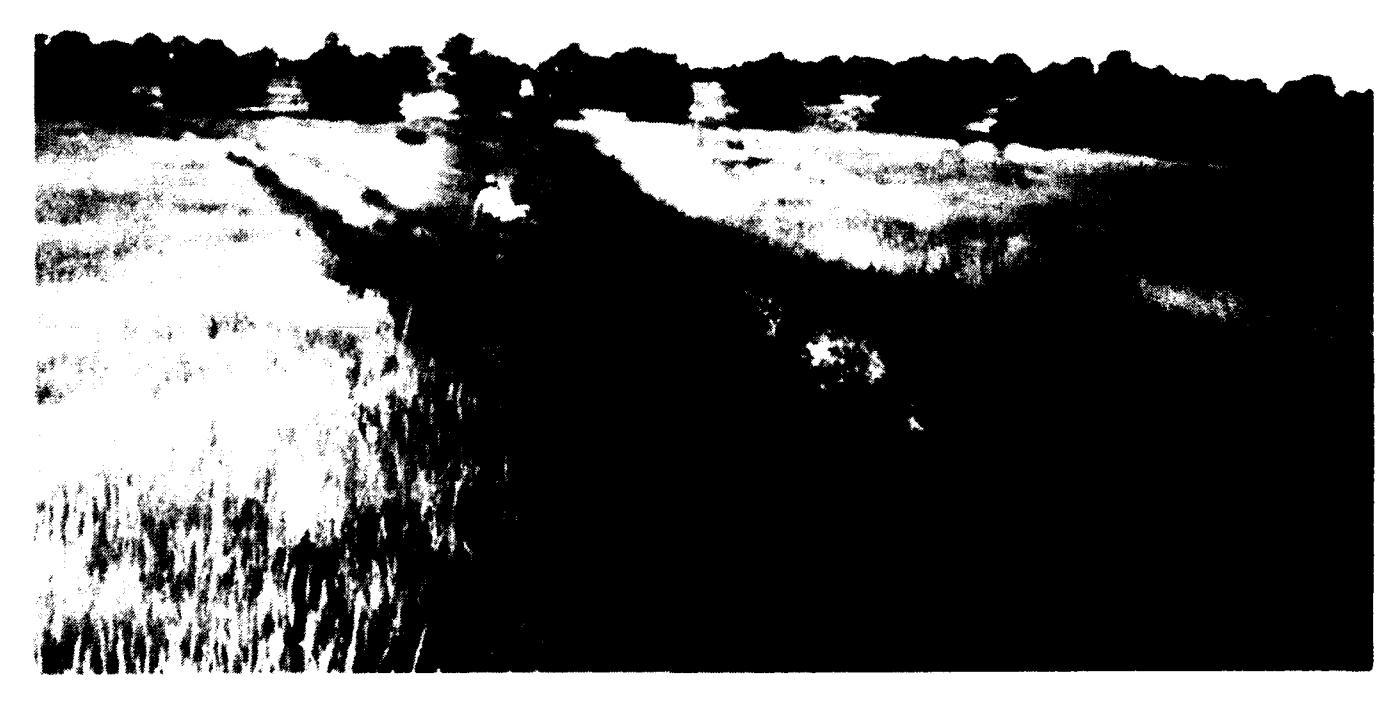
Figure 7. View of the east slope of the FEAP site in July 1985.

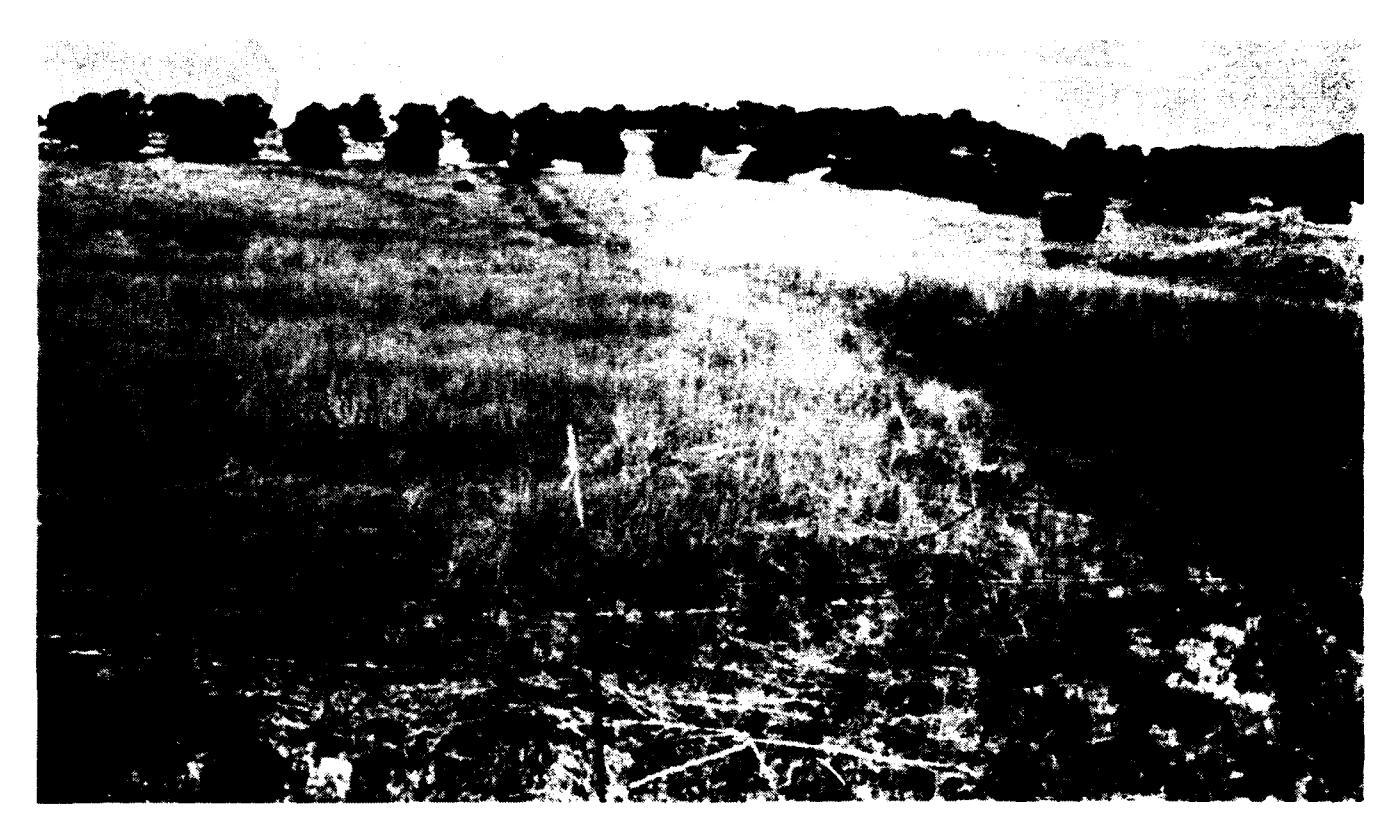
Figure 8. View of the east slope of the FEAP site in July 1986.

grassy areas of low disturbance. In July 1986 (Figure 8), the two treated roads are very difficult to discern, but the entire area looks more uniform because grasses have begun to invade the untreated roads. Because the period before the July 1986 monitoring session received below normal precipitation, very few large weeds were encountered in 1986, unlike 1985. Many of the forbs and grasses were dormant or dead in 1986. The progress of revegetation on treated area H and the natural revegetation exhibited by untreated area A in Figures 4 through 8 is typical of many areas of the site. However, there are some portions of each treatment area where revegetation is progressing more slowly, probably because of adverse microsite conditions.
