Undersea Biomedical Research. Vol. 17, No. 5, 1990

Atmosphere contamination following repainting of a human hyperbaric chamber complex

R. S. LILLO, J. W. MORRIS, J. M. CALDWELL, D. M. BALK, and E. T. FLYNN

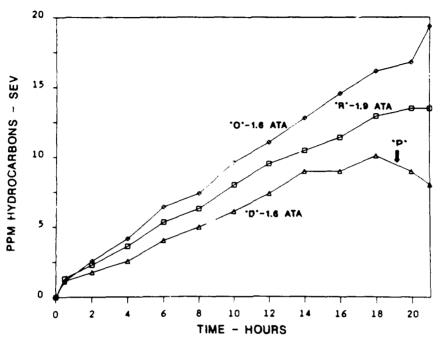
Monitoring the chamber atmosphere of "D", "R", and "O" with a PID for approximately 1 day showed that hydrocarbon levels increased with time (test C, Fig. 2). After the chemical absorbent Purafil was loaded into the canister of the ACS loop of "D", hydrocarbon levels began to decline. After this, another test (D) showed that hydrocarbons could be maintained at low levels for 1 day by scrubbing the atmosphere with the ACS canisters filled with Purafil. This was confirmed both by analysis of the end-dive sample as well as by periodic PID readings during the test.

Fig. 2. Test C. Hydrocarbon levels increase with time in "D", "R", and "O" when chambers are left pressurized at 1.6 or 1.9 atm abs with all ACS loop canisters empty. At time indicated by "P", Purafil was loaded into the canister of the ACS loop of "D". A decline in the hydrocarbon level of "D" was then observed as gas was circulated by the ACS. Measurements were made with a PID.

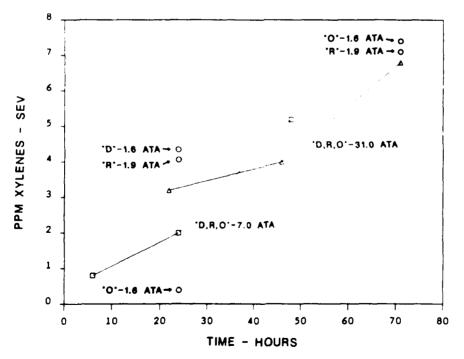
This test series evaluated the contamination problem. Results (Table 1 and Fig. 3) indicated that hydrocarbons accumulate in the chambers with time but, interestingly, the off-gassing rate does not seem to be affected by a 20-fold range in testing pressure. Contamination levels after this test series seemed similar to that observed before.

Fig. 3. Hydrocarbon levels (in terms of total xylenes) increase in "D", "R", and "O" when chambers are left pressurized at depths ranging from 1.6 to 31.0 atm abs. Testing pressure does not seem to affect the rate of hydrocarbon buildup. Data taken from test series E (Table 1).

The reason for the relatively low reading of 0.4 ppm for "O" during test E.4 is not known.
