CR 91.006

An Investigation Conducted by:
EG&G Idaho
Idaho Falls, ID 83415

Contract Report

CAST COIL TRANSFORMER FIRE SUSCEPTIBILITY AND RELIABILITY STUDY

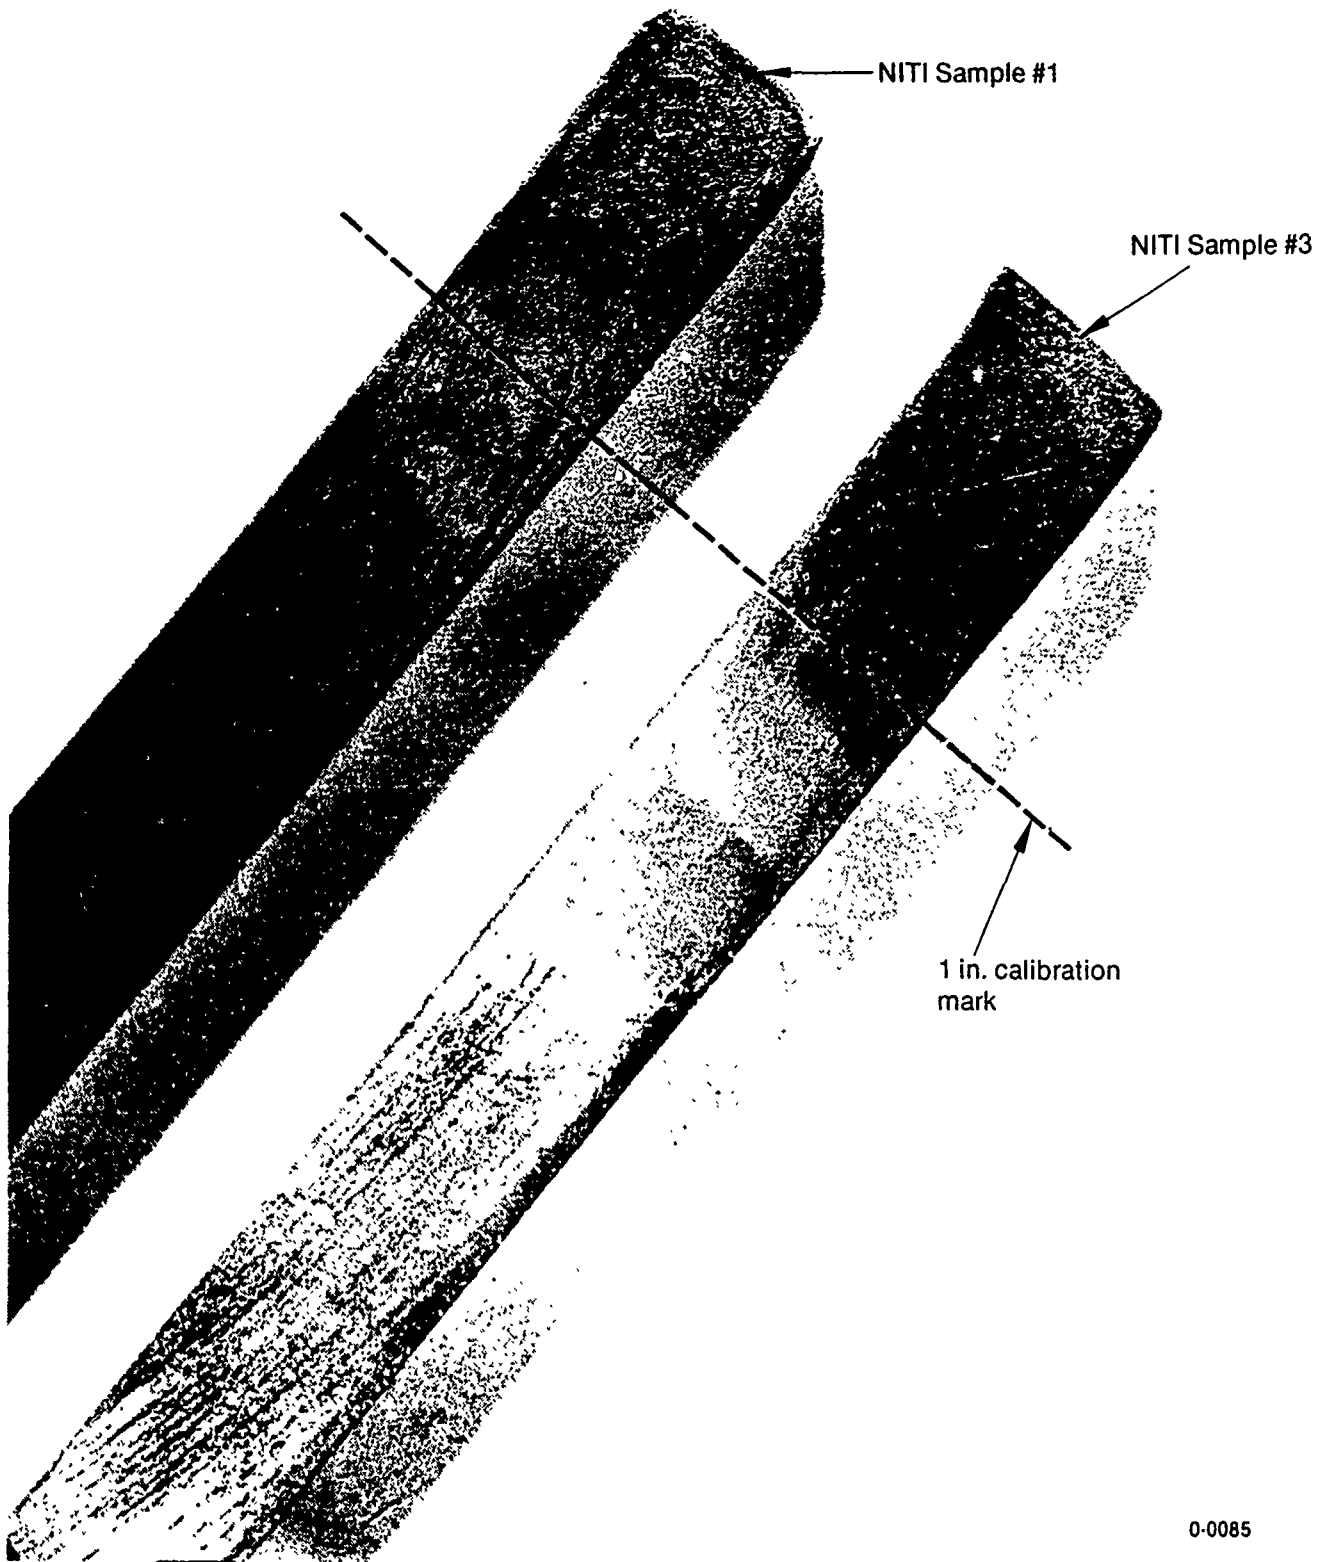
Figure C-2. This photograph is of two silica-filled BPA epoxy samples (National Industri Transformer, Inc.) that have been subjected to the burn tests. The flames caused a minimum amount of degradation of the material. In comparison to Figure C-1 the filled sample was less effected than the unfilled sample. This material also proved to be nonburning by the definition of the test procedure.

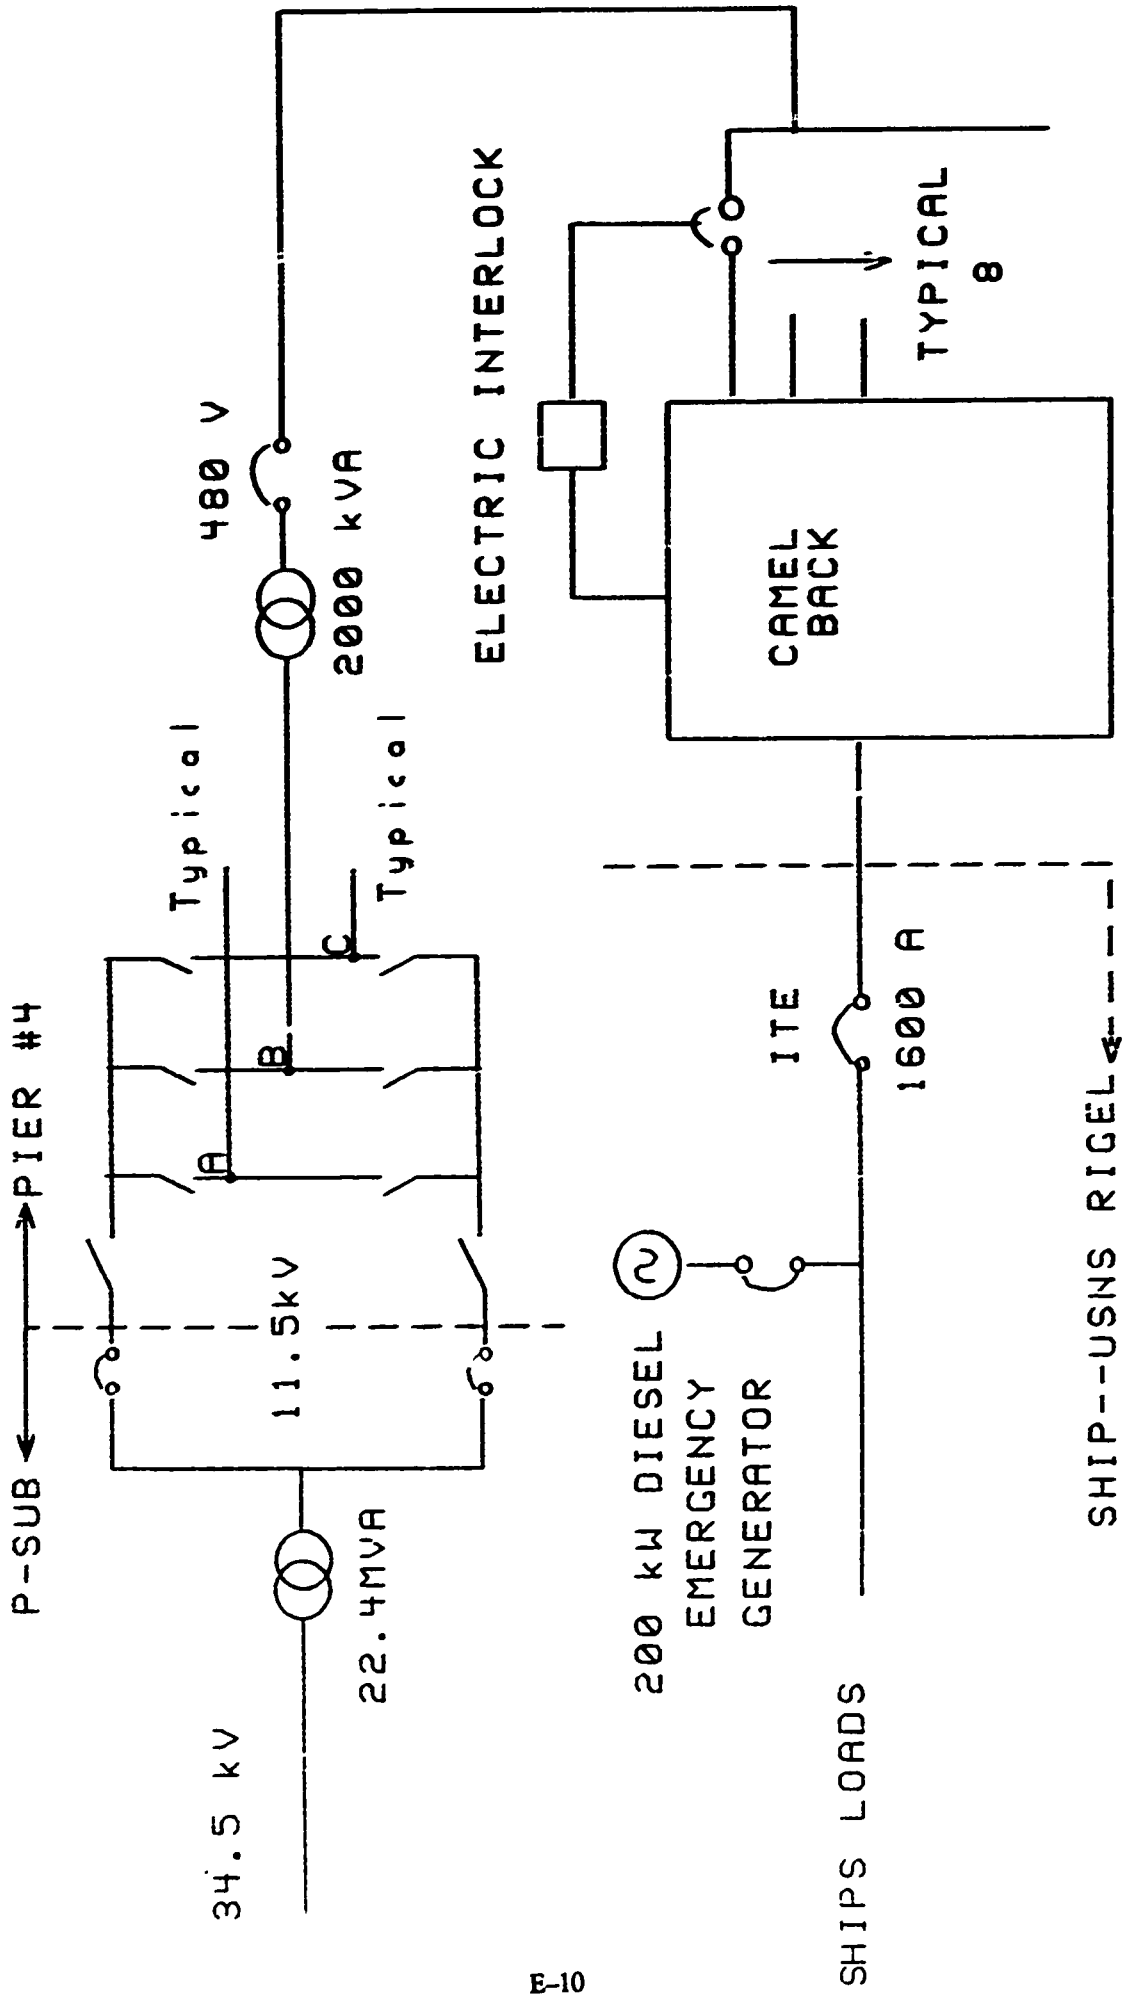
System One-Line Diagram.

The two adjacent coil assemblies were damaged by the heat and fame, but the damage was not as significant as that on the faulted coil. The fault continued for a substantial amount of time before the primary protection cleared. Estimates of the fault duration are vague and contradictory but most likely is 2 hours or more based upon the magnitude of heat damage.

After the primary protection cleared the fault, the ships 200 kW emergency generator was brought on line. Refer to the one-line diagram on the following page. The operator experienced difficulty in getting the voltage to stabilize and eventually the generator's breaker tripped off line. The operator then began to shed unnecessary loads to reduce the load level on the generator. The problem still existed and at that point it was determined that the shore to ship power feed had not been disconnected as is required. It has been estimated that approximately 30 minutes passed before the shore power cables were disconnected from the USNS Rigel. Therefore, the USNS Rigel provided both heat and arcing directly to the fault and sustained the fire for an additional 30 minutes.
