BLISTERING OF GRAPHITE/POLYMER COMPOSITES GALVANICALLY

COUPLED WITH METALS IN SEA WATER

AN ANNUAL REPORT

ONR Contract # N0001491J1328

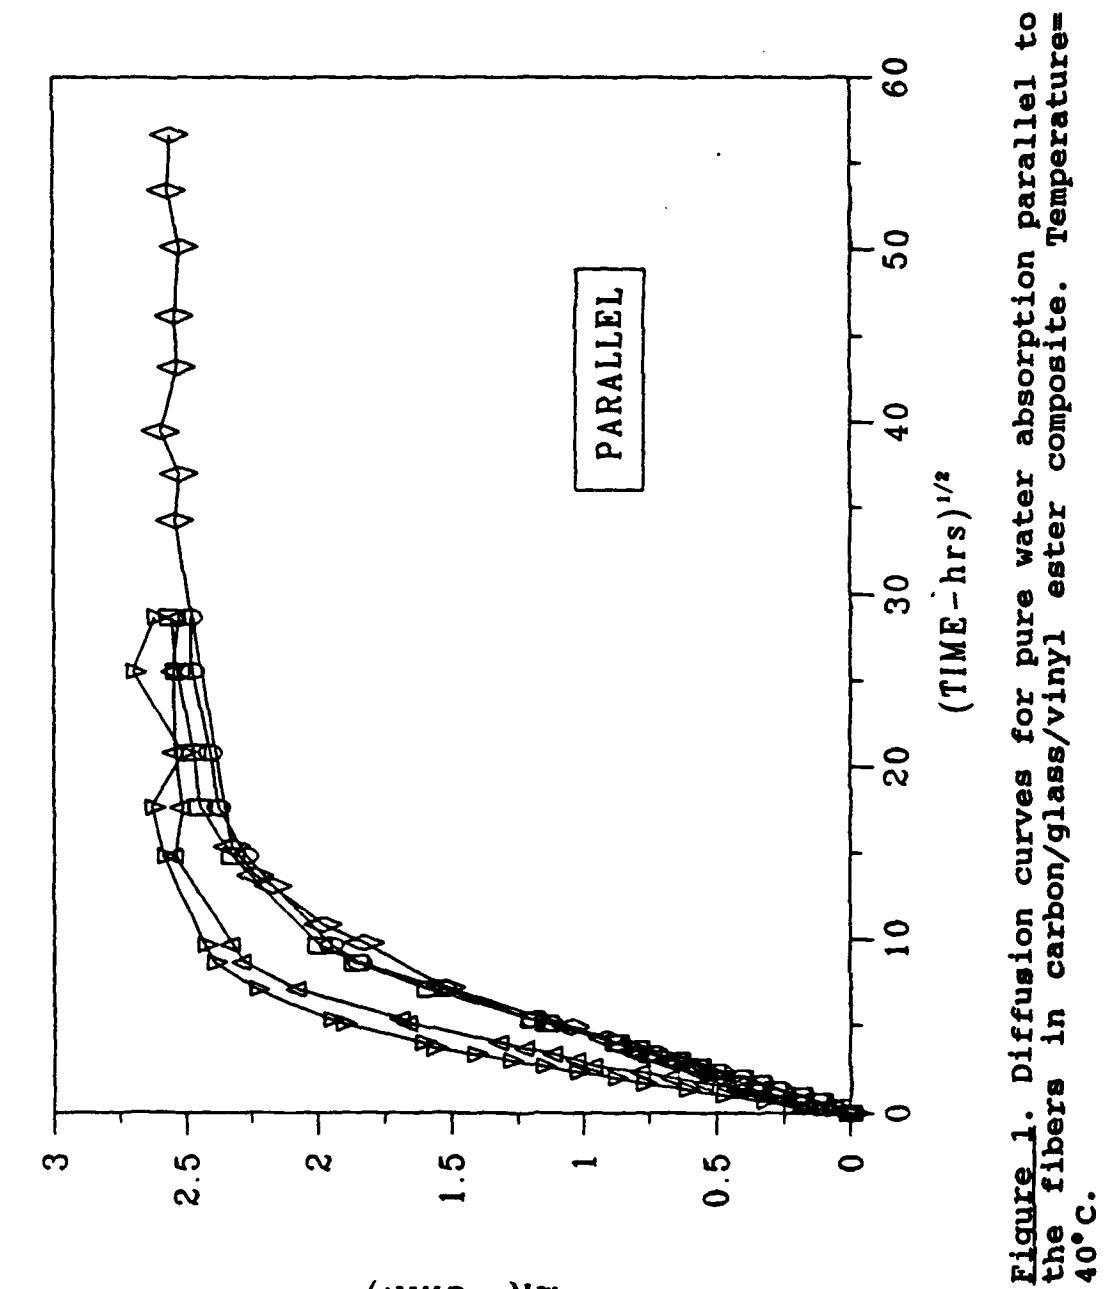
The results of the absorption experiments are shown in Figures [1], [2], [3] and [4]. Whereas figures [1] and [2] present diffusion data parallel and transverse to the fibers respectively for pure water, figures [3] and [4] present similar data for 3% NaCl solution. The ordinate in these plots is % weight gain based up on the polymer content of the composite. The curves clearly demonstrate Case I or Fickian diffusion. The absorption curves for neat resin at the same experimental conditions are shown in Figure [5]. It is difficult to conclude whether the sorption behavior of the polymer is Fickian or

non-Fickian from these curves. Previous investigation by Lee [5] suggested a Fickian type absorption in similar vinyl esters. But the plateaus in the present curves support a two stage diffusion. However, this is unlikely for vinyl esters and the error could be attributed to experimental scatter. More data on water diffusion in neat resin is required to draw any conclusion. The saturation values for both the composite and the resin are presented in Table [1]. The water diffusion coefficients for the composite are also presented in Table [1]. It can be seen that the diffusion parallel to the fibers is higher than that normal to the fibers by an average 1.5 times. This is due to less obstruction in the direction parallel to the fibers. The D_P/D_N , however, is 15% lower for the case of 3% NaCl solution. Contrary to expectations, the average diffusion coefficients for pure water are lower than those for NaCl solution by 10% and 25% for parallel and normal diffusion respectively. These reductions, however, are within the range of experimental data scatter. The saturation values for the 3% NaCl are about 7% lower than those for pure water whereas theoretical prediction is that the reduction should be by about 3%. The explanation again is that these differences are within the range of data scatter. The average saturation value for the composite is about 2.5% whereas for neat resin it is about 1.6%. This huge increase of about 63% in water pick-up in the composite could be due to water accumulation at the interface because of debonding caused by water. Another possibility is the presence of thixotropes in the composite. Usually silica based thixotropes are widely used and these are greatly hydrophilic. In fact, trace amounts of silica found in the precipitates from blister fluids by EDAX analysis makes this look more plausible.
