DOT/FAA/RD-92/8

Performance of Insulated Pavements at Newton Field, Jackman, Maine

May 1992

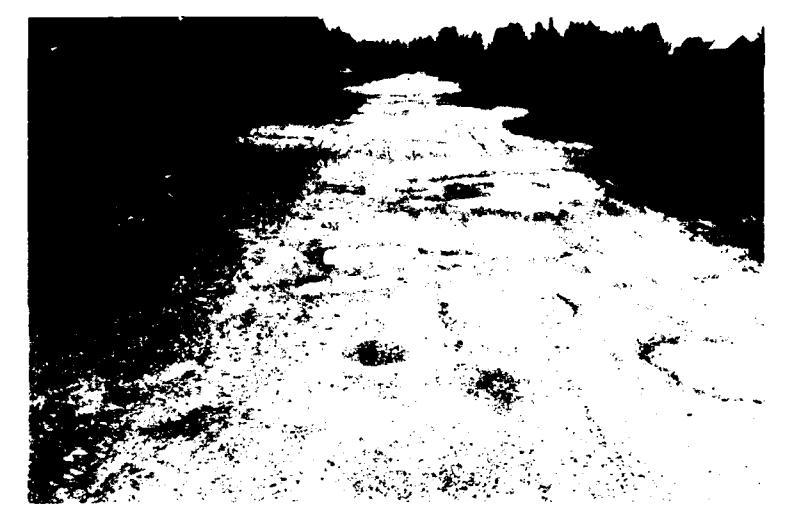
The runway at Newton Field was reconstructed in 1986. The old runway was in extremely poor condition, as is shown in Figure 2. The longitudinal and transverse pavement surface was highly irregular and was disintegrating as a result of moisture entering the large number of cracks. Although located in the same vicinity as the old runway, the new 2900- \times 60-ft runway is longer, wider, and at a slightly different orientation than the old runway.

a. Looking northwest.

b. Boulder heave. Figure 2. The Newton Field runway before 1986.

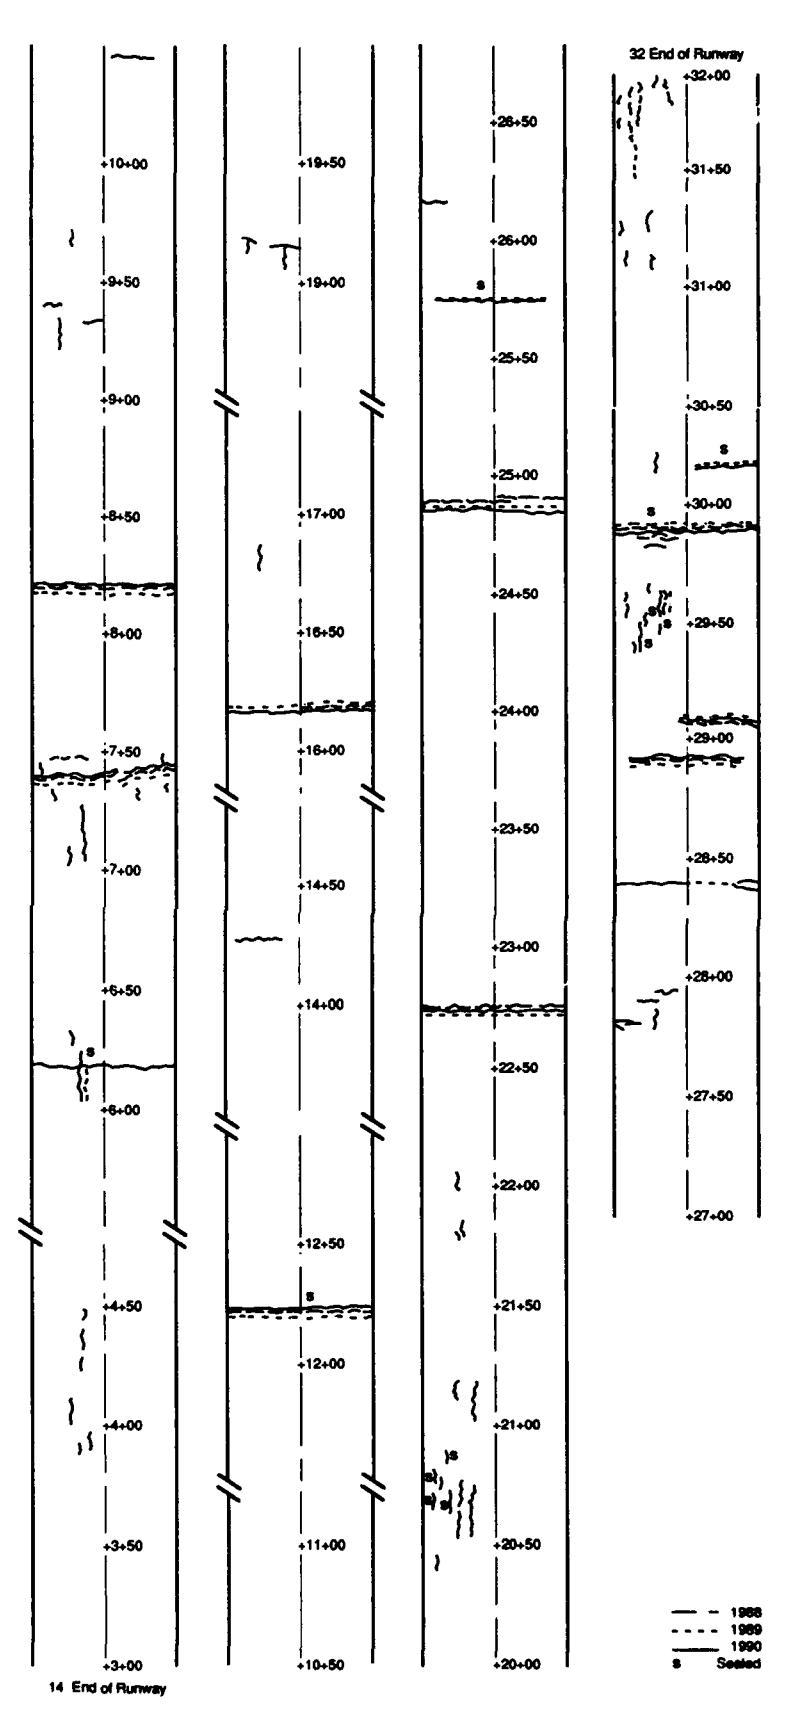
Figure 9. Newton Field pavement crack map.

The progression of crack development following placement of the final $1^{1}/_{4}$ -in. asphalt concrete lift in 1987 is shown in Figure 9. Although the cracks had been sealed in September 1989 with a rubberized crack sealer and polyfiber, nearly all cracks have since reopened. In all instances, the failure occurred due to a loss of adhesion between the asphalt pavement and the sealing agent. The crack shown in Figure 10a was unsuccessfully sealed with silicone shortly before being resealed with the rubberized crack sealer.

Generally, the cracks have manifested memselves in two varieties: small longitudinal cracks typically occurring in localized groups, and individual long, wide, transverse cracks. Elev-

en transverse cracks extend across, or nearly across, the entire runway, and two transverse cracks extend across the taxiway. Crack density is particularly high at the southeast (32) end of the runway; elsewhere, cracks are fairly evenly distributed.

The asphalt concrete is beginning to exhibit signs of secondary cracking. One possibility is that the base course has eroded from beneath some of the larger cracks; however, no evidence of removed material has been observed at the edges of the runway. Figure 10b illustrates a crack at least 9 in. deep at station 16+15, and Figure 10c shows the results of the secondary cracking and ensuing settlement of approximately 3 in. at station 29+95. While Figures 10b and c represent the most extreme of the crack-related failures exhibited by the four-year-old pavement, progressive deterioration is inevitable unless the cracks are successfully sealed.

2. Extreme pavement distress is exhibited by cracks up to 9 in. deep and by severe secondary cracking. It is recommended that both the pavement surface and the underlying insulation be monitored for horizontal displacement. From this it could be determined whether the extreme crack-related failures are due to differential movement caused by the extreme temperature fluctuations experienced by insulated pavements, movement of the asphalt concrete and frozen base, or shrinkage of the asphalt concrete due to accelerated aging.

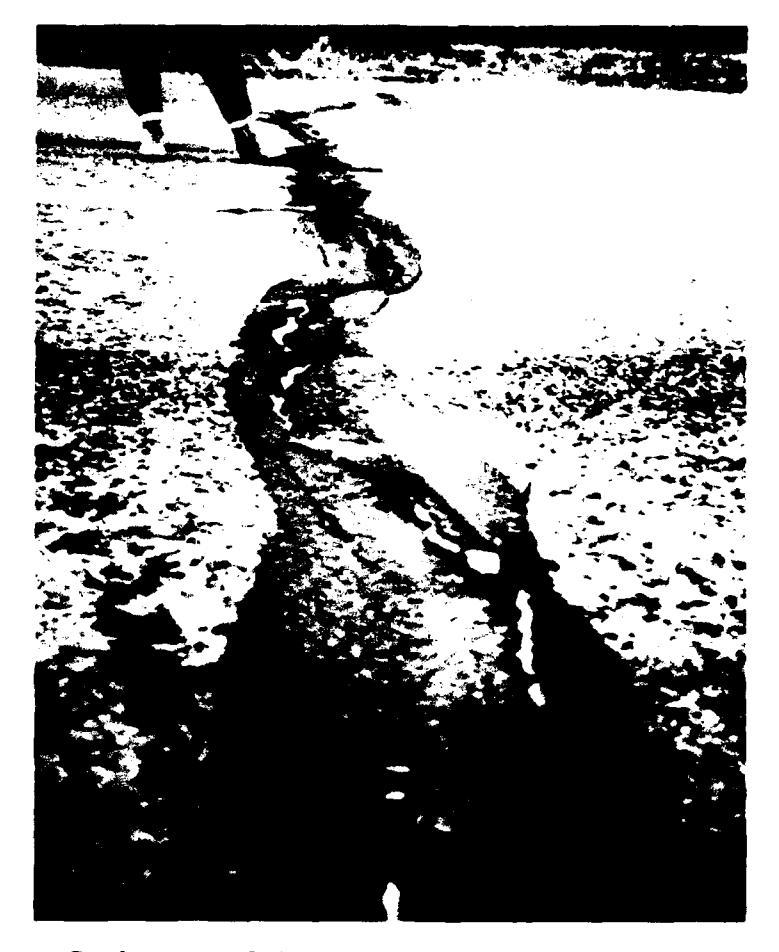
a. Crack at station 8+22 initially sealed with silicone, then with a rubberized crack sealer.

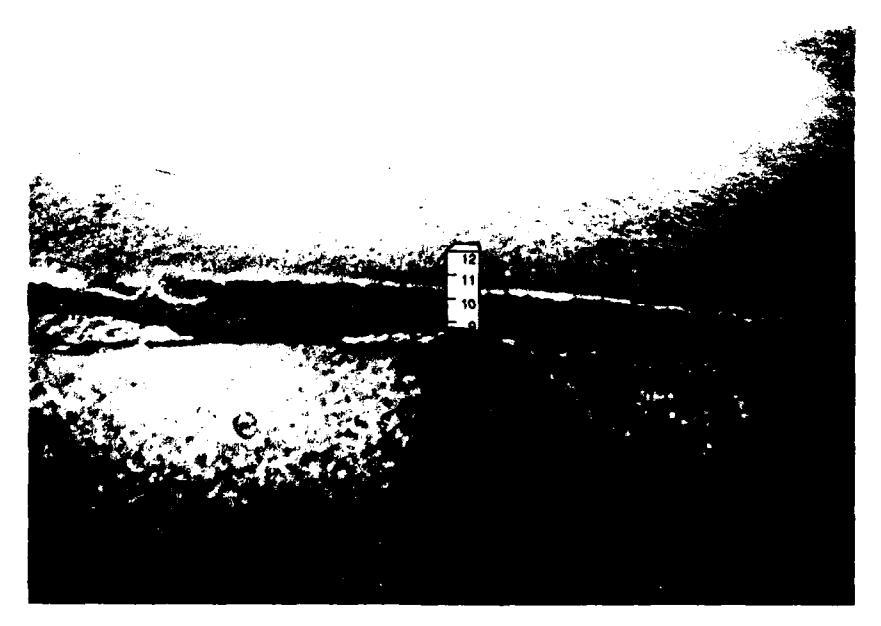
b. Crack at station 16+15. Figure 10. Cracks in the Newton Field runway.

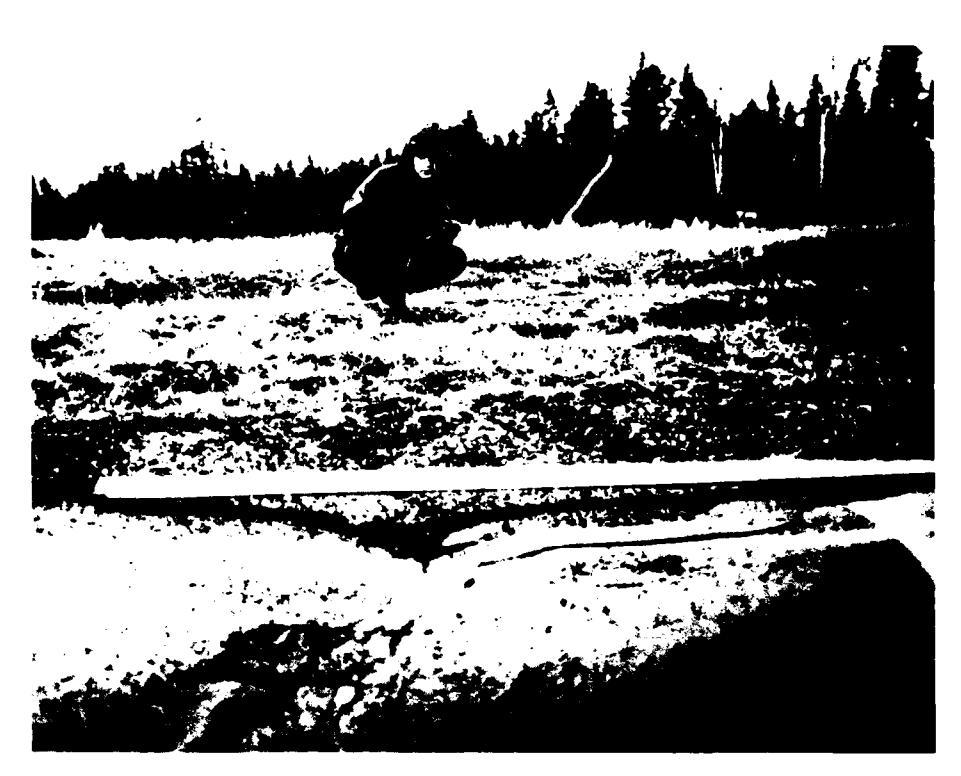
c. Settlement of pavement at station 29+95 Figure 10 (cont'd).

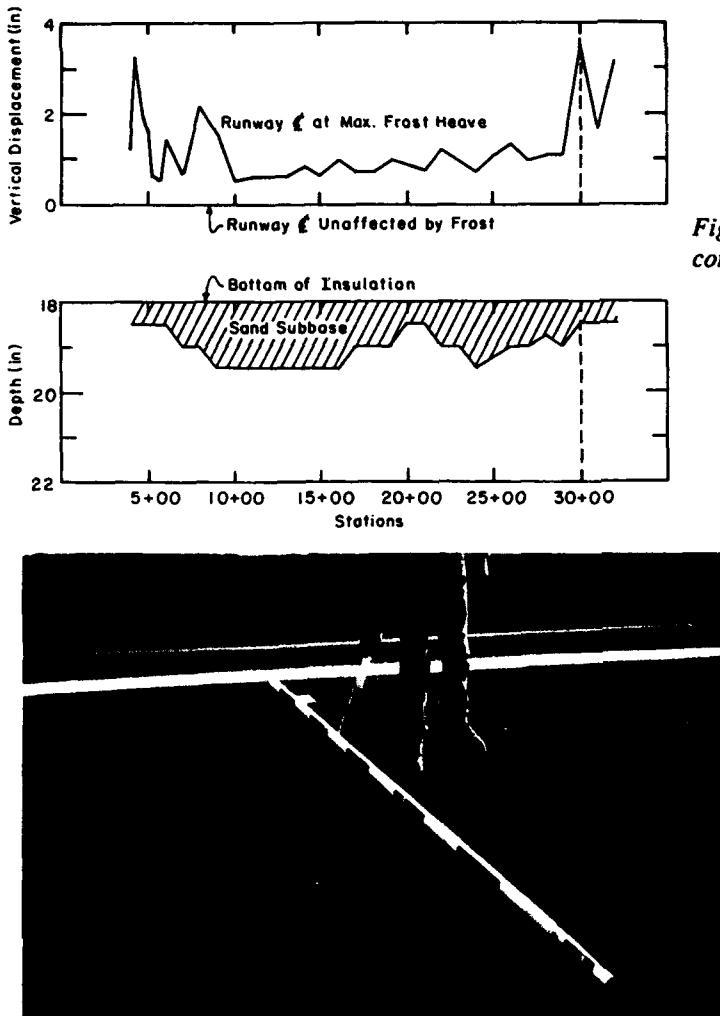
Figure 11. Profile of frost-heaved centerline and corresponding depth of sand subbase, March 1990.

insulated pavement at Nichols Road was approximately 1 in. While the maximum frost heave along most of the runway was only slightly greater than that observed at the test sections, substantial frost heave occurred in three localized areas: station 4+00 to station 6+00 exhibited approximately 3 in. of frost heave; stations 8+00 to 9+00, approximately 2 in.; and stations 30+00 to

32+00, approximately 3 in. Figure 11 shows both the March 1990 centerline profile and the depth of sand subbase along the length of the runway. The areas that experienced appreciable frost heave generally correspond to the two ends of the runway that were excavated to a lesser depth. In addition, both ends of the runway were particularly spongy during construction.

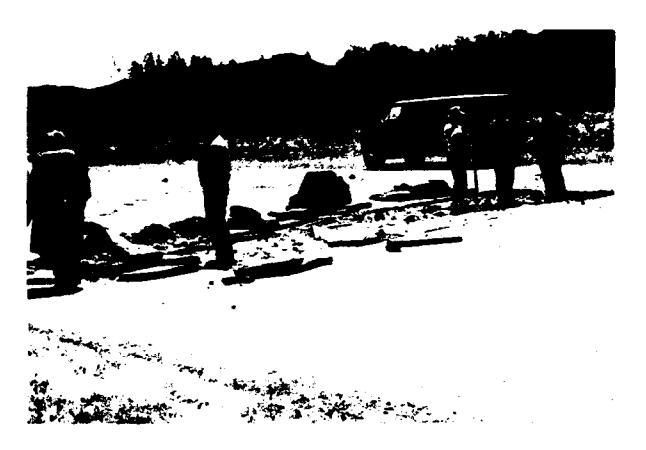
Figure 16. 1987 removal of pavement at station 30+00.

ized settlement (Fig. 16). Figure 17 shows the overlapping and damaged insulation that was removed and replaced. The damaged insulation at this particular location had been attributed by the consulting/design firm to settlement of the backfill above the 10-in. PVC sewer line that crosses the runway at a depth of approximately 8 to 9 ft beneath finished grade. It is probable, however, that similar insulation damage or separation of adjacent panels caused the temperature anomaly at station 4+50. Similar problems also are probably responsible for the substantial differential frost heave at both ends of the runway. These areas were undoubtedly more unstable during construction than areas with a thicker layer of granular material beneath the insulation. Since the subgrade possessed very low strength during construction, movement of the insulation panels due to construction traffic probably caused the individual boards to move, resulting in gaps in some locations and overlap in others.

direction of the resident engineer, the insulation was removed, the subgrade was removed to the desired depth, and the geotextile, insulation, and base course were all replaced.
