US Army Corps
of Engineers
Construction Engineering
Research Laboratory

AD-A272 573

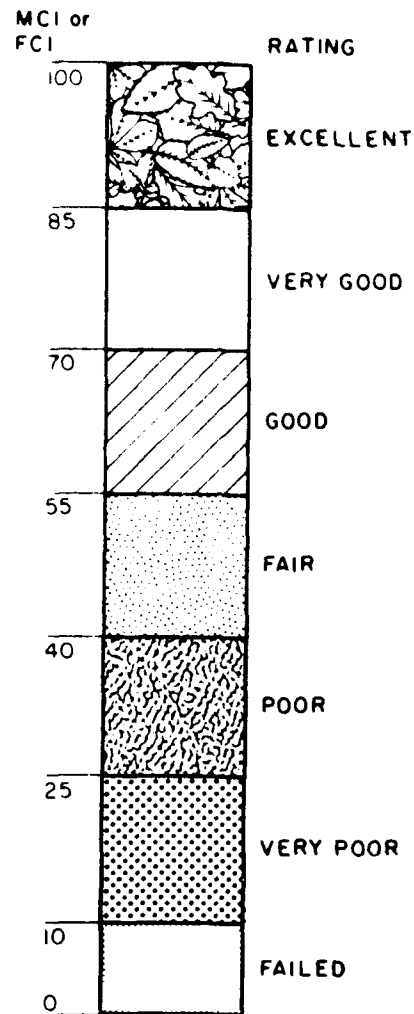
Figure 1. Membrane and Flashing Condition Indexes (MCI and FCI) and Ratings.

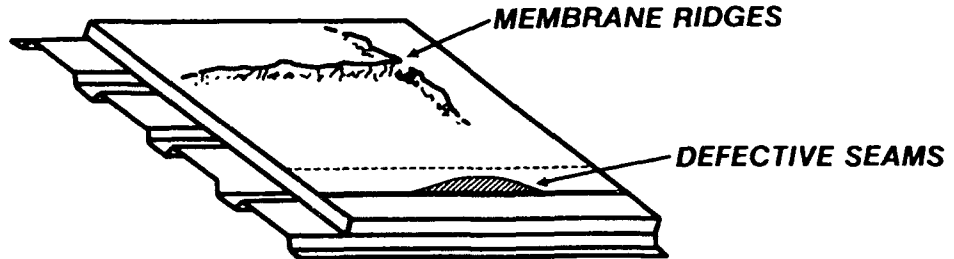
STEP 3: Determine Deduct Values.

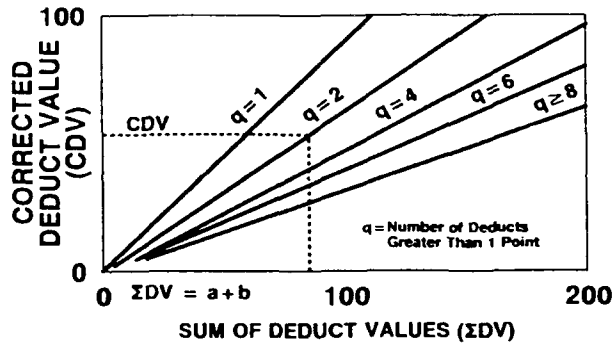
STEP 6: Determine Membrane and Flashing Condition Ratings.

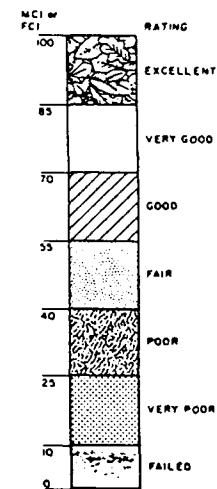
STEP 5: Compute Membrane and Flashing Condition Indexes.

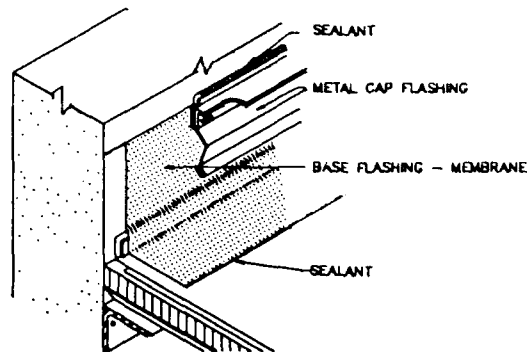
Medium: Any of the following defects:

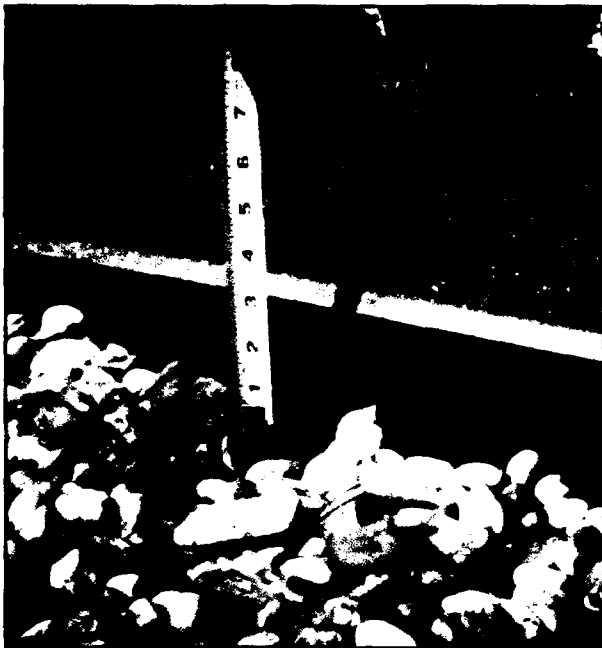
BFL2
<Low Severity>
Top of base flashing is less than 6 in. above the membrane

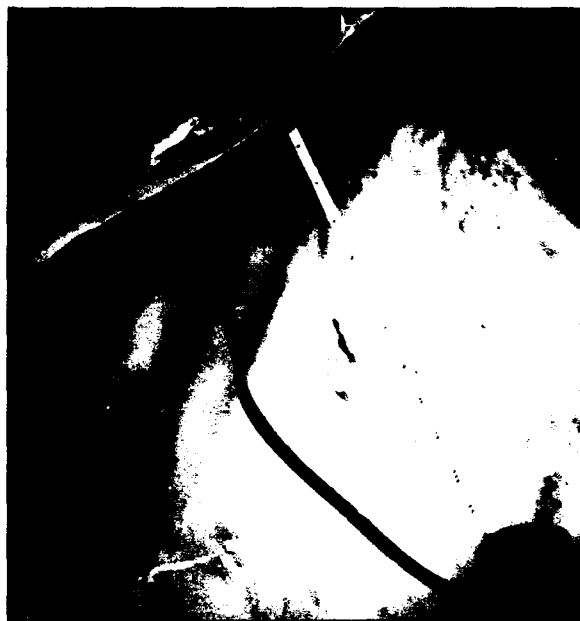
BFM6
<Medium Severity>
Loose termination bar where no counterflashing is used

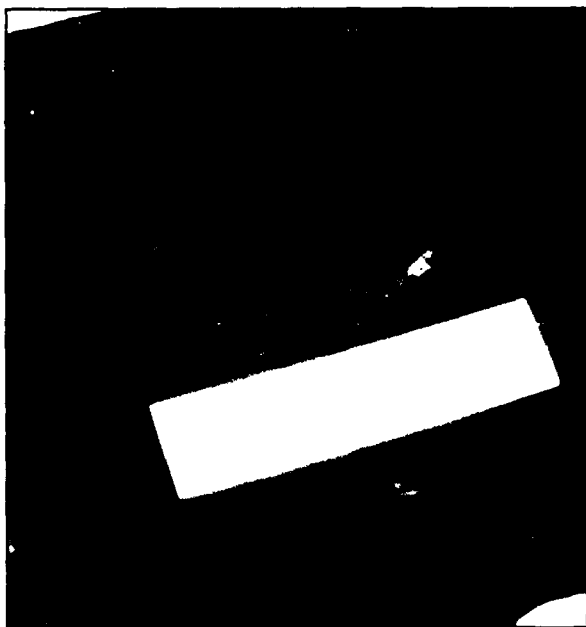
BFH1
<High Severity>
Eroding of base flashing that allows water to penetrate

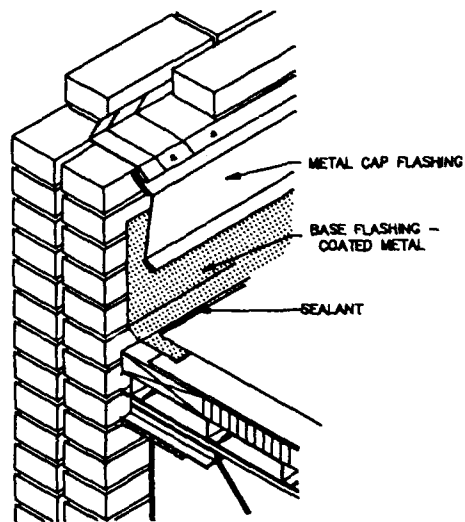
Medium: Any of the following defects:

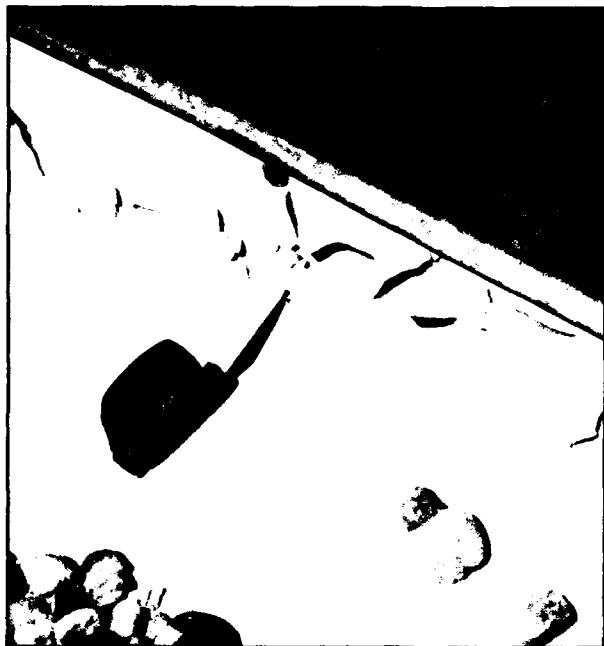
BCL1
<Low Severity>
Loss of protective coating

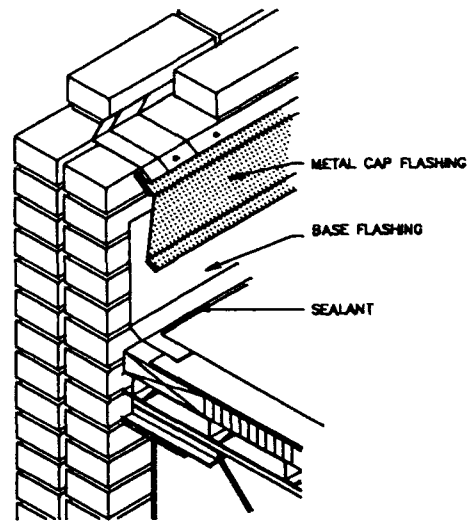
METAL CAP FLASHING (MC)

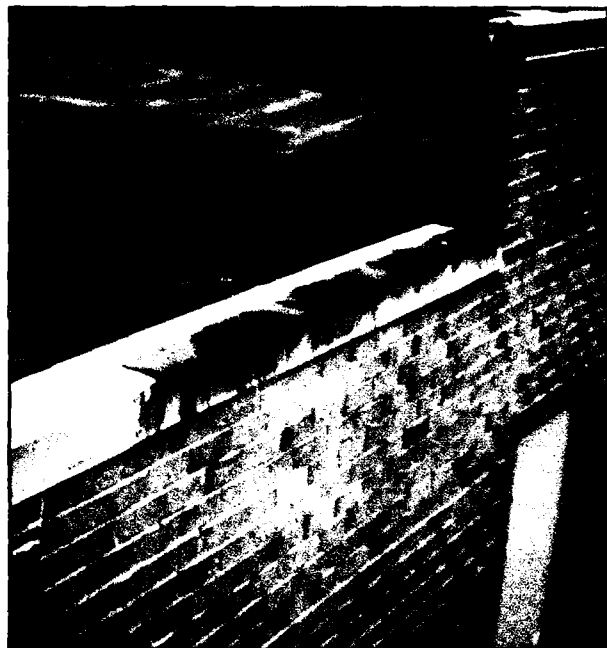
MCL1
<Low Severity>
Corrosion without holes

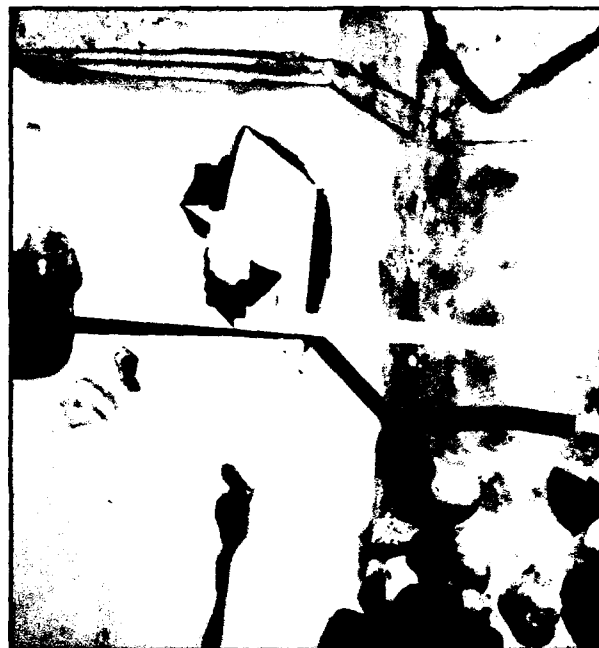
MCL1
<Low Severity>
Loss of protective coating

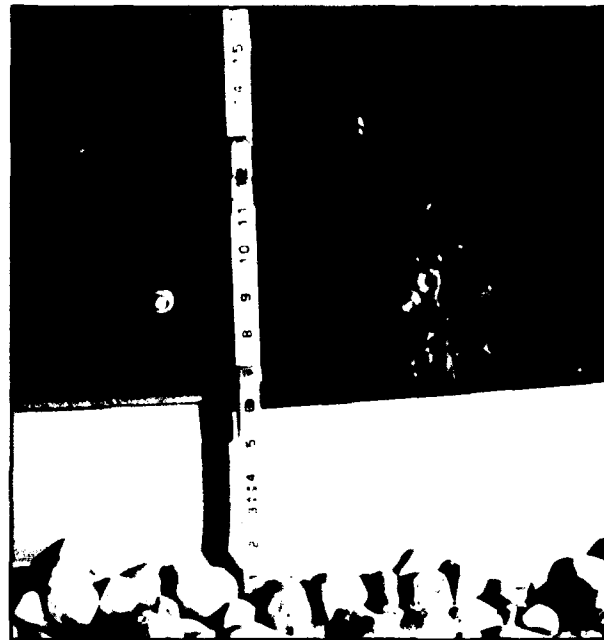
MCM2
 <Medium Severity>
 Metal cap flashing has loose fasteners

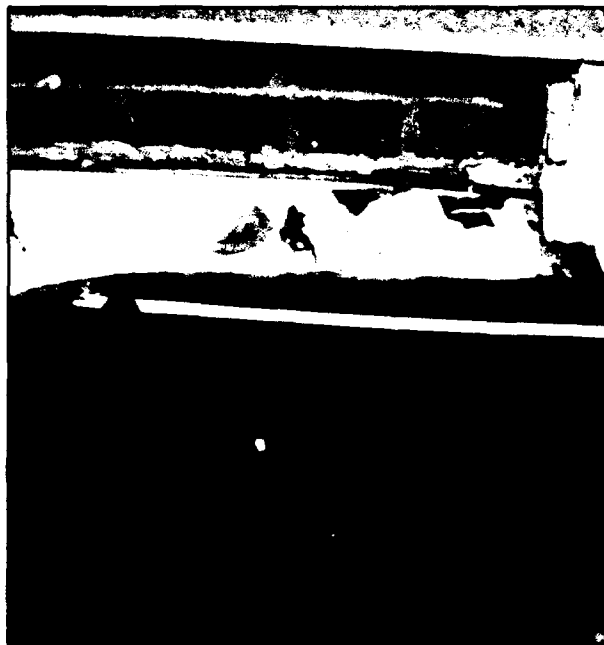
MCM3
 <Medium Severity>
 Metal cap flashing has rough edges that are in contact with the base flashing

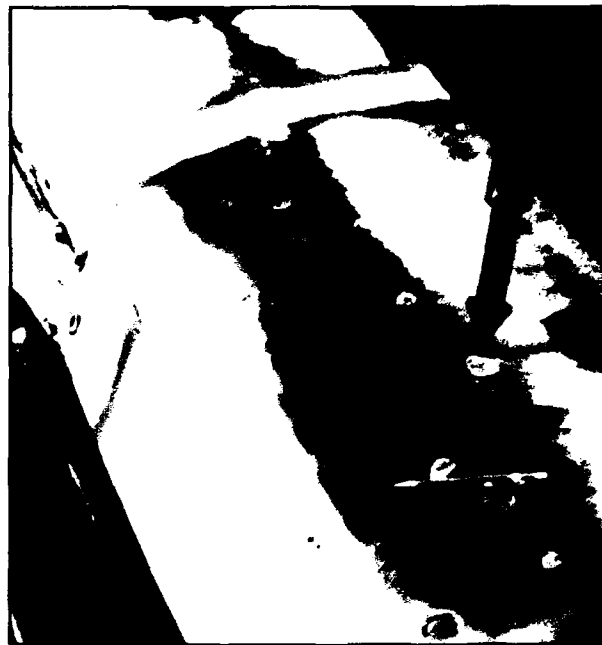
MCH2
 <High Severity>
 Corrosion holes have occurred through the metal on a horizontal surface

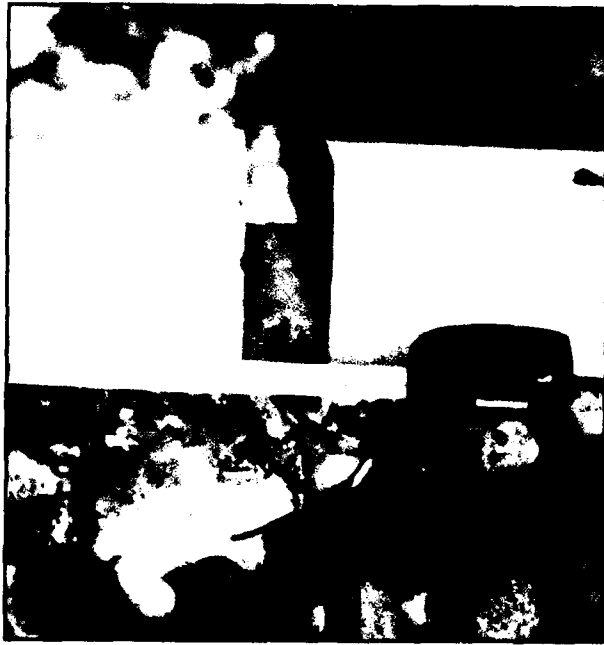
MCH3
<High Severity>
Metal cap flashing has missing joint cover

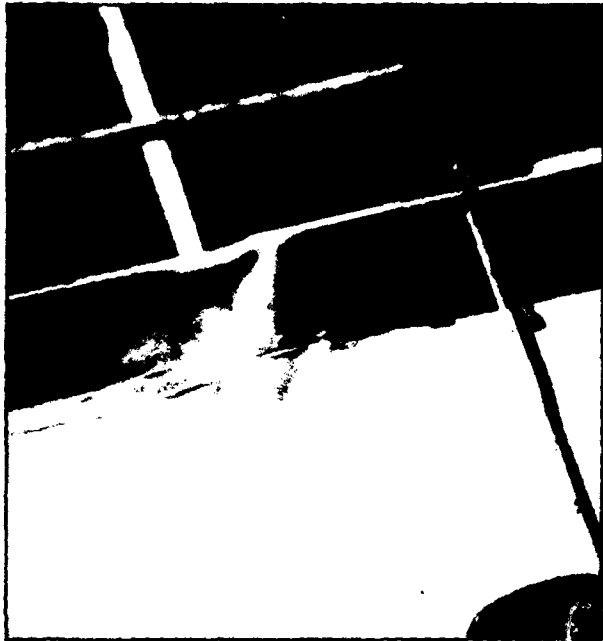
EML4
<Low Severity>
Distortion of joint cover

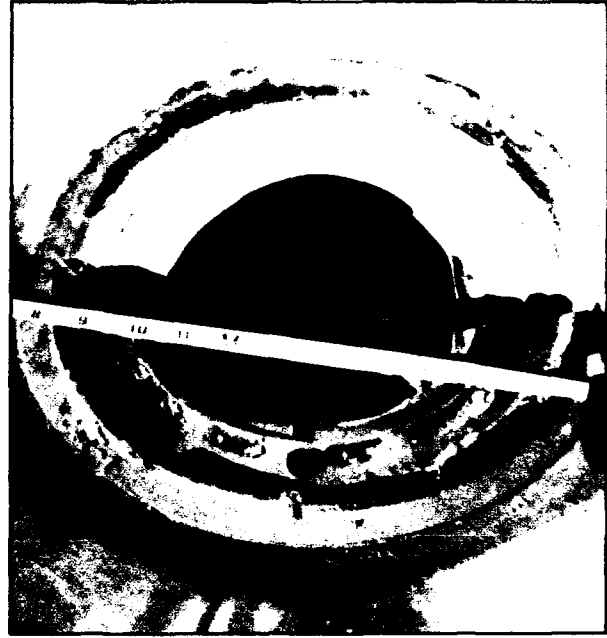
DRH3
 <High Severity>
 Clamping ring is broken

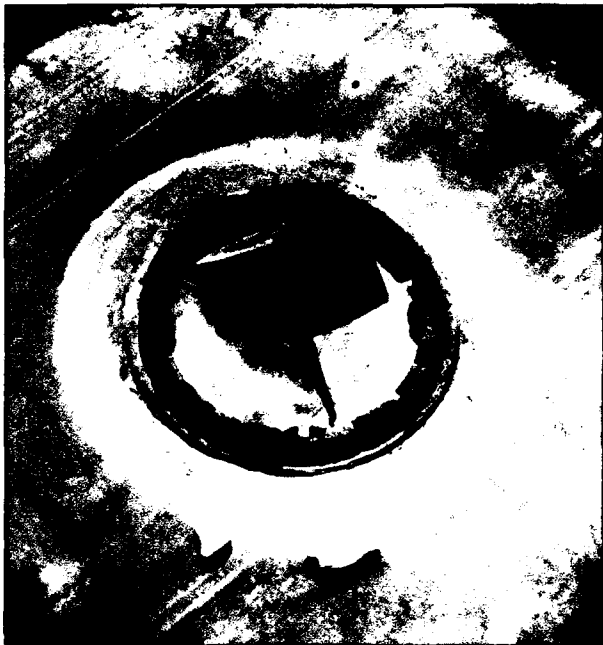
DRH3
 <High Severity>
 Bolts are missing from clamping ring

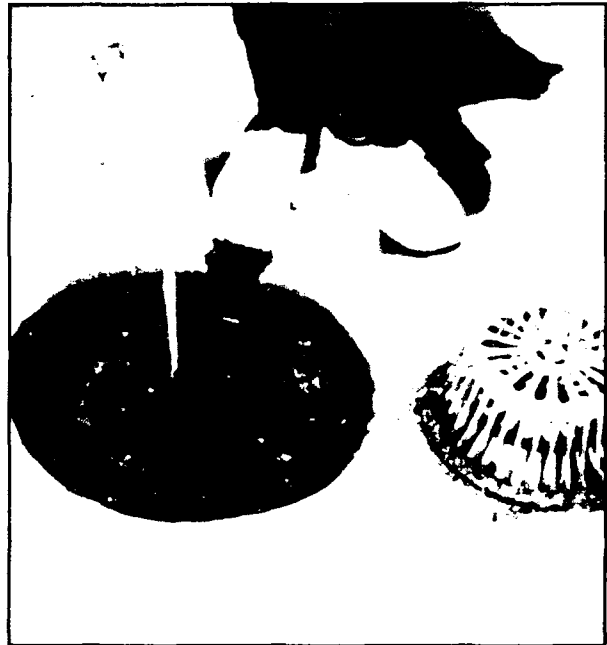
DRH4
 <High Severity>
 Drain is clogged

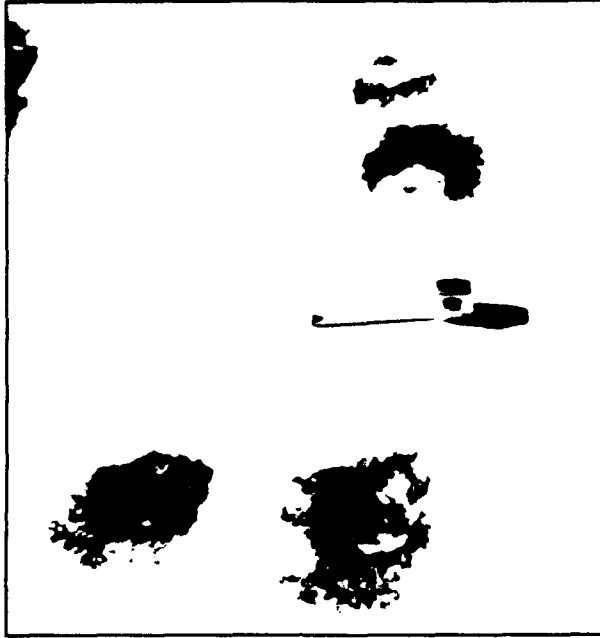
RGL1
<Low Severity>
Watertight ridges having no open breaks

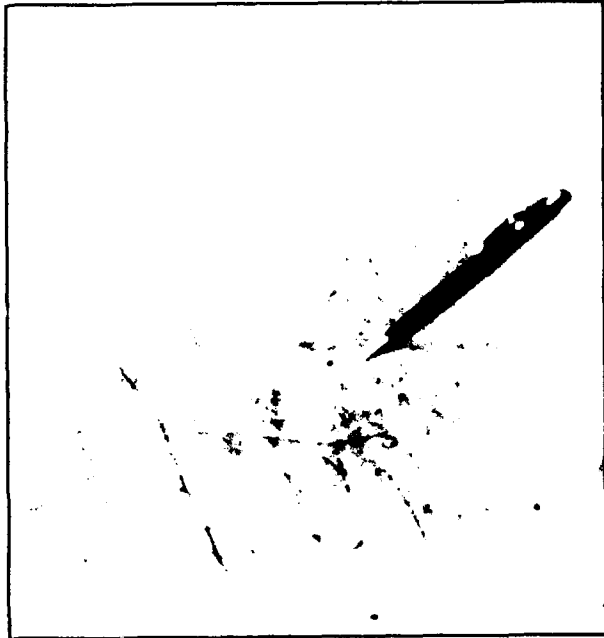
HLL1
<Low Severity>
Surface scratches and abrasions

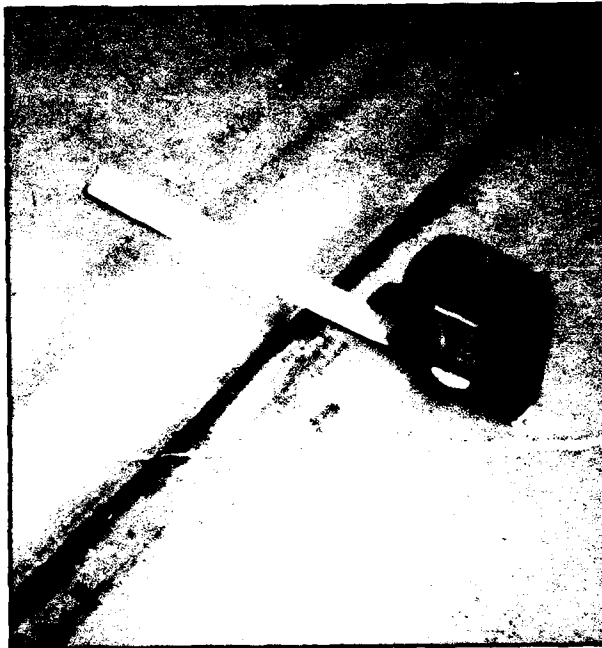
DSL1
<Low Severity>
Missing lap sealant

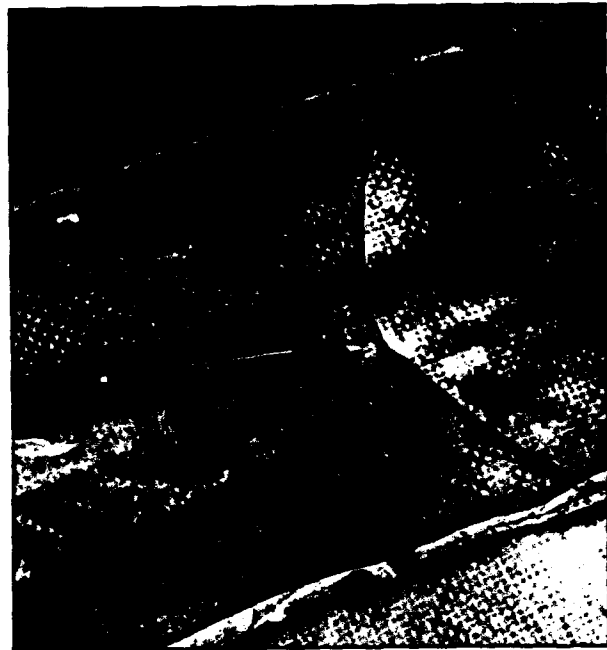
DSL2
<Low Severity>
Missing lap sealant with exposed reinforcement material

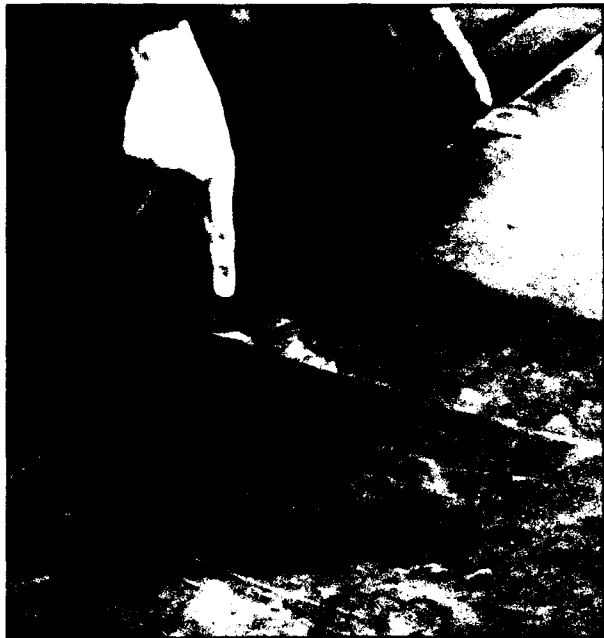
DSL3
<Low Severity>
Seam is open less than 1/2 in.

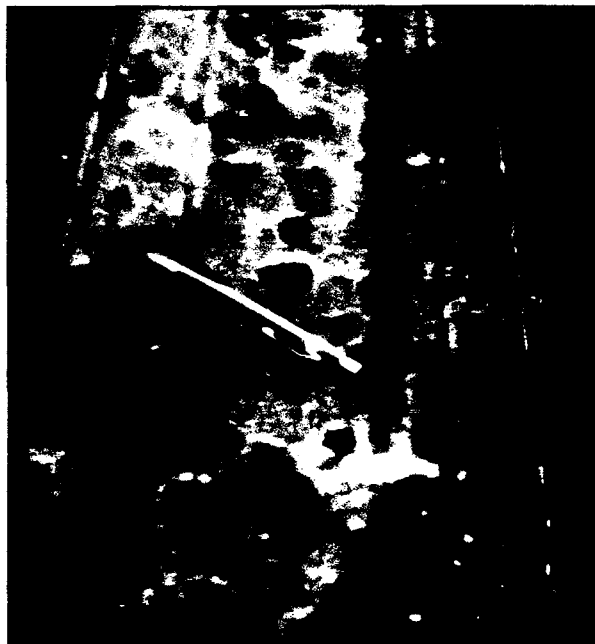
DSL6
<Low Severity>
Blisters within seam

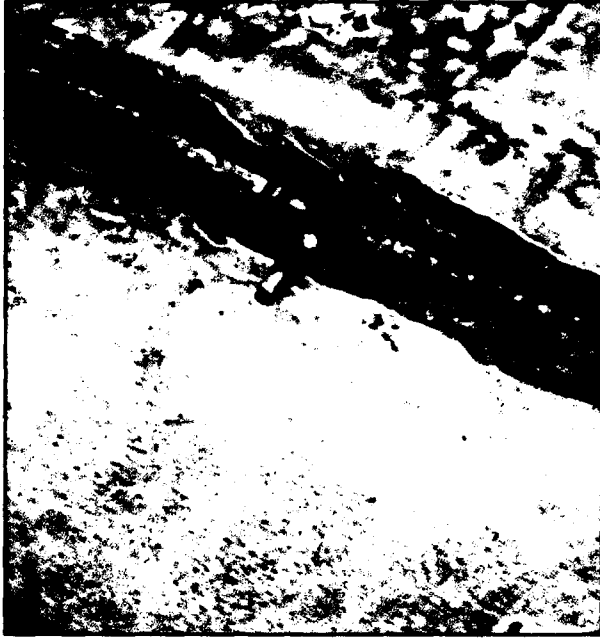
DSM1
<Medium Severity>
Seam is open more than 1/2 in.

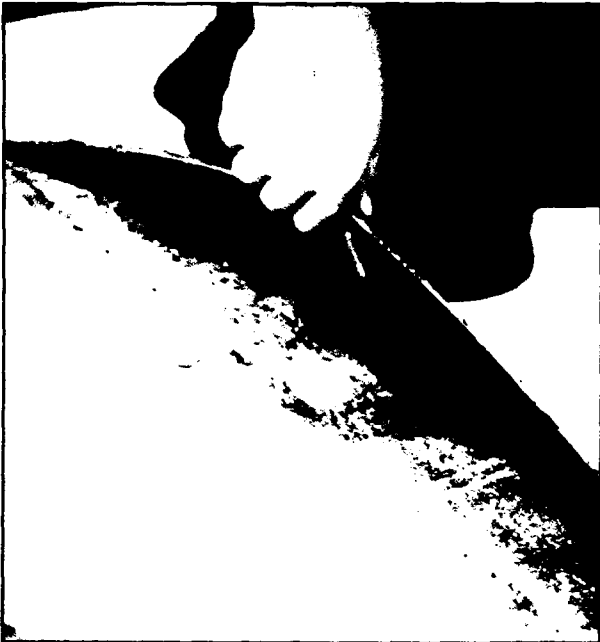
DSH1
<High Severity>
Seam is open through its entire depth

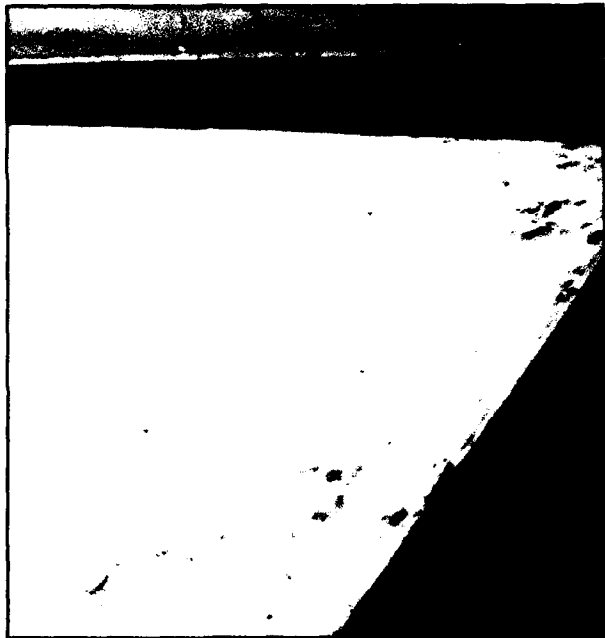
SCL1
<Low Severity>
Loss of protective coating

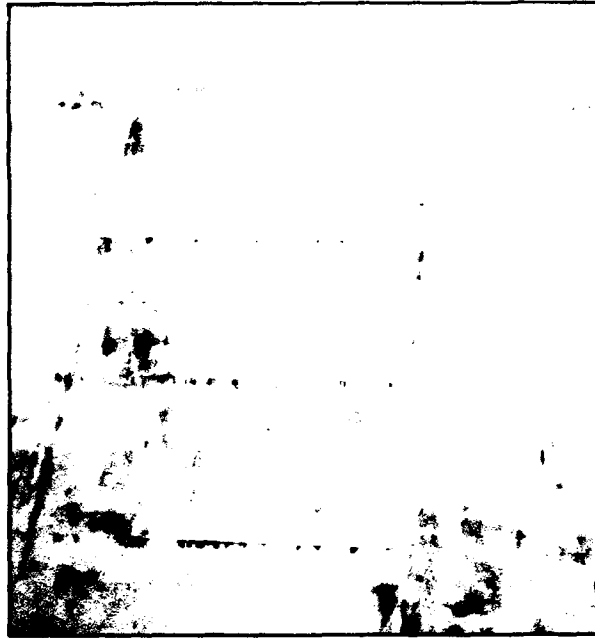
SCM1
<Medium Severity>
Loss of protective sand coating

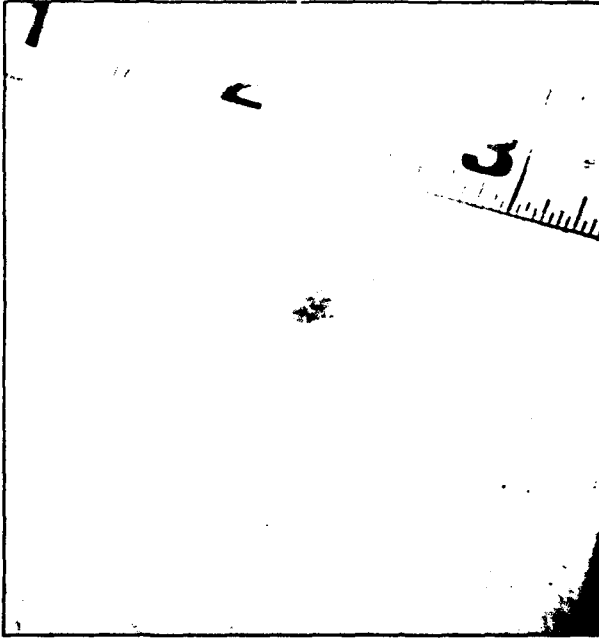
MDL1
<Low Severity>
Light crazing of membrane surface

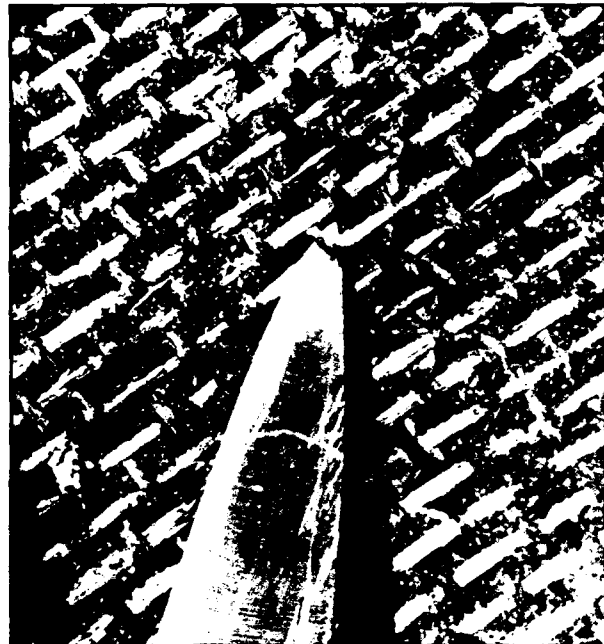
MDH1
<High Severity>
Scrim completely exposed

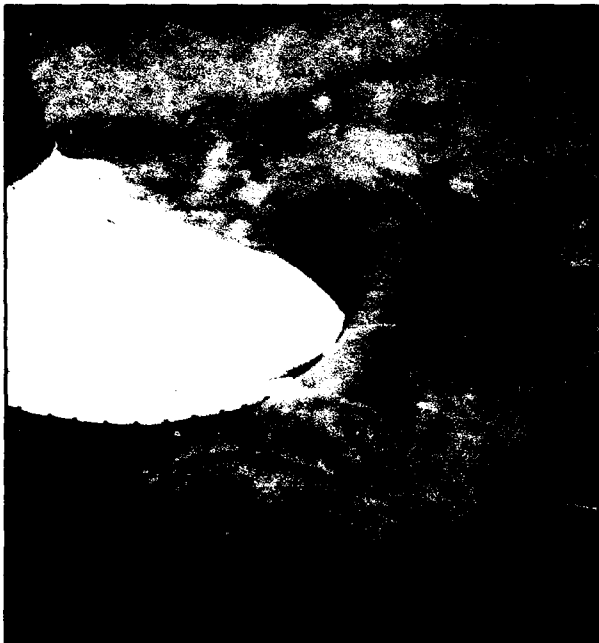
SSL1
<Low Severity>
Unattached membrane of less than 2 sq ft

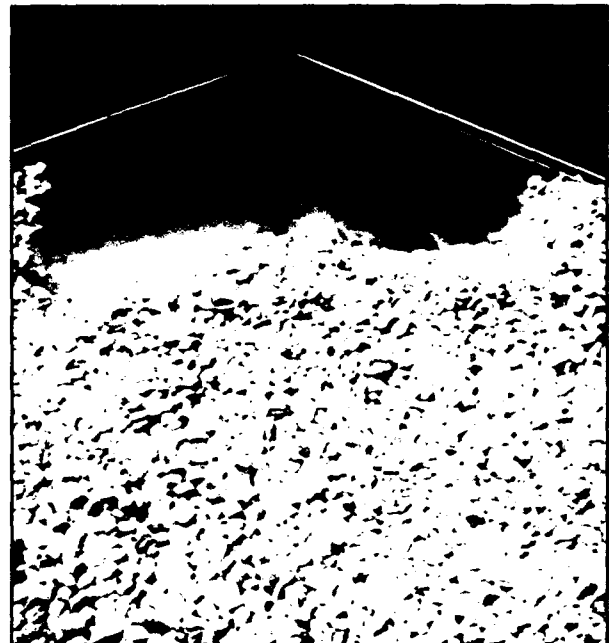
SSL2
<Low Severity>
Ballasted system, bare area of less than 4 sq ft

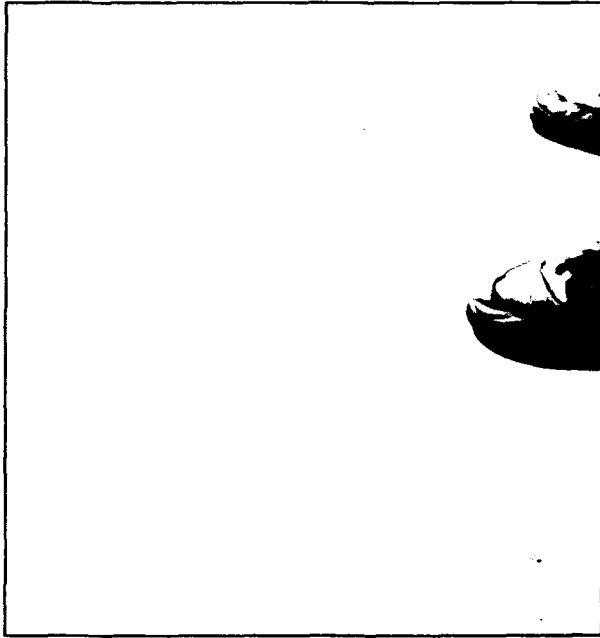
SSM1
<Medium Severity>
Unattached membrane of more than 2 sq ft but less than 100 sq ft

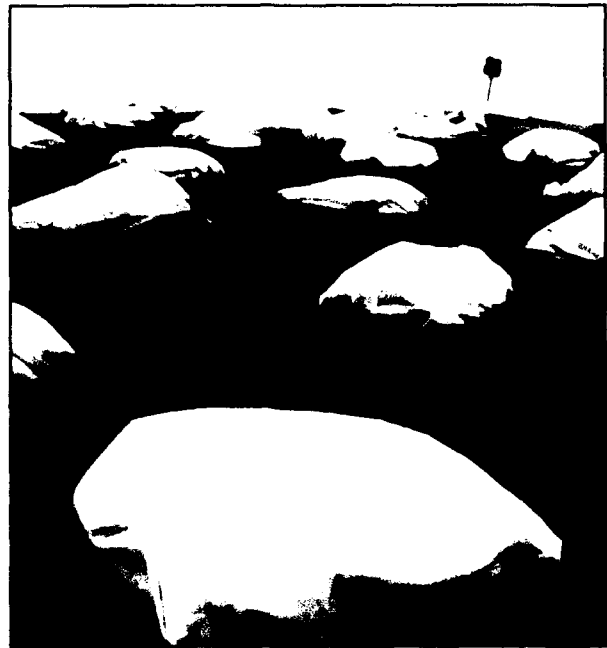
SSH1
<High Severity>
Unattached membrane greater than 100 sq ft

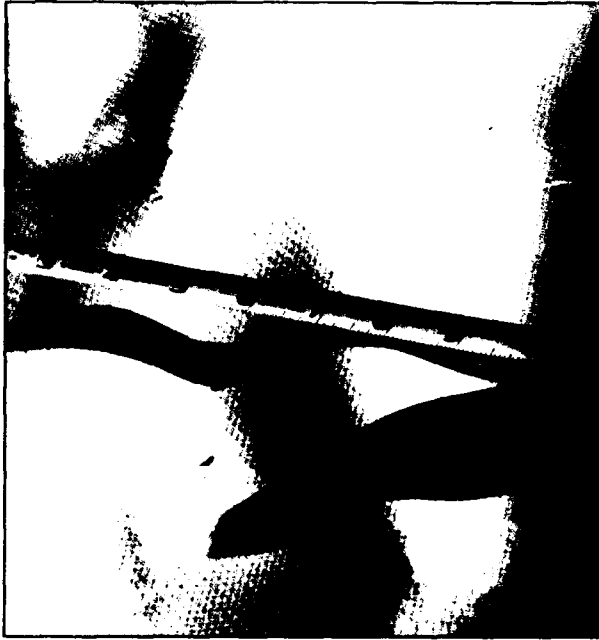
SSH2
<High Severity>
Adjacent mechanical fasteners have lost their attachment capability

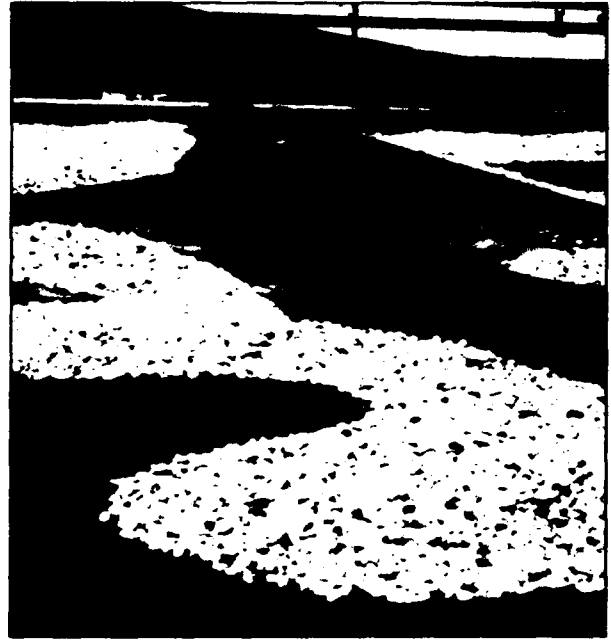
SSH4
<High Severity>
Ballasted system, bare area more than 100 sq ft

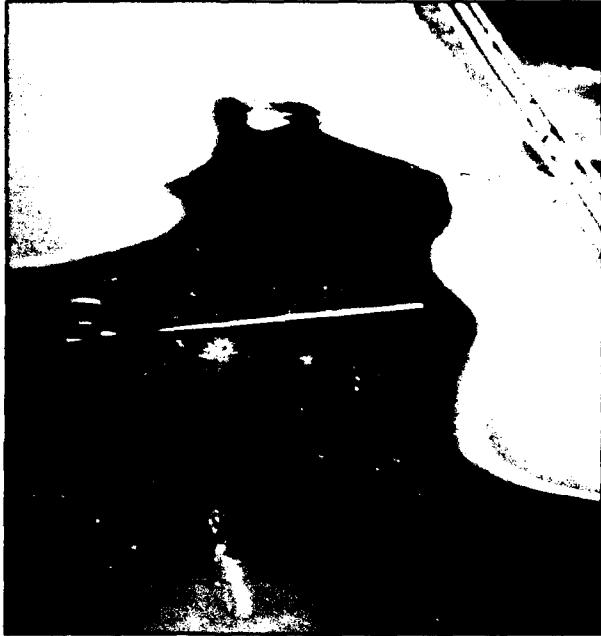
MSL1
<Low Severity>
Membrane tension caused by warping or bowing of the substrate

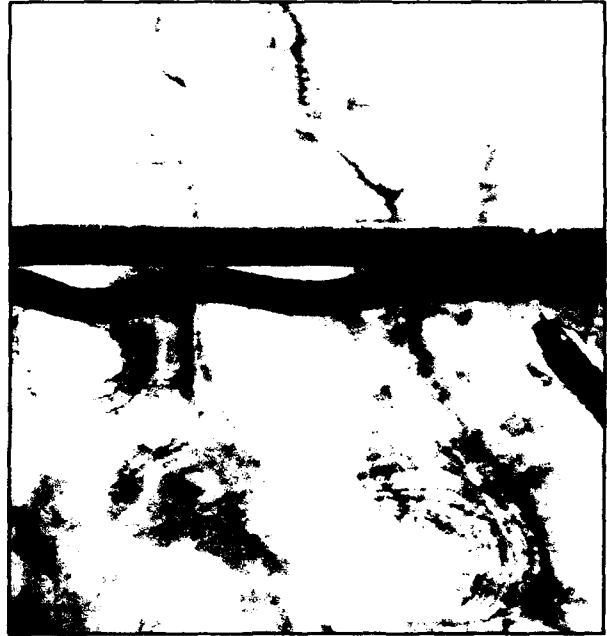
MSM1
<Medium Severity>
Uneven support more than 2 in. wide

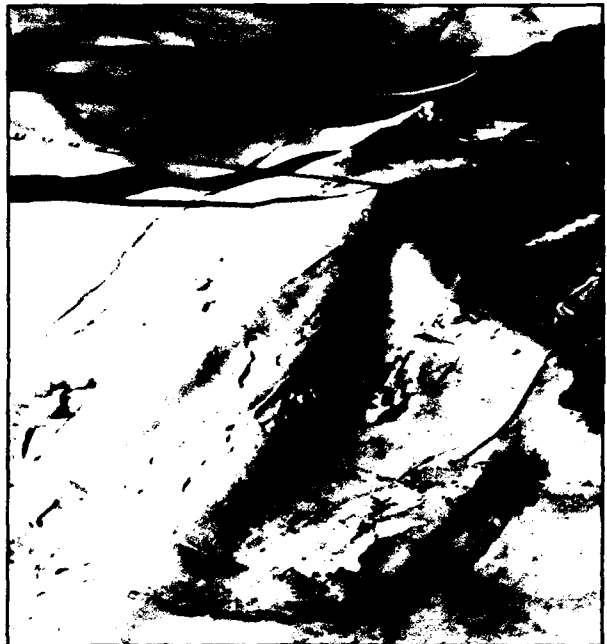
MSM3
<Medium Severity>
Lumps indicating foreign material

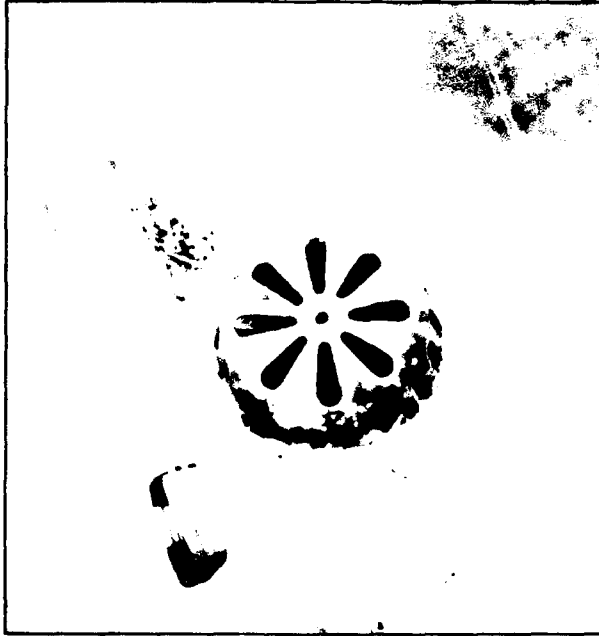
DVM1
<Medium Severity>
Vegetation that has not penetrated the membrane

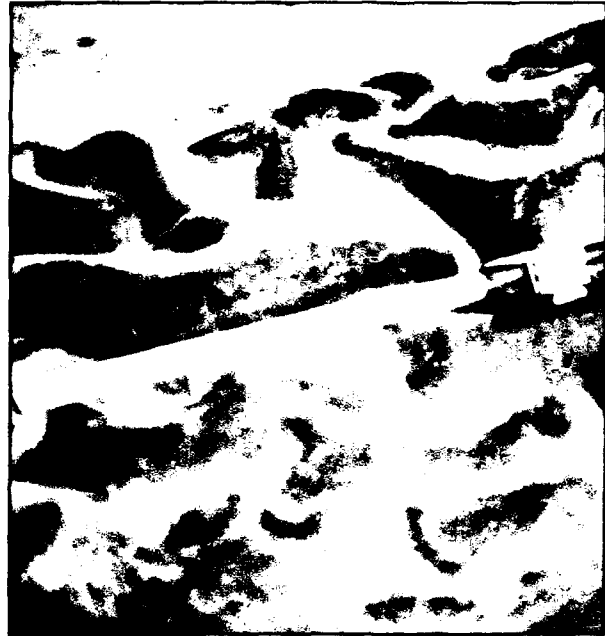
DVM2
<Medium Severity>
Degradation of membrane caused by solvents or oil

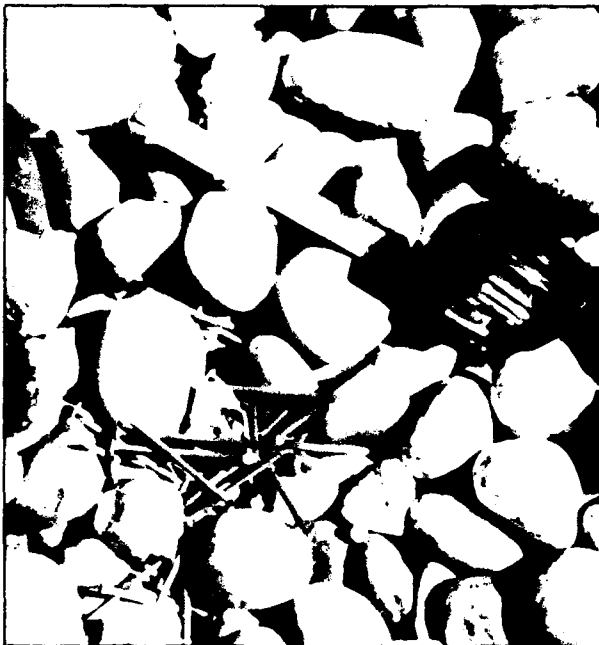
DVM3
<Medium Severity>
Foreign materials that were not removed during inspection

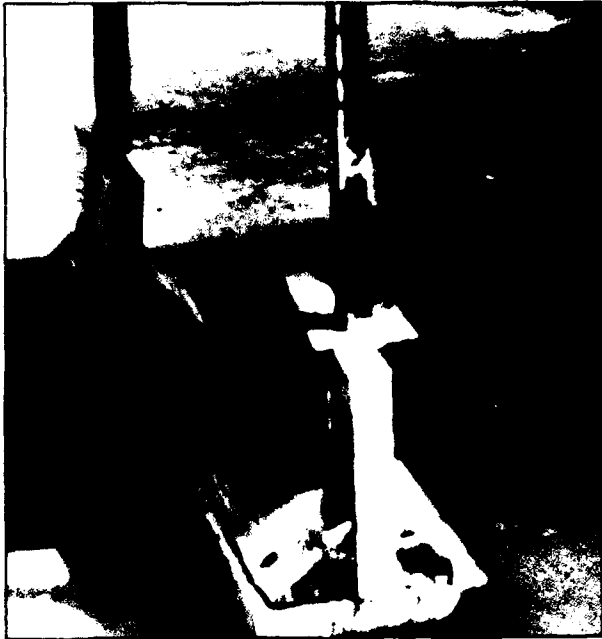
EQL1
<Low Severity>
Equipment stand supported by wood blocking

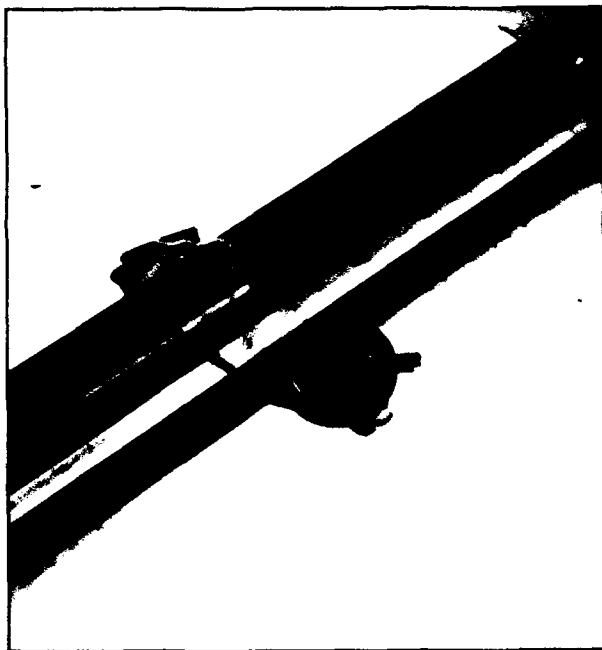
EQL1
<Low Severity>
Improper equipment supports

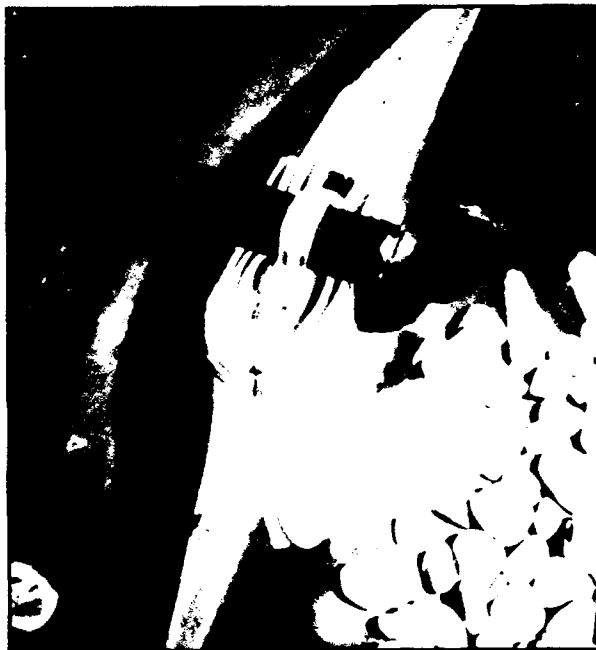
EQH1
<High Severity>
Movement of support has cut the membrane

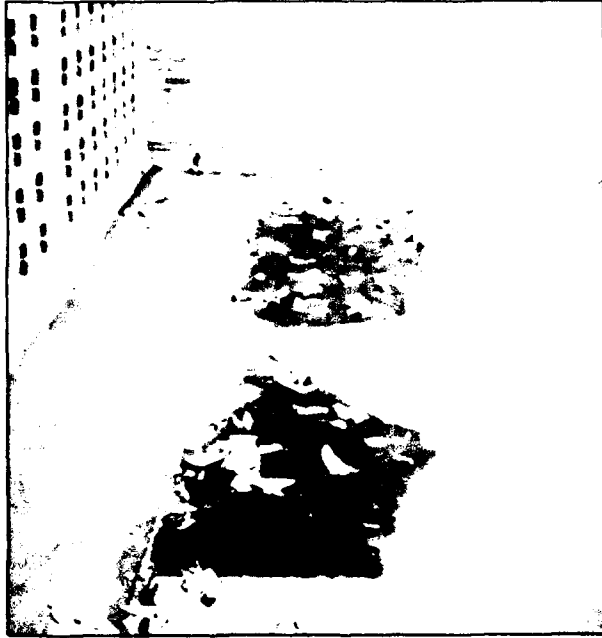
PDL1
<Low Severity>
General ponding

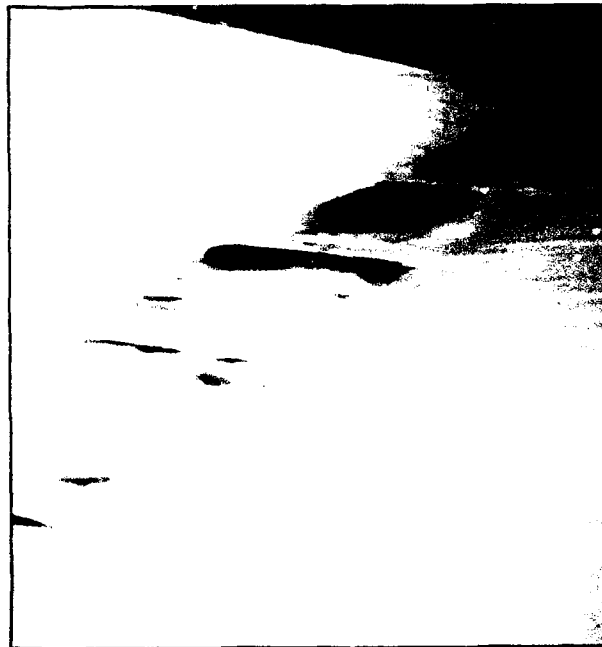
PDM1
<Medium Severity>
Ponding caused by wrinkles or folds in the
membrane

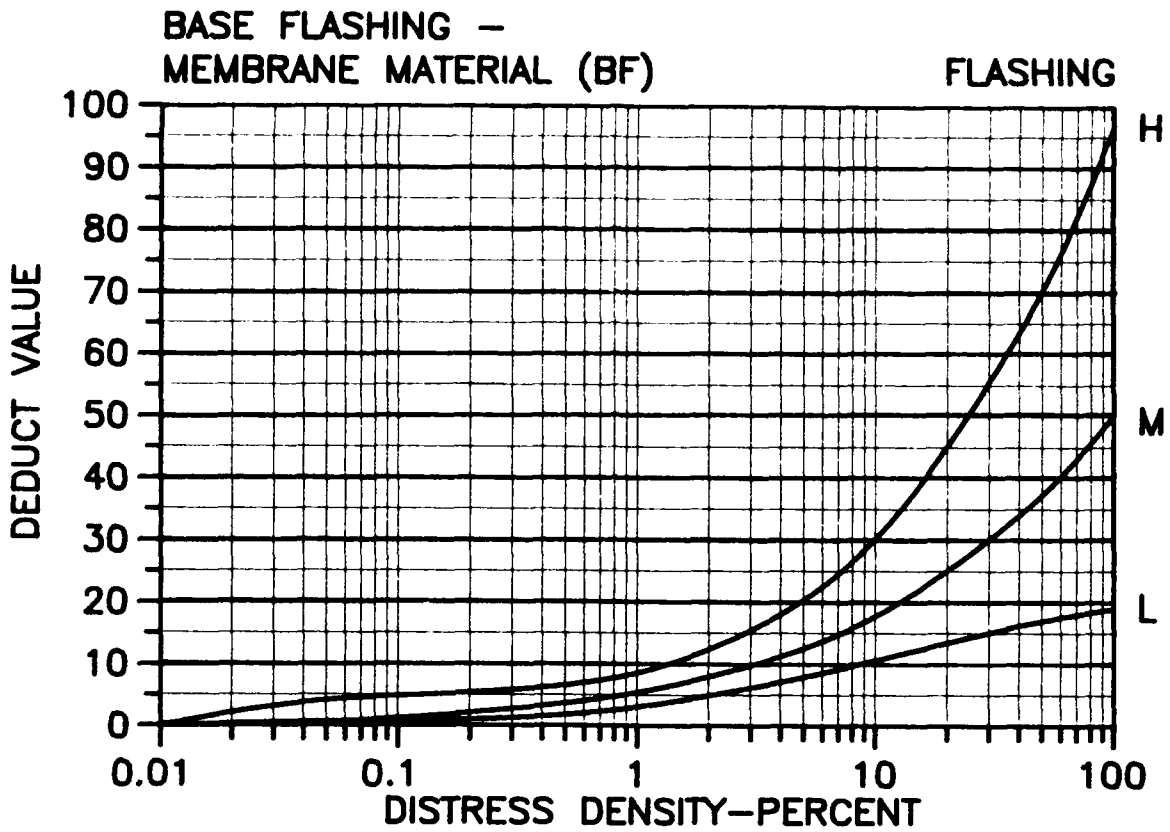
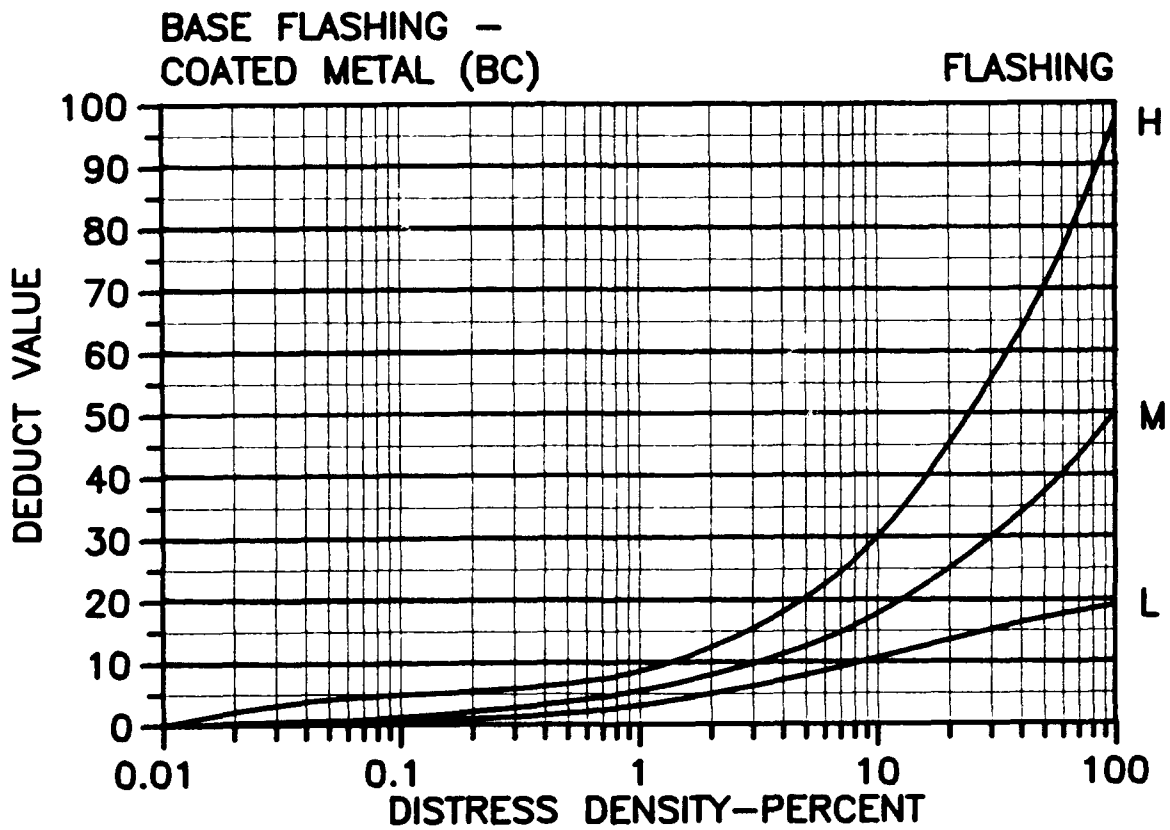
APPENDIX A: Deduct Value Curves
