R-2933

July 6 1993

AXKT PHASE 3 FINAL REPORT
CONTRACT N00014-88-C-6027

SUBMITTED BY
SIPPICAN, INC.
7 BARNABAS ROAD
MARION, MA 02738

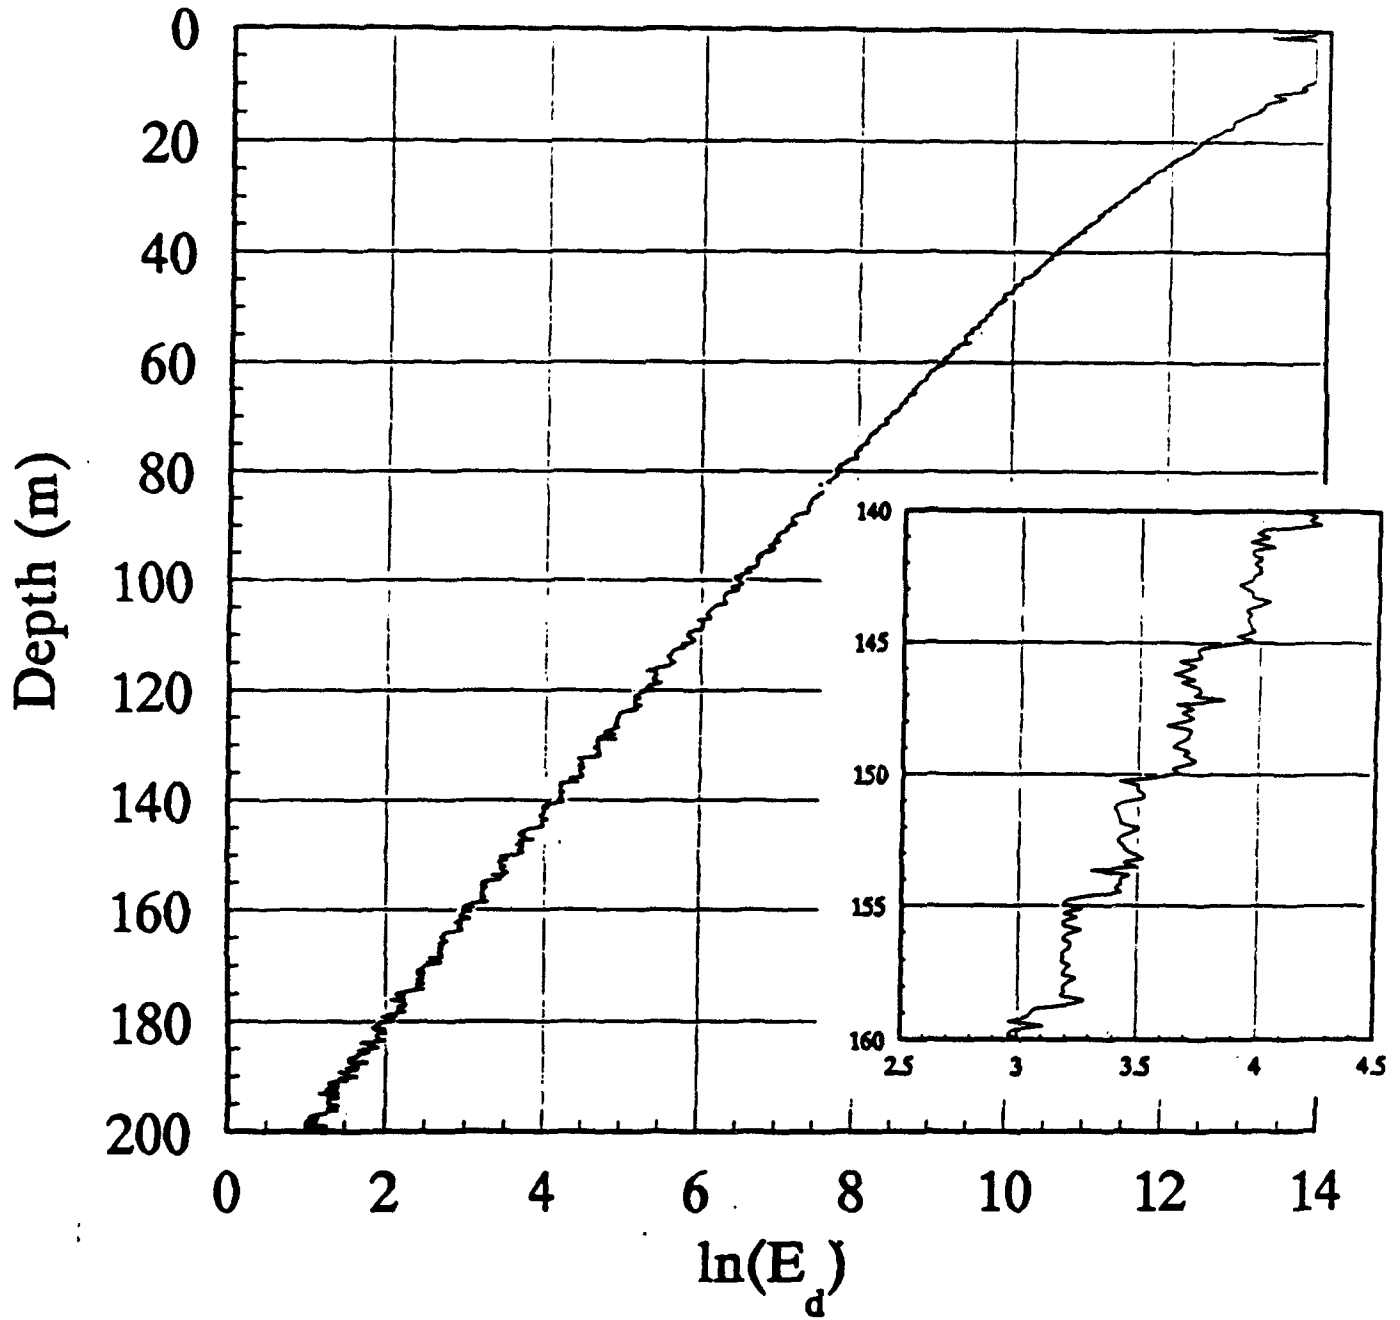
On data from three of the units, there appeared a granularity or quantization in the profile. This staircase phenomenon appears when certain conditions are met, i.e., the optical intensity is at a particular level (usually at a low illumination level) and the rate of attenuation with depth is relatively slow. When these conditions are met, the data will not correctly follow the illumination gradient smoothly, but will 'lock' onto a particular illumination level for a short length of time and then snap to a new light level and remain at this new level. This process repeats itself many times, thereby creating a trace that appears to have steps in what would normally be a smoothly changing illumination level. Graph 1 illustrates this effect. In the inset of the graph is an expanded view of the steps. As can be seen, these steps increase in severity as the light intensity decreases. The effect of these steps is to introduce a large amount of noise in the computed K value. In the extreme, the K is zero for a short depth where the step plateau is and the K is huge for the place where the step begins its transition. Currently the only way to deal with the steps is to filter the raw irradiance data and then calculate the K value from this data.

Several of the XKT units exhibited signal saturation at the surface just after probe release. This condition (See graph 1) causes an apparent constant level of optical illumination (a 'K' of zero) for a certain depth. This condition is almost certainly a result of mis-scaling the electronics in either the probe or the buoy as the actual detector has a considerable greater dynamic range than the electronics. There is no processing technique that will re-create this piece of data, it is completely lost. After a certain depth is reached, the water column will have attenuated the light to the point where the signal becomes 'on-scale' and will be processed. As the measurement for K is a differential measurement, the loss of this data does not effect the remaining data.

Several units that were deployed exhibited a condition of 'saturation' when the probe was still near the surface. Upon descending to a deeper depth, the units would then resume normal operation and provide a good data set (See graph 1).

During the tests for logarithmic conformity, the digitization or staircase effect was again noted. The manifestation of the effect is shown on graph 7 (Also graph 1 for a real time display). Again, further work will be required to determine the cause and the corrective action of this problem.

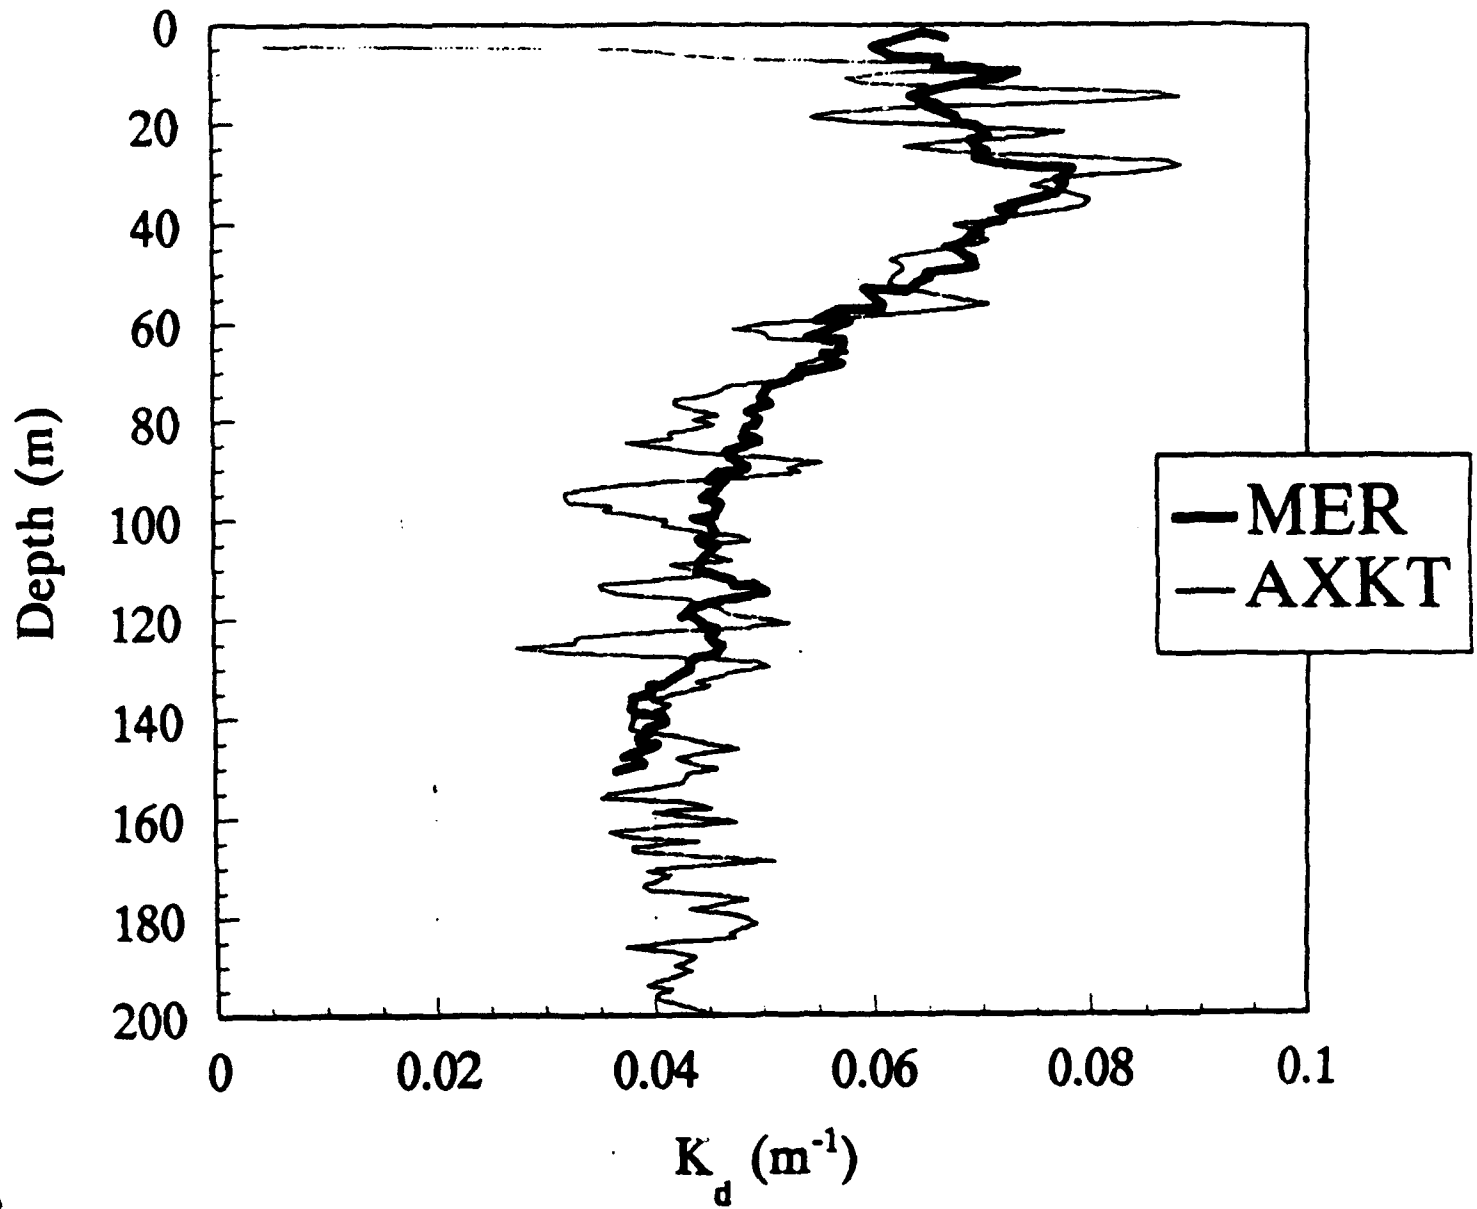
The effect of the electronic change to speed up the response of the probe looked encouraging. The comparison of data from the cable lowered MER and the few AXKTs that gave a good data set showed that the 'smearing' effect is considerably smaller with both instruments showing the same transition regions. Graph 4 shows a data set from the AXKT as compared to the MER optical data. The region from 20 to 60 meters, which has the greatest dynamics, indicates that the XKT keeps up with the MER for the average trend of data. The greater fluctuations of the XKT are possible due to the relatively rapid drop rate (relative to the MER), necessitating shorter averaging bins that allow for greater noise levels.

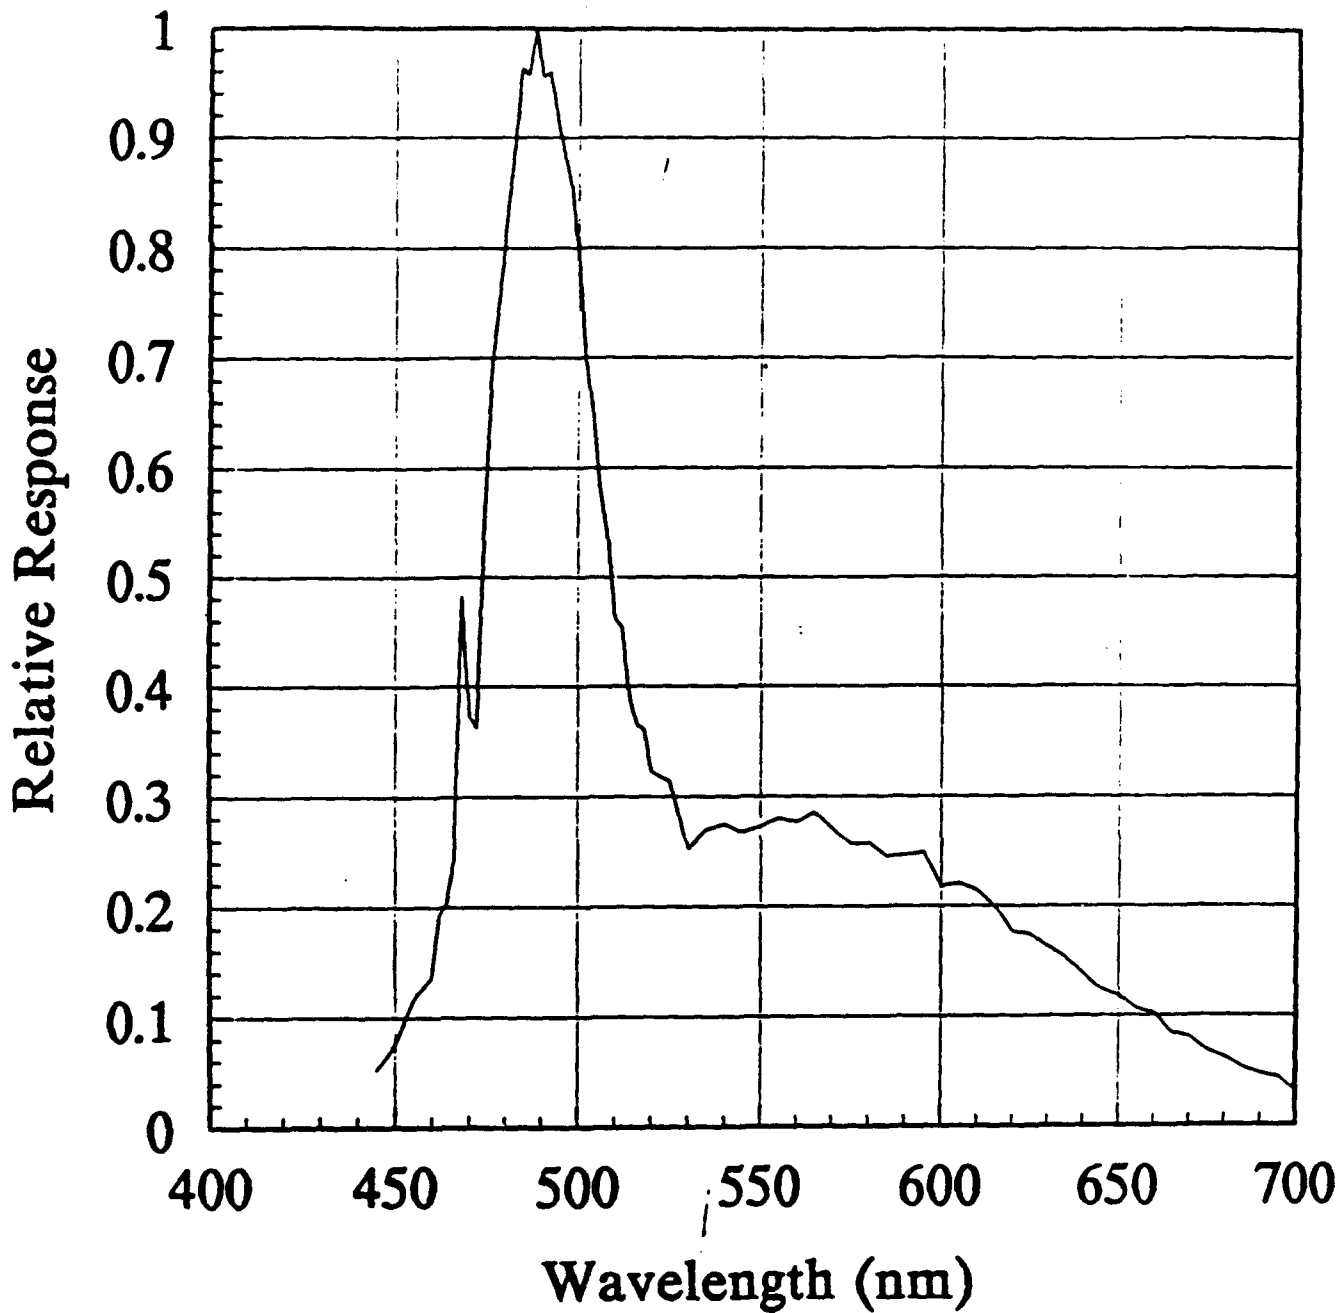
Graph 5

The probe was characterized for sensitivity versus wavelength (See graphs 5 and 6). In both cases the pass band appeared to be ± 20 nanometers (half power point). It was noted that at the longer wavelengths, (> 530 nm), the transmission of optical energy remained above 10%. This red energy could introduce some error into the signal at the near surface due to biasing because of selective attenuation of the water column. Some work will be required to identify new filters to reduce this 'red shift'.

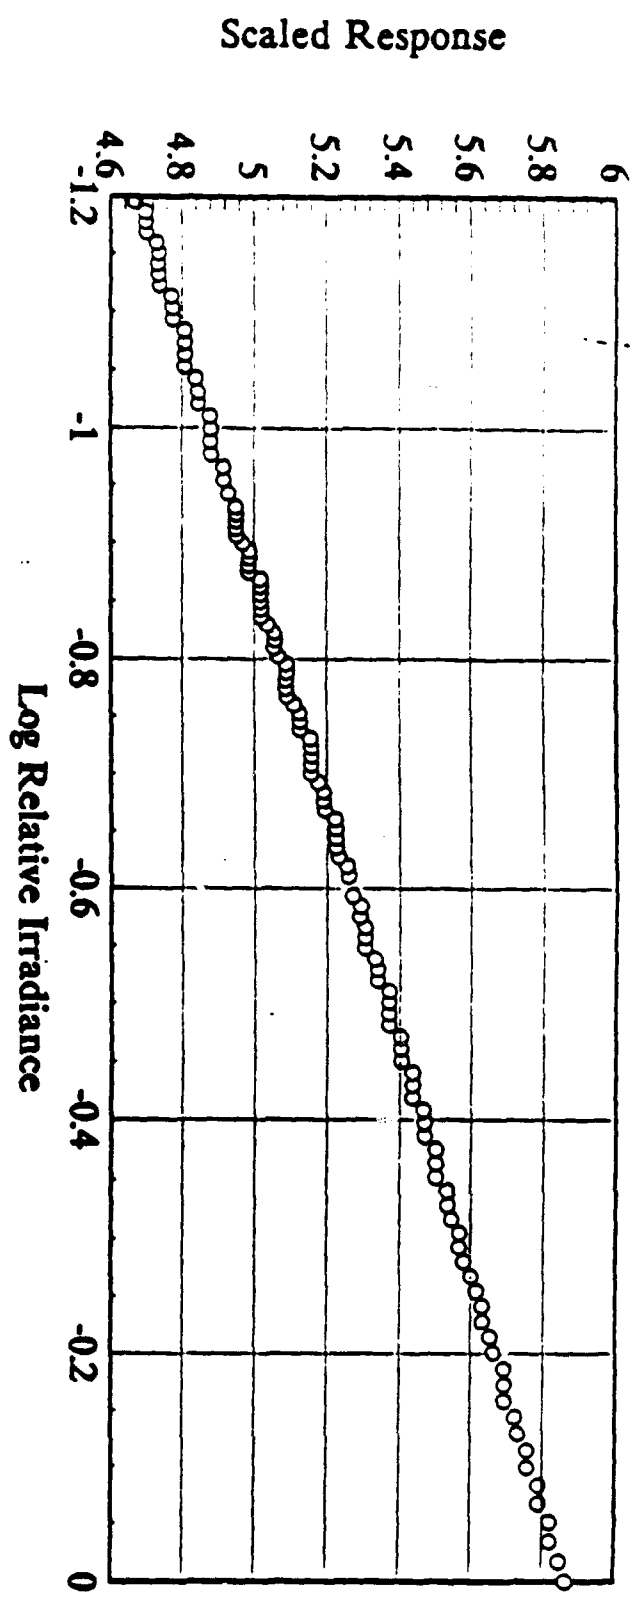
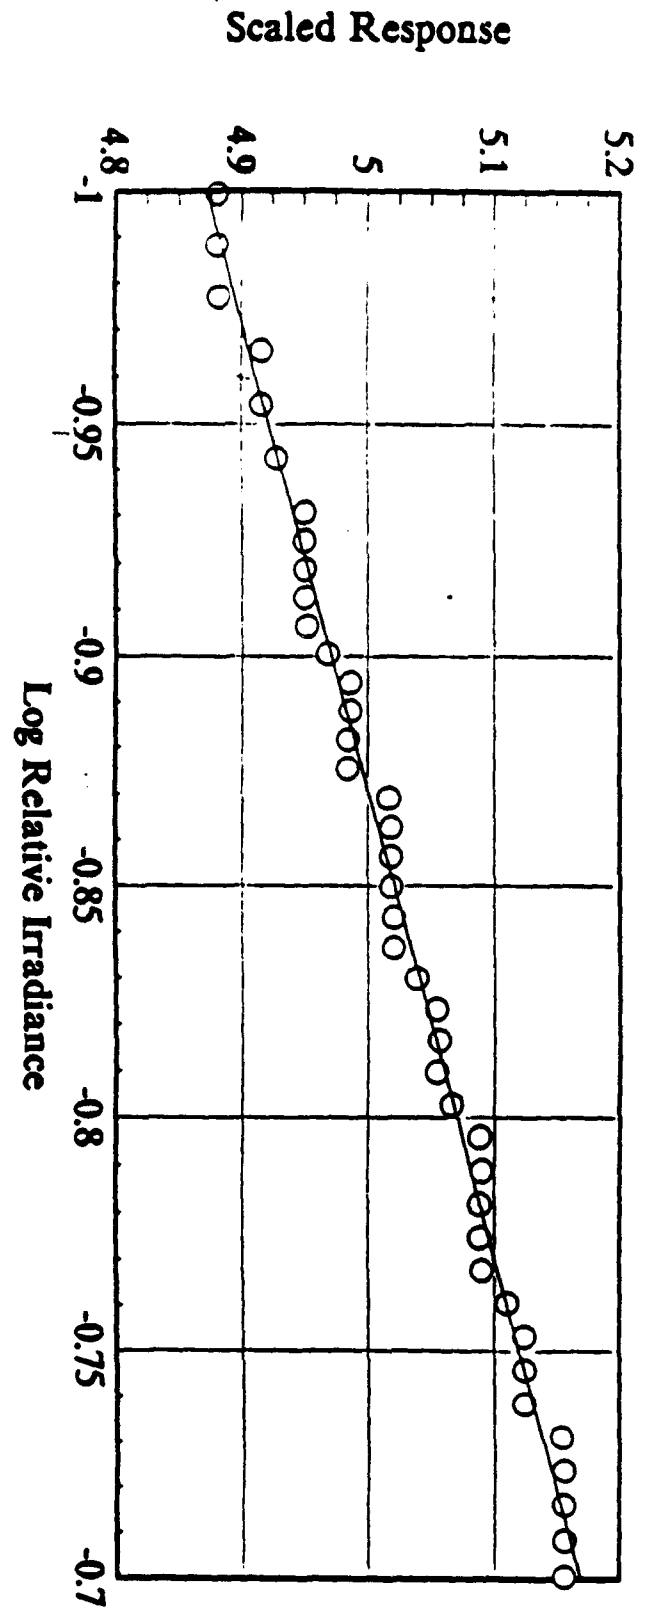
Graph 7

The 'steps' that were observed during the first two tests were verified in the laboratory with a controlled light source (Discussed later in this report). It appears that the probe electronics, particularly at the low light levels, would create an inadvertent feedback path that would lock the signal at a particular level. This level would remain until the outside illumination changed sufficiently to force the circuitry to 'step' to another level. At this point the correction to this problem is unknown. More laboratory analysis must be done to ascertain the exact conditions under which this problem appears.

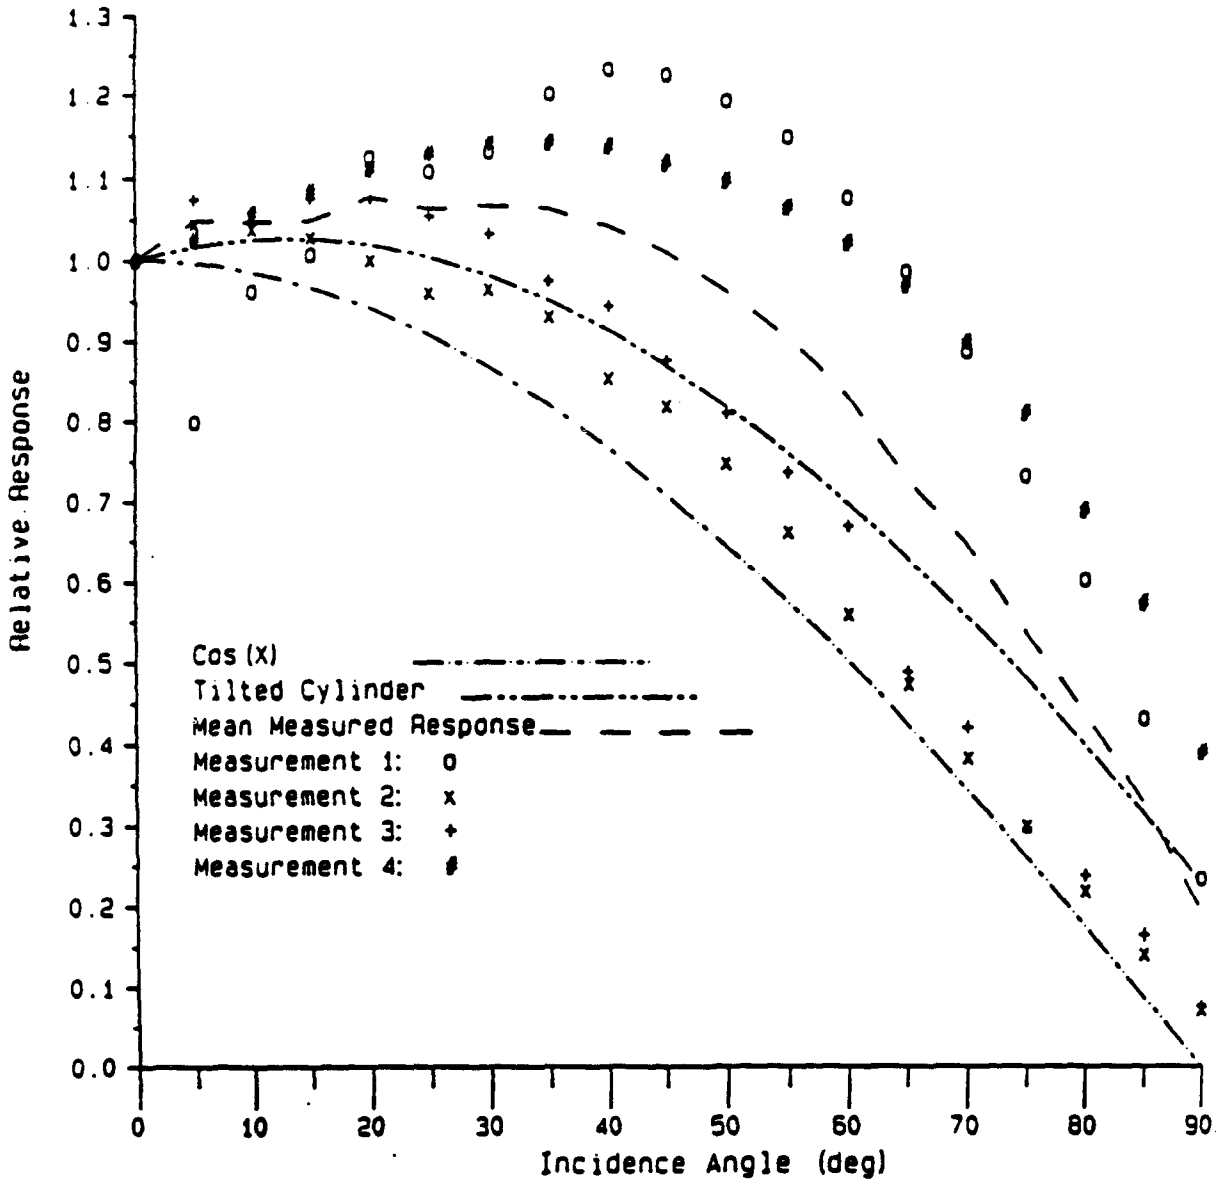
The directional response of the XKT detector was measured and compared to the ideal response of cosine weighted device. Graph 8 indicates the actual versus true cosine response of the detector assembly as a function of incident angle. As can be seen, the device has less than 10% error at the low (< 30 degrees) angles, increasing with angle until at 45 degrees, the error increases to approximately 25%. It was noted that by recessing the actual detector within the housing, a much better correlation might be expected. It is also possible that reflections off the Delrin diffuser may be skewing the response with different angles. Testing needs to be done to determine the best geometry to produce the desired response.
