CLEAN-COAL TECHNOLOGY BY-PRODUCTS USED IN A HIGHWAY EMBANKMENT STABILIZATION DEMONSTRATION PROJECT

A Thesis

The Ohio State University 1994

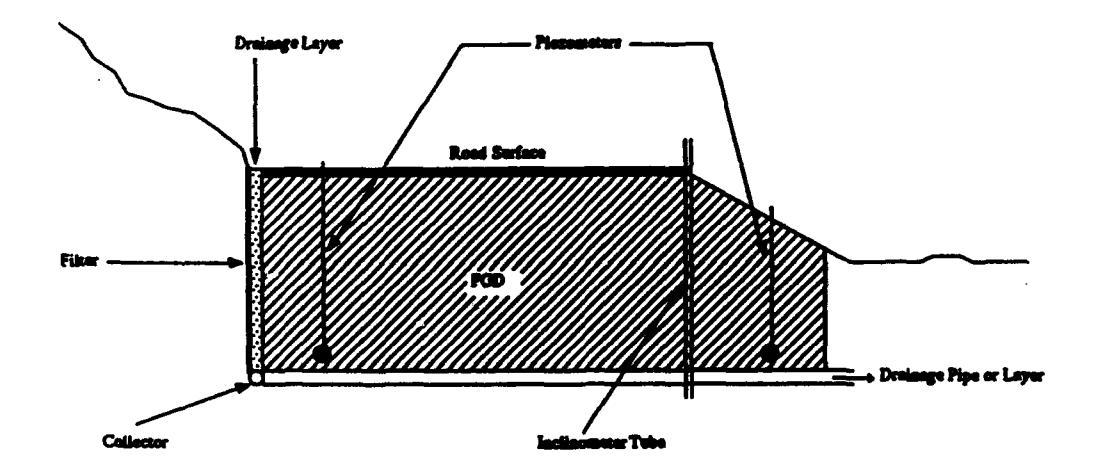
it was determined that a more substantial repair project would be undertaken. Surface conditions indicate that the current slide is rotational in nature with a scarp roughly following the centerline of the road. A subsurface investigation of the site was conducted in early September, 1993, by ODOT. Although the full results are not yet available, the base of the slide appears to be approximately 6 meters below the roadway. However, there is ample evidence that the area has experienced multiple slides in the past. This demonstration project calls for the Ohio Department of Transportation (ODOT) to excavate the natural soil above the slide plane and replace that soil with dry FGD by-products from AEP's Tidd plant. A sketch of the intended design for this site is given as Figure 1.3. The measurements made on the Tidd by-product at EORDC clearly show that when compacted, this material reaches a very high strength and would therefore be a suitable material for stabilizing this slide.

Figure 1.3: SR 83 Cross-Section.

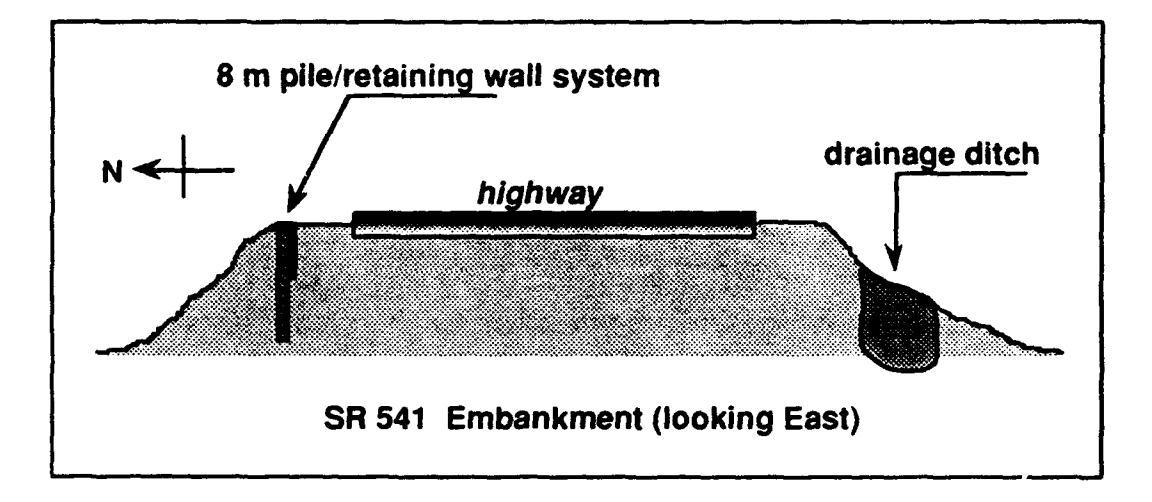
Figure 2.2. SR 541, 1986 ODOT Repair.

There is very little repair history for this section of roadway for the first 20 years after construction was completed. In 1985, road surface settlement was noticed around Station 55+00. The road settlement became progressively worse and was accompanied by some indications of a rotational slide. Reportedly, the base of the embankment was covered with small traverse ridges and there was evidence of soil upheaval. In 1986, an ODOT repair team attempted to correct the problem and prevent any further deterioration by digging a 4 meter deep trench at the top of the slope for a distance of approximately 25 meters and driving a series of 8 meter piles. Next, sections of guardrail were attached to the piles that effectively created a 25 meter long, 4 meter wide retaining wall. The trench was then backfilled and the highway surface repaired. Another trench was excavated on the south side of the roadway and a drain was installed to intercept surface and subsurface flow associated with the adjacent hillside. Figure 2.2 depicts that repair effort. The repair seemed to work and nothing further was done to this section of highway for the next three years.

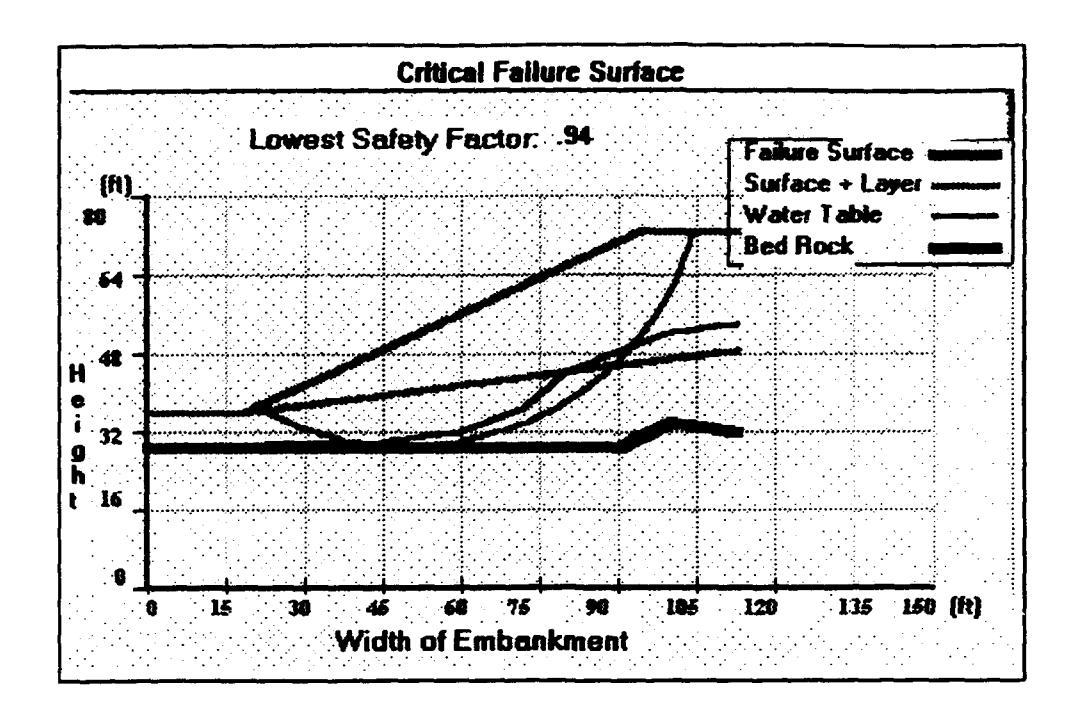
Figure 3.2 depicts the original embankment and the most critical failure surface. It shows a rotational failure starting approximately 2 meters from the edge of the highway and terminating near the toe of the slope. The failure surface is a circular arc that passes through the embankment material and natural soil, tangent to the underlying bedrock. The calculated factor of safety associated with this slope is approximately 0.95.

Figure 3.2. SR 541 Embankment, Original Profile, Critical Slip Plane.

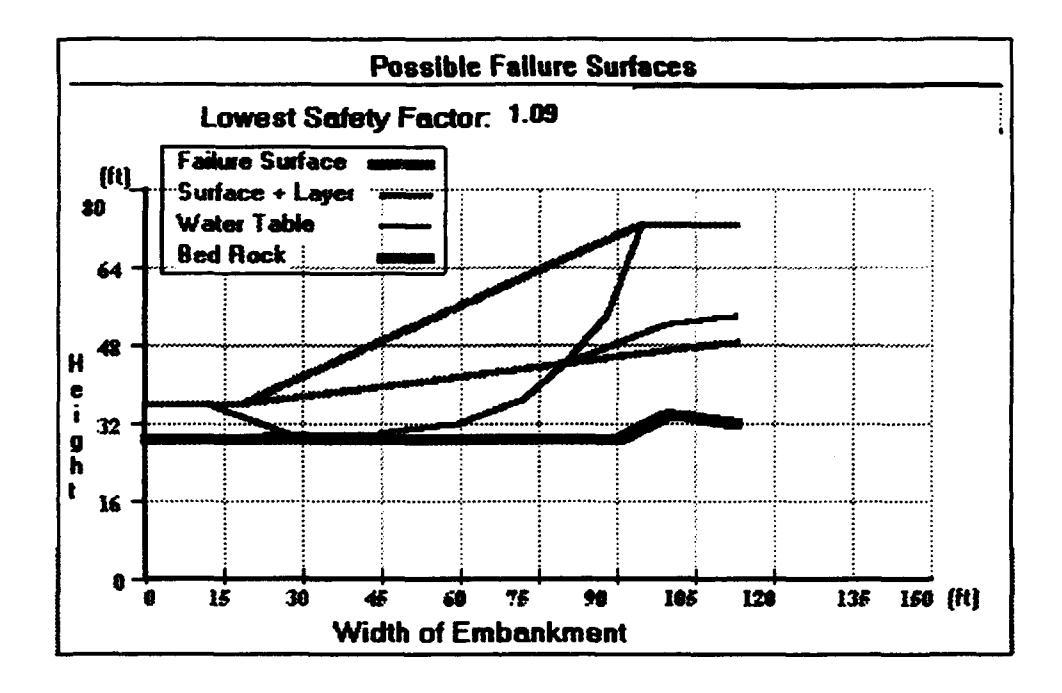
the failure plane and the elevation of the water table. Given the variable nature of soil and the possible alternate locations for the water table, the author feels the results match well. It may be inferred that the two failure surfaces are nearly identical, as is the difference in the calculated factors of safety (0.95 v. 1.1).

Figure 3.3. SR 541 Embankment, Original Profile, Actual Slip Plane.

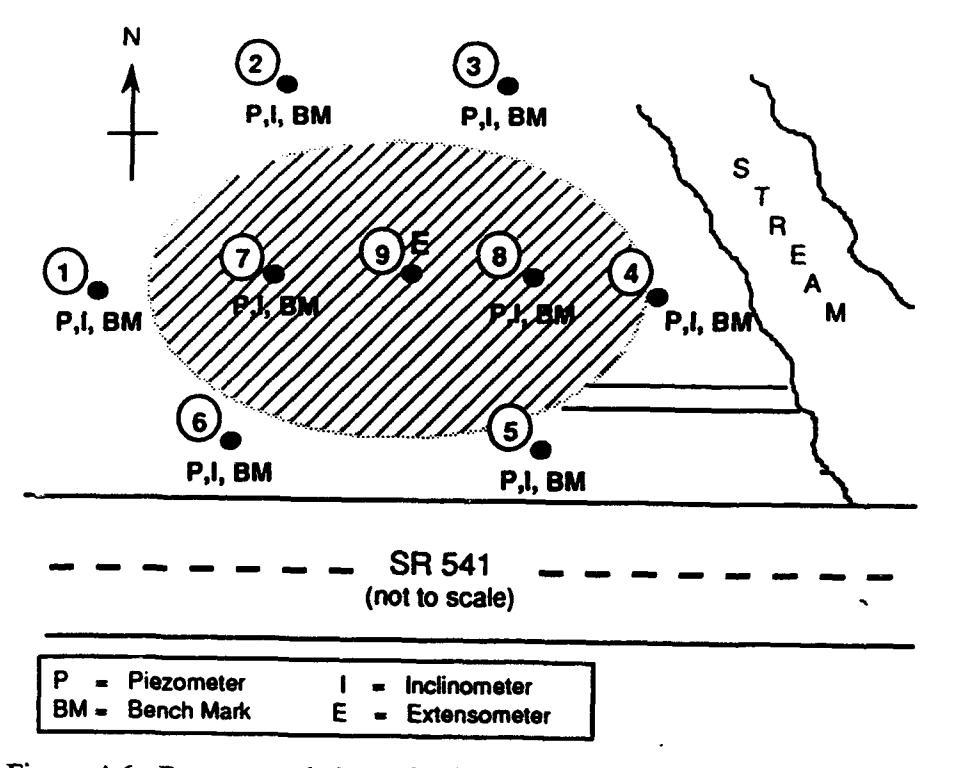
Figure 4.6. Recommended Monitoring of SR 541 Embankment.

either increases or decreases. The importance of proper geotechnical instrumentation for monitoring the movement of this embankment is obvious. The question is not whether it should be done, but rather who will fund it and who will actually instrument the embankment. Several methods of instrumentation and monitoring are outlined herein, but full texts exist that offer comprehensive guidance into the field (i.e. Dunnicliff, 1988).
