USACERL Technical Report 95/02 May 1995

Thermal Energy Supply Optimization for Aberdeen Proving Ground-Edgewood Area

Distribution System Condition Assessment and Recommendations

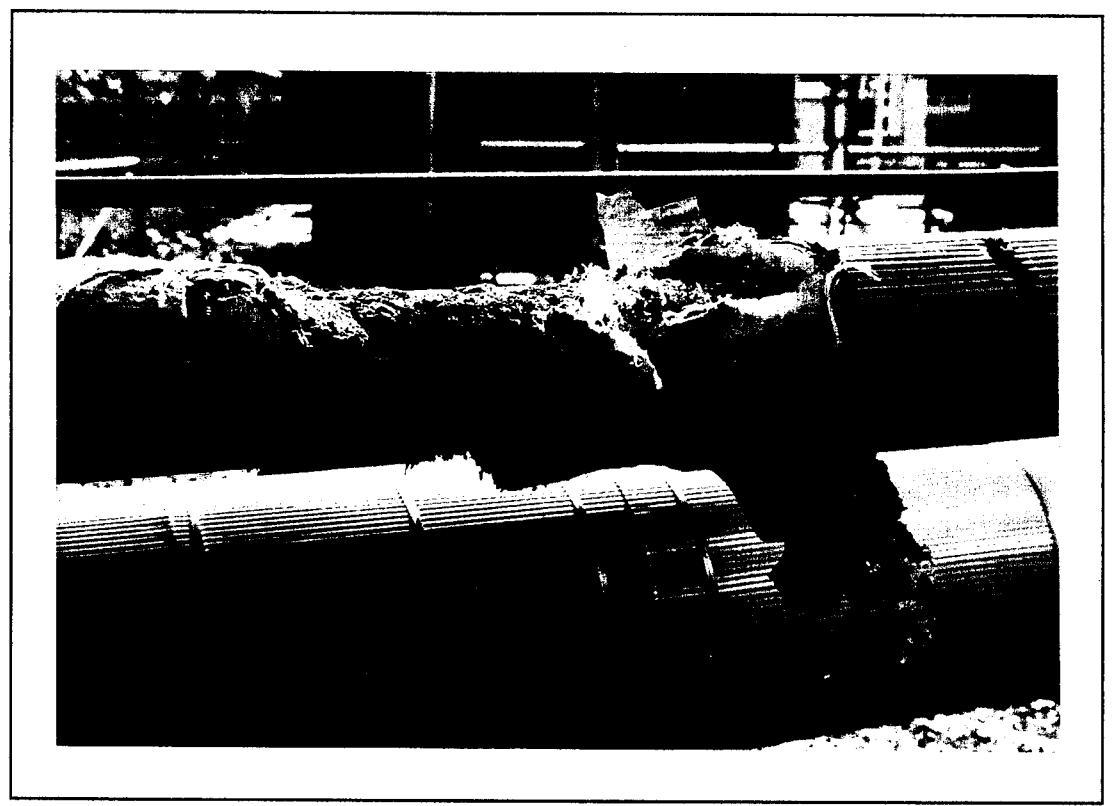
Figure 1. Deteriorated insulation on section 3312-37A near Bldg E3370.

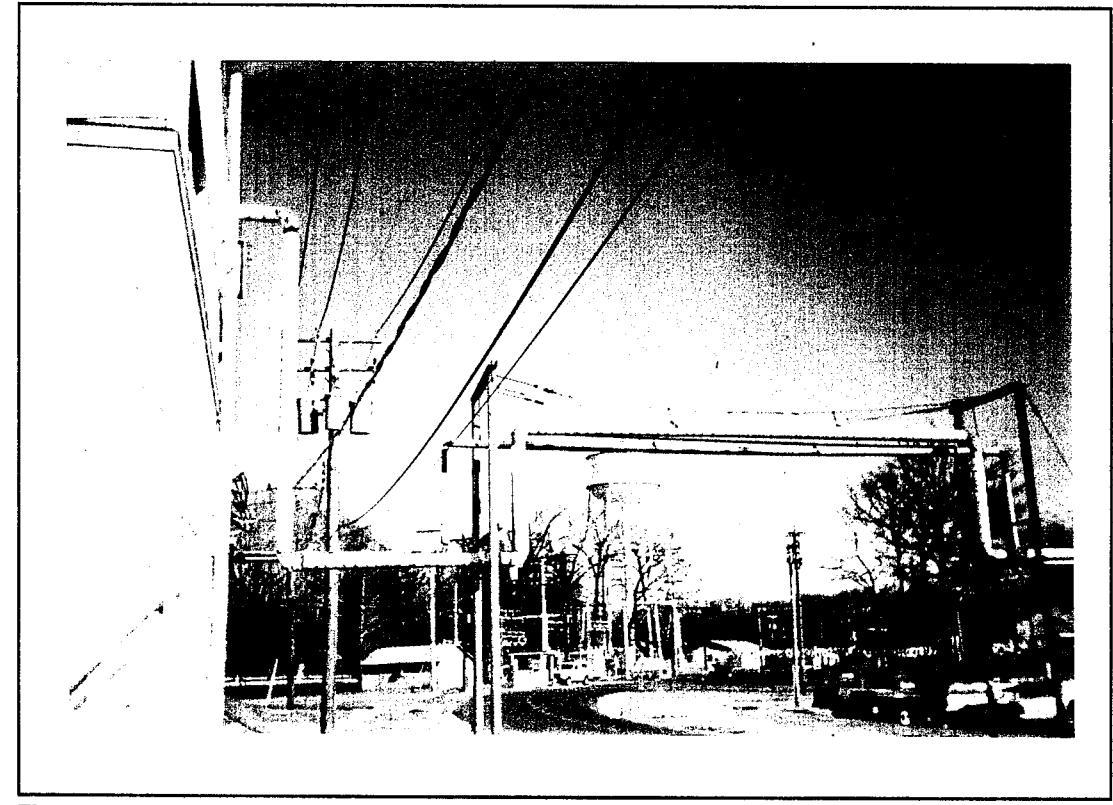
An estimated 2,000 ft of aboveground piping, ranging from 2 to 6 in. in diameter, was found to be without insulation. In addition, there are numerous sections (such as that shown in Figure 1) where insulation and insulation covering are damaged. Missing insulation is particularly a problem at pipe elbows. Figure 2 shows an example of this.

Figure 2. Typical example of missing insulation on pipe elbows near Bldg E3312.

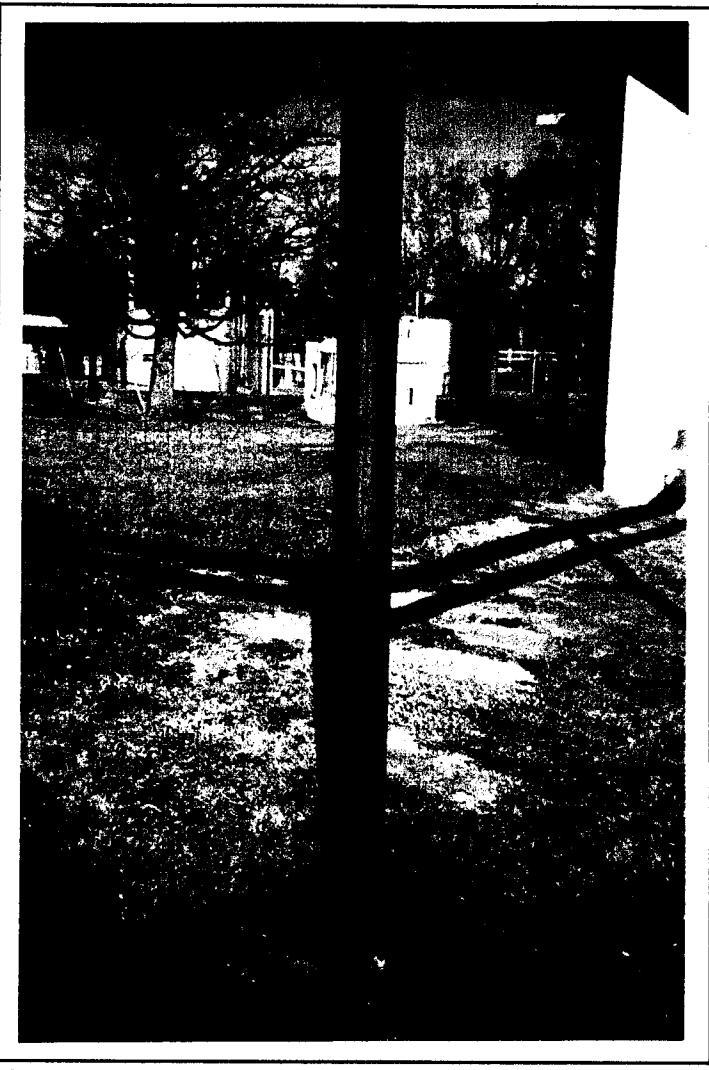
Many of the metal support poles are in need of recoating. Figure 3 shows a typical example of deteriorated coating on support poles. An important issue here is the possible presence of lead-based paint. Testing on one of the poles supporting the aboveground piping indicated the presence of lead. One test does not provide enough

Figure 3. Typical example of deteriorated coating on support pole near Bidg E3312.

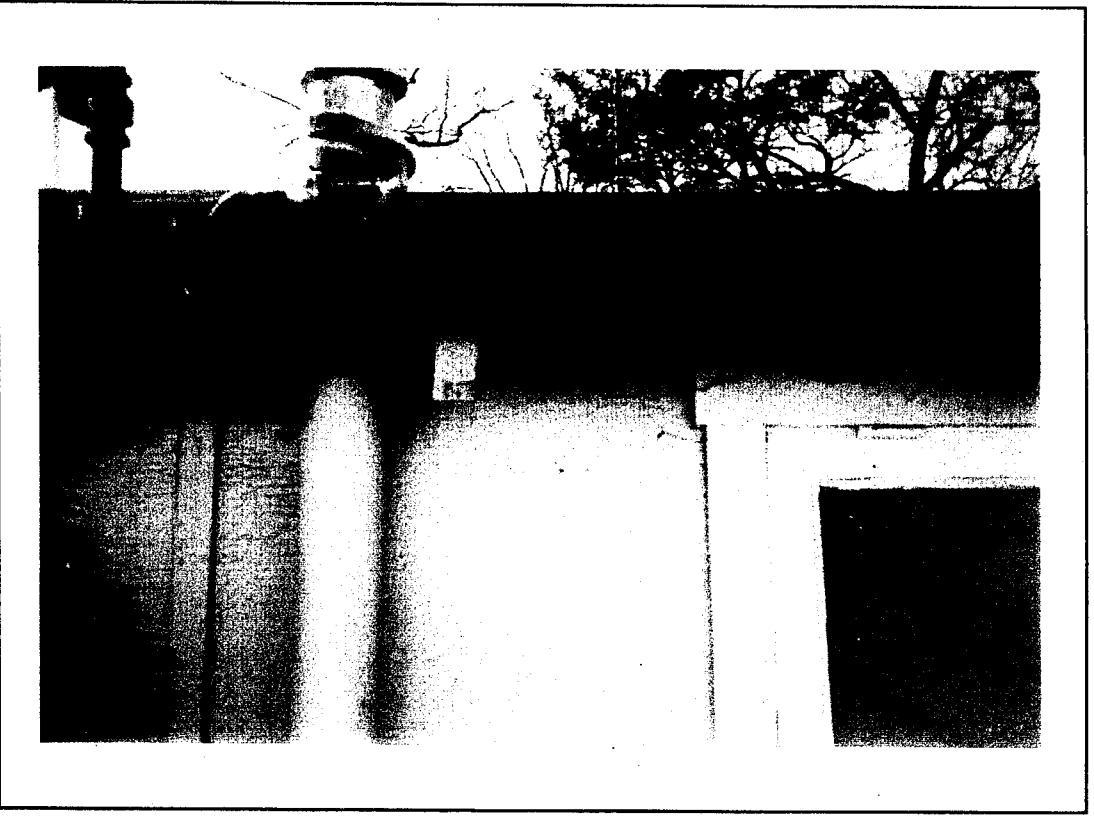
supports on the low profile aboveground lines were damaged and did not function as designed. Other locations were observed where "substitute" supports had been used. Figure 4 shows a location where a cloth strap was used to support a pipe. This practice should be discontinued. Figure 5 shows an example of a pipe that was not resting properly on support rollers. As noted above for piping anchors, this deficiency can result in unacceptable stresses and possible pipe or fitting damage.

Figure 4. Improper pipe support at Bidg TE3613.

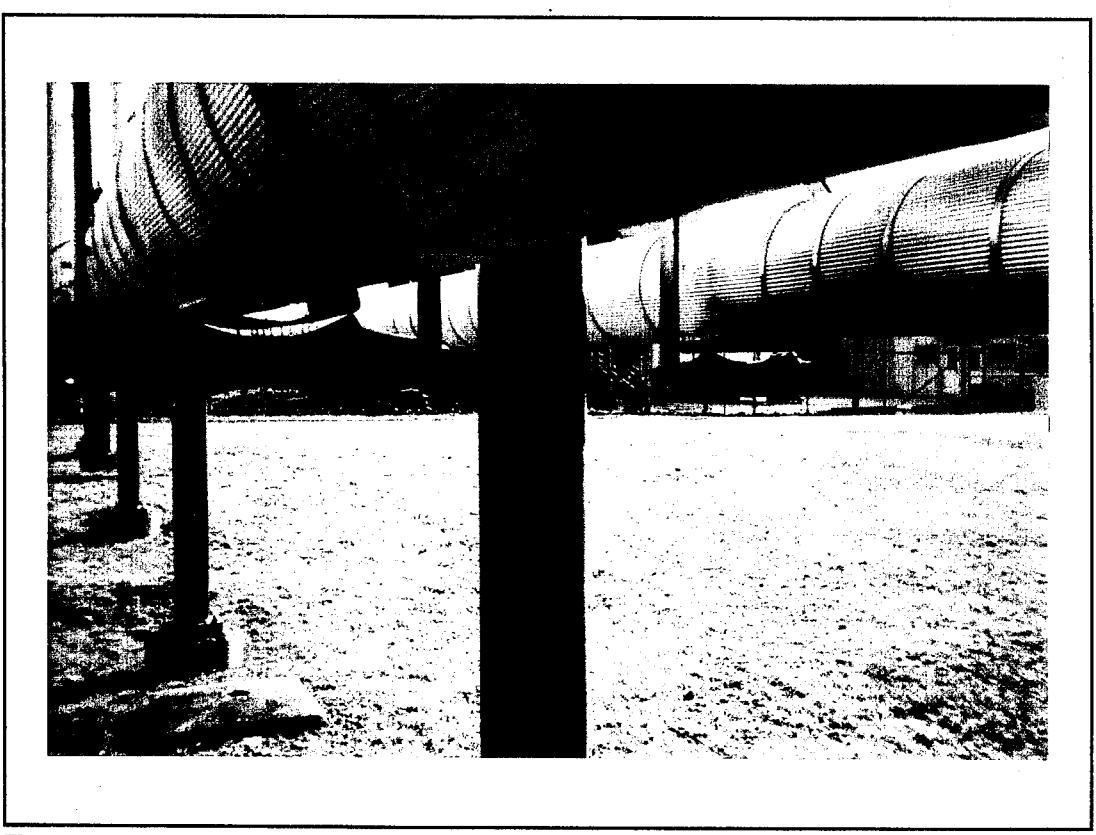
Figure 5. Typical example of pipe not resting properly on support rollers on line to Bldg E3570.

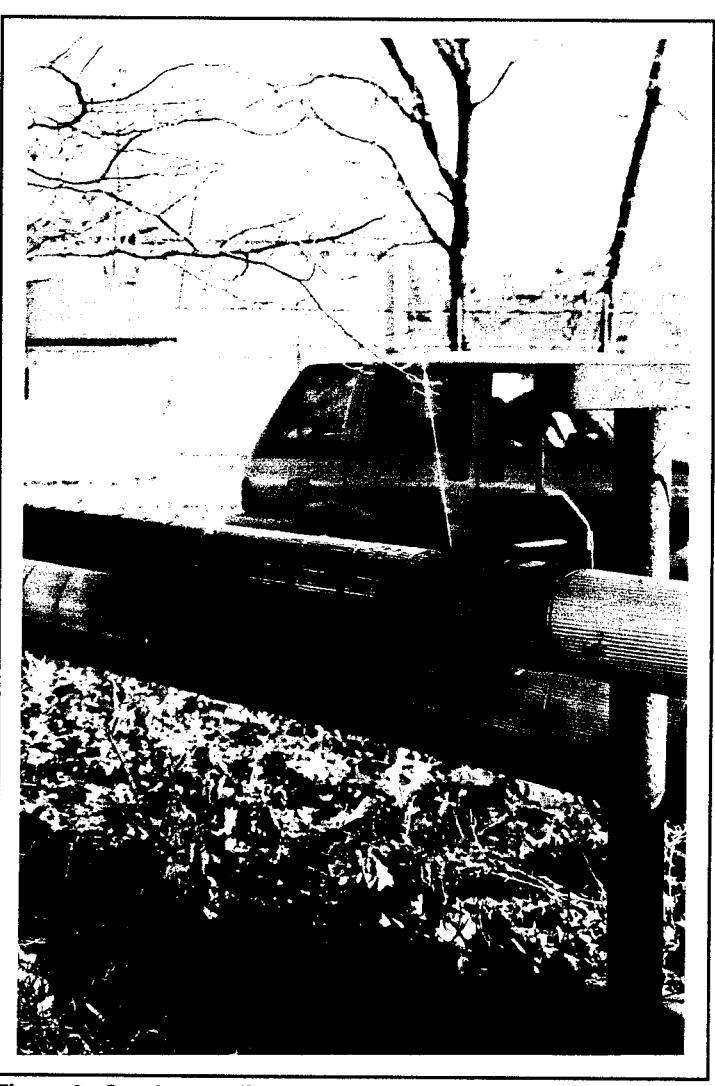
from the outside. This observation was supported by the fact that most leaks were on the top area of the pipe. If corrosion was being caused by the condensate acting from the inside, most of the leaks would appear along the bottom of the pipe. Most likely, the severe corrosion along this section is due to wet insulation at the pipe surface. The steam lines were in fair condition. In addition, there was excessive vegetation, including several trees, growing between the steam and condensate line (Figure 7). This vegetation should be removed. Areas of missing insulation were also observed (Figure 8).

Figure 6. Condensate line leak near Bldg E3607.

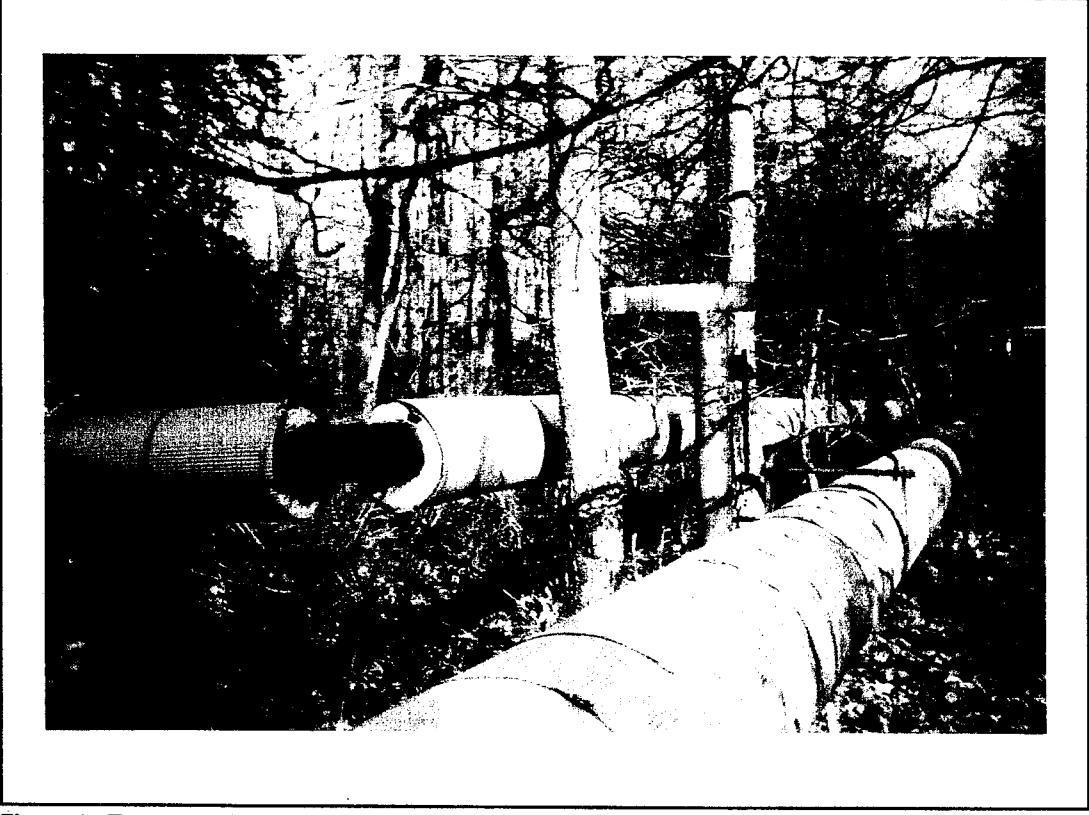
Figure 8. Trees growing between lines and missing insulation on pipe elbows on Section 3312-37A.

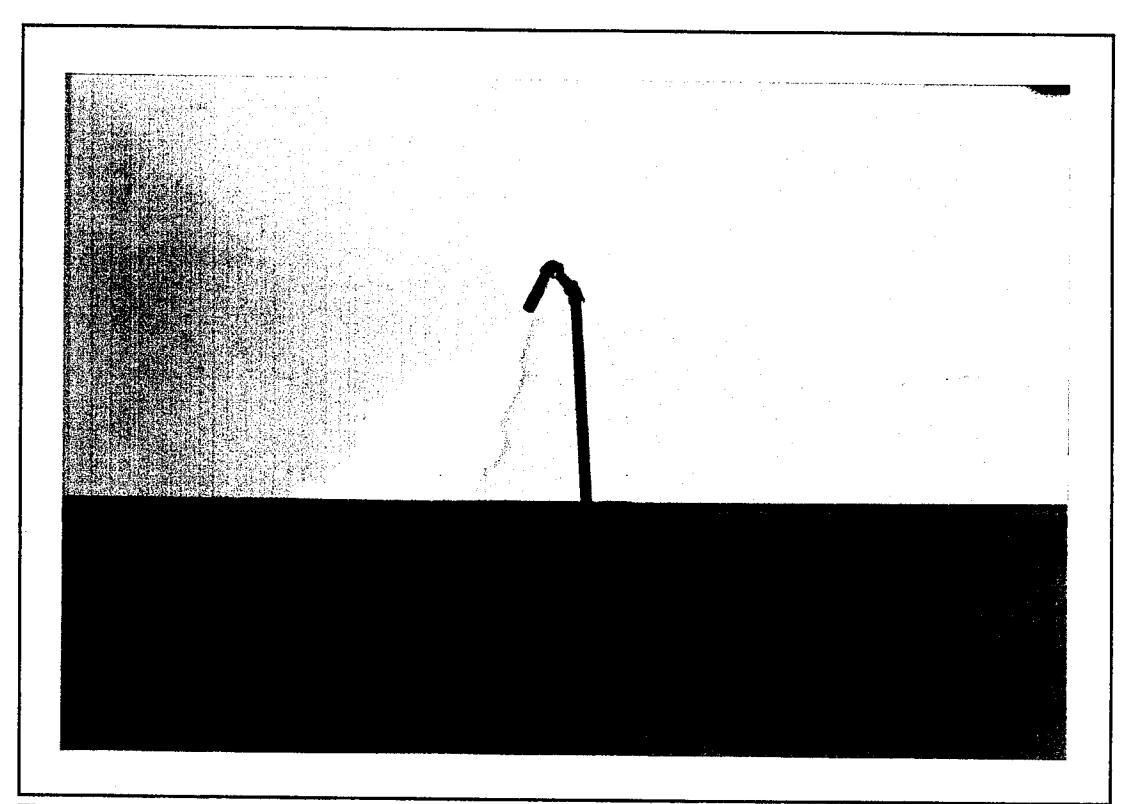
In some instances it was found that condensate was being dumped rather than being returned to the boiler plant. This practice, when combined with trap failure (Figure 9), dramatically reduces system efficiency. The extra costs

Figure 9. Failed steam trap at Bldg E3516, reportedly replaced 3 years ago.

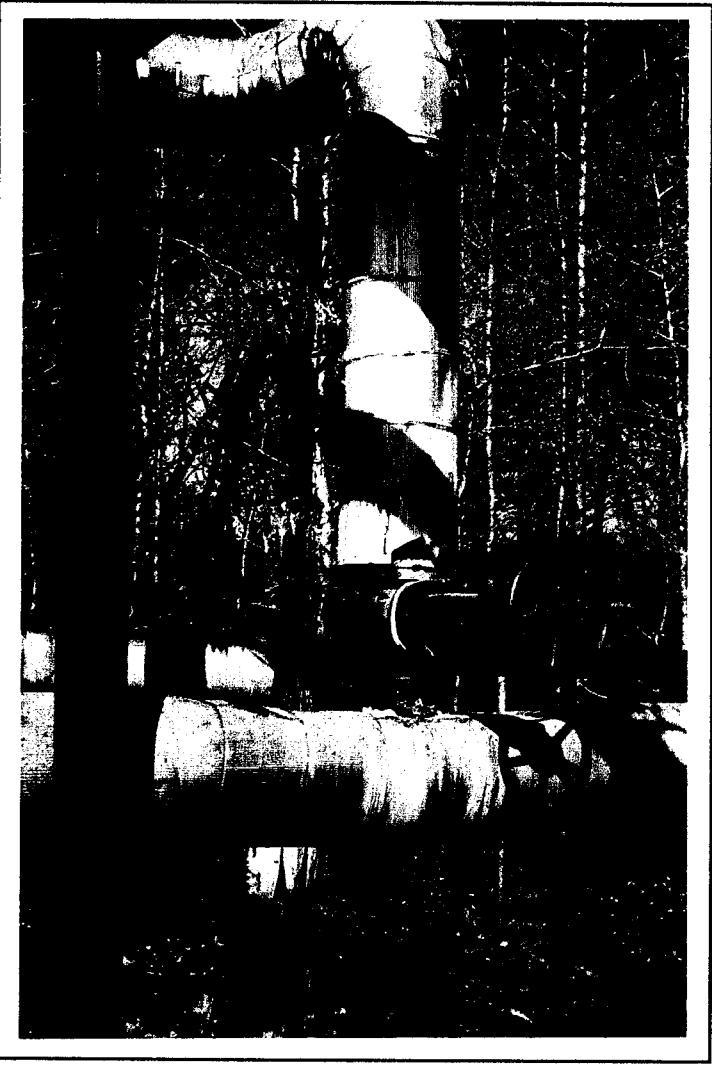
Other defects observed were leaking flange gaskets (Figure 10) and leaking valve packing (Figure 11). These defects also cause significant heat loss. Figure 12 shows a condensate tank resting directly on the ground. Contact with the soil will accelerate the failure of this tank due to corrosion. In addition, Figure 12 shows a typical case of missing pipe insulation.

Figure 10. Leaking flange gasket at junction between old and new system near 3300 area.

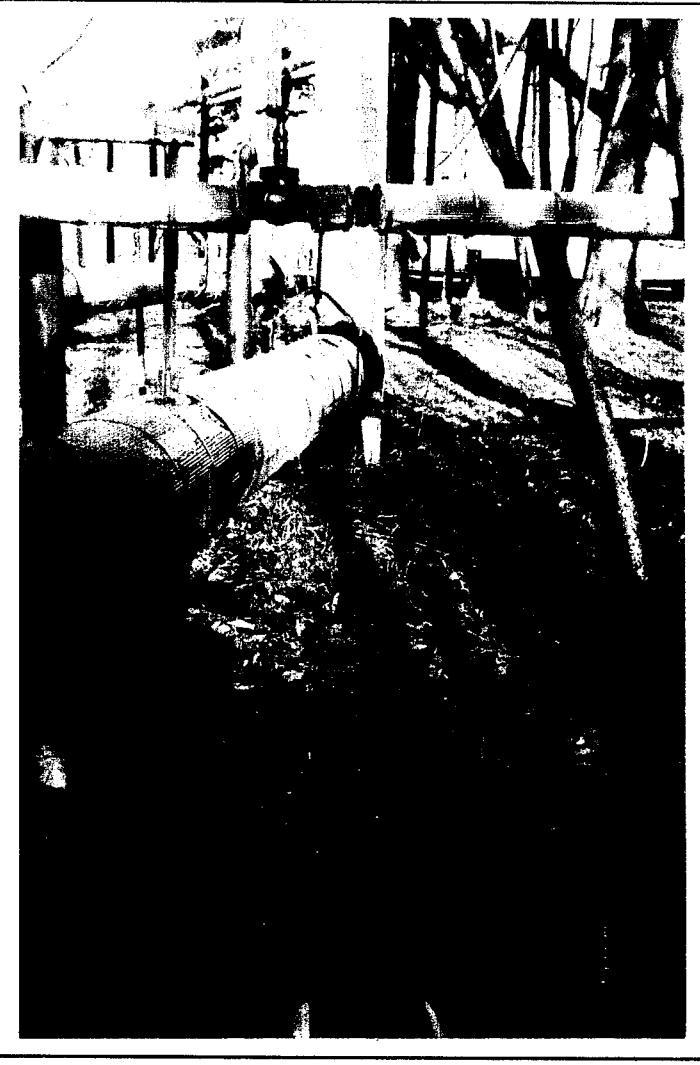
Figure 11. Leaking valve packing on 2 in. return line from Bldg E3580.

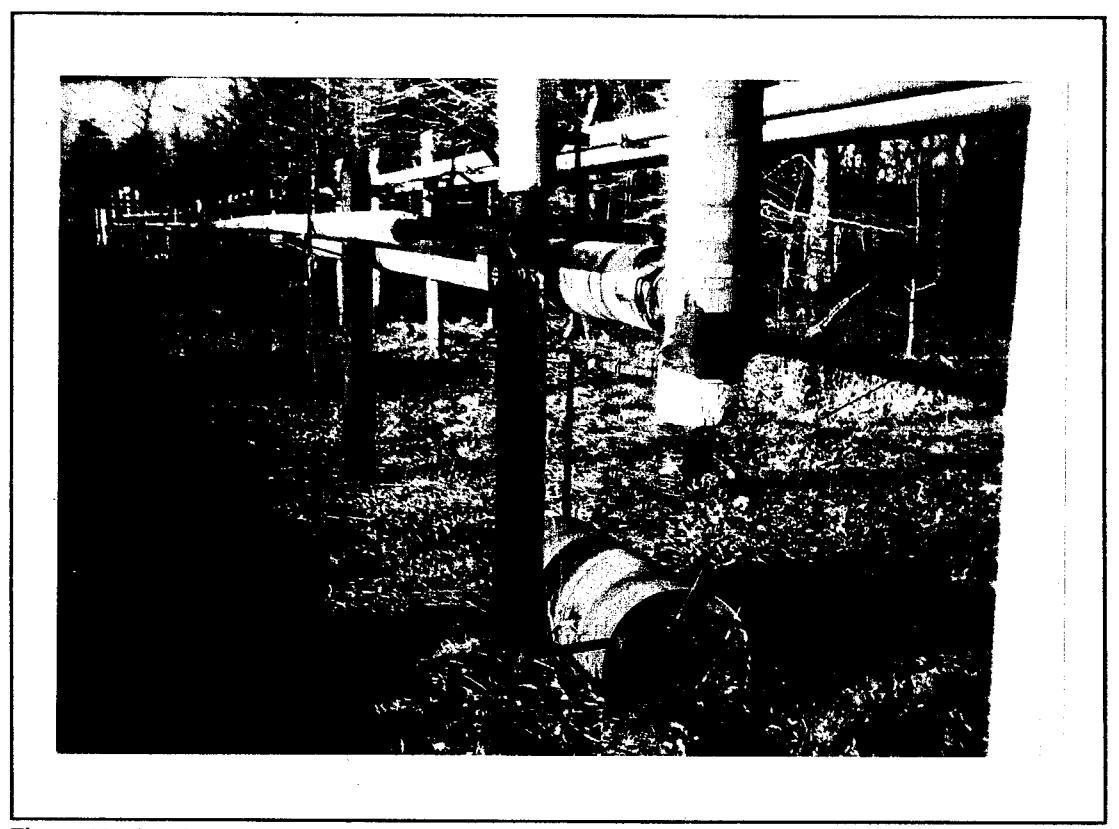
Figure 12. Condensate tank resting on the ground near Quanset huts in 3000 area, with insulation missing from pipe.

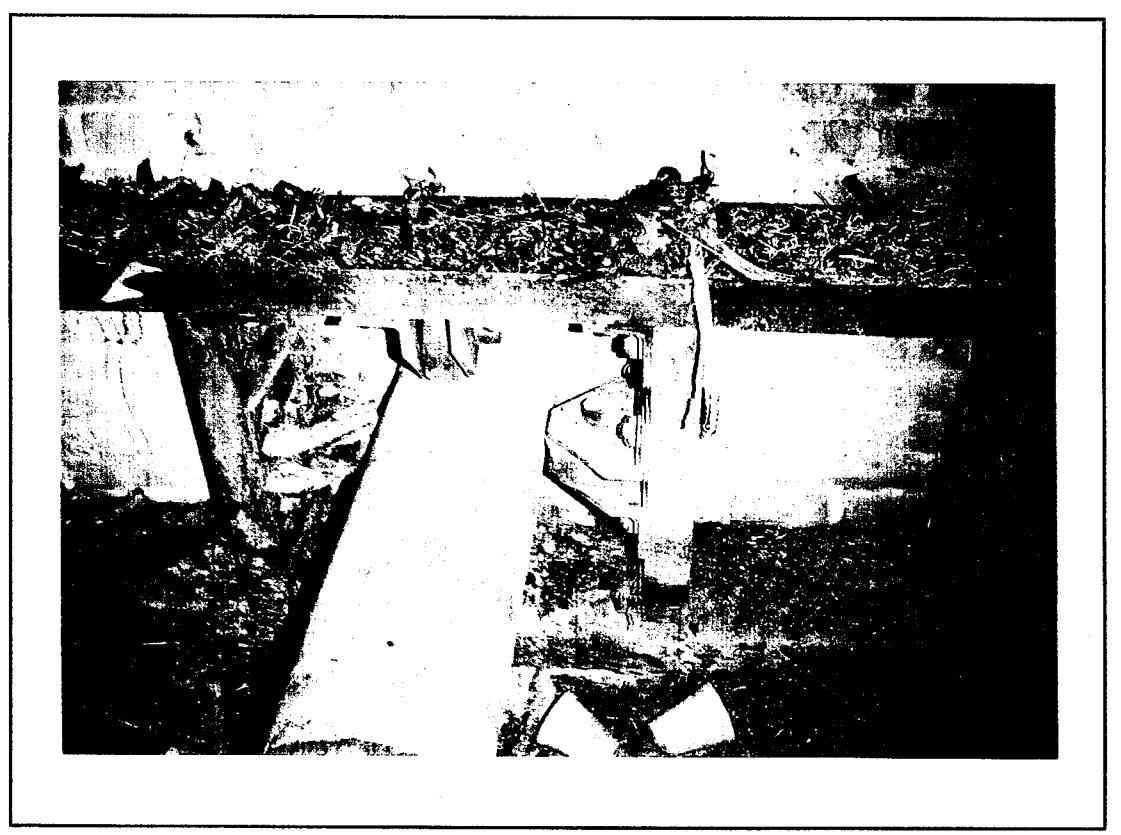
Many of the screens on the manhole tops are missing and should be replaced to prevent the manholes from collecting debris. Figure 13 shows an example of a manhole containing excessive debris. Such debris can prevent or severely impede the drainage of water from the manhole.

Figure 13. Typical example of excessive debris in manhole (no. 5320).

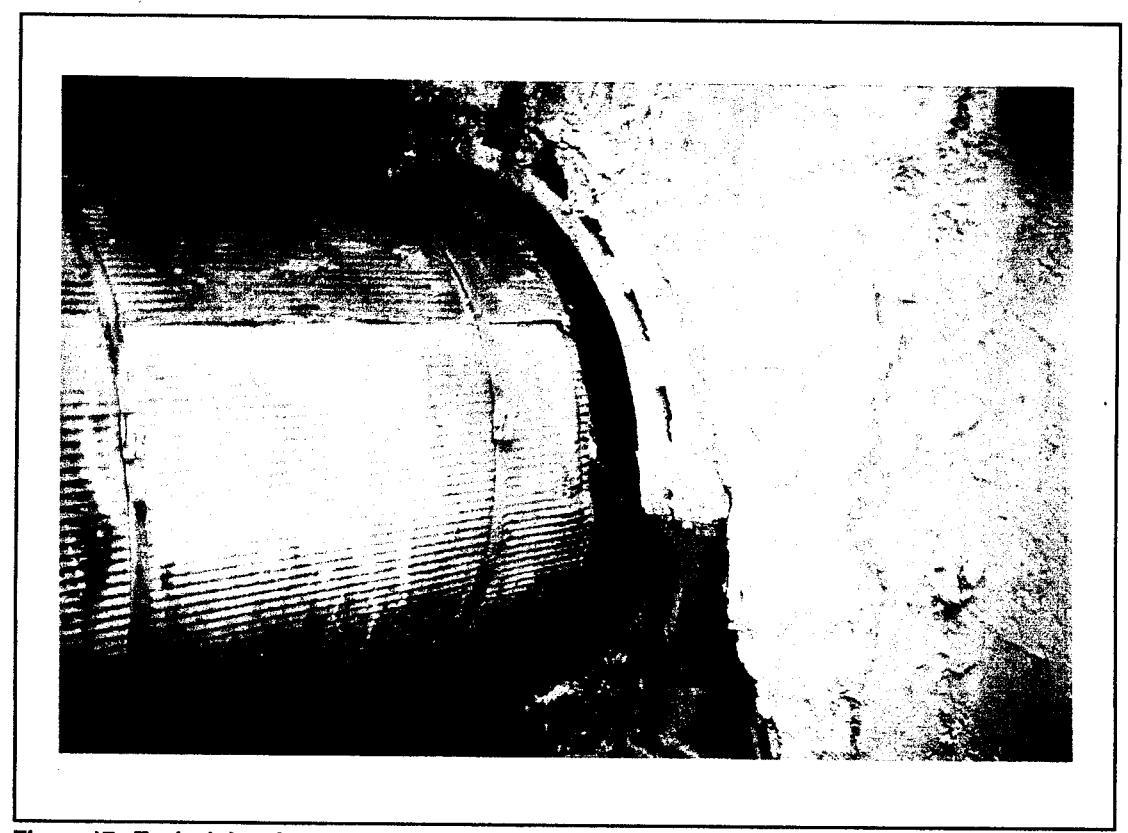
Manhole wall penetrations involved the extension of conduits through slightly oversized holes that were caulked and cemented at the interior surface of the walls. Most of the caulking at conduit wall penetrations was dried and deteriorated. Figure 17 shows a severely deteriorated manhole penetration. The caulking could not prevent groundwater infiltration into the manhole. This problem may contribute significantly to the flooding problem discussed in the previous paragraph. Also note the severe corrosion of the pipe entering the ground in Figure 17. In this example there was no evidence of the current practice, which is to use a metallic wall sleeve with a flange water stop and link seals to prevent water entry. Another problem that was frequently observed was old manhole penetrations that had not been properly sealed (Figure 18). Improper sealing provides another route for groundwater infiltration into the manhole.

Figure 17. Typical deteriorated manhole wall penetration (no. 5100), with corrosion on pipe entering the ground.

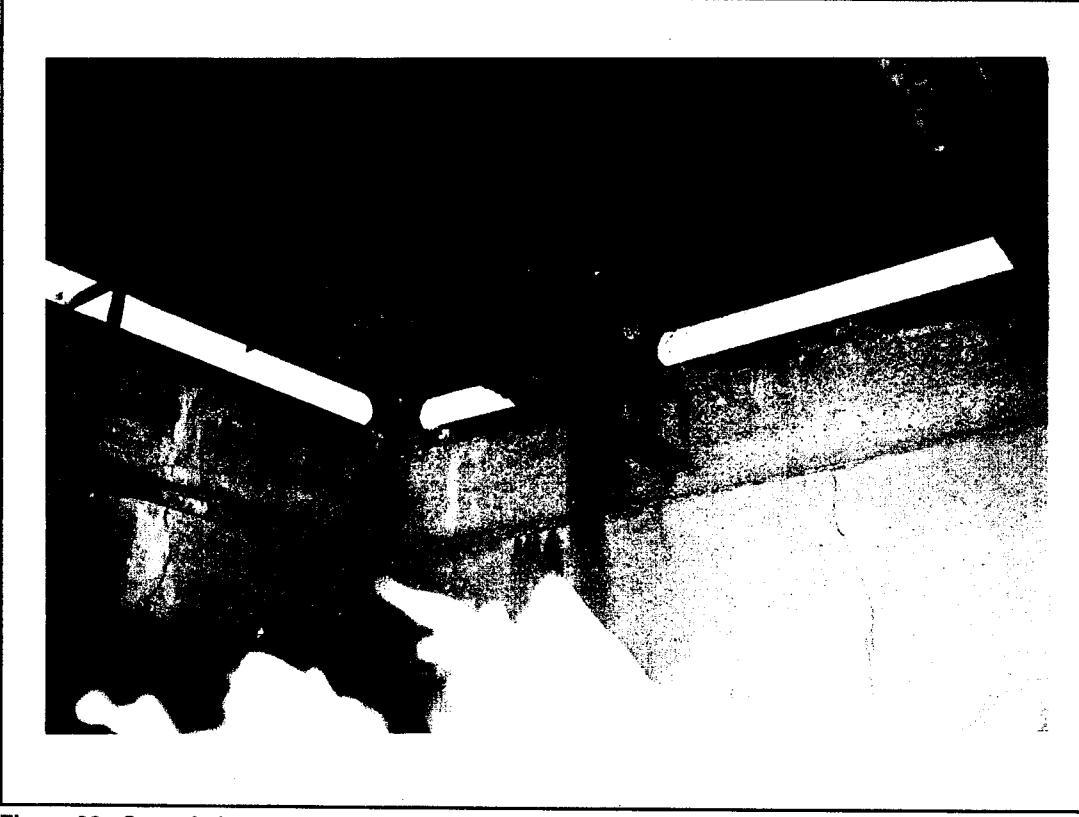
Steel beams supporting manhole walls were heavily pitted and corroded (Figure 19), as are the inner surfaces of the steel plates on the manhole tops. Manhole walls are also deteriorating, with excessive spalling and cracking evident (Figure 20). These conditions may present a future safety problem.

Figure 20. Corroded manhole support beams and cracking of manhole walls in manhole 4040.

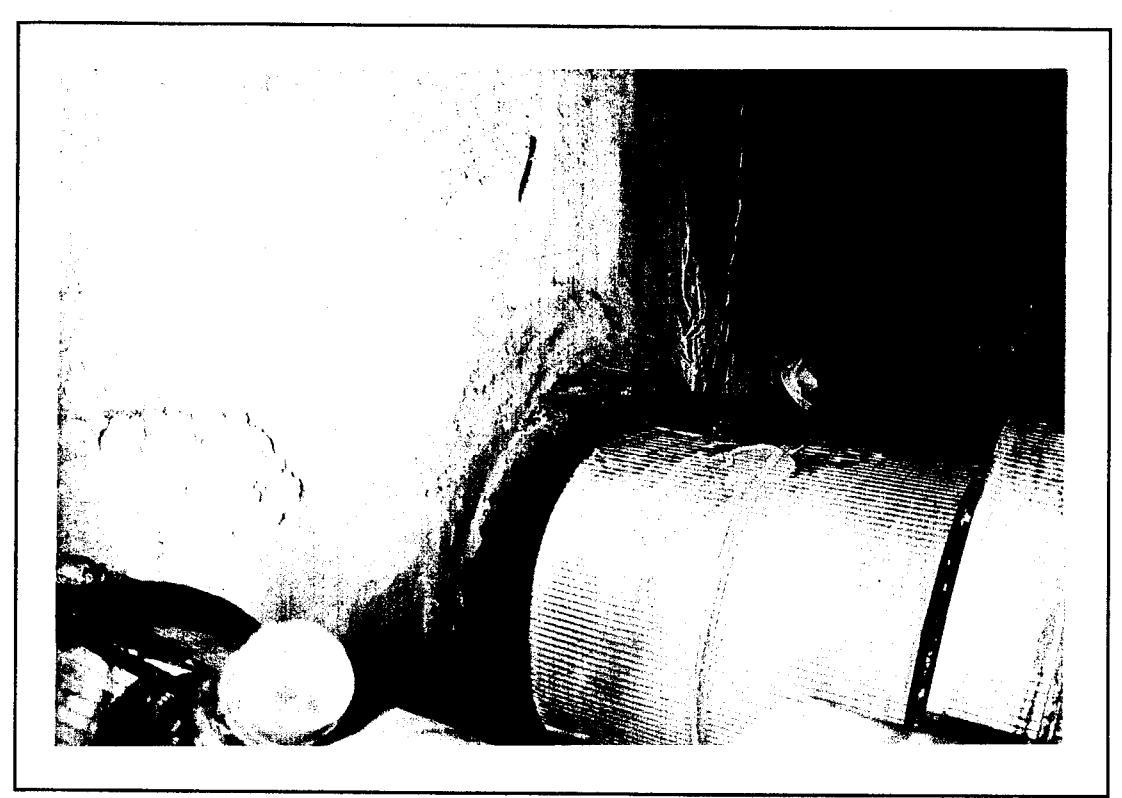
Figure 21. Plugged vents in manhole no. 4040.
