New Generation Runway Visual Range (RVR) Final Operational Test and Evaluation Report: Volume III

July 1996

DOT/FAA/CT-TN95/32-III

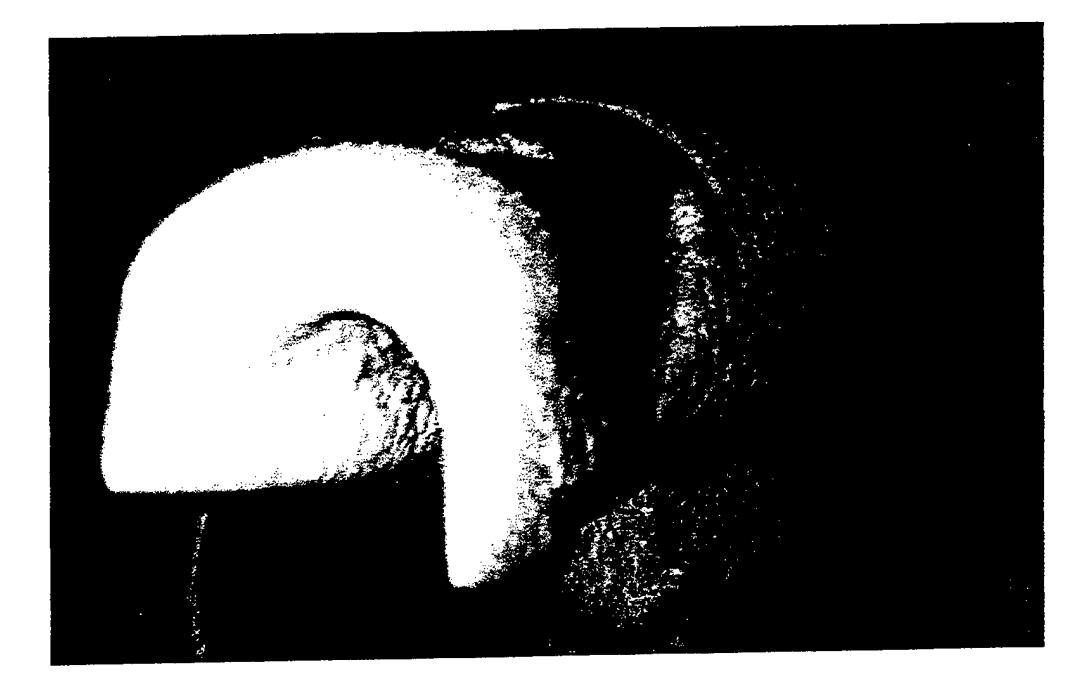
It was noted during the events, that snow accumulated on unheated areas on the underside of the sensor hood (e.g., ref. photo 2). Additionally, snow clogging occurred on the sensor window. Because the sensor uses forward scatter technology, light impediments (e.g. VS clogging) to the scatter volume can result in higher than actual RVR readings.

PHOTO 2. VISIBILITY SENSOR SNOW CLOGGING

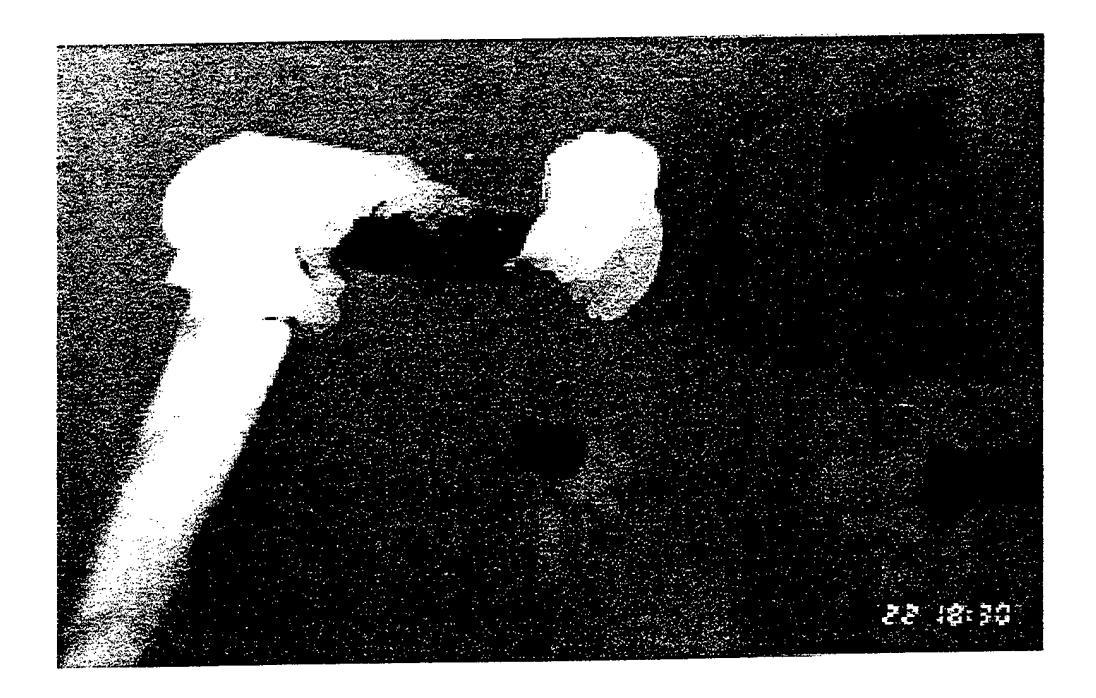
PHOTO 5. ICE CONGLOMERATE FORMATION

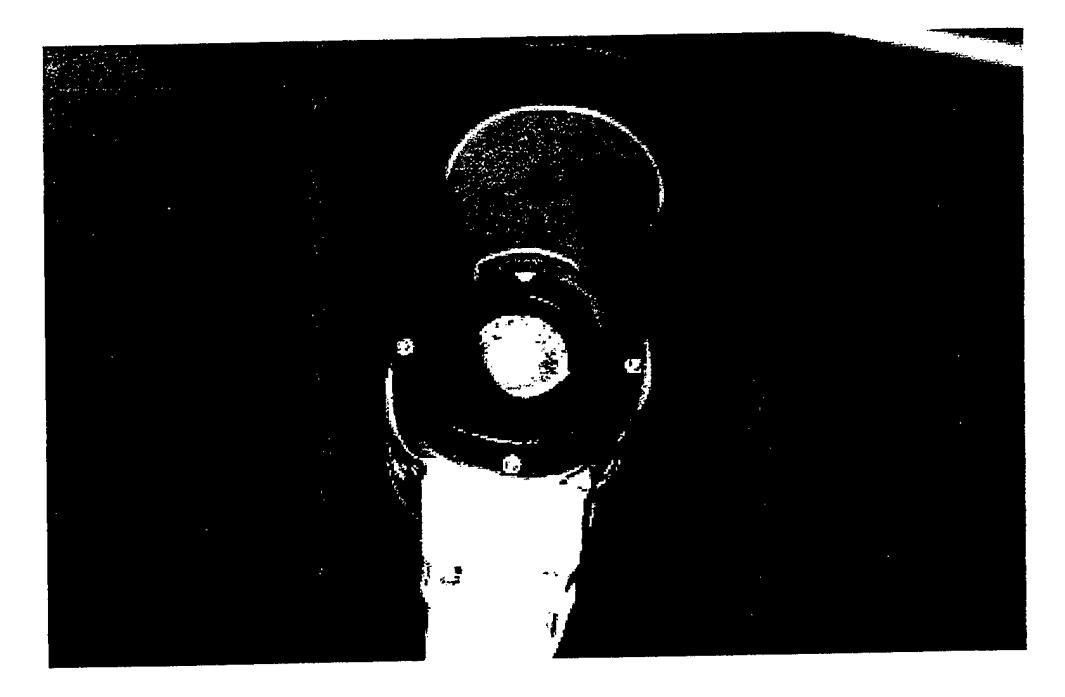
PHOTO 6. LOOK-DOWN VS SNOW CLOG "THIN" AT CENTER

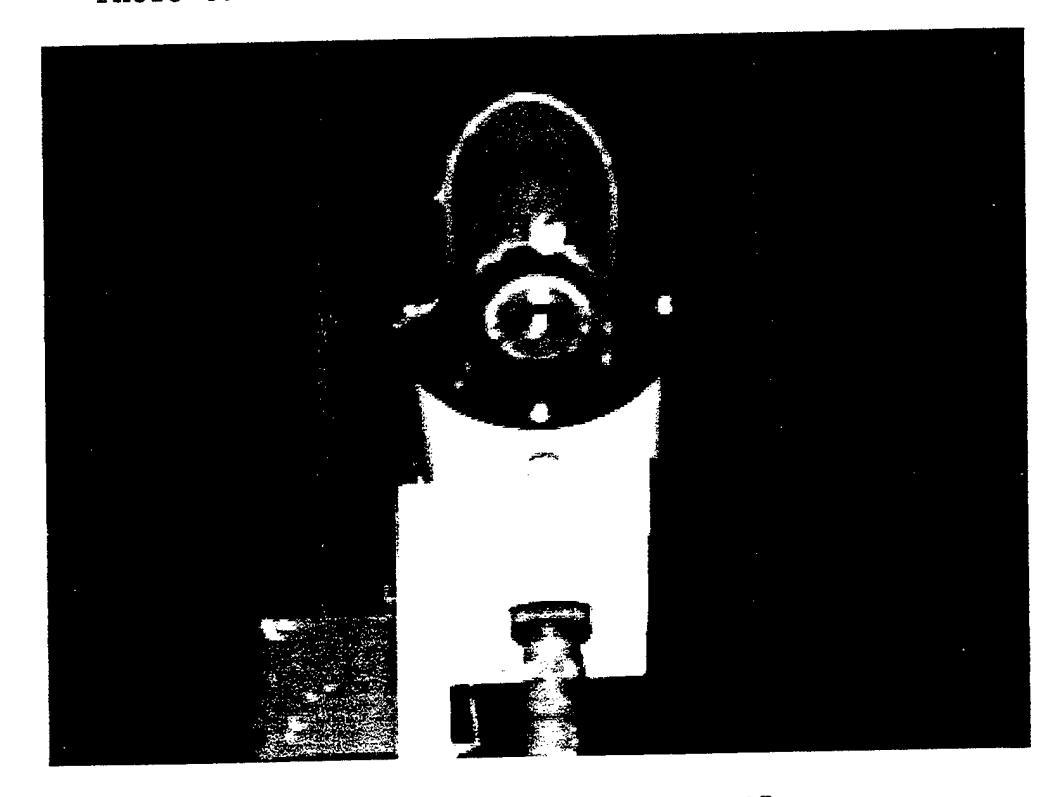
PHOTO 7. ALS "DONUT CLOG"
