Feasibility (Section 1135) Report and Environmental Assessment

Fish Passage Modification Charles River Dam Boston, Massachusetts

December 1992

INSPECTION REPORT

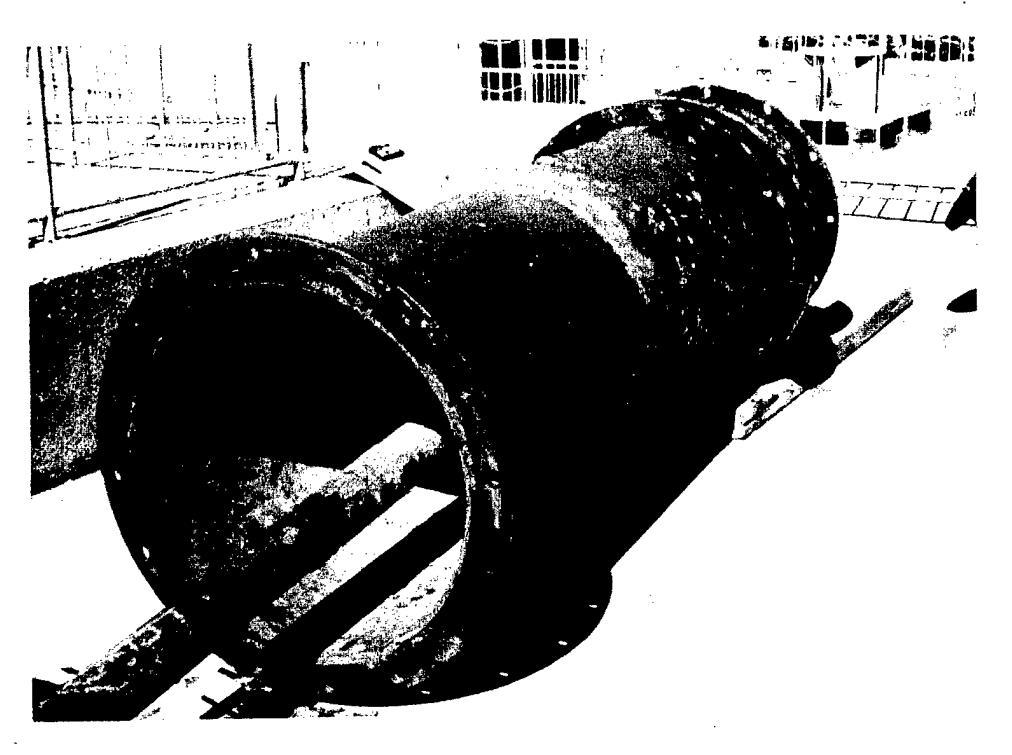
FIGURE 1. Fishway pump outer casing and shaft enclosing tube.

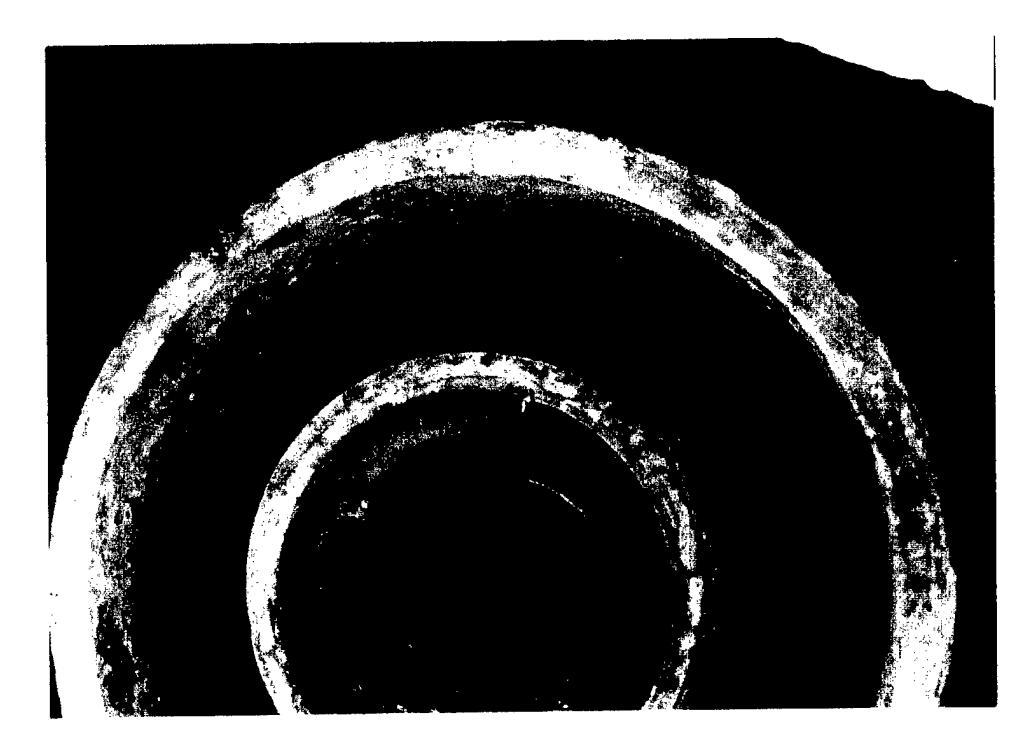
FIGURE 4. Fishway pump suction bell & lower bearing support.

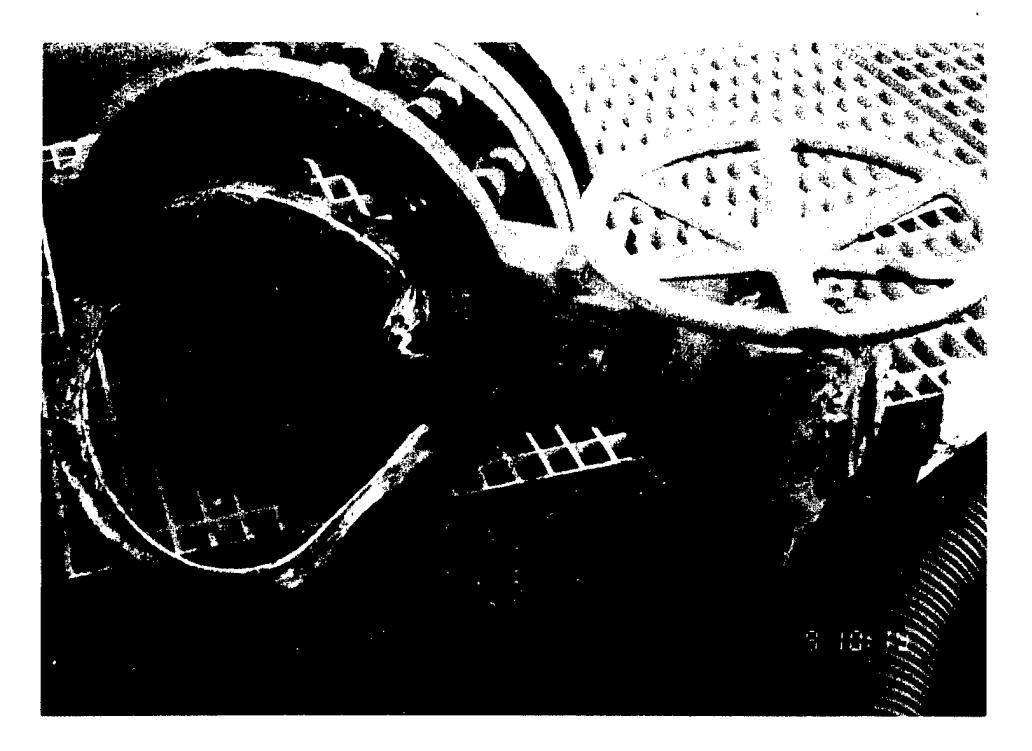
FIGURE 5. Butterfly valve from 20" diffuser line.

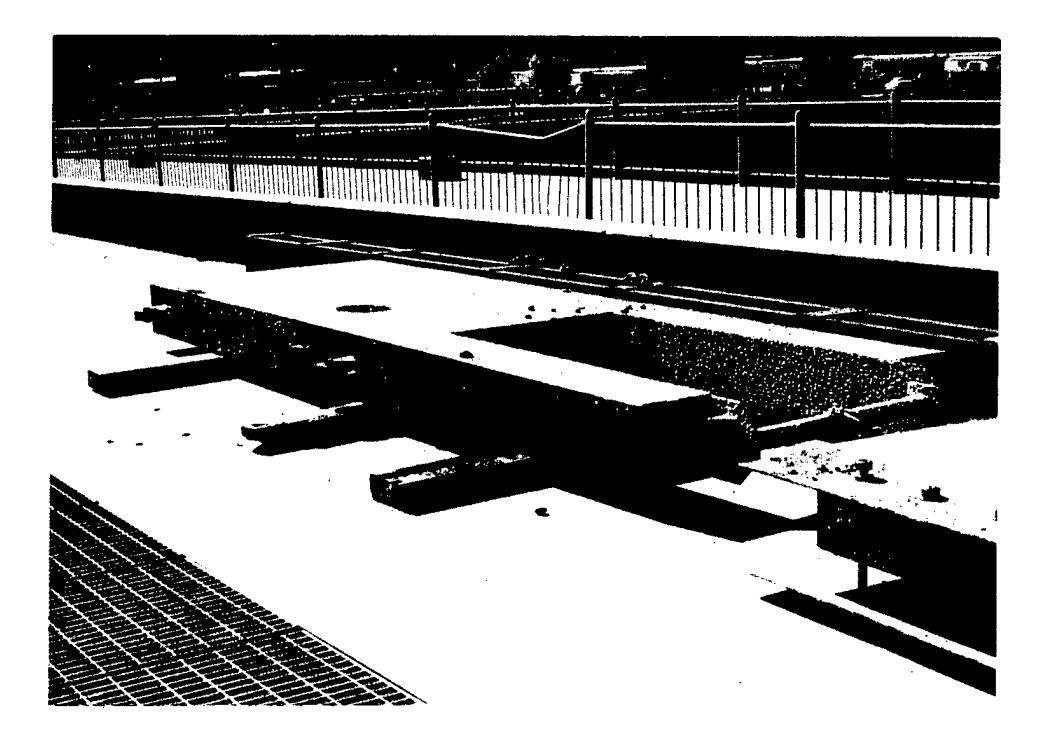
FIGURE 6. Floating weir, upper section.

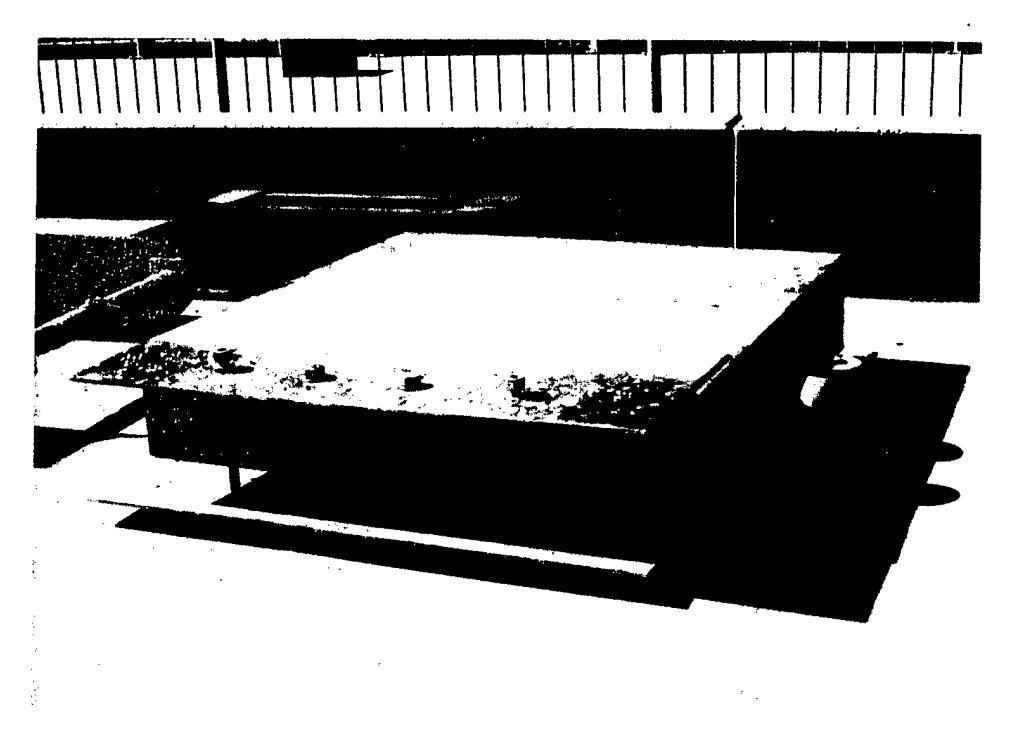
FIGURE 7. Floating weir, lower section.

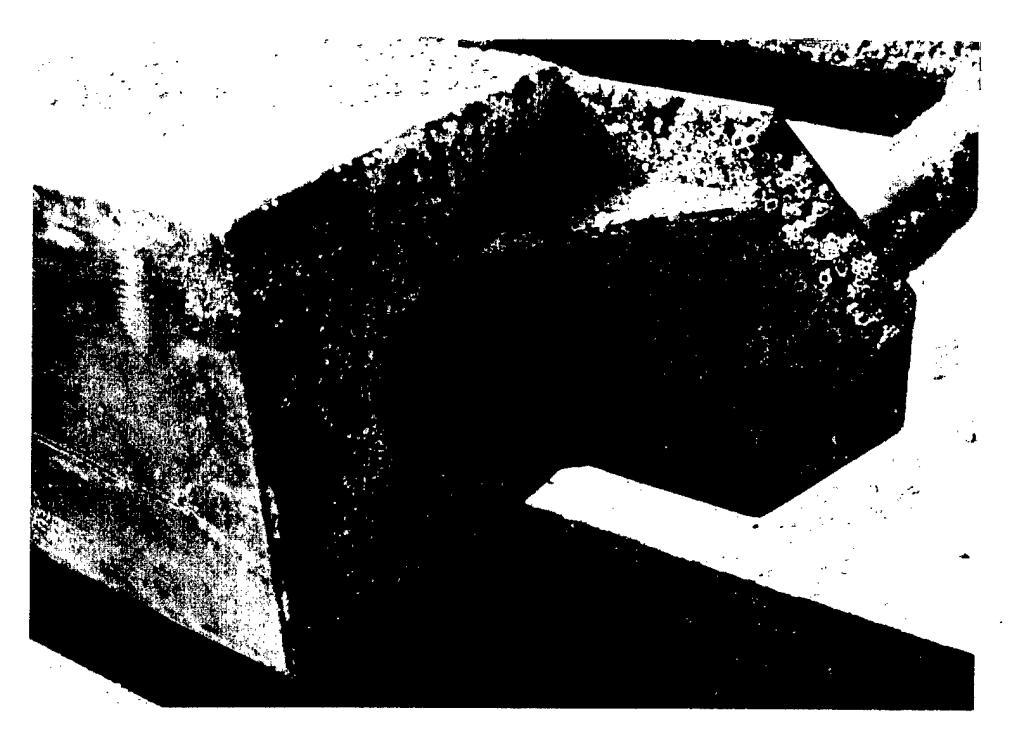
FIGURE 8. Floating weir, fill connection.
