# **National Transportation Safety Board**

### Safety Recommendation

Date: October 7, 1998

In reply refer to: A-98-87

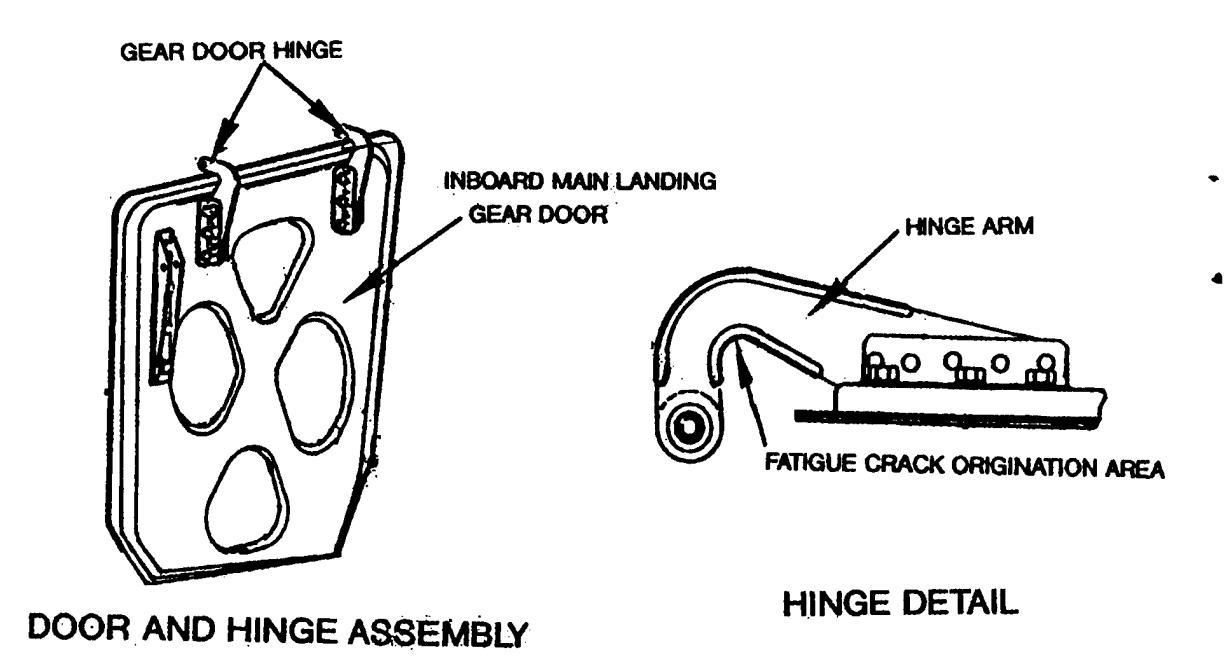
Figure 1. Piper PA-31 Main Landing Gear Door Assembly

arm (see figure 1). The arm is subjected to cyclic loading during service, and the forging flash is a high-stress region of the hinge.

In 1980, following several incidents of fatigue cracks in the original hinge, Piper Aircraft Corporation (now New Piper Aircraft, Inc.) issued Service Bulletin (SB) 682, which recommends inspection of the PA-31 MLG inboard door hinge assemblies and hinge attachment angles for cracks within the first 100 hours of operation or during the next scheduled inspection, whichever occurs first, and every 100 hours thereafter unless/until an acceptable replacement part is installed. The SB recommends that all cracked door hinges be replaced with the improved P/N 47529-32 hinge assemblies before further flight. Upon installation of the improved hinge assembly, repetitive inspection of the hinge assembly is not required. On December 19, 1980, the Federal Aviation Administration (FAA) issued Airworthiness Directive 80-26-05, mandating the actions specified in this SB.

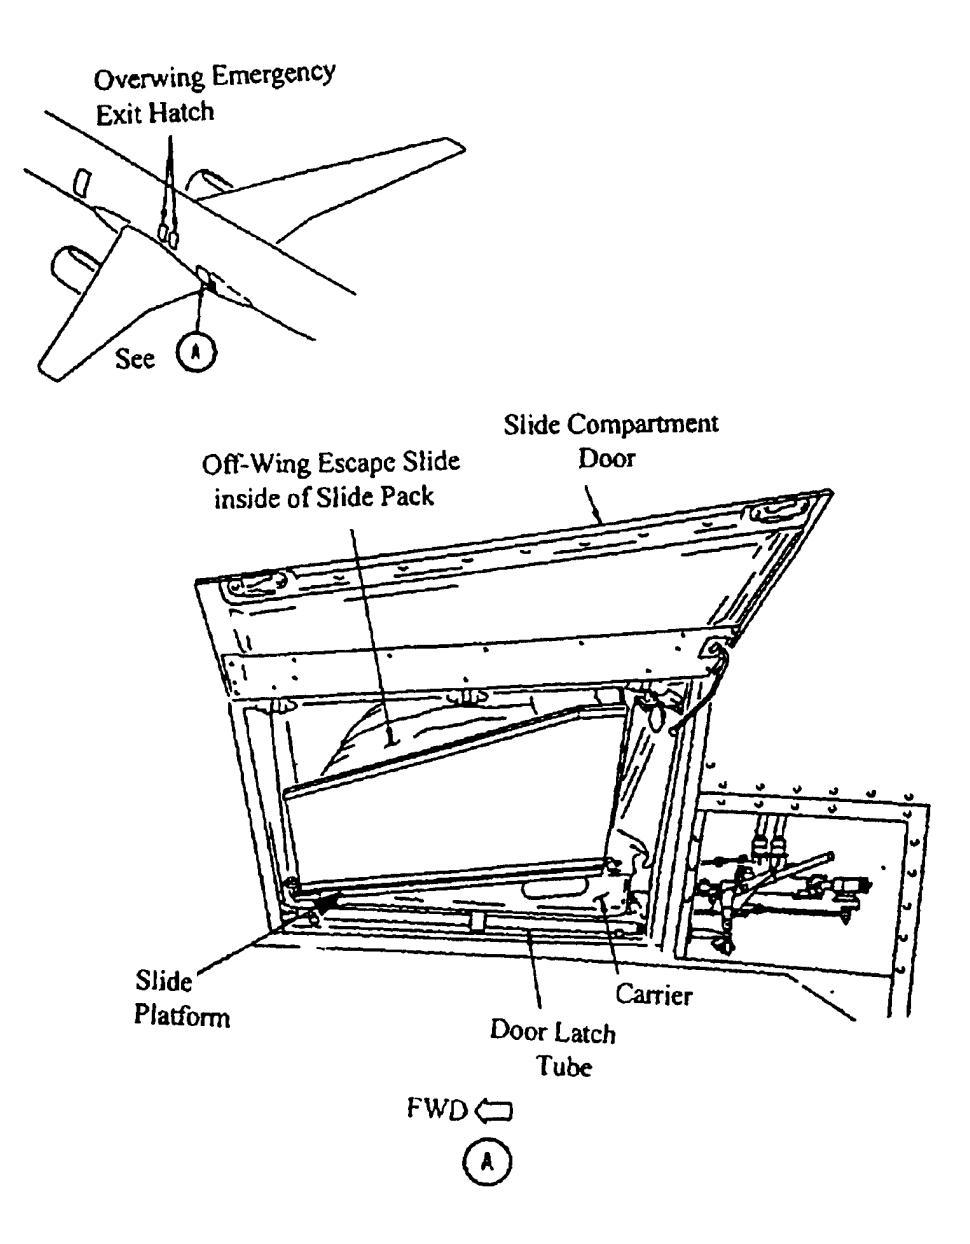
Figure 1.—B-757 Off-Wing Escape Slide Assembly

down position, stating that "it took several attempts to move the actuator handle to the latched position." The mechanics stated that after the door was latched one mechanic ran his finger around the door to ensure it was closed, and then both mechanics checked the EICAS in the cockpit to ensure that the door was closed. One of the two mechanics said that he had received instructions on how to replace the slide about 4 or 5 years ago during a 2-week B-757 initial maintenance training class that provided instructions on all B-757 systems. The other mechanic had not yet received training on the B-757 off-wing escape slide replacement during his 3 months of employment at Delta.

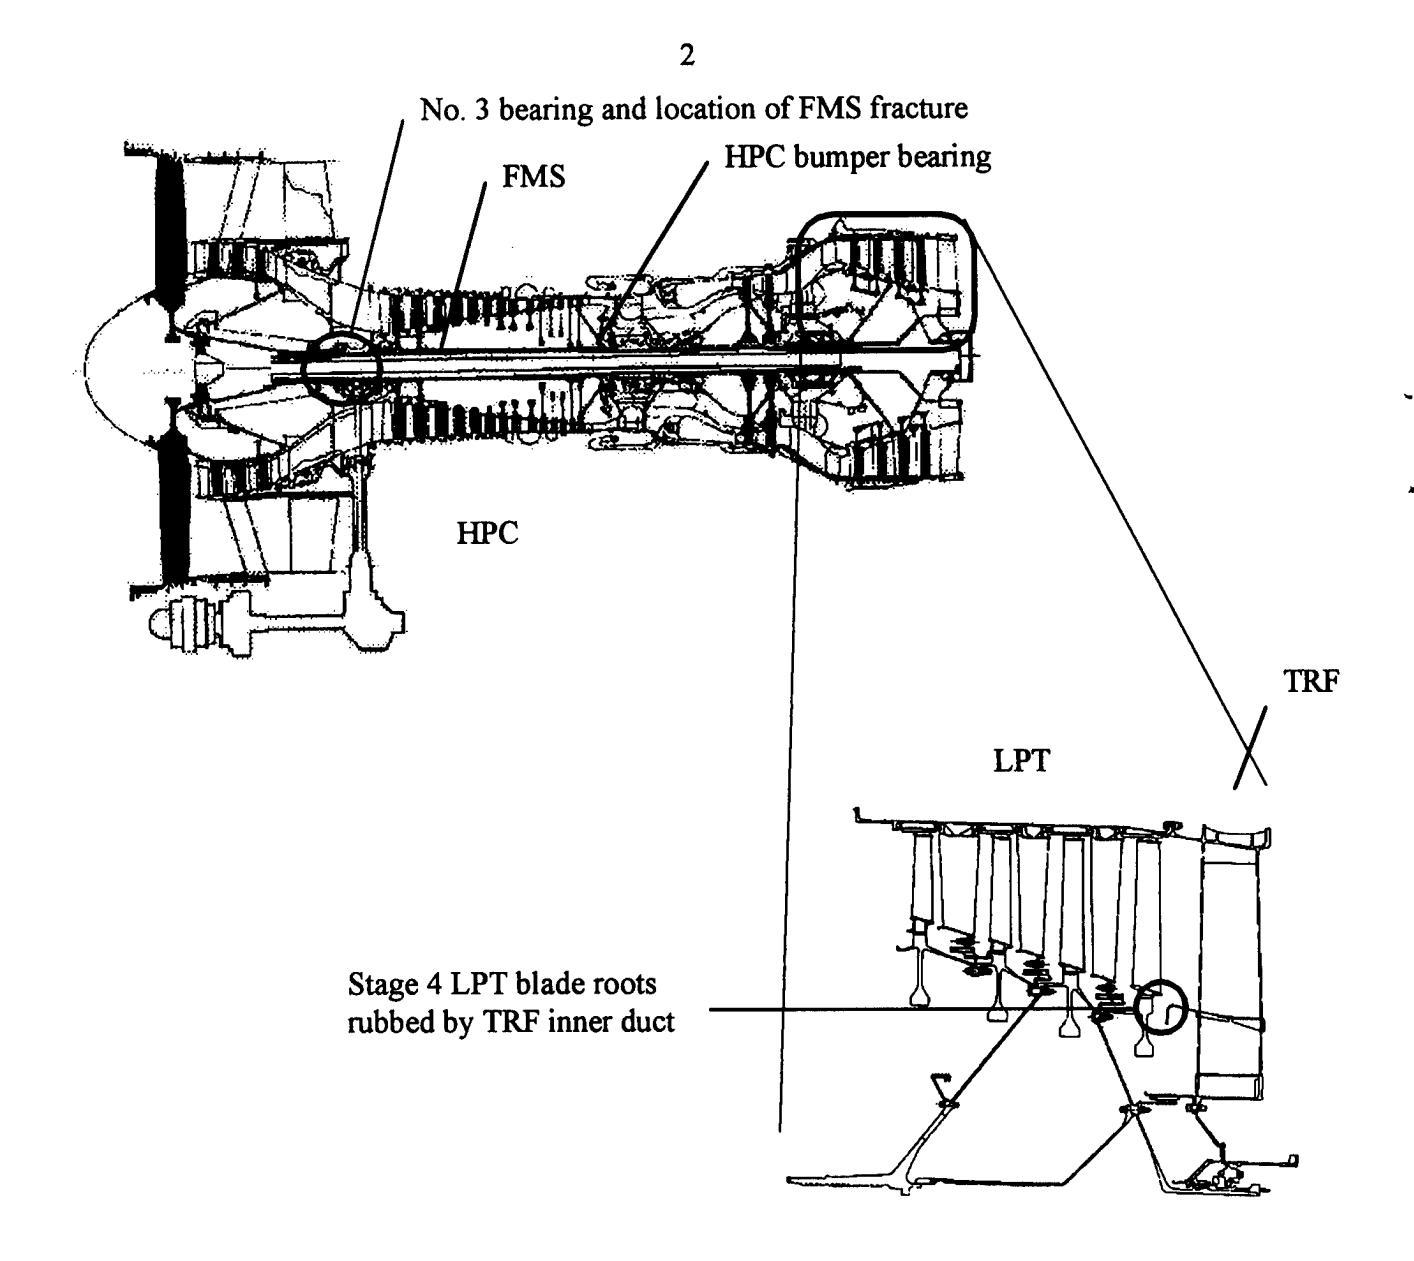
Figure 1. Cross section of CF6-50 engine and expanded view of LPT module

Disassembly of the engine, serial number (SN) 455-954, at GE's Engine Maintenance Center, Ontario, California, under the direction of the National Transportation Safety Board, revealed that the fan midshaft (FMS) was fractured circumferentially, just aft of the No. 3 (roller) bearing. Although the No. 3 bearing was damaged, the damage was typical of secondary damage that would have occurred late in the engine failure sequence.

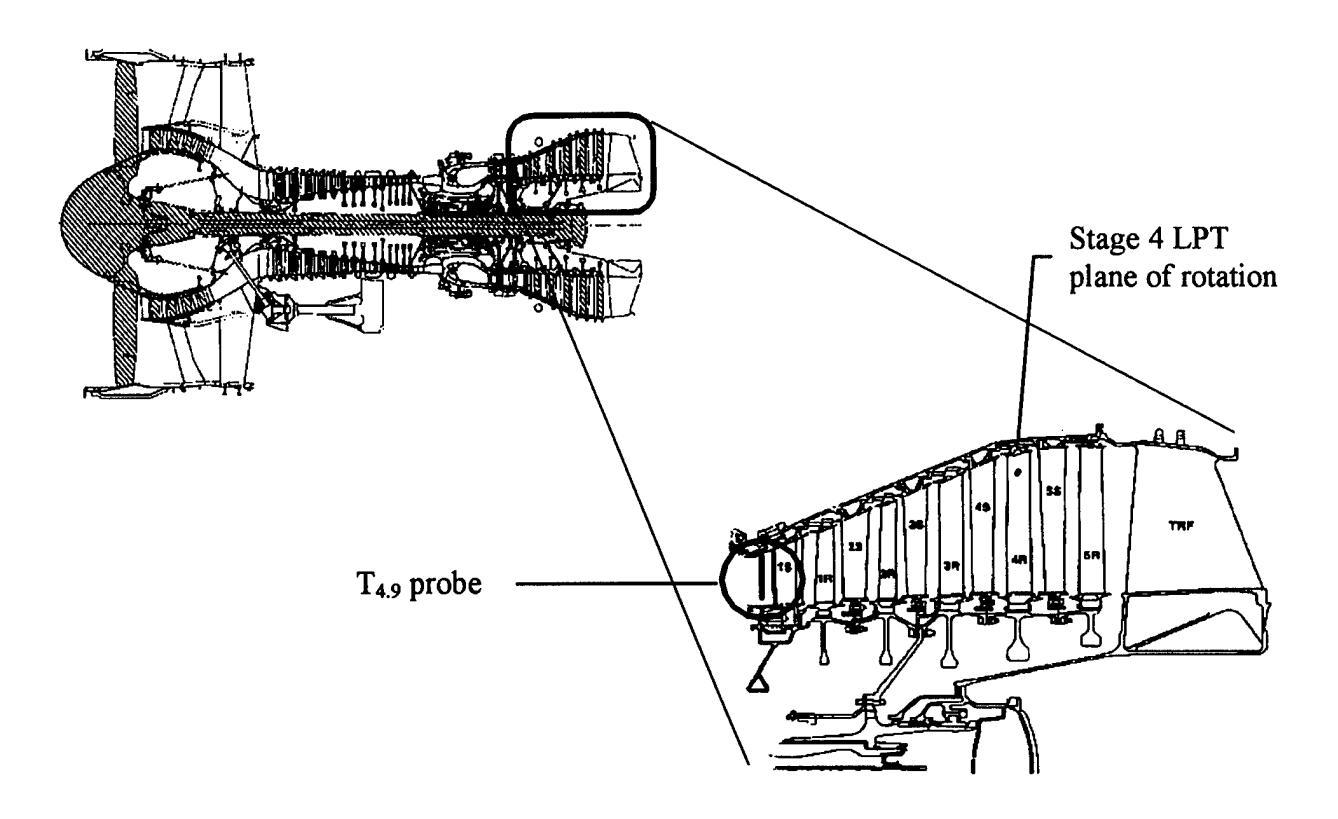
Figure 2. Cross section of CF6-80C2 engine and expanded view of LPT module

The Safety Board is aware of a similar event that occurred on September 5, 1997, when a Federal Express (FedEx) McDonnell Douglas MD-11 airplane, equipped with GE CF6-80C2 engines, had an uncontained LPT failure in the plane of the stage 4 LPT rotor. The disassembly of the FedEx engine showed that a stage 1 LPT airseal segment had broken loose from the LPT case and passed through the gaspath causing the breakage of the downstream turbine blades. As in the American Airlines LPT, the damage in the FedEx LPT rotor was more extensive downstream along the gaspath. The evidence shows that both the American Airlines and FedEx LPT cases withstood the initial containment challenge of the separation of an LPT blade, however, neither case could withstand the loads imparted by the resultant mass of broken LPT airfoils. This suggests that the design containment capability of the LPT case is inadequate.

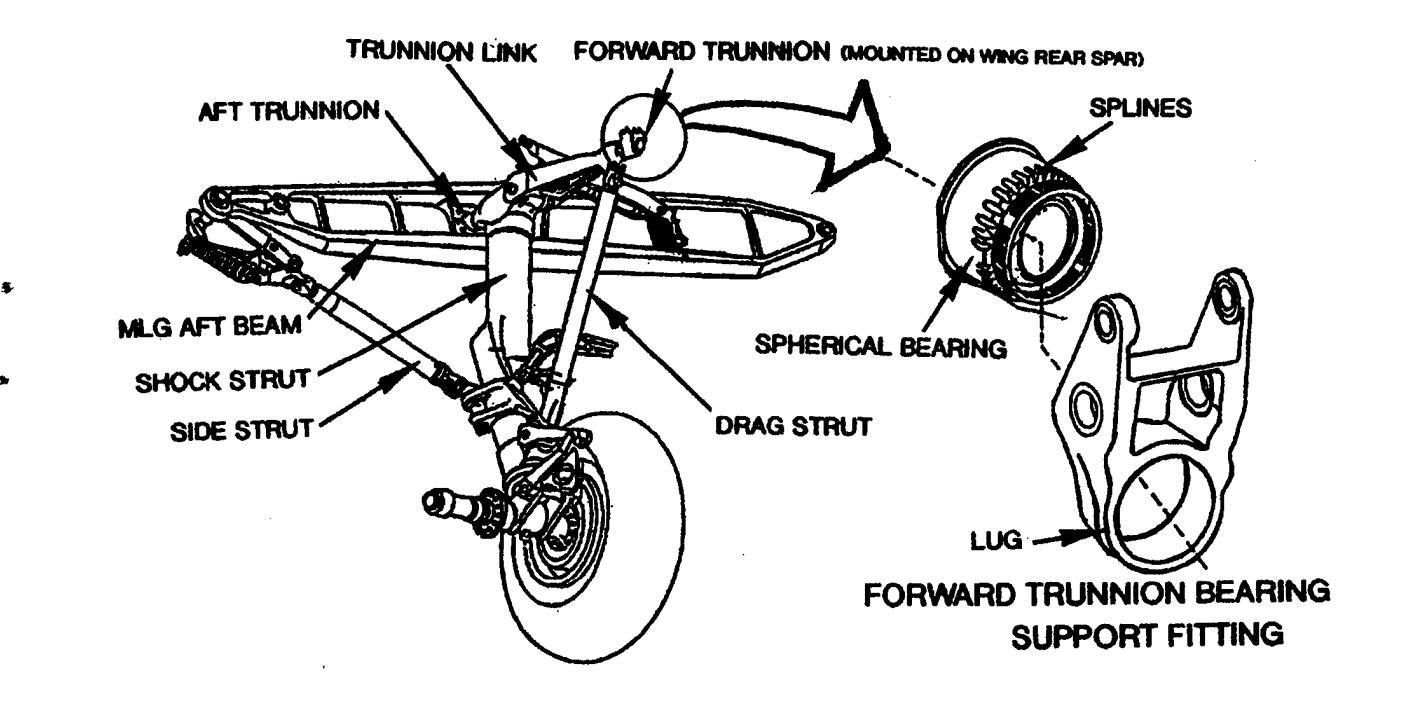
Figure 1. Boeing 727 Main Landing Gear Assembly

The right MLG of the B-727 is a conventional, two-wheel landing gear with three support points: the forward trunnion, the aft trunnion, and the side strut (see figure 1). A trunnion link is mounted between the shock strut and the rear spar. The aft end of the trunnion link is pinned to the shock strut, and the forward end pivots in a spherical bearing mounted in the forward trunnion bearing support fitting.<sup>1</sup> The spherical bearing has external splines that are used for locking the bearing assembly and retaining it within the support fitting lug. The splines contact a portion of the inner surface of the lug, leaving the gaps between the splines exposed to possible corrosion. The trunnion bearing support fitting is a round housing made from 4330M steel. The inner bore of the housing has chrome electroplating, which is the bore's primary means for corrosion protection. The fitting is mounted on the rear spar of the wing with high-strength bolts.

Examination of the trunnion bearing support fitting at the Safety Board's materials laboratory revealed corrosion at the forward edge of the fitting's lug in many of the exposed areas between the bearing splines. Fatigue cracking emanated from two locations within a severely corroded area, and intergranular stress corrosion cracking (SCC) stemmed from the fatigue cracking. This corroded area was 0.15-inch wide by 0.37-inch long by 0.07-inch deep. The fracture was caused by a combination of fatigue cracking and SCC.

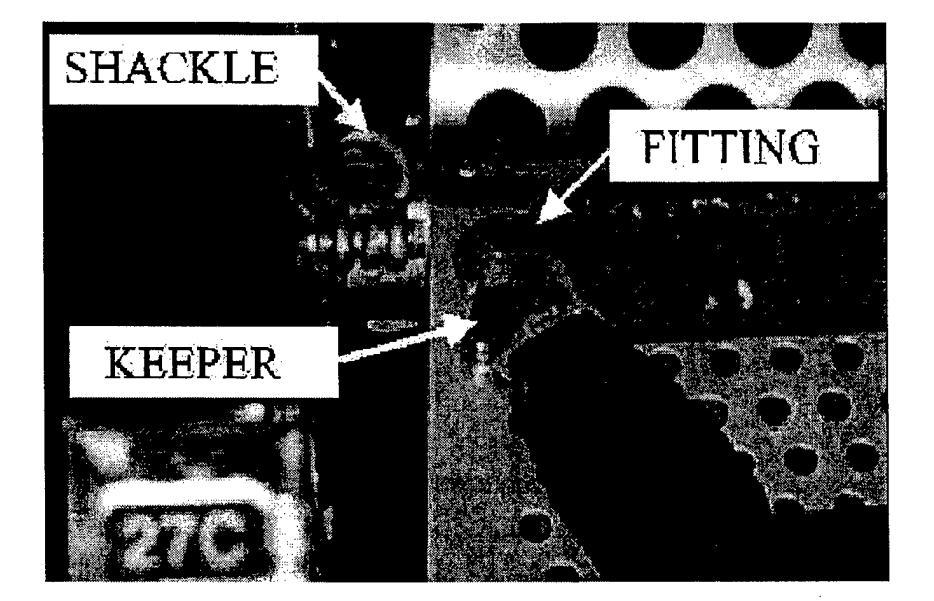
Figure 1.—Seatbelt Assembly

Both seatbelt assemblies are of a design commonly used in commercial airplanes. The seatbelt assembly consists of the standard release buckle, webbing, and an attachment fitting with a spring clip keeper at each end of the belt (see figure 1). The attachment fitting clips over a shackle that is bolted to the seatframe.

The Safety Board has previously addressed the issue of seatbelts becoming unhooked. During its investigation of a British Aircraft BAC-1-11 that encountered severe turbulence near Orlando, Florida, on May 24, 1988, the Safety Board found that three passenger seatbelts had detached during the turbulence. The passengers were displaced in their seats and sustained minor injuries. Safety Board investigators and Civil Aeromedical Institute (CAMI) engineers conducted tests at CAMI to identify ways that seatbelt attachment fittings could detach from the shackles bolted to the seatframes. The tests revealed that when the bolt used to fasten the shackle to the seatframe is overtightened, the shackle cannot move vertically to self-center, preventing the seatbelt end fitting from centering on the shackle. When this condition occurs, the end fitting cannot align with the seat occupant, and minimal side loads can force open the end fitting's spring-loaded keeper and detach the end fitting from the shackle.

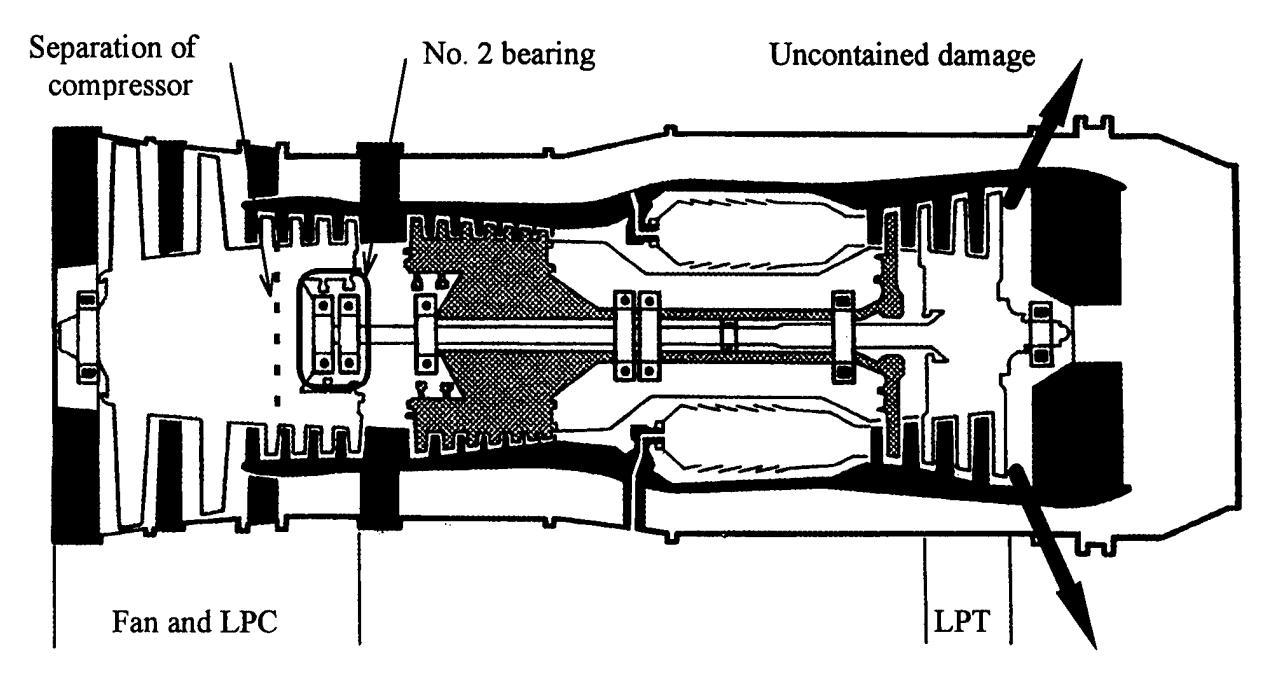
Figure 1. JT8D engine

The JT8D engine's low pressure rotor system is made up of a two-stage fan, which consists of the 1<sup>st</sup> and 2<sup>nd</sup> stage fan rotors,<sup>3</sup> and a four-stage low pressure compressor (LPC), which consists of the 3<sup>rd</sup>, 4<sup>th</sup>, 5<sup>th</sup>, and 6<sup>th</sup> stage compressor rotors. The two-stage fan and four-stage compressor are joined to the three-stage LPT, which consists of the 2<sup>nd</sup>, 3<sup>rd</sup>, and 4<sup>th</sup> stage turbine rotors, by a drive shaft, all of which rotate as one unit under normal conditions (see figure 1). The examination of the incident engine revealed that the 1<sup>st</sup> and 2<sup>nd</sup> stage fan rotors and the 3<sup>rd</sup> stage compressor rotor rotated together but independently from the remainder of the low pressure rotor system from the 4<sup>th</sup> stage LPT disks were intact but that all of the LPT blades were fractured adjacent to the blade root platforms, and most of the LPT vanes were missing. Although the engine was outfitted with an LPT containment shield, as required by Airworthiness Directive (AD) 94-20-09, the containment shield was broken into three pieces, and the engine was cut in two just aft of the LPT by liberated LPT blades.<sup>4</sup>

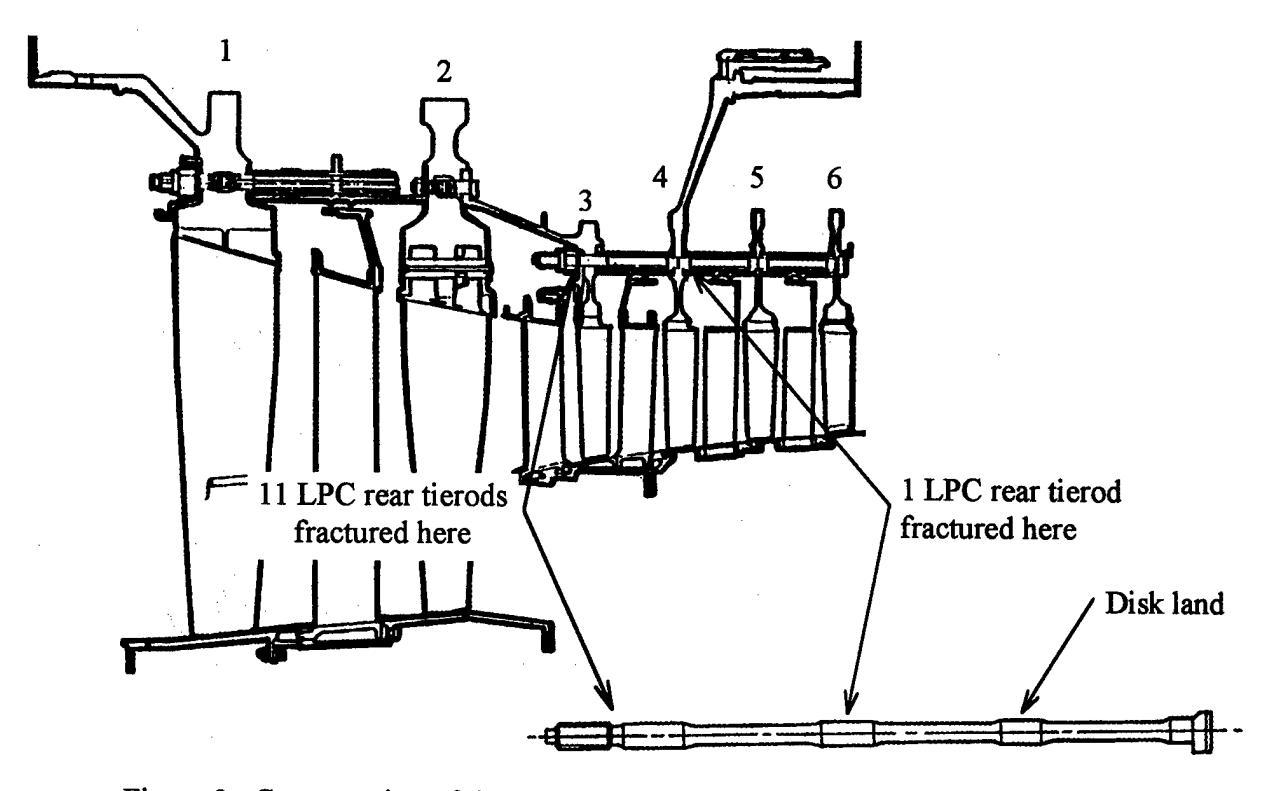
Figure 2. Cross-section of the JT8D fan and LPC and view of an LPC rear tierod

The 4 stages of the JT8D engine's LPC are held together by 12 long bolts, called LPC rear tierods, that pass through alternating disks and spacers (see figure 2). The disassembly of the Royal Airlines LPC revealed that one LPC rear tierod, part number (PN) 789550, was fractured transversely across the tierod's 4<sup>th</sup> stage compressor disk land.<sup>5</sup> The entire fracture face on the

tierod had surface corrosion, suggesting that the tierod had been broken for some time. Because of overstress, the 11 remaining LPC rear tierods were fractured at their forward ends between the  $3^{rd}$  stage compressor disk lands and the tierod nut threads. All six of the recovered tierod nuts and ends had numerous pockmarks on one side, and the tierod ends were bent away from the pockmarks. The pockmarks and bending damage suggest that after the initial tierod fractured and was liberated from the compressor, it tumbled around in the cavity at the front of the LPC and impacted the other tierod nuts and ends until they eventually fractured, causing the compressor to separate between the  $3^{rd}$  and  $4^{th}$  stage rotors and the engine to fail. Eleven equally spaced fan exit vanes had the imprints of the tierod nuts on the leading edge, indicating that the 11 remaining tierods fractured simultaneously when the engine failed.

The Safety Board's examination of the LPC rear tierod with the corroded fracture face revealed that a fatigue fracture originated from a small area of galling<sup>6</sup> on the 4<sup>th</sup> stage compressor disk land. On July 7, 1982, as a result of 33 LPC rear tierod fractures at the 3<sup>rd</sup> and 4<sup>th</sup> stage disk land locations that caused damage in JT8D engines, P&W issued Service Bulletin (SB) 5407.<sup>7</sup>
