Tree strikes, you're out!

Tree strikes: selected accident briefs

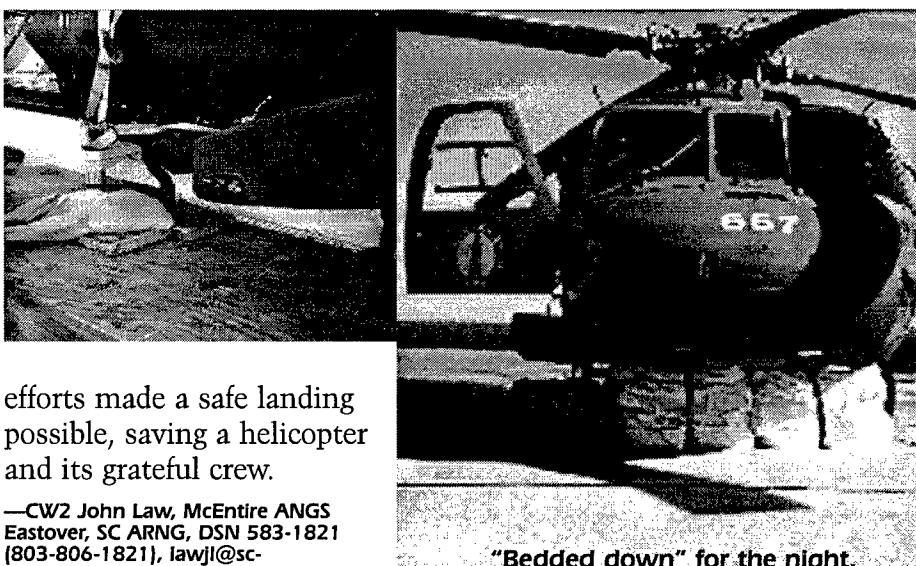
As the photos show, this one had a happy ending. Chalk it up to teamwork and true crew coordination that extended to include the ground crew. Their

"Bedded down" for the night.
