## Inspection of Demonstrator Bonded Repairs on a QANTAS 747-300: September 1999

DSTO-TR-0900

Airframes and Engines Division Aeronautical and Maritime Research Laboratory

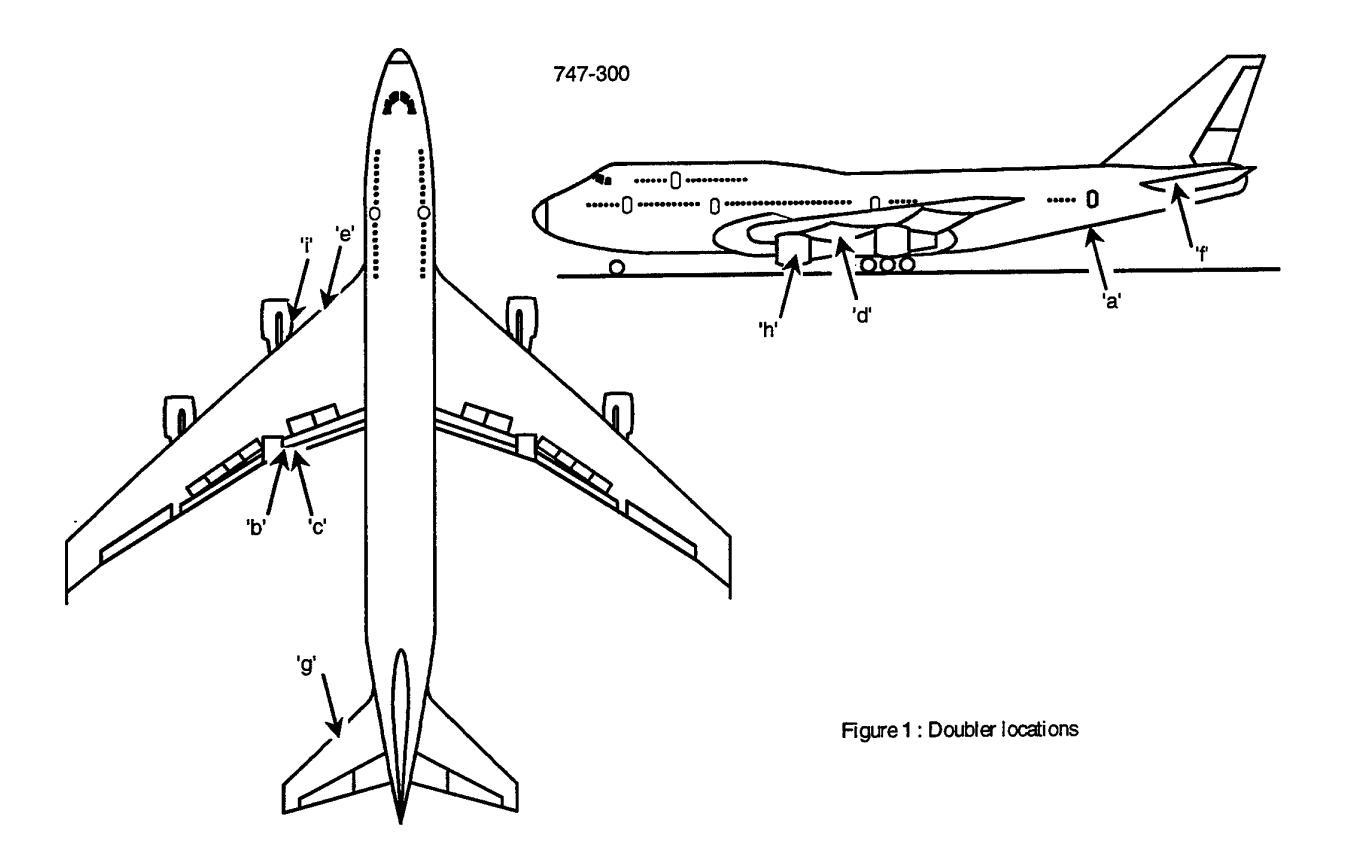
The demonstrator repairs in the program were placed in areas of the QANTAS 747-300 aircraft that were known to be prone to corrosion damage, bird strikes, stone and Foreign Object (FO) strikes as well as areas prone to oil and grease. In all nine demonstrator repairs were applied to the aircraft as shown in Figure 1.

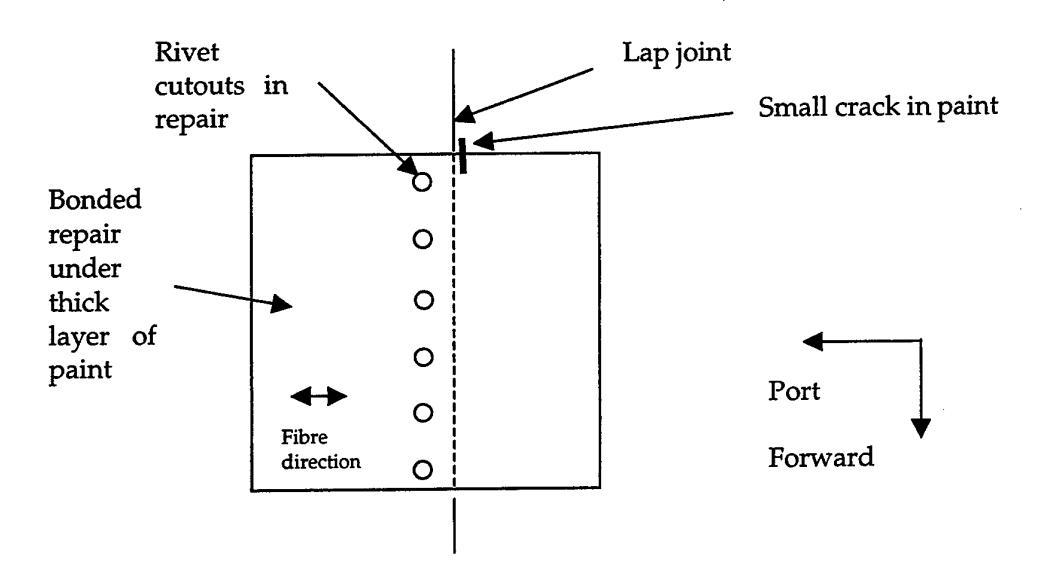
Inspection of this repair proved difficult, as there was a thick layer of paint over the repair. Tap test and visual inspection showed no signs of degradation of the repair. There was a small crack in the paint at the aft edge of the repair running in the longitudinal direction as shown in Figure 2.

Figure 2. Orientation of repair at location 'a', showing crack in paint.

The crack in the paint at location 'a' was possibly due to movement at the junction of the lap-joint seams and the repair. A full inspection of this repair was not possible due the thickness of the paint in the region. The condition of this repair will be determined at a later stage after removal of the paint.

- 7. The demonstrator repair at location 'a ' should have the paint removed from over it to allow for a more thorough examination of the crack location and to confirm whether or not it was a crack in the repair or a defect in the paint.
- 8. The demonstrator repairs at locations a, c and d should remain in service and be inspected at regular intervals. Should they start to degrade they should also be removed from the aircraft.

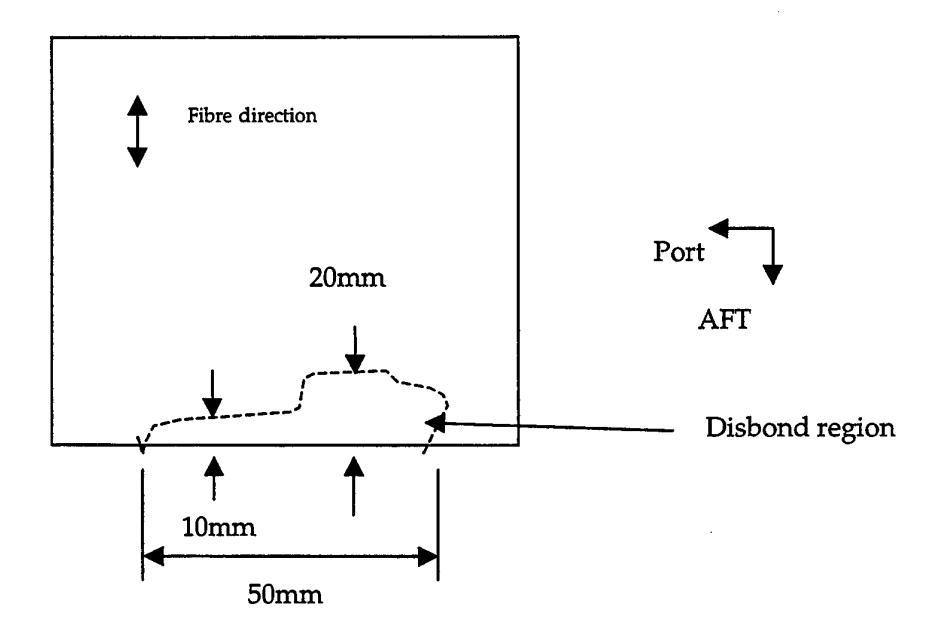
Visual inspection showed that the repair was in excellent condition, with a small crack in the covering-coat of paint along the width of the repair at the trailing edge. A tap test suggested that the repair had disbonded along this edge to a depth of approximately 20mm. There were no signs of erosion or impact damage. The aluminium skin in this region was rather flexible, with no support structure underneath. The map of the disbond indication is shown in figure 3. Photograph 1 shows the repair on the aircraft and the region in question.

Figure 3. Disbond map for repair 'b'.

At this time it was difficult to ascribe a reason for the disbond at location 'b' as there were no signs of erosion to the repair. It is possible that this disbond may have been caused by acoustic vibration causing fatigue in the adhesive. The indication could be of a disbond due to adhesion failure, however this would be unlikely as the condition of repair 'a' which had the same adhesive/cure system as 'b' exhibited very good durability with no indications of disbond due to adhesion failure.

The acoustic fatigue could have been caused by unsteady airflow over the top surface of the wing and flap while the flap segments were deployed. Confirmation of the disbond size and cause can only be determined by the careful removal of a segment of the repair for fractographic analysis.

- 5. The demonstrator repairs at locations b, e and g should be removed before they degrade to a level where they may compromise the safety of the aircraft or the personnel working on the aircraft. These particular repairs have proven their durability through prolonged service and it is doubtful that much more information could be gleaned by leaving them on the aircraft.

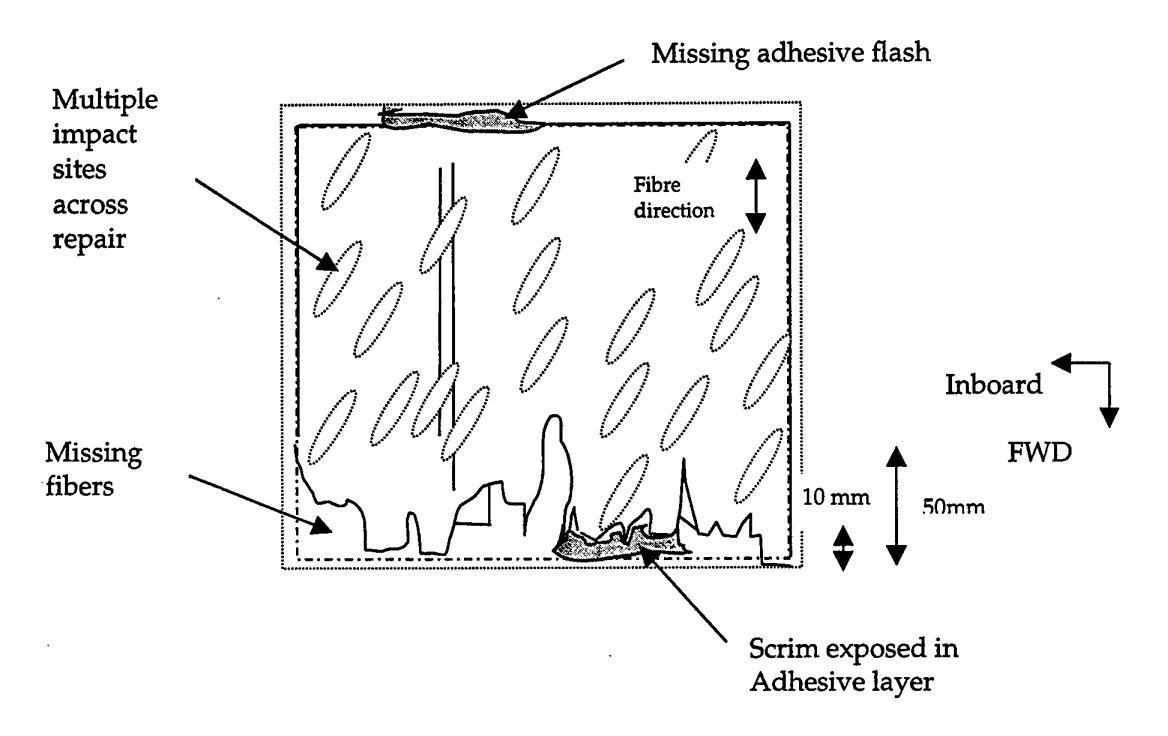
This repair showed significant erosion damage to the leading edge and top surface. There was evidence that the repair had been repainted many times during the life of the repair.

The main erosion damage was present at the leading edge of the repair. Within the first 12mm from the leading edge, most of the repair was eroded away, leaving traces of primer and adhesive only. The remaining ply damage extended up to 50mm back along the repair. The carrier scrim in the adhesive and the aluminium substructure was exposed in some areas, with some fibre tearout along the entire length of the repair. Damage on the leading edge of the repair effected all 4 plies.

Erosion had removed the adhesive and the primer from the areas where the aluminium surface was exposed due to lost fibers.

The second type of damage was at 45 degrees to the direction of the fibers, where foreign object damage (FOD) had caused paint stripping and damage to the surface of the repair as shown in photographs 2 and 3. On the rear edge of the repair part of the adhesive flash was also missing.

Despite the extensive damage and erosion, the bond integrity remained excellent with no abnormalities detected during the tap test.

Figure 4. Damage due to erosion and impact on location'e'. Bond integrity was excellent across remaining areas of repair.

The source of the impact damage to the repair at location 'e', the leading edge of the wing, was most probably due to material being thrown up from the nose wheels

during landing and takeoff manoeuvres. This was characterised by the angle of the FOD markings on the repair that traced a direct line between repair and nose wheel bogey.

The only reason the repairs at locations e and g should be left on the aircraft is for the trial fitment of an erosion protection shield for in service effectiveness trials.

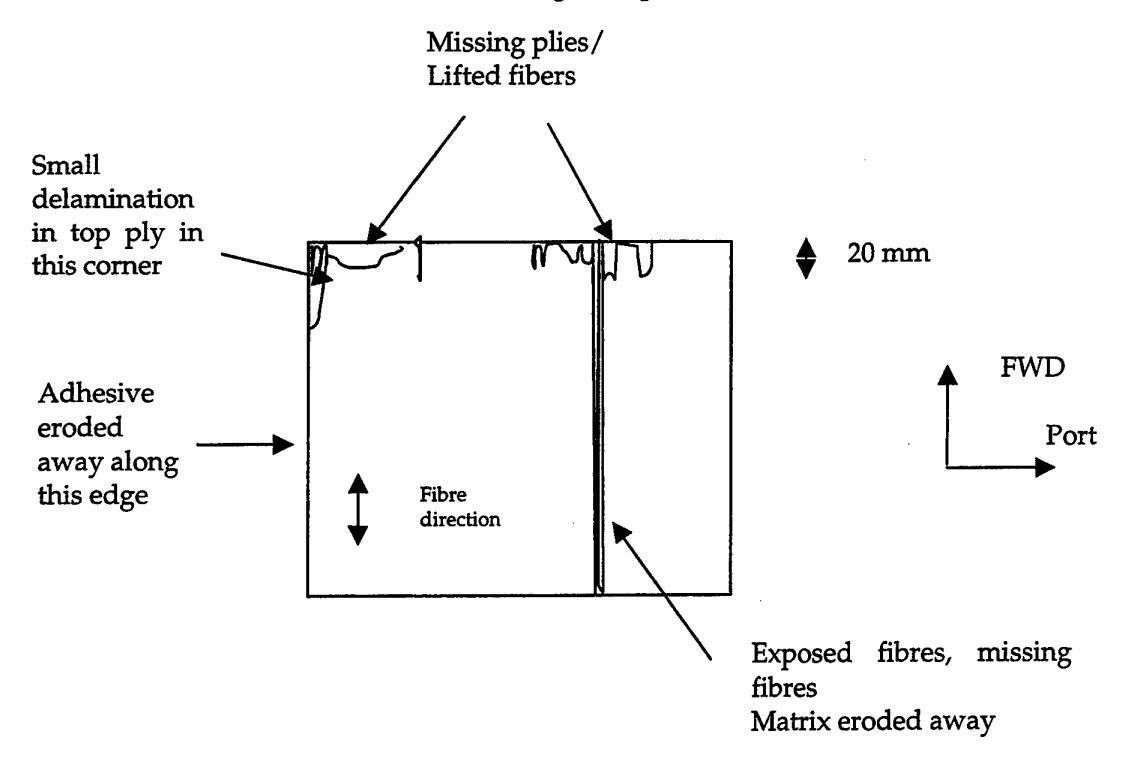
The repair at this location showed significant signs of erosion, mainly to the leading edge. There was significant fiber-tear out along the length of the repair in the top ply (Figure 5, photo 4). Many loose fibres were present, which were removed for safety reasons during the inspection. There were signs of a small delamination in the corner of the repair between the outer layer and the second layer. Bond integrity was excellent with no other abnormalities detected during the tap test.

Figure 5. Damage map of location 'f'

The repair at location 'f', on the lower surface of the stabiliser was more sheltered from debris and FOD than the repair on the top surface 'g', already described above, and hence saw less damage.

6. The demonstrator repair at location 'f' should either be removed or a protective sheath installed over it to trial an erosion protection system.

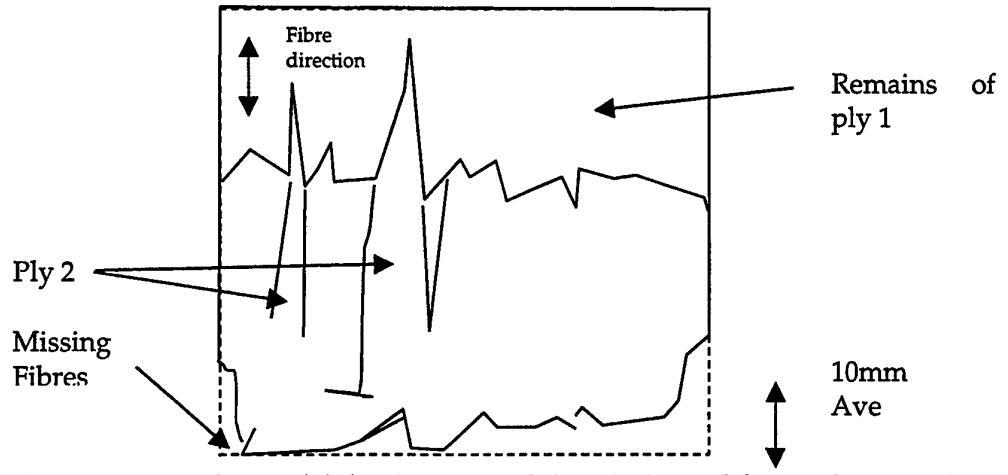
Significant erosion of this repair had occurred. Despite being painted over many times (Photo 6), indications were that up to 60% of the top ply, 10% of the second ply and approximately 5% of the third ply had eroded away. In the region 0 to 10mm from the leading edge, most of the fibres had eroded away over the width of the repair. In the areas where the repair had eroded away, the primer and grit blast surface had also been removed leaving a bare aluminium surface.

In one region, approximately 3mm x 3mm, the adhesive had eroded away from between the aluminium and the boron (Figure 6), leaving the fibres free. The remainder of the repair had excellent bond integrity.

Figure 6. Damage map of region 'g' showing extent of ply stripping and damage due to erosion.

The repair 'g', on the top surface of the stabiliser, was in line with the exhaust gas path of the number 2 engine. During takeoff and landing, with the aircraft in a nose high position, the exhaust gases ricochet off the runway and will carry any loose material up at high velocity towards the horizontal stabiliser.

The top surface of the stabiliser is more exposed than the lower surface while the aircraft is in this flight condition. This is due to the negative trim setting angle of the stabiliser which leaves the leading edge of the stabiliser rotated downwards with respect to the trailing edge, exposing more of the top surface than the lower surface to direct airflow.
