US Army Corps of Engineers. Engineer Research and Development Center

Structural Evaluation of Aircraft Hangar 46, Corpus Christi Army Depot

February 2001

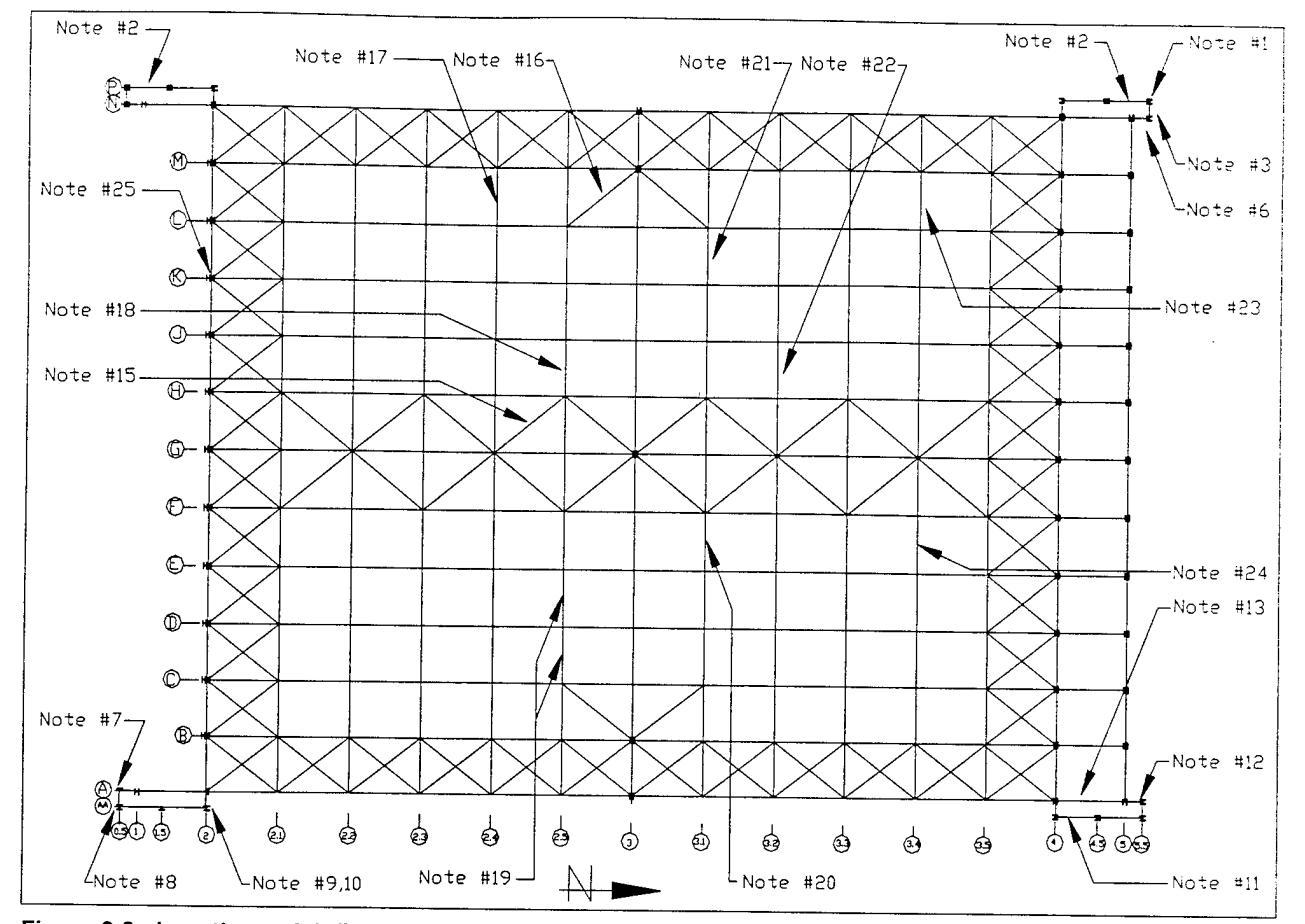
Figure 2-3. Locations of deficient structural members.

The following notes on specific deficiencies were recorded from observations made during the inspection. These notes are related to strength reduction and in many cases indicate the need for repairs. For location of members on a plan view of the hangar, see Figure 2-3. Notes in parentheses indicate member size.

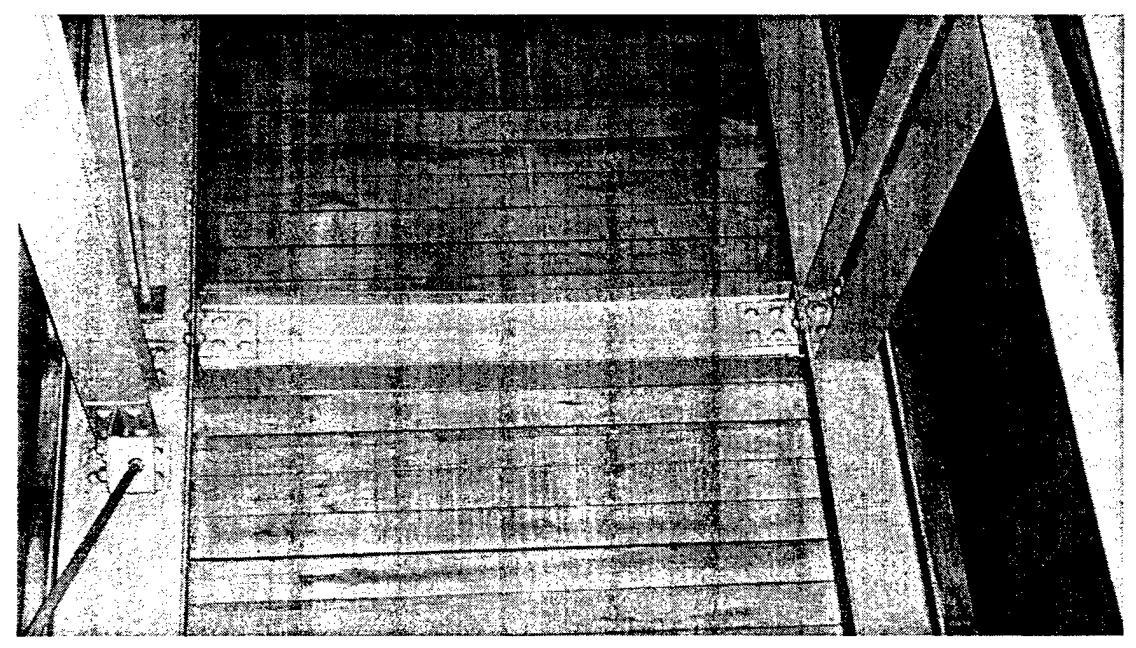
Figure A-2. Buckled horizontal brace (10-I-21), second floor between Columns P5.5 and N5.5.

- 2. Tighten or replace loose tie rods (7/8 in. diameter) attached to columns P0.5, P1.5, P4.5, P5.5.
- 3. The buckling horizontal brace (10-I-21) on the second floor, between columns P5.5, N5.5, is not designed for compression, but has been acting as a compression member. This brace is considered to be a secondary member. It would be possible to increase stiffness and strength through retrofit, but this would make connections more vulnerable to failure. Therefore, no retrofit is advised.

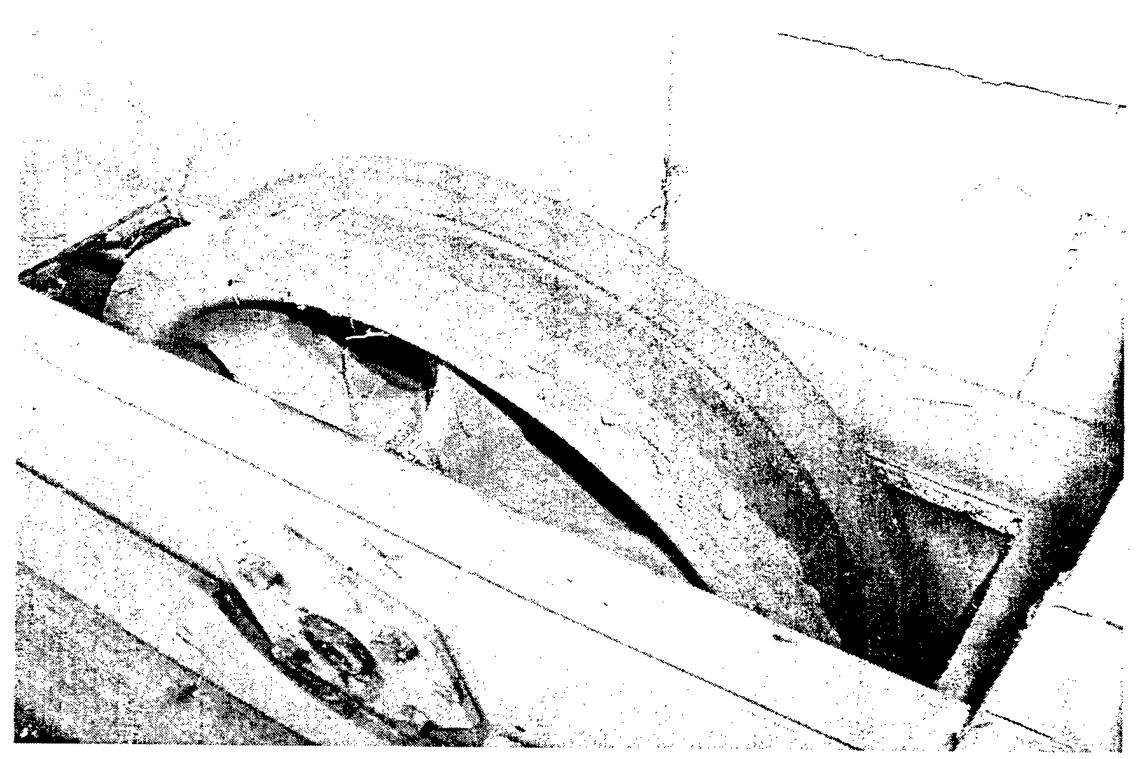
Figure A-3. A typical deteriorated hangar door wheel.

- 4. Deteriorated hangar door wheels should be replaced to ensure the strength of the door system under wind loading.
- 5. Dented vertical members near handles on hangar doors can result in loss of structural integrity of doors. Do not open doors with chains; use original design method for opening doors.

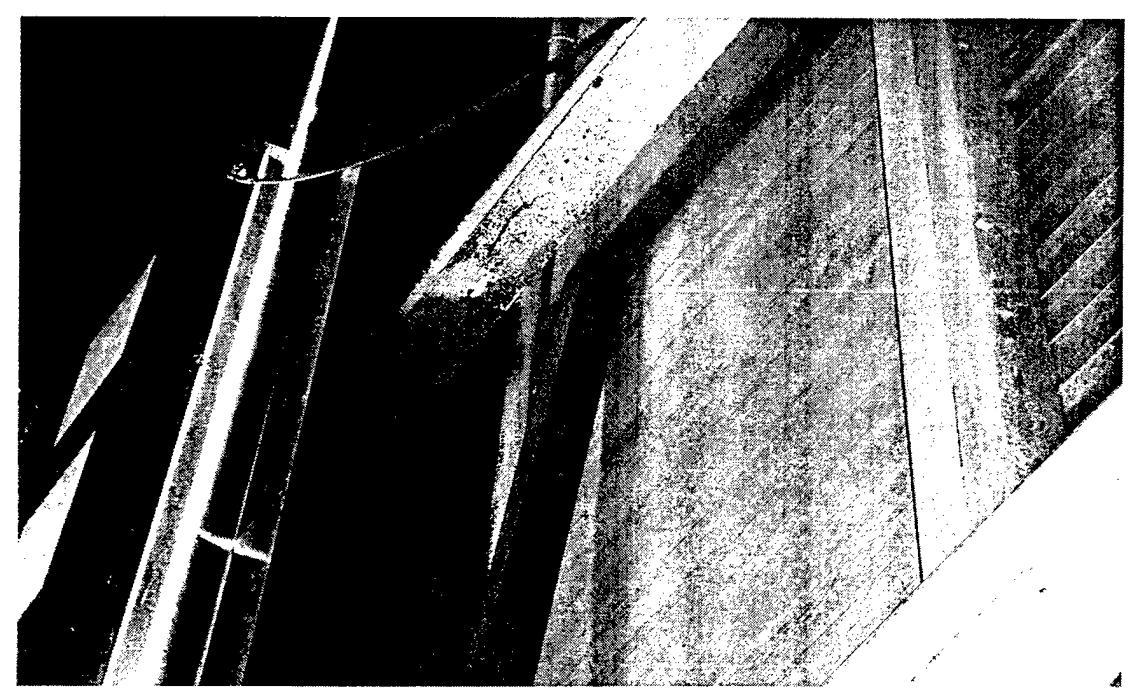
- 9. Unsupported wood column (4x4 post) near column AA2 is a safety hazard. See Figure A-6.
- 10. A makeshift wood column (4x4 post) near column AA2 provides inadequate support of second floor beam between columns AA2 and AA1.5. See Figure A-7.
- 11. A beam is under torsional stress at the second floor between columns AA4 and AA4.5 (6-H-15.5).
- 12. Major corrosion of the web and flange at the base of column A5 (18-I-47) has resulted in an estimated 30 percent strength reduction. See Figure A-8.
- 13. Minor corrosion of the web and flange at the base of column A5.5 (8-H-31) has resulted in an estimated 10 percent strength reduction. See Figure A-9.

Figure A-6. Loose timber near Column AA2.

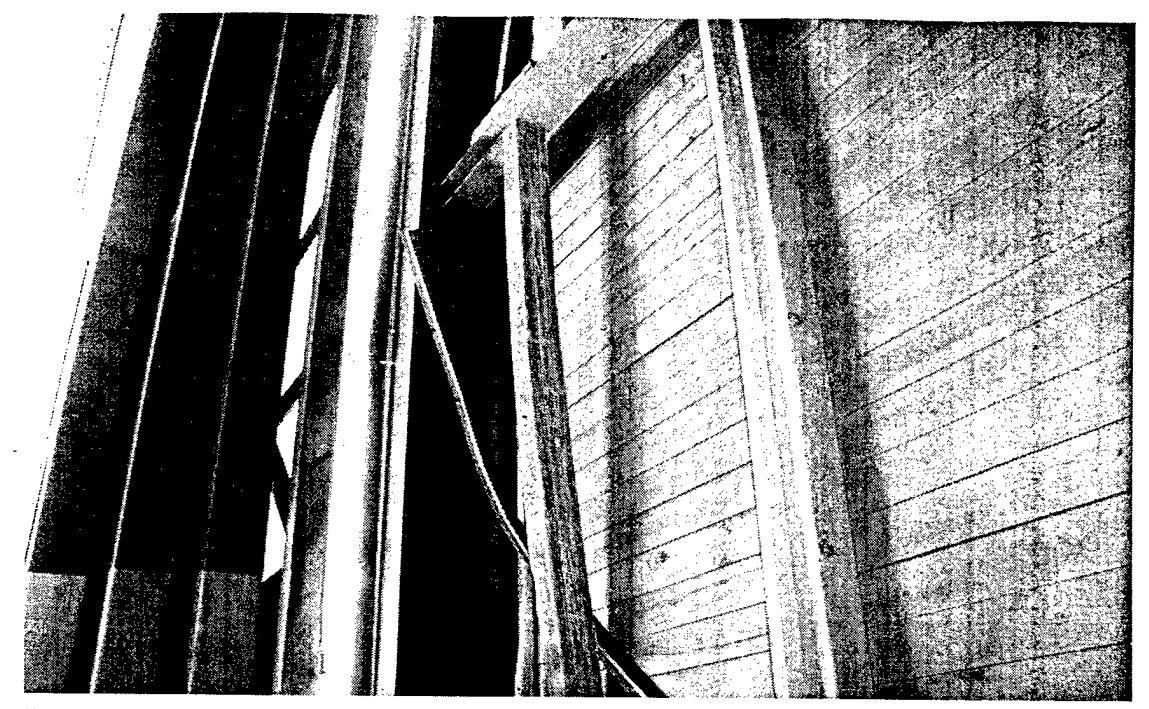
Figure A-7. Makeshift support near Column AA2.

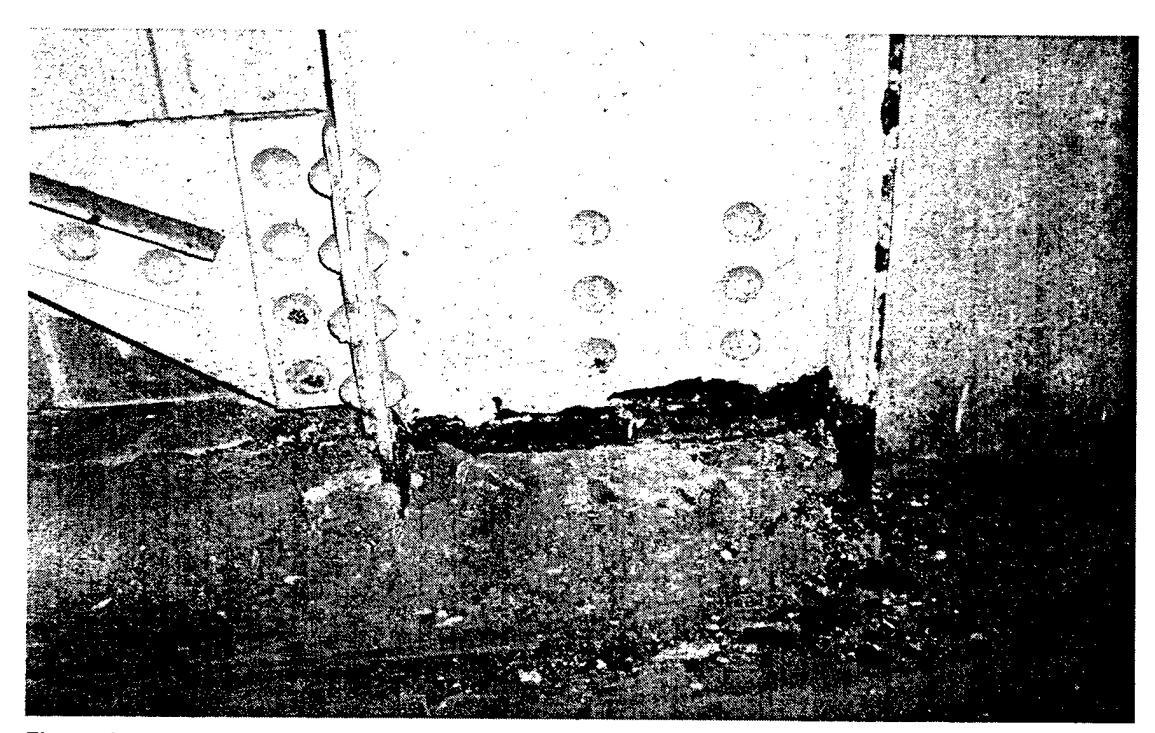
Figure A-8. Major corrosion at base of Column A5 (18-I-47).

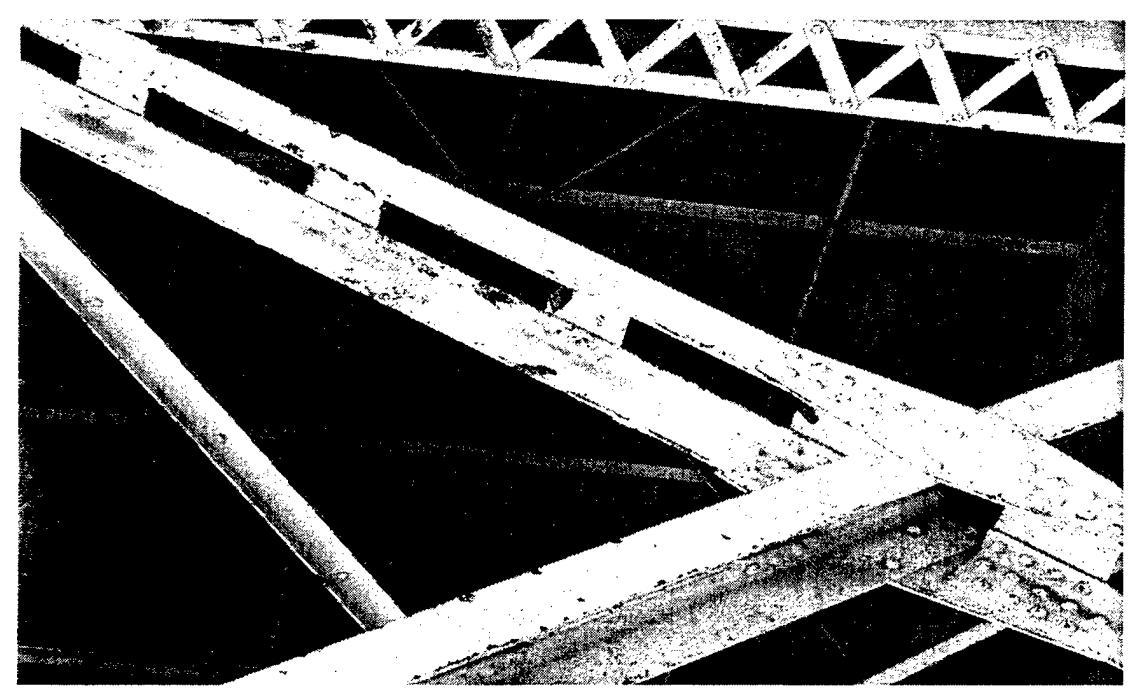
- 14. Entire hangar is losing paint. See Figure A-10.
- 15. Minor buckling of diagonal braces (single angle, $3\frac{1}{2} \times 2\frac{1}{2} \times \frac{1}{4}$) has occurred at the following locations:

Figure A-10. Typical example of elements needing fresh paint.

- 14. Any unpainted steel needs to be painted; use as listed in Figure D-1 of TR-99/27.
- 15. No retrofits are necessary for buckling bracing members listed in notes 15 and 16 of Chapter 2; these angles are intended for tension only.
- 16. No retrofit is necessary for column K2 (18-I-85), but further welding damage and gouging of the sort identified here should be avoided.

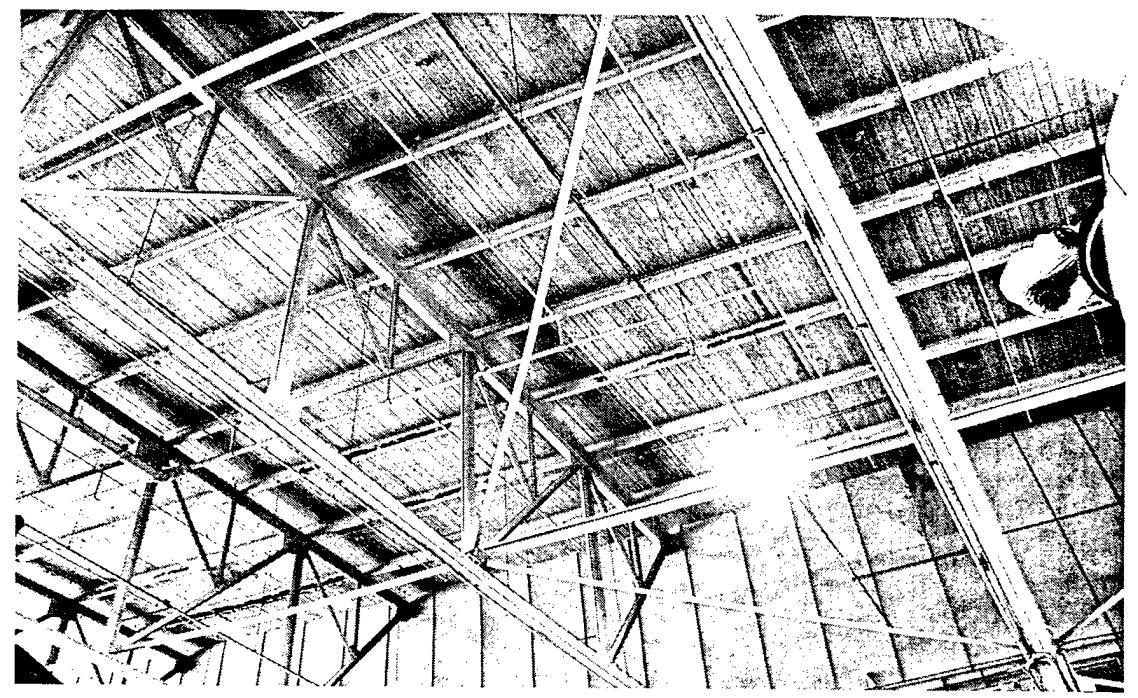
Figure A-11. Buckled diagonal between Columns G2.4 and H2.5.

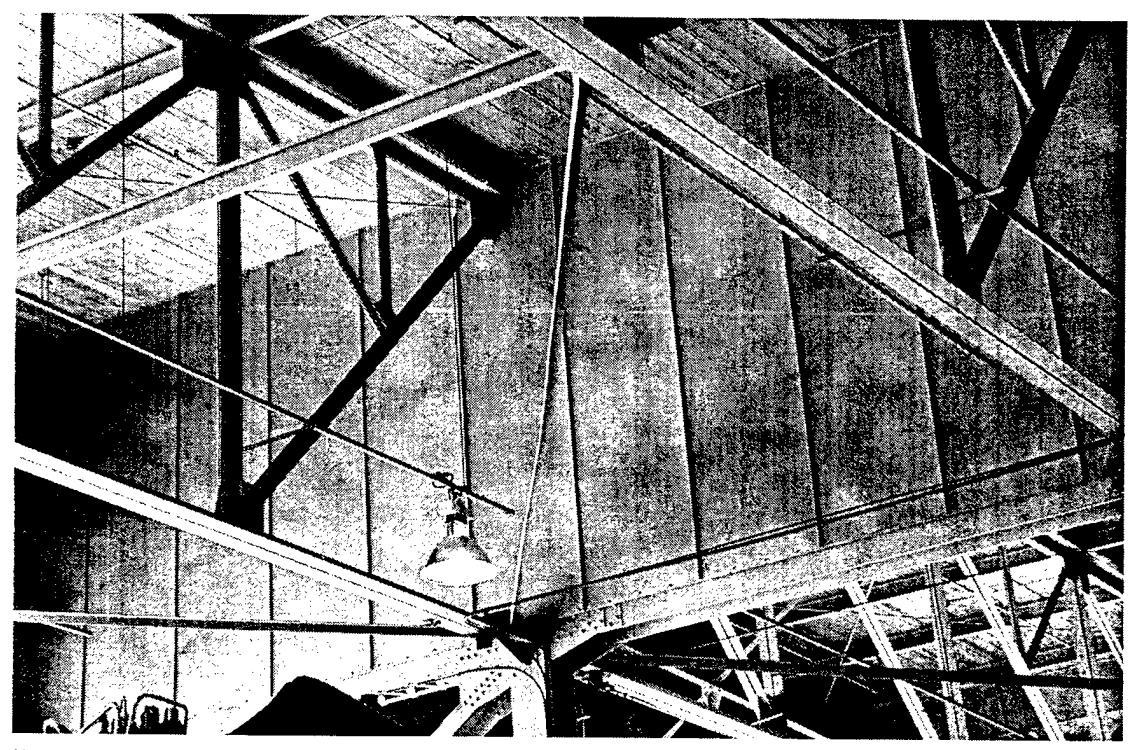
Figure A-12. Buckled diagonal between Columns L2.5 and M3.

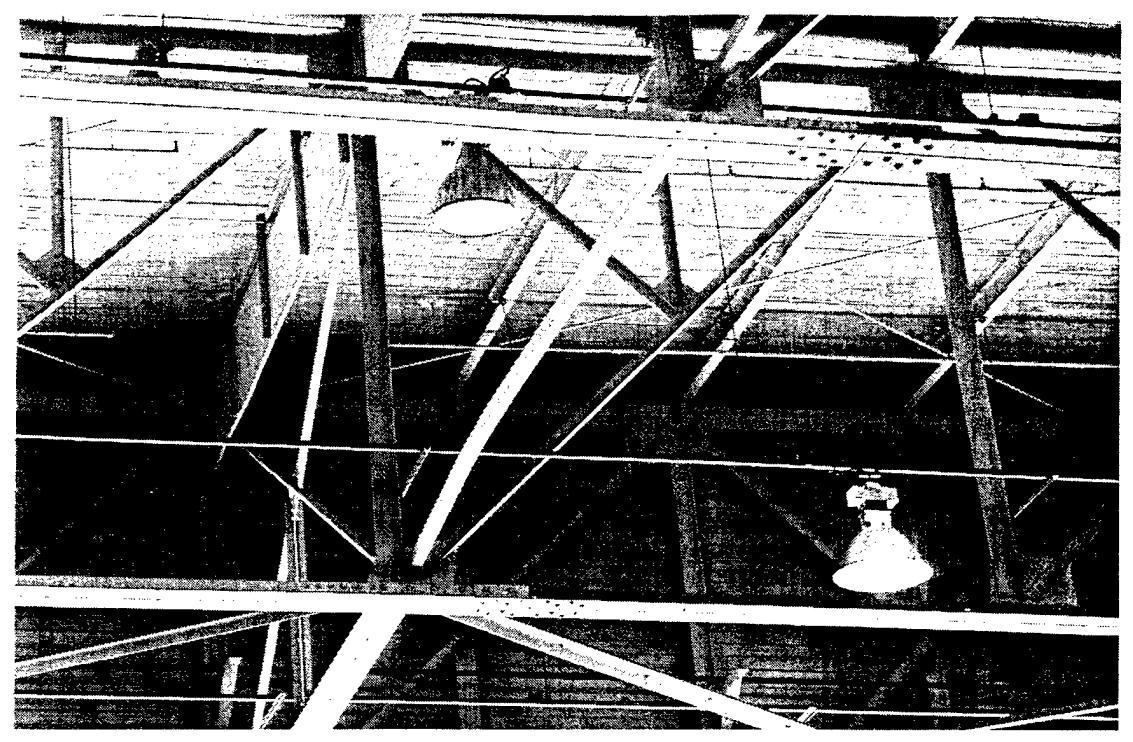
Figure A-13. Buckled bottom chord between Columns L2.4 and M2.4.

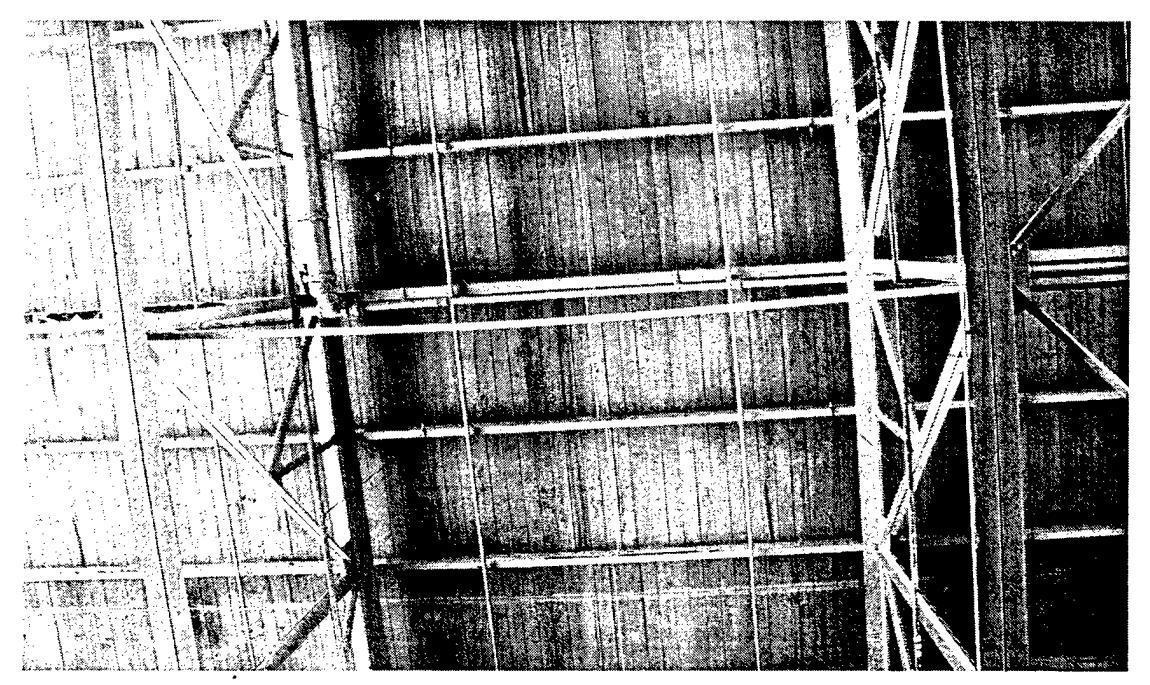
Figure A-14. Buckled bottom chord between Columns H2.5 and J2.5.

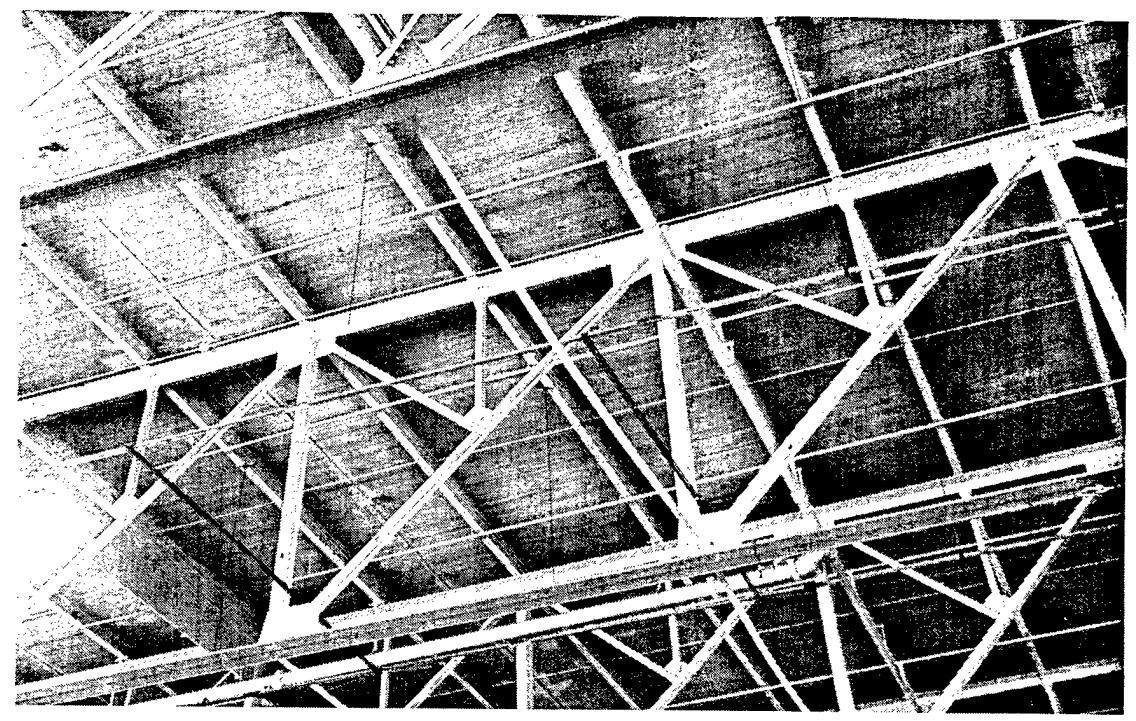
Figure A-15. Buckled bottom chord between Columns C2.5 and E2.5.

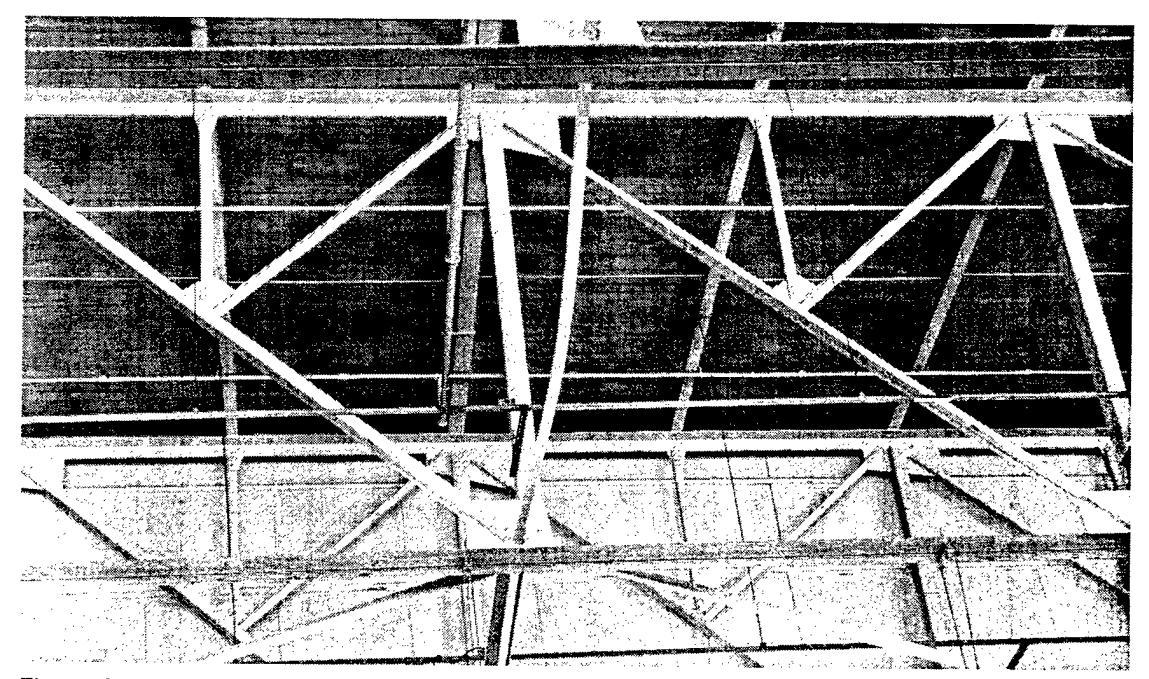
Figure A-16. Buckled bottom chord between Columns E3.1 and F3.1.

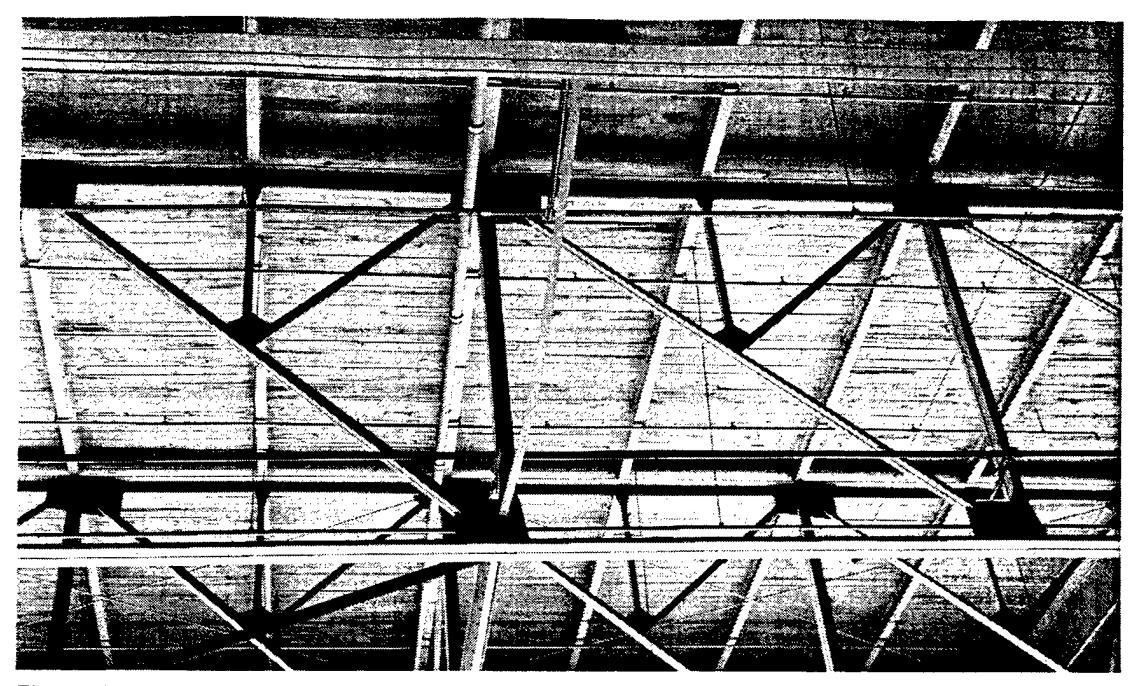
Figure A-17. Buckled bottom chord between Columns K3.1 and L3.1.

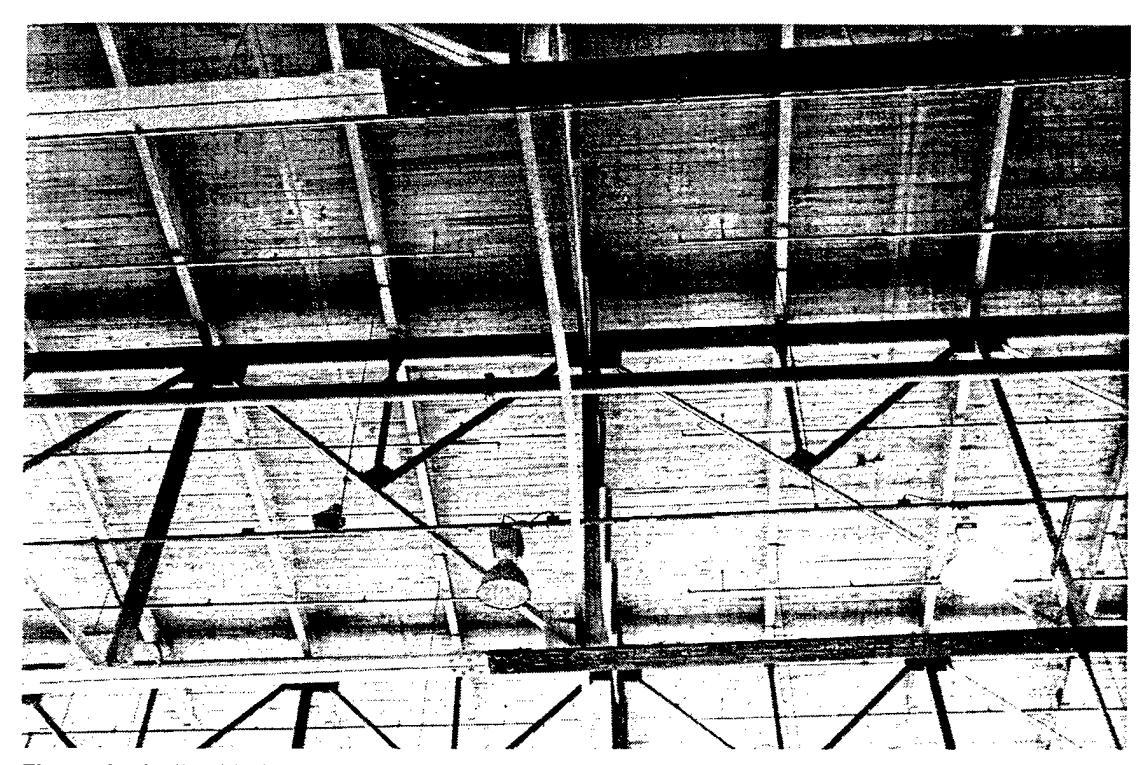
Figure A-18. Buckled bottom chord between Columns H3.2 and J3.2.

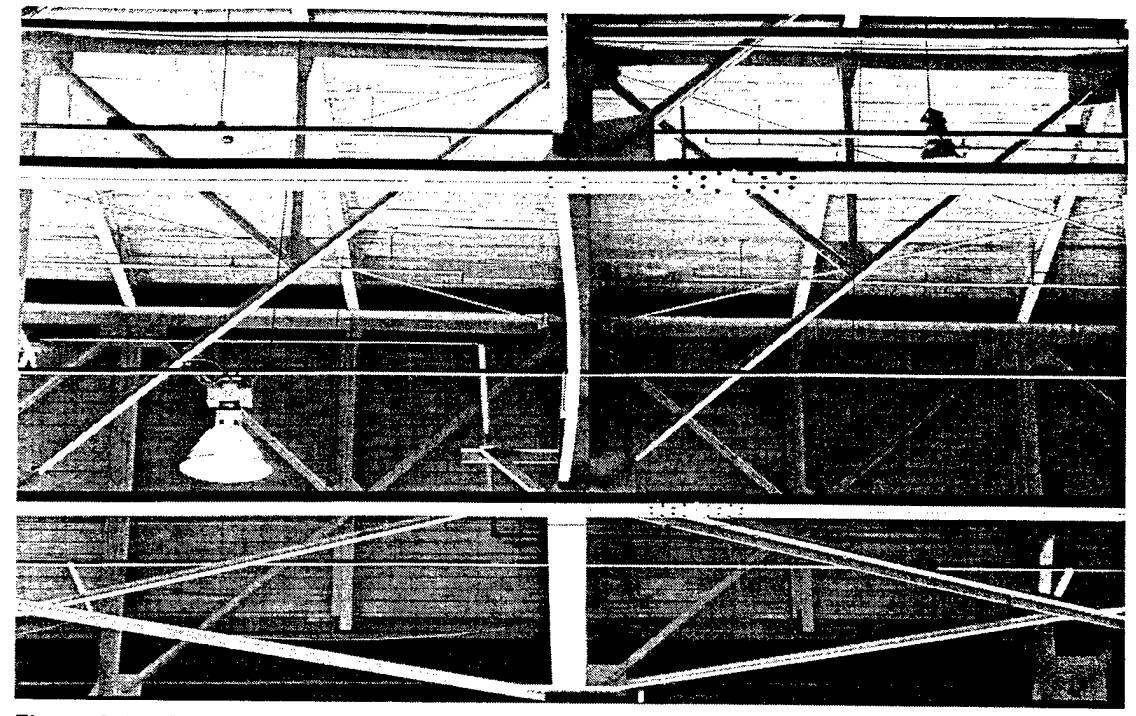
Figure A-19. Buckled bottom chord between Columns L3.4 and M3.4.

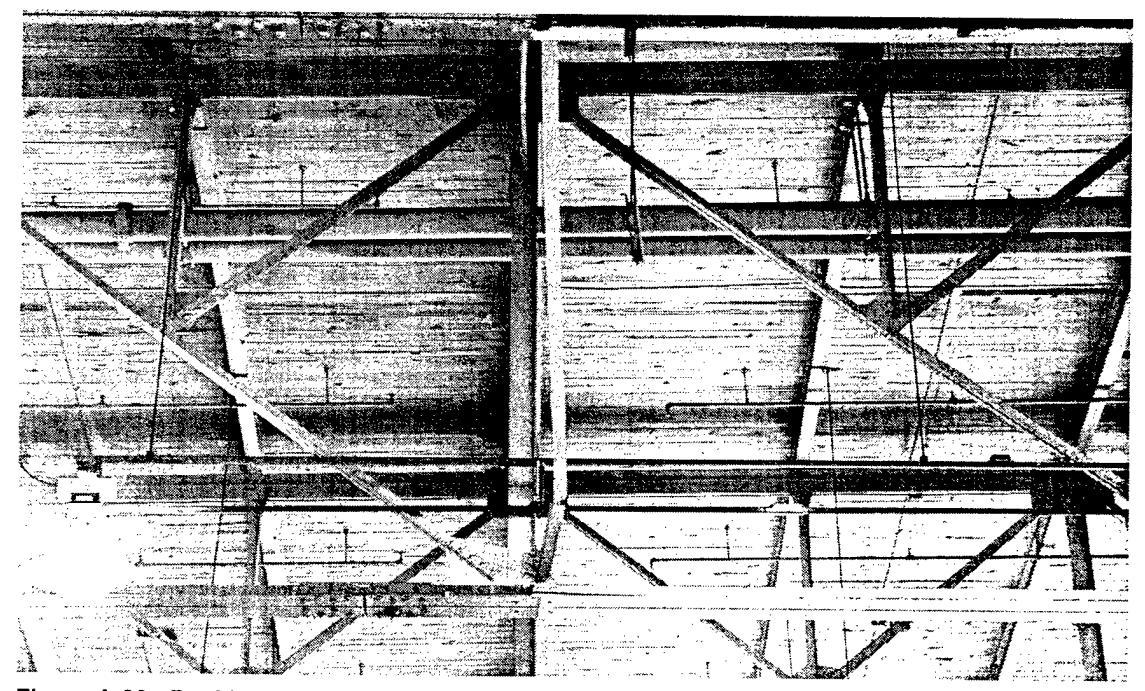
Figure A-20. Buckled bottom chord between Columns E3.4 and F3.4.

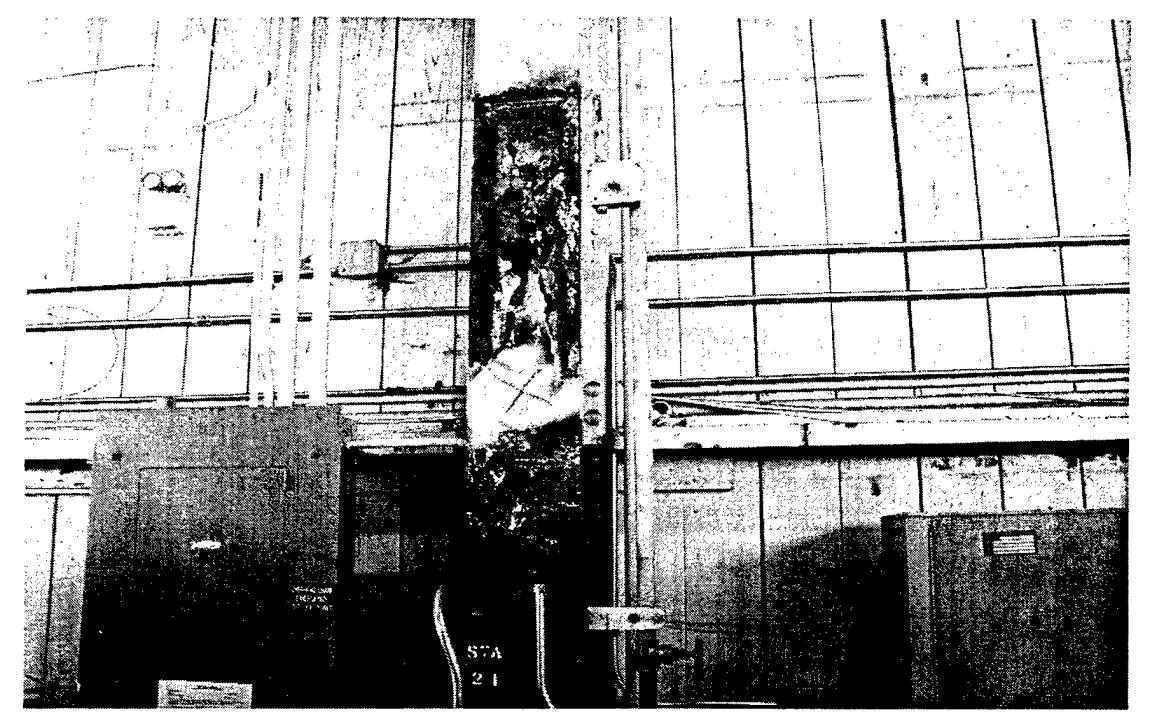
- 17. A column located at K2 (18-I-85) has been damaged from welding and gouging, resulting in an estimated 5 percent strength reduction. See Figure A-21.

Figure A-21. Damage to Column K2 (18-I-85).
