NASA TM X-1194

INVESTIGATION OF HYDROTEST FAILURE OF THIOKOL CHEMICAL CORPORATION it : 260-INCH-DIAMETER SL-1 MOTOR CASE

NATIONAL AERONAUTICS AND SPACE ADMINISTRATION • WASHINGTON, D. C. • JANUARY 1966

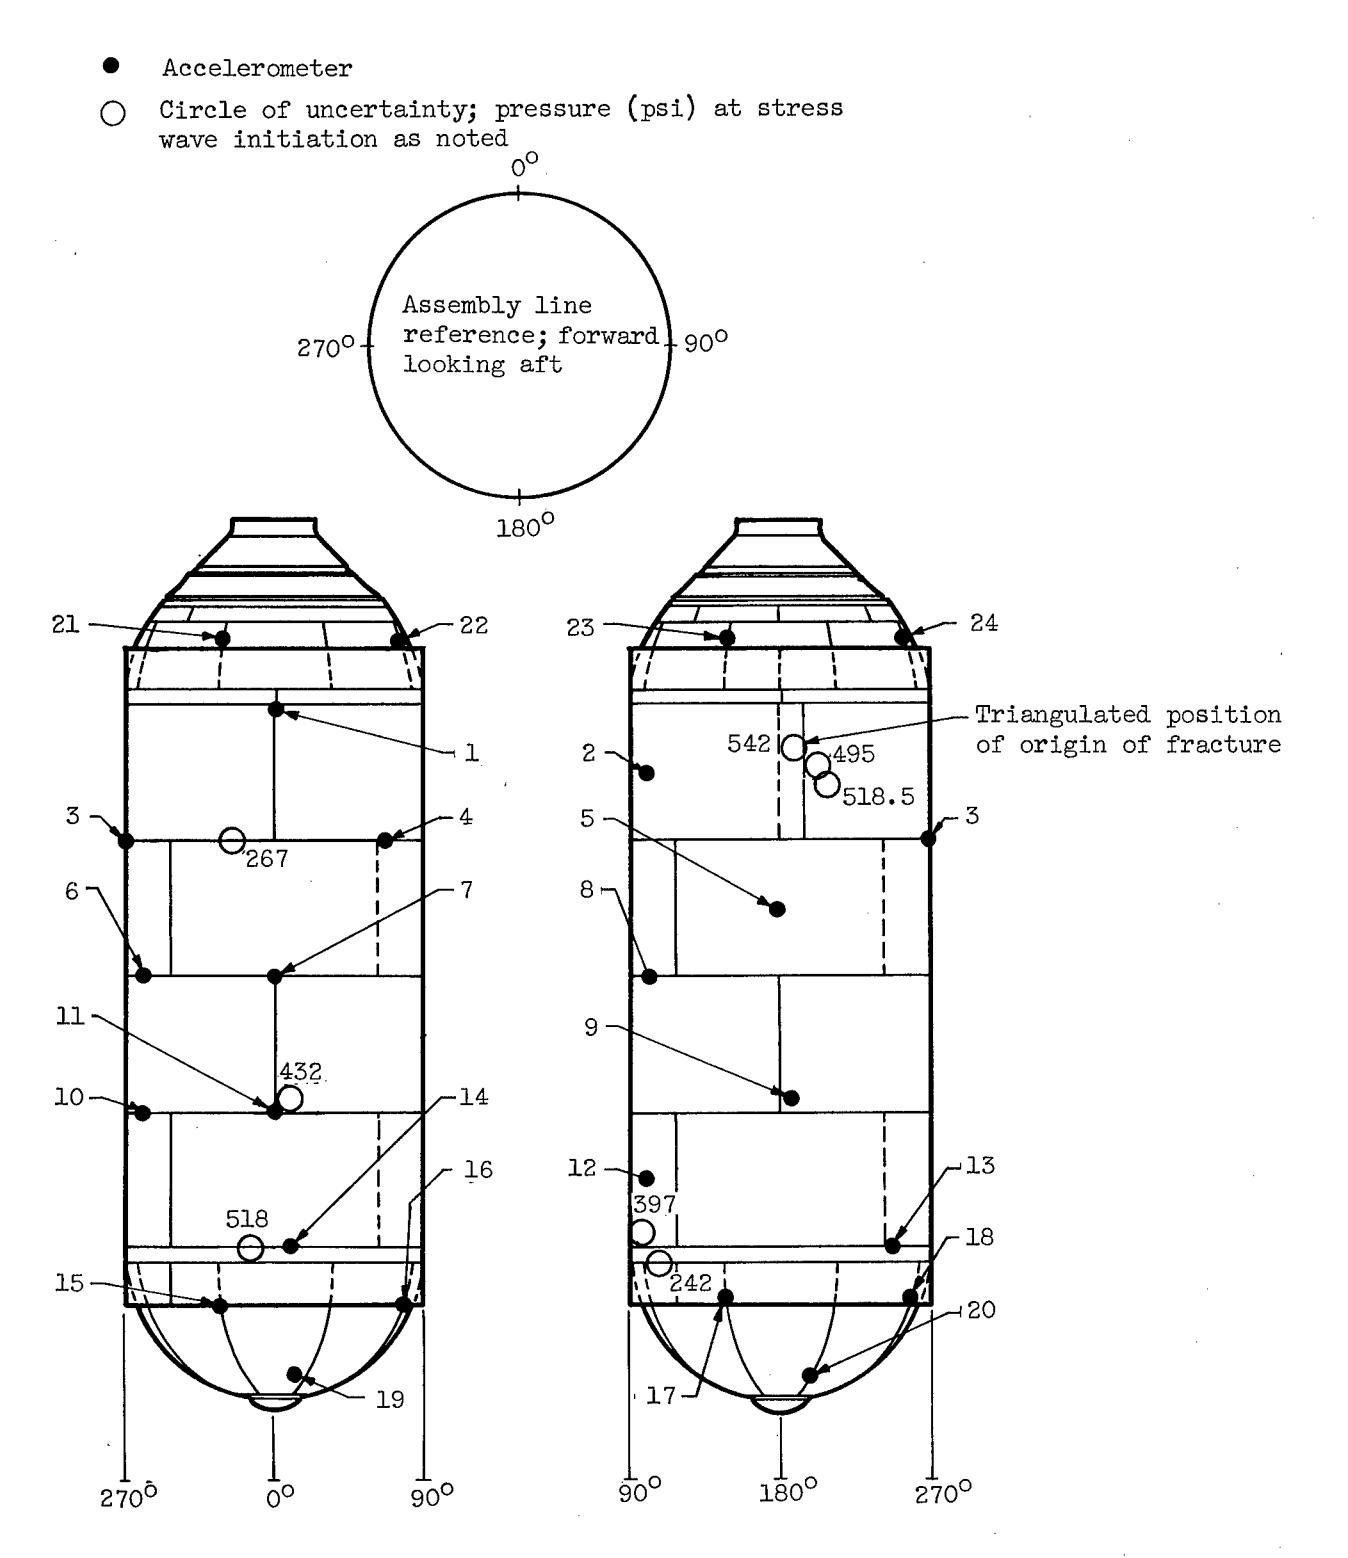
During hydrotest, the accelerometer system mounted on the motor case indicated eight stress waves, including the wave that occurred at failure. The predicted origins and the pressures at stress wave initiation are also shown in figure 3. The first stress wave occurred at a pressure of 242 psi. Previous experience in using a stress-wave detection system on hydrotest of motor cases has shown similar stress wave initiations in areas not related to final failure. Three of the stress wave origins were in the region of the lower skirt where the motor case was bolted to the hydrotest thrust stand. It is probable that some of these stress waves resulted from movement at the bolt holes.

Figure 3. - Locations of accelerometers and stress wave origins on 260-inch-diameter SL-1 motor case.

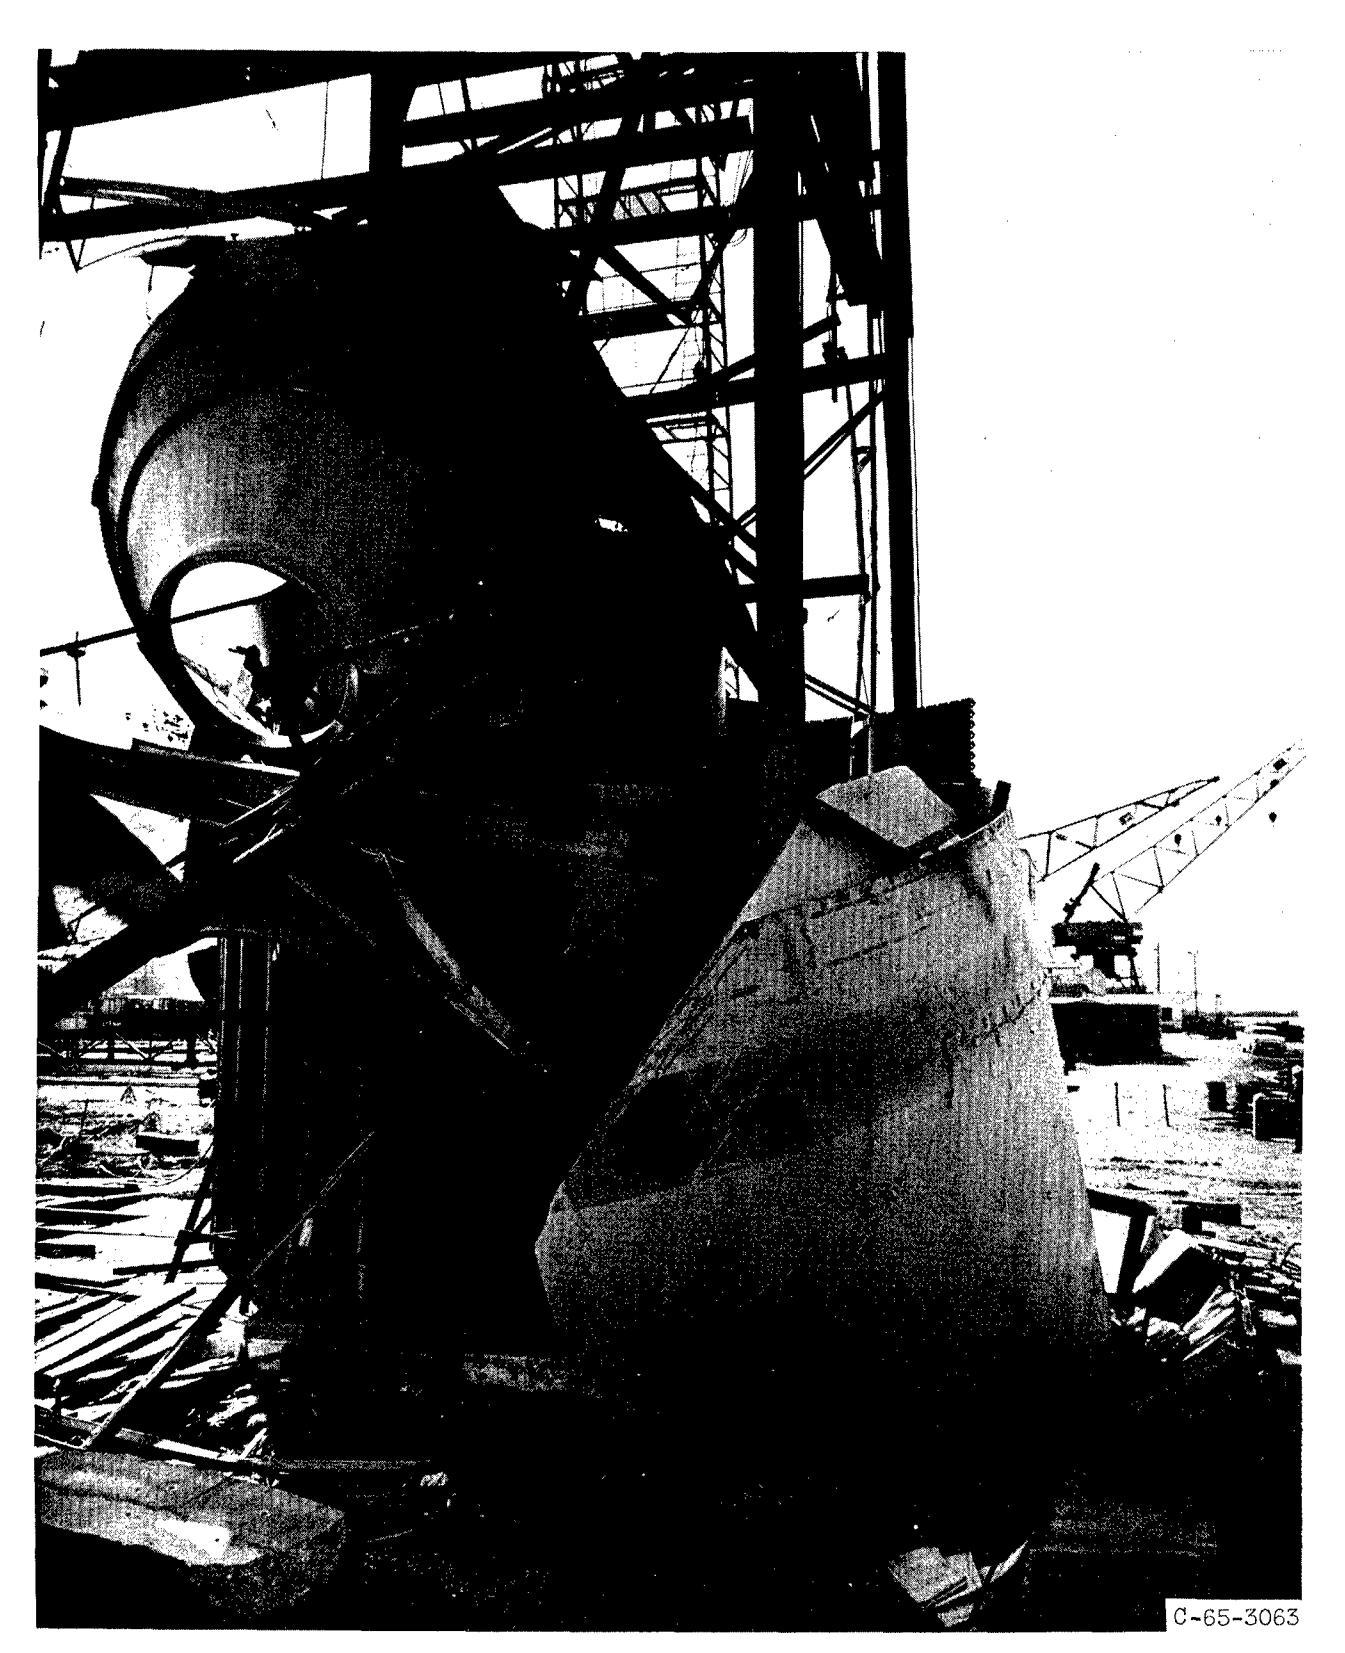
On failure at a gage pressure of 542 psi, the motor case had shattered into several large pieces and many smaller ones that fell into a precarious, interlocked pile within the test tower. Several days were required to remove the pieces to a large shop where they were laid out on the floor for detailed examination. Figure 5 is a photograph taken during this operation that shows the test tower site. A large piece consisting of the aft head and part of the cylindrical section is resting in the framework of the tower, and another large piece of the cylindrical section that had been removed from the tower is shown in the foreground. In spite of the lengthy exposure in the open air, the fracture surfaces were not visibly rusted; nor were they mechanically damaged in handling to any important extent. It was necessary to cut two of the larger pieces with a torch to facilitate removal, but these cuts did not impair the subsequent examination. Figure 6 shows the pieces laid out on the shop floor with the aft head in the center foreground and the other pieces arranged as nearly as possible in proper relation to one another.

Figure 5. - Portion of failed motor case as it was being removed from hydrotest tower.

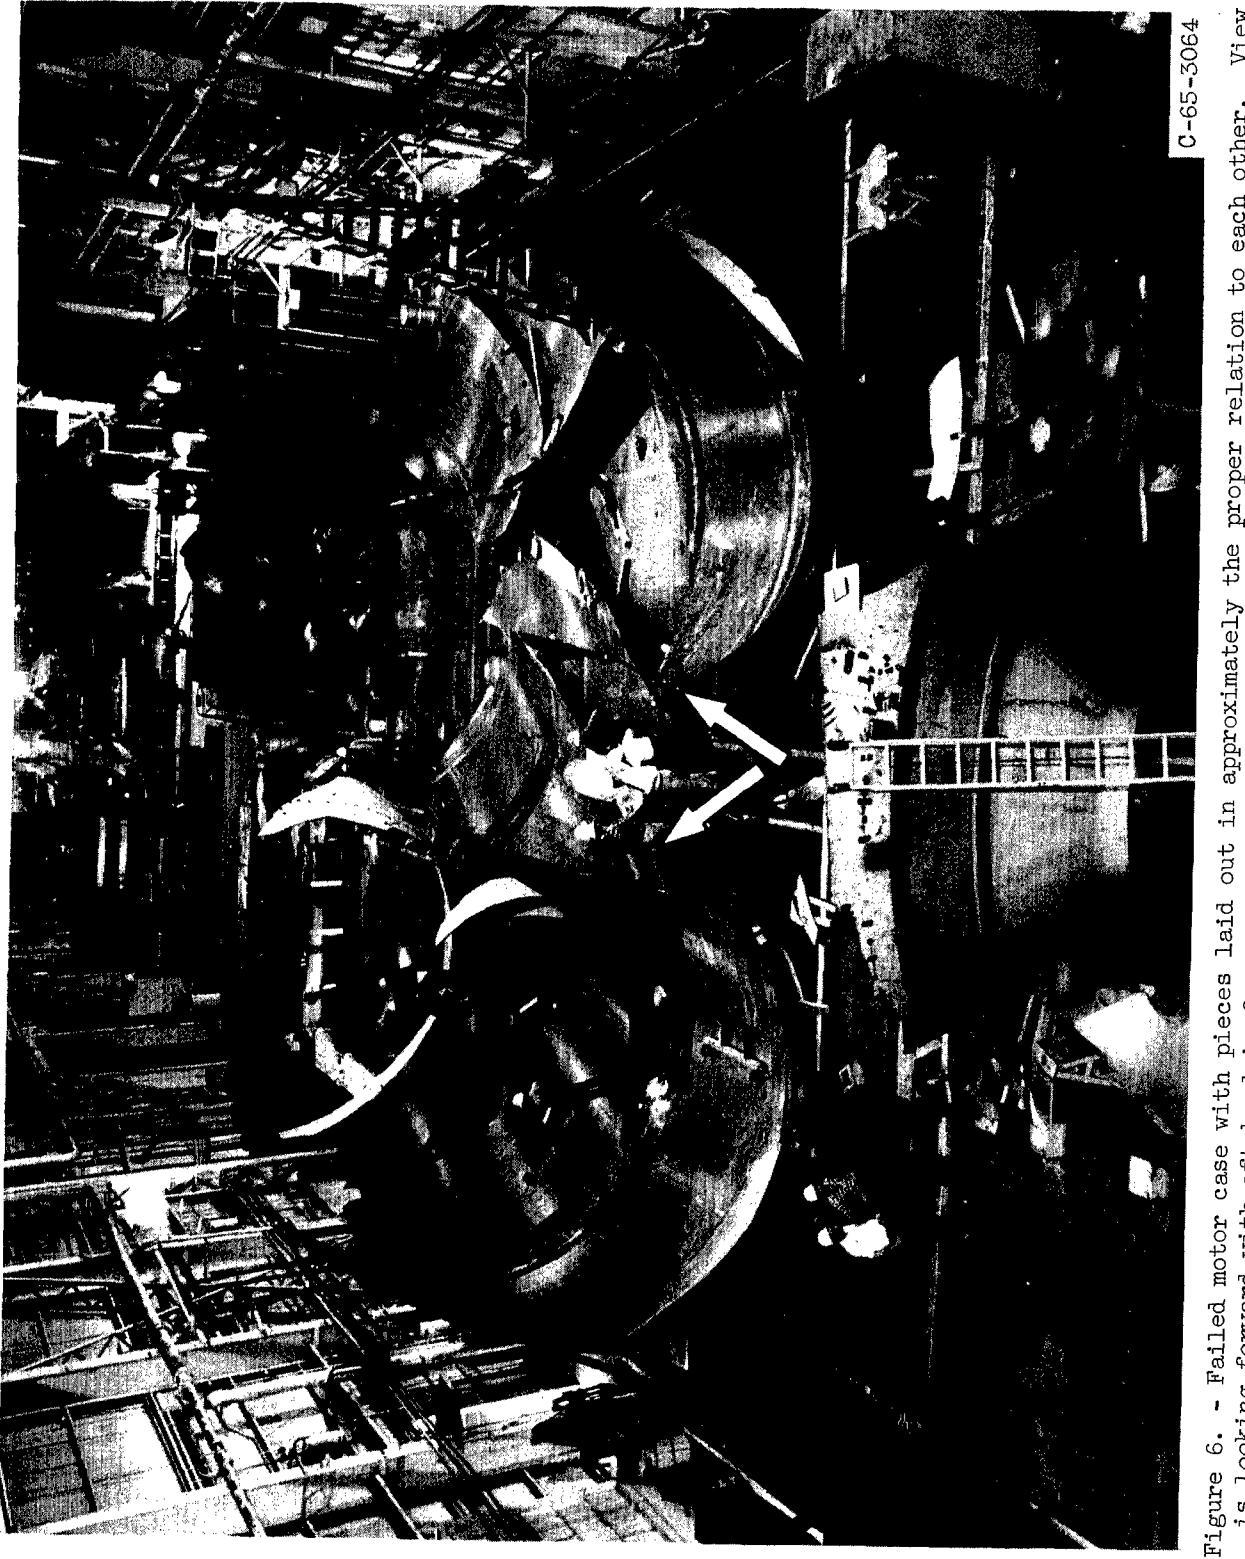
Figure 6. - Failed motor case with pieces laid out in approximately the proper relation to each other. View is looking forward with aft head in foreground. Origin of fracture indicated by arrows.

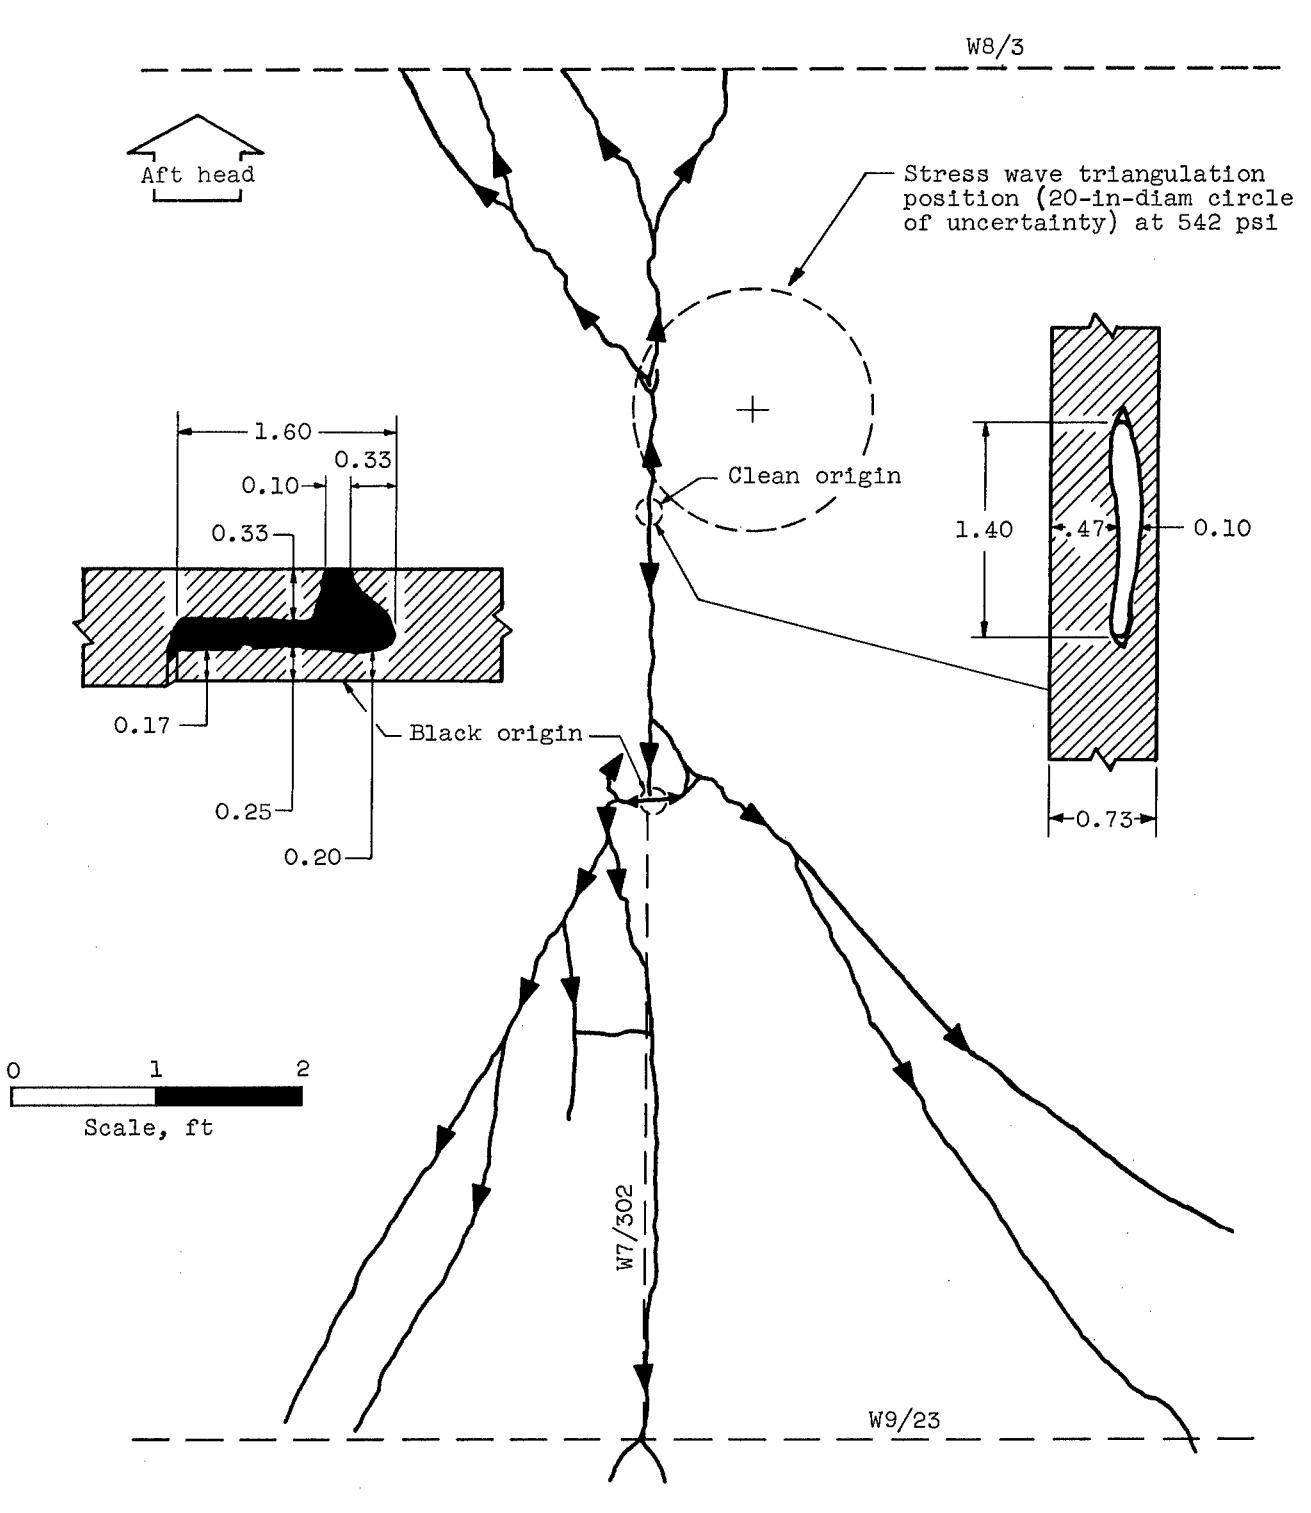
From the fracture map (fig. 7), it is clear that the fracture pattern developed from an origin close to the W7/302 longitudinal weld and somewhat forward of the W8/3 aft Y-ring weld. Although they are not shown here, the fracture paths in the skirts and the domes were completely mapped, and it was established that they had developed from cracks running out of the cylindrical section. There were no independent origins in these parts of the motor case, although there were one or two fracture branches that had run from the cylinder into one of the heads and then continued on back into the cylinder.

In fact, the local fracture pattern in figure 7(b) can only be explained satisfactorily if it is assumed that fracture started first at the clean origin with the initial, longitudinal crack running both aft toward the head and forward toward the position of the black origin. The intensity of the stress field around the black origin would have increased with the approach of the crack, so that secondary crack propagation would have been triggered at the black origin before the primary crack reached it. The subsequent intersection of the developing transverse crack by the primary crack would then have disturbed the stress field in a way that would account for the early branching of both ends of the transverse crack. Since the velocity of propagation of brittle fracture in steel can approach 5000 feet per second, it is likely that the interval between primary and secondary crack initiation would be of the order of a millisecond.

(b) Detail in immediate vicinity of primary and secondary origins. Inset sketches show shapes and dimensions of the two origins.

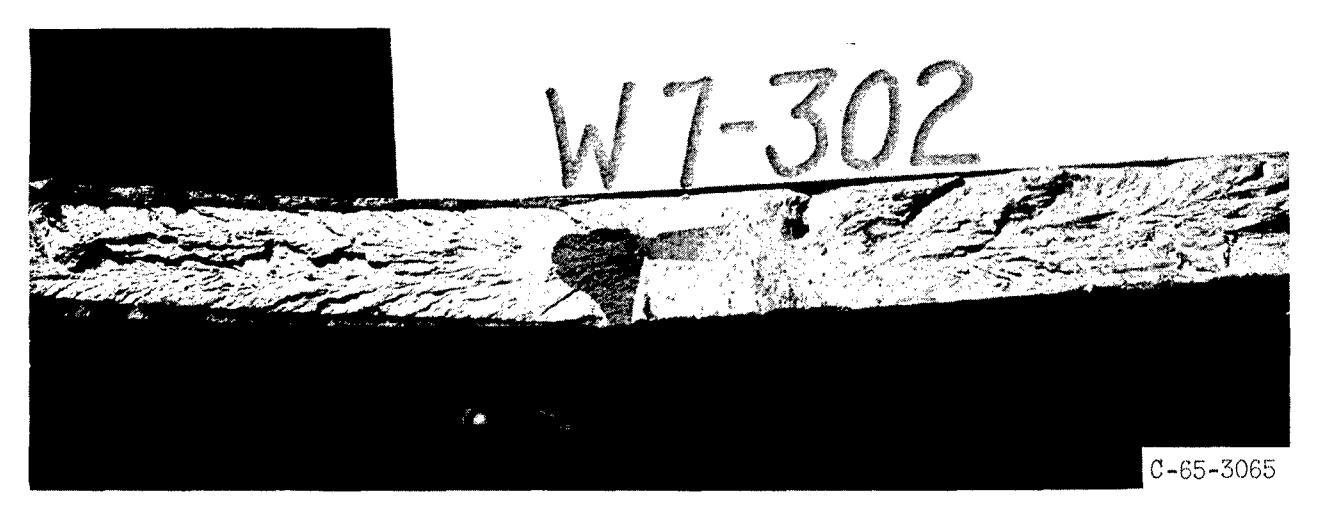
Figure 8. - Typical chevron markings on fracture surface showing directions of fracture propagation away from black origin.

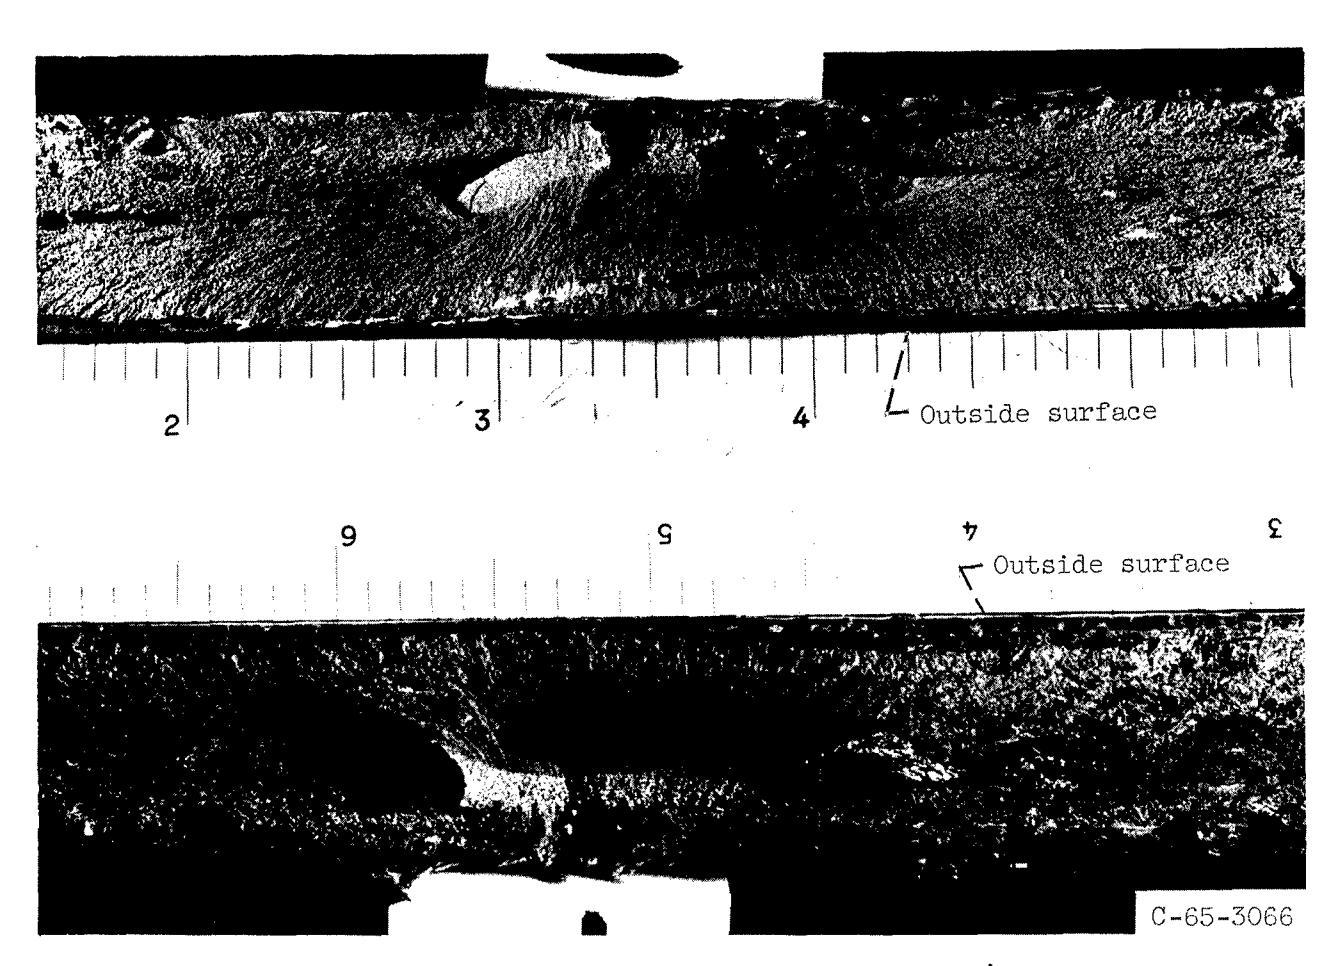
Two distinct fracture origins were discovered in the expected region, both associated with areas of TIG weld repair on the inside surface of the W7/302 weld. One origin was oriented parallel to the weld centerline, and the other transverse to it. The positions of these origins and sketches of their contours are shown in the detail fracture map (fig. 7(b)). Because of the obvious difference in appearance to the naked eye, the longitudinal defect was termed the "clean" origin, and the transverse defect the "black" origin. Photographs of the mating surfaces of the clean origin are shown in figure 9. The boundary is quite distinct except for two damaged places on one of the mating surfaces that must have rubbed against another piece of metal, but the appearance of the origin surface differs only in texture and tone from that of the surrounding fracture: there is no suggestion of a deposit on the surface. On the other hand, the black origin was covered with a tightly adhering, black deposit, as shown in figures 8 and 10. This deposit was eventually identified as essentially an iron oxide. This difference between the two origins is probably connected with the fact that, whereas the boundary of the black origin extends to the outer surface of the vessel wall, the clean origin is completely submerged within the wall.

Figure 9. - Mating surfaces of clean origin on W7/302 weld.

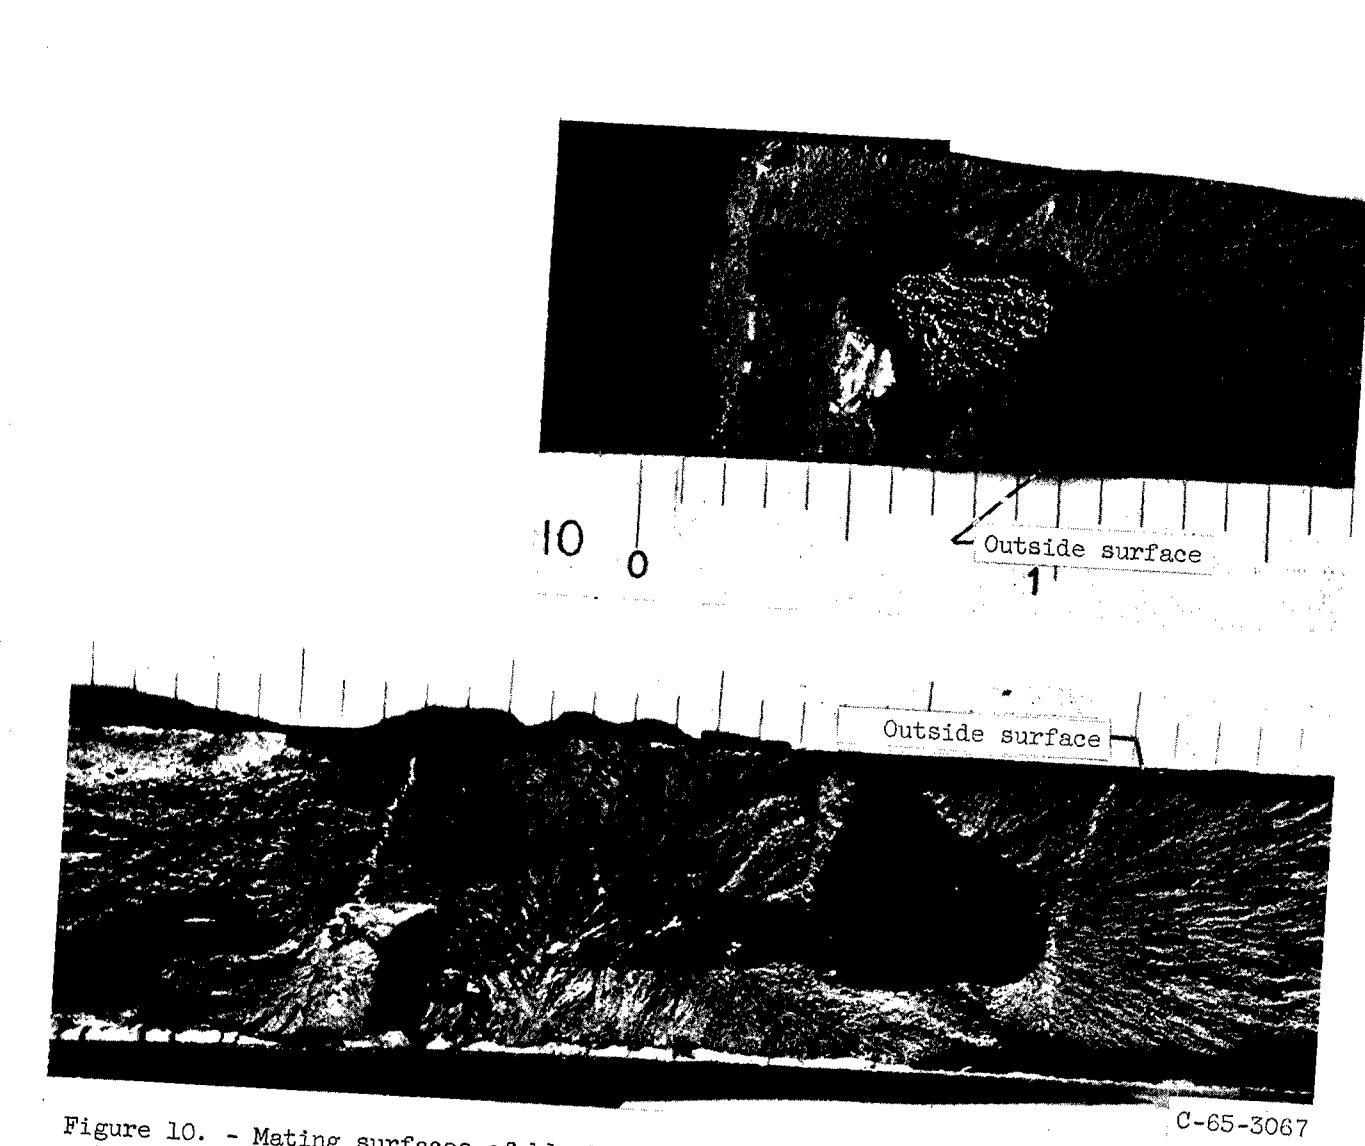
The black deposit on the transverse origin was examined by glancing-angle X-ray diffraction, electron diffraction, and electron-probe microanalysis. The diffraction patterns corresponded to a mixture of ferrous oxide (Fe_2O_3) and ferric oxide (Fe_3O_4). The analysis showed that the metallic constituent was predominantly iron with small amounts of nickel, molybdenum, cobalt, and titanium. This oxide must have formed at a high temperature. Comparison of the color with oxidized crack surfaces obtained by heating in air at high temperatures suggests a formation temperature at least as high as 800° F. It would appear that at least some of the oxidation must have occurred during the aging cycle at 835° F.

Estimation of the upper bound $K_{\rm I}$ value for the black origin is much more uncertain. The $K_{\rm I}$ value should be greatest at the sharp corner in the origin boundary (figs. 10 and 12), but advance of the crack front from this point would produce a smoother contour and, temporarily, a lower $K_{\rm I}$ value. Since there is no better basis for estimation, it will be assumed that the $K_{\rm I}$ value for this origin is unlikely to be greater than that based on an ellipse 1.6 inches long by 0.5 inch wide (this width being equal to the distance from the outer surface of the wall to the far boundary of the origin). The upper bound $K_{\rm I}$ value calculated on this basis is then 37 000 psi \sqrt{in} . The fact that the black origin was open to the surface over a short distance will hardly

Figure 10. - Mating surfaces of black origin on W7/302 weld. (Part of black material has been removed from one surface for analysis.)

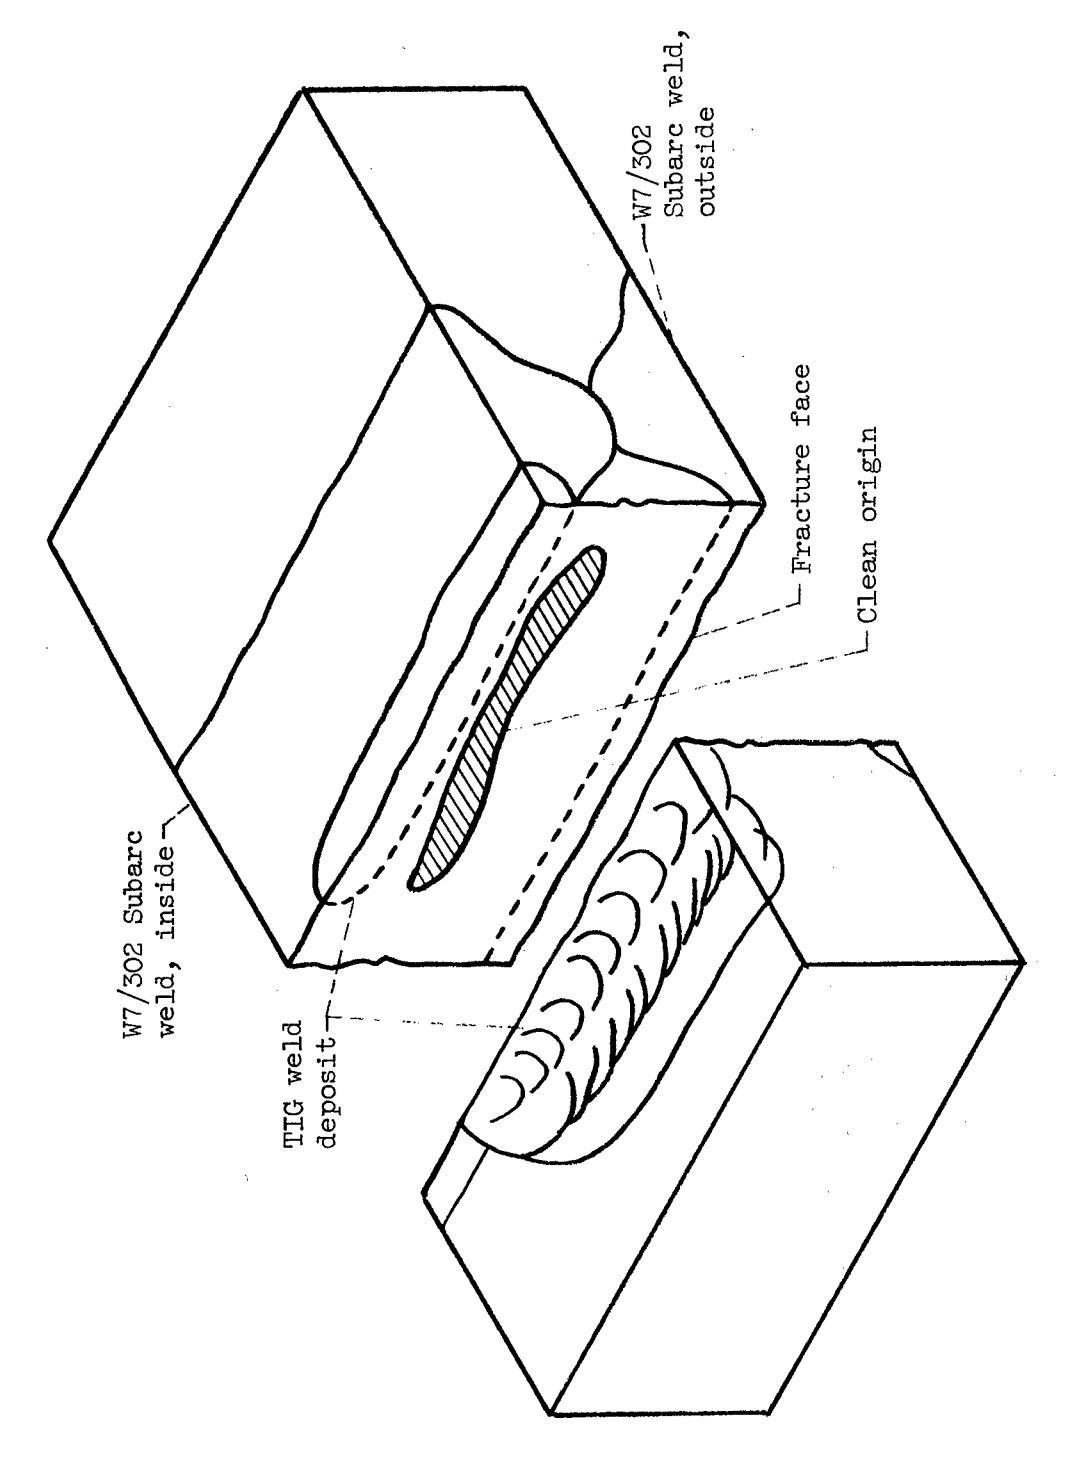
ground and etched to reveal the positions of the fusion lines and heat-affected zones of the W7/302 weld. It was then found that each origin was located beneath a separate manual TIG weld that had been deposited on the inside of the vessel to replace part of the original subarc weld. These locations are indicated in figures 11 and 12. The clean origin (fig. 11) was located near one edge of what appeared to be a fusion line TIG repair weld, and the black origin (fig. 12) was located near one end of a TIG repair, which covered the whole width of the weld and heat-affected zones. These locations are discussed in greater detail later. The TIG weld areas were identified by the responsible welding engineer as simulated repairs to an originally sound subarc weld. The simulated repairs had been made as part of an investigation concerned with cracking that had been encountered in TIG repair welding of meridional dome Experimental TIG repairs had been made at three places on the W7/302 welds. weld, but a total of four nondestructive inspections by PT, UT, and RT at times varying from 1 day to 19 weeks after the repairs were made had revealed no indications of defects in the repaired regions. The more detailed examination of the two origins is discussed in the next section, following discussion of the sequence of fracturing.

Figure 11. - Isometric drawing showing relation of clean origin to weld deposits.

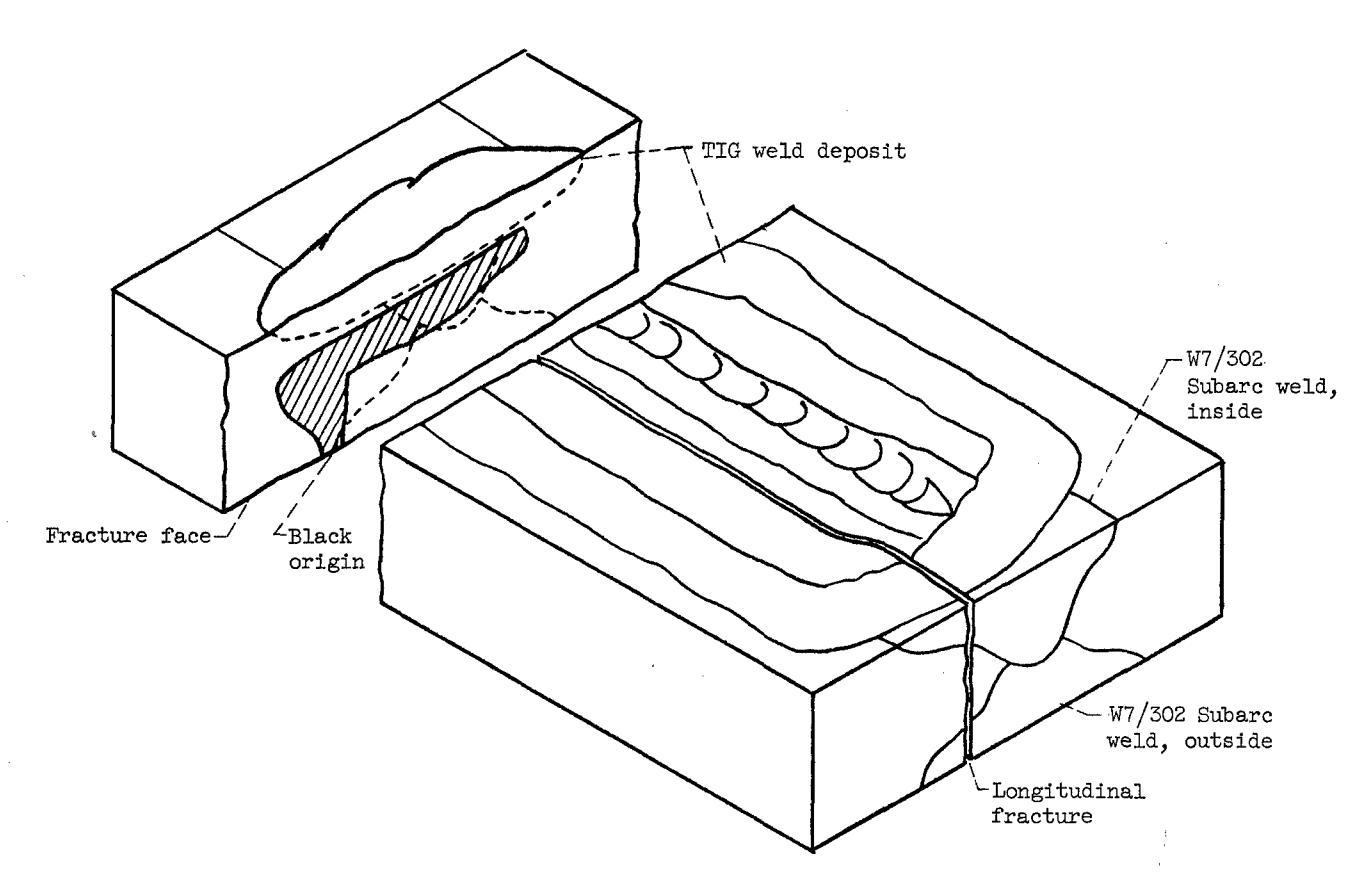
The nominal stress across the black origin is estimated to have been 46 000 psi at the failure pressure of 542 psi. This estimate allows for the static pressure head and the thrust on the fixed piston, but assumes the bending stress to be zero. The estimate of the lower bound of the K_I value for the black origin is based on an ellipse 1.6 inches long by 0.2 inch wide; these dimensions correspond to those of the black origin if the enlarged end is neglected. The estimated lower bound K_I value for the black origin is then 25 000 psi $\sqrt{\text{in.}}$, and this is probably a good estimate of the correct value for the narrow limb of the origin that crosses the subarc weld proper (fig. 12).

Figure 12. - Isometric drawing showing relation of black origin to weld deposits.

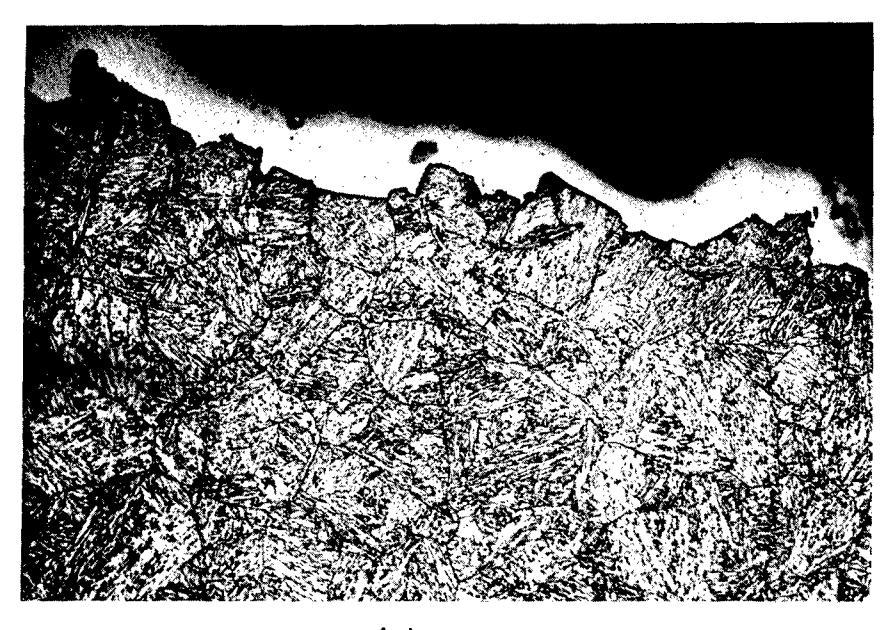
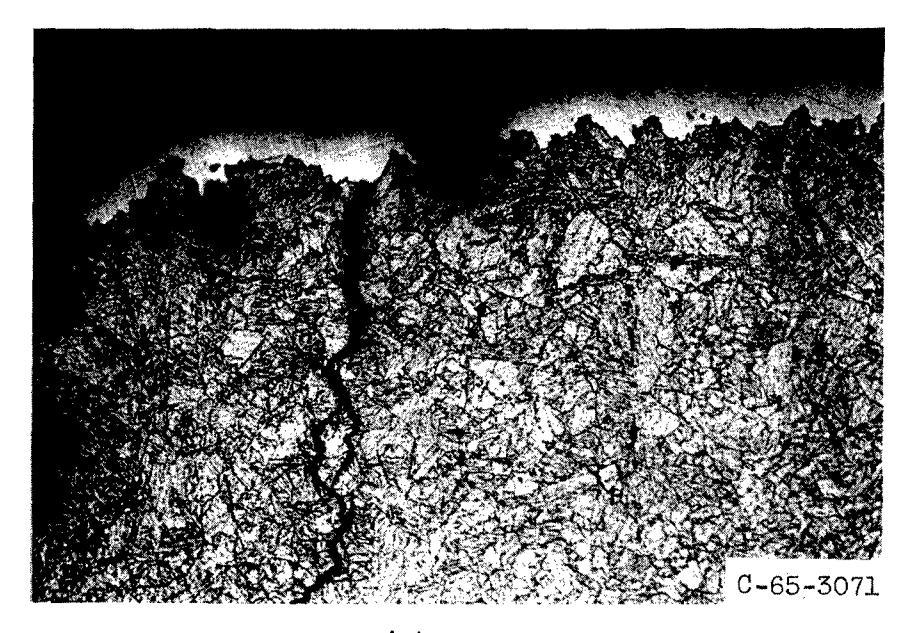
Figure 21. - Fracture profiles of clean defect region (section B-B of fig. 20(a)). Nital etchant. X200.

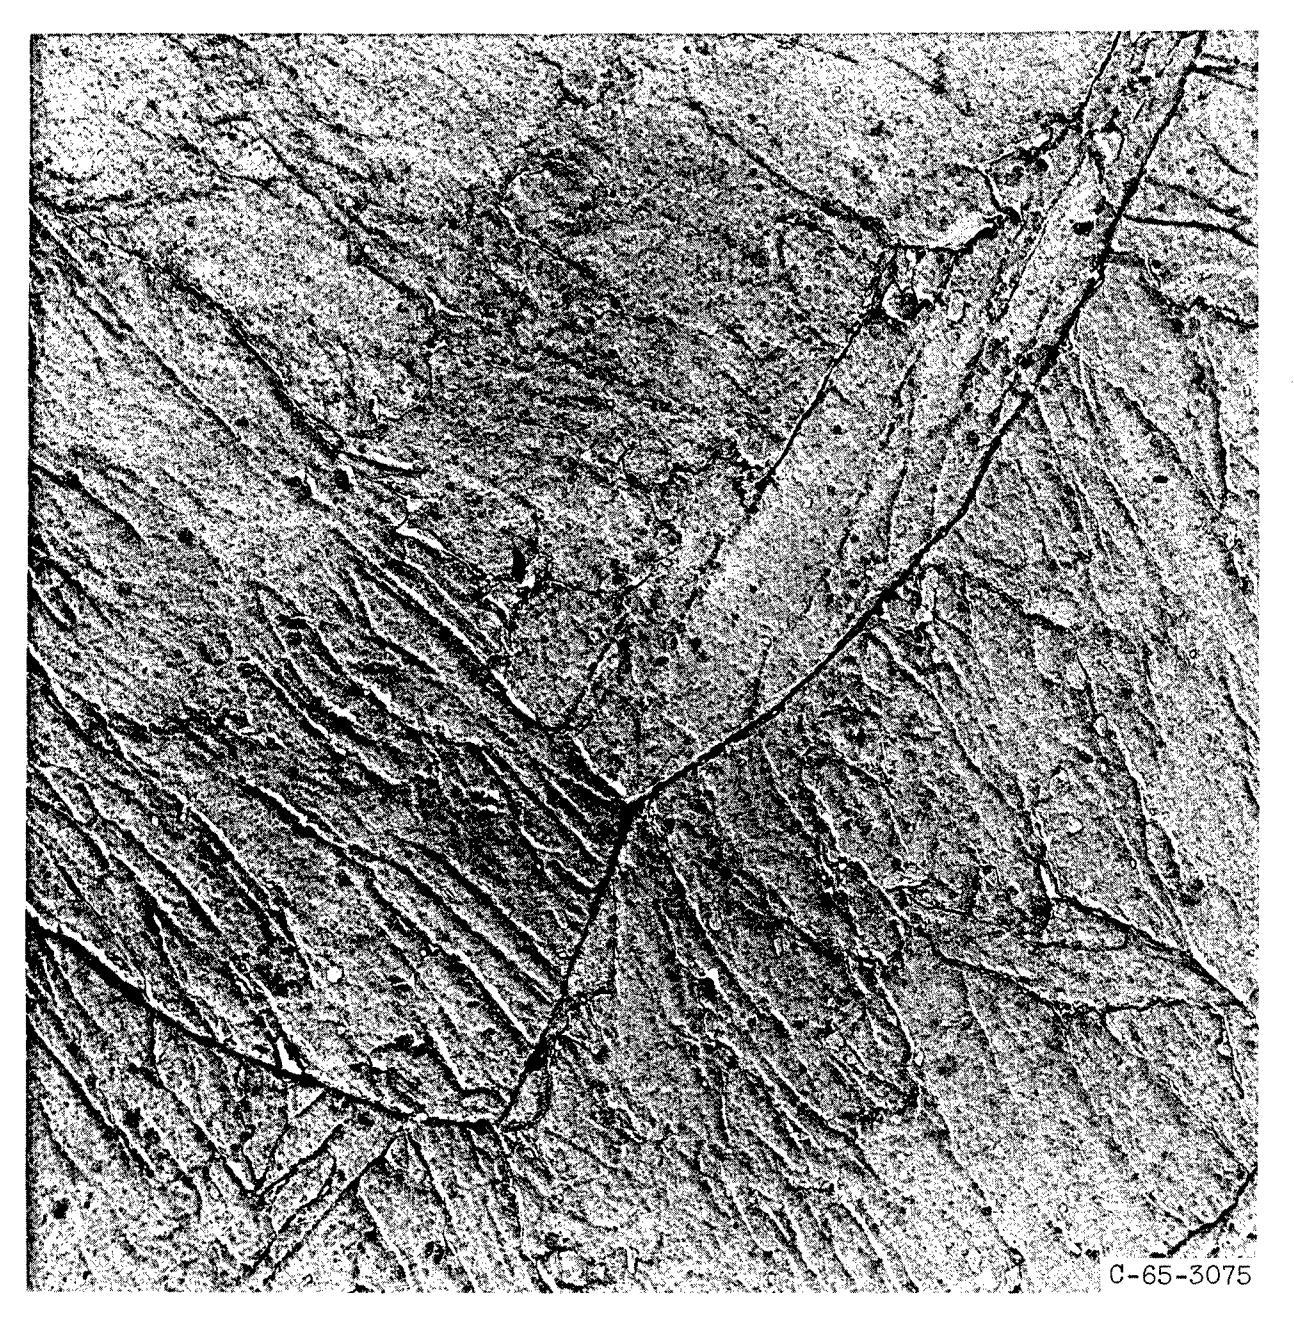
Figure 23. - Replication electron micrograph of area near clean defect. x12 000.

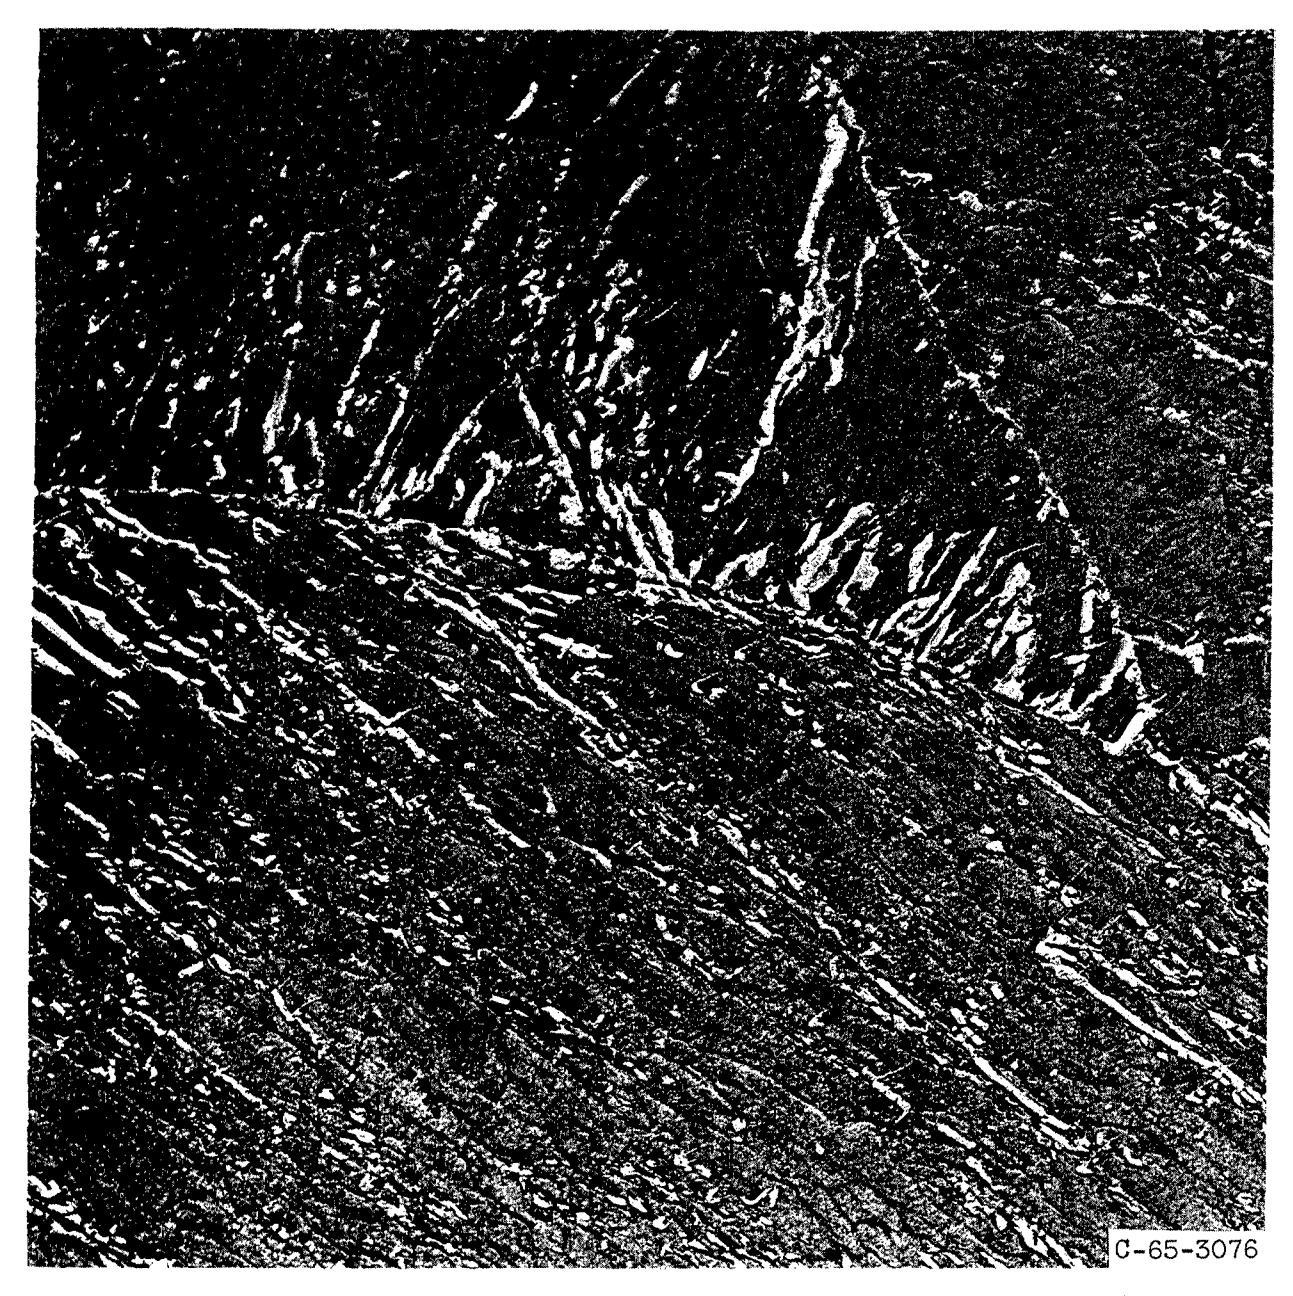
Figure 24. - Replication electron micrograph of region of base plate near subarc weld fusion zone in clean defect region. X10 000.
