NASA TM X-1194

INVESTIGATION OF HYDROTEST FAILURE OF THIOKOL CHEMICAL CORPORATION it : 260-INCH-DIAMETER SL-1 MOTOR CASE

NATIONAL AERONAUTICS AND SPACE ADMINISTRATION • WASHINGTON, D. C. • JANUARY 1966

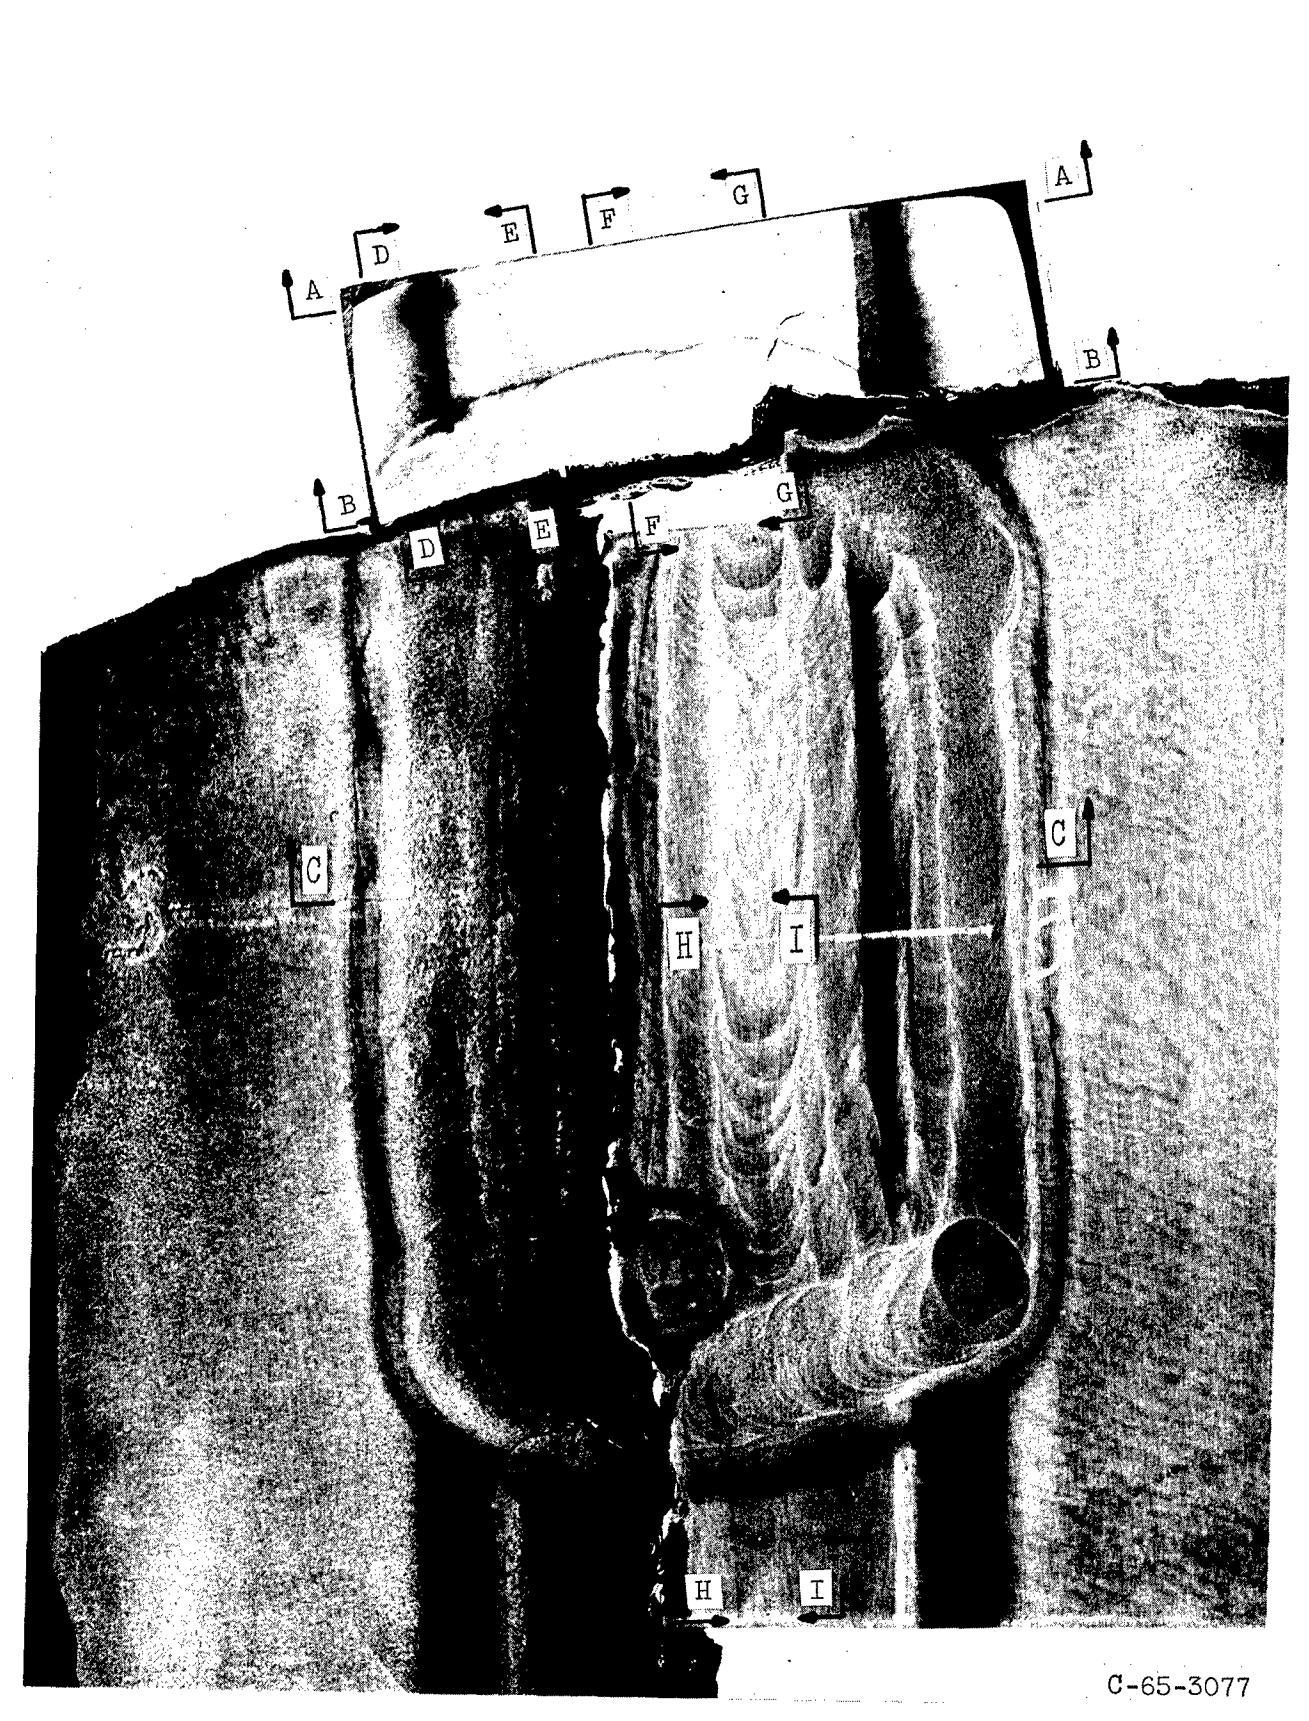
Figure 25. - Composite view of black defect region. Fragments 5, 6, and 8. x1.5.

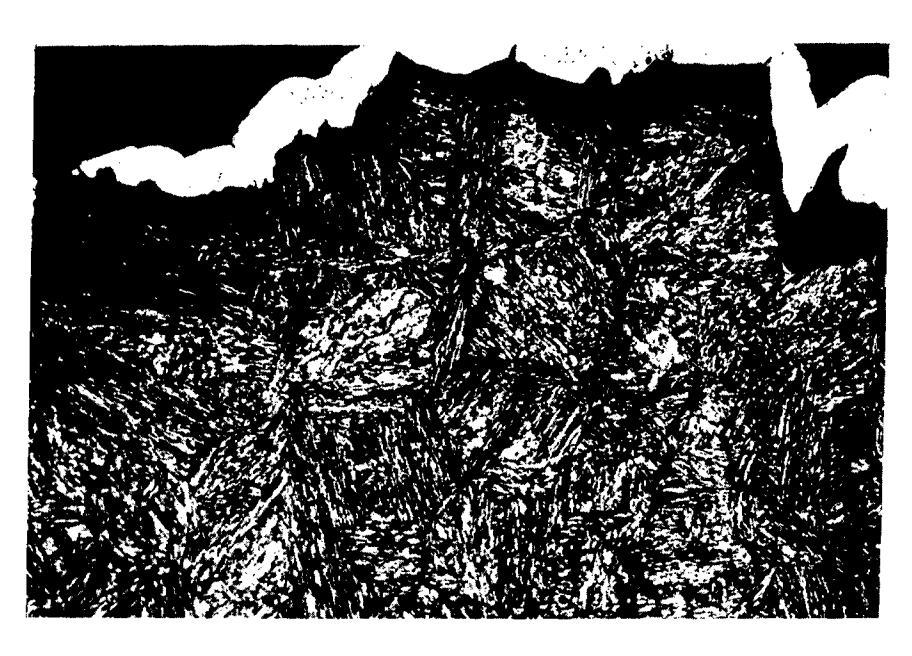
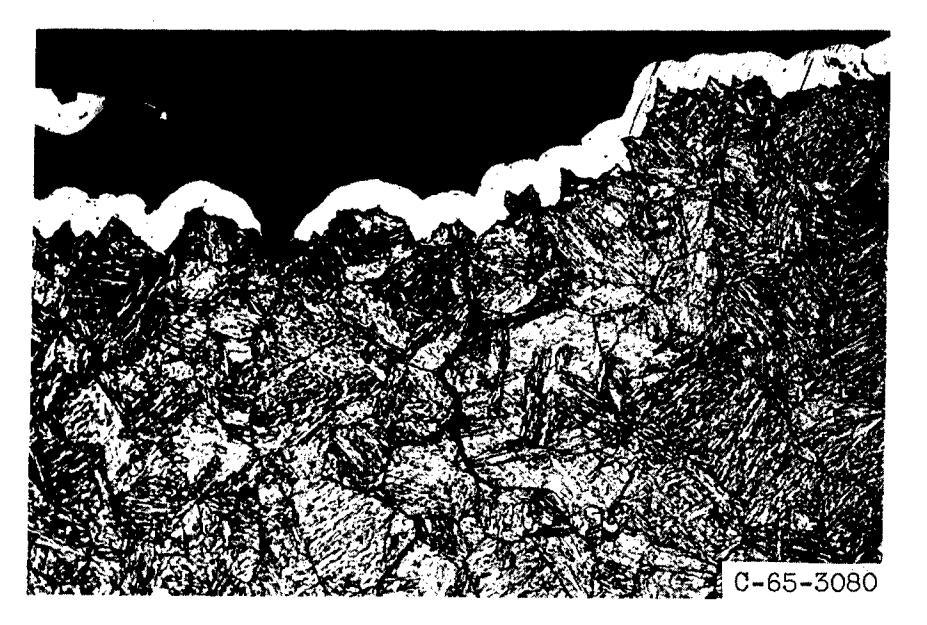
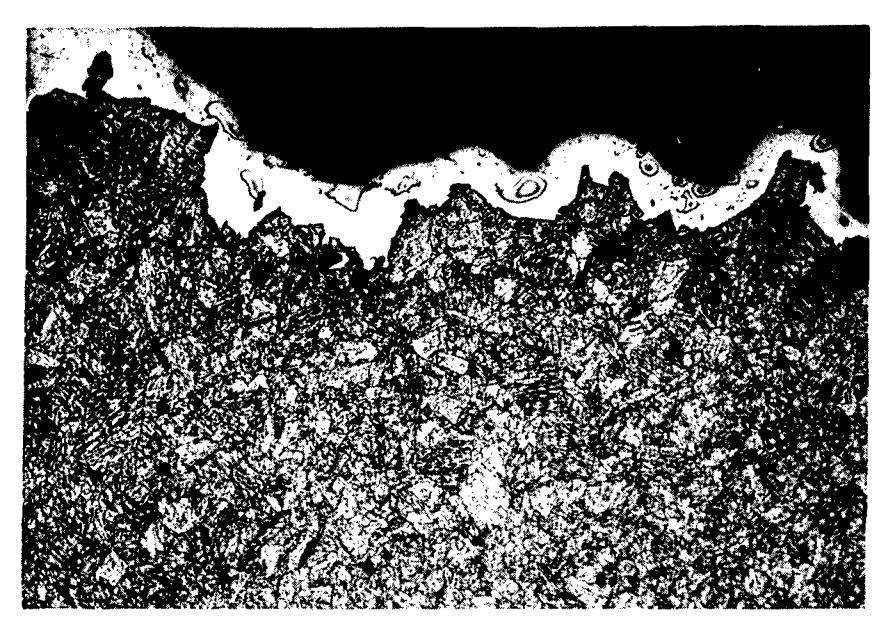
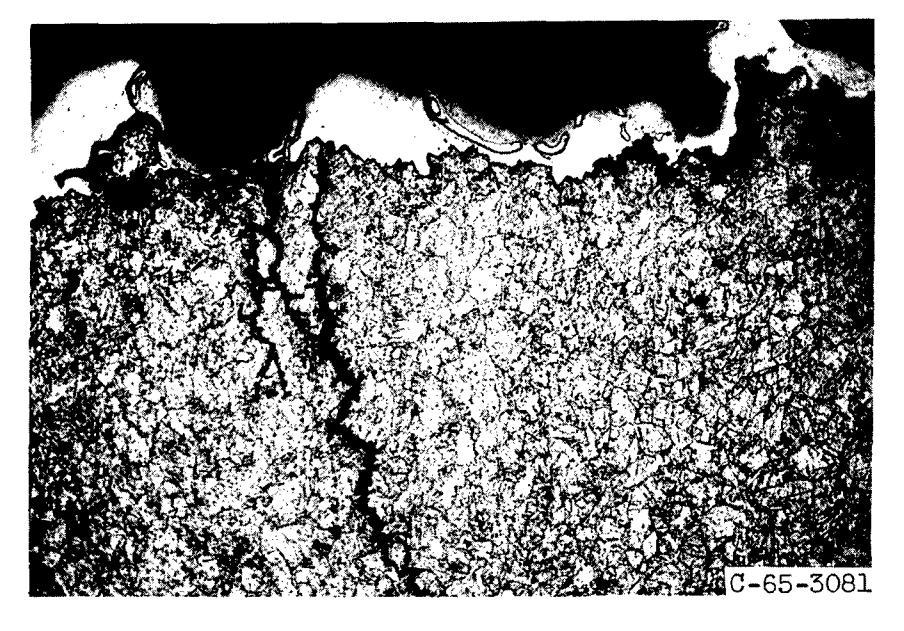
(a) Black defect (from area 1, section E-E, fig. 27).

(b) Away from black defect (base plate, from area 2, section E-E, fig. 27).

Figure 28. - Fracture profiles of black defect region. Nital etchant. ×200.

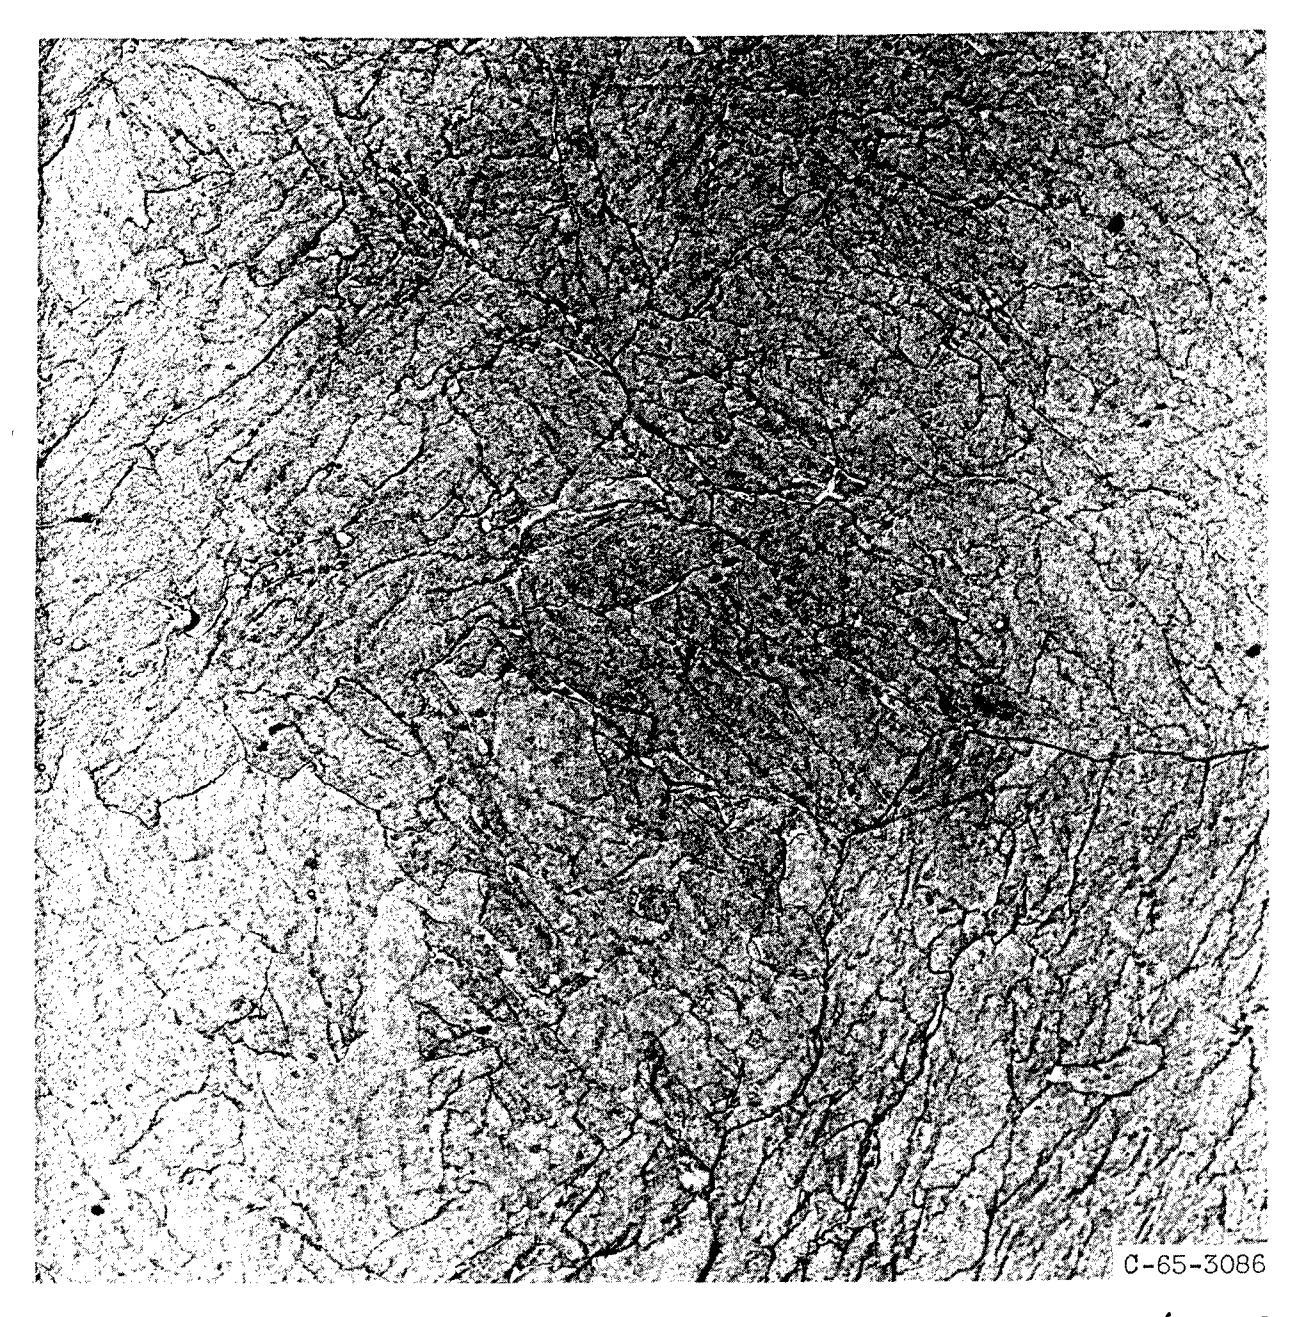
Figure 30. - Replication electron micrograph of area near black defect (HAZ of base plate). ×10 000.

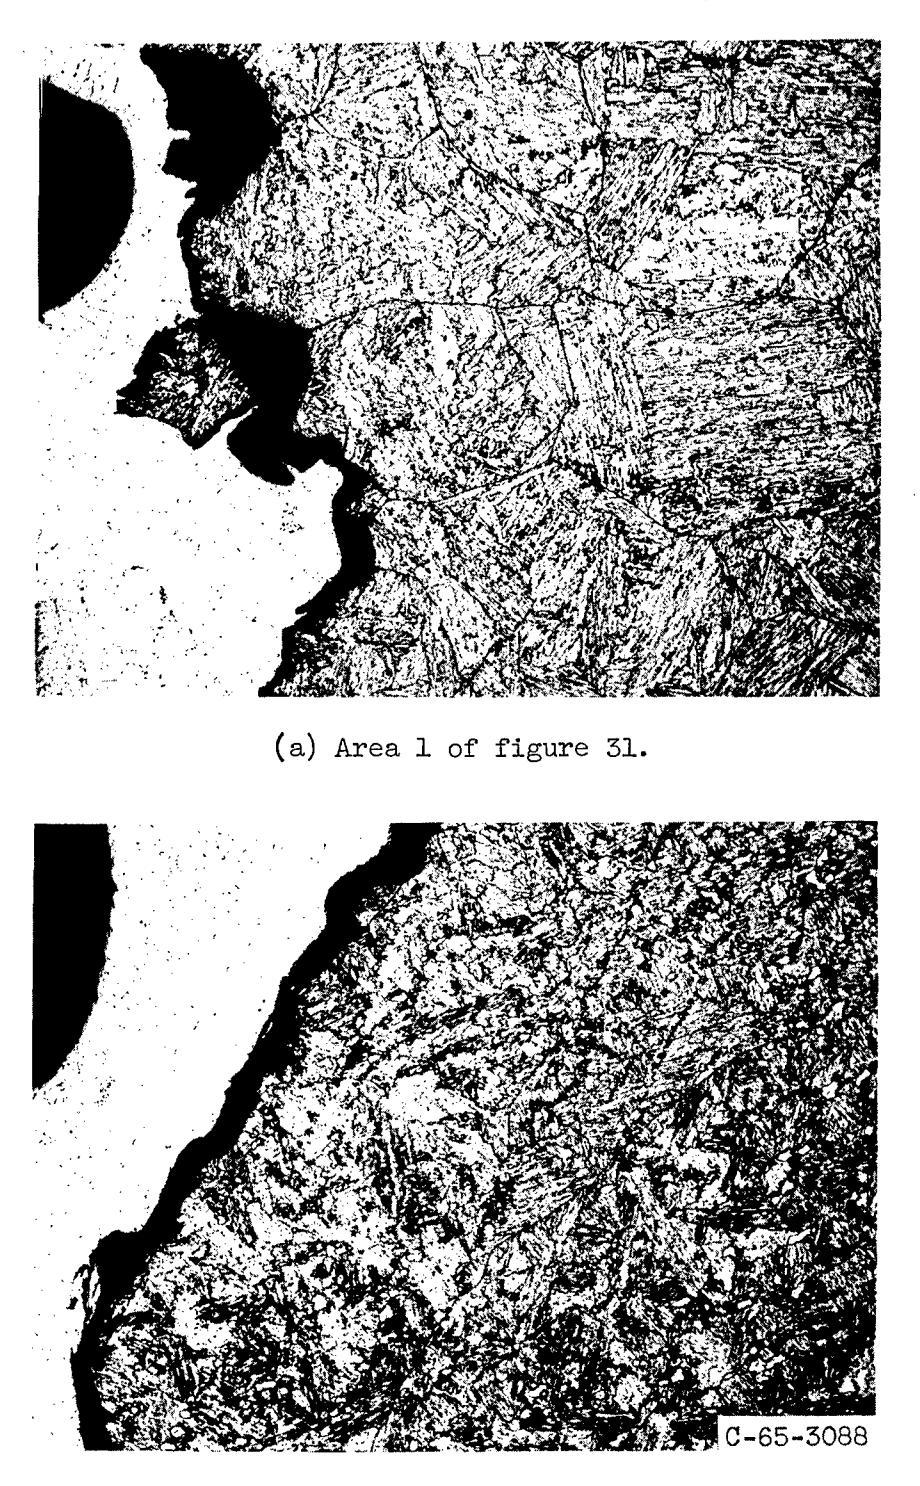
Figure 32. - Fracture profiles of fracture along weld W7/302. ×200.
