# CURRENT STATUS OF ARMY PROGRAM TO UPGRADE DEACTIVATION FURNACES TO MEET RCRA--LESSONS LEARNED

Jerry R. Miller Chief APE Division Directorate of Ammunition Equipment Tooele Army Depot, Tooele, Utah 84074

Presented at the 27th
Department of Defense Explosive Safety Seminar
Sahara Hotel and Casino
Las Vegas, Nevada
20-22 August 1996

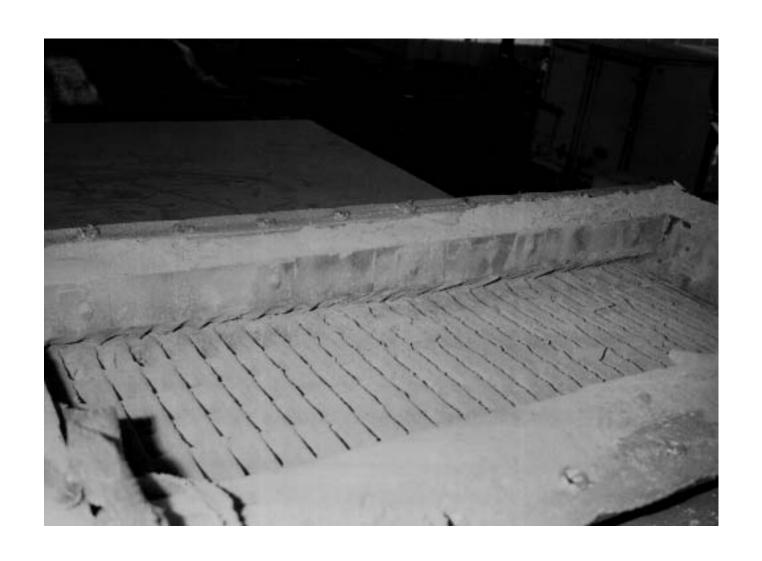
In August 1994, an attempt was made to perform another Trial Burn Test so the munitions containing such constituents as Diphenylamine (DPA) and Hexachlorobenzine (HCB) could be incinerated under the established Part B permit. Most small arms ammunition fall into this category. The three 3-hour test runs feeding the 50 Cal. M48A1 rounds combined with chemicals and HCB could not be completed. The high temperature gas cooler became plugged with particulate. The plugging of the cooler block as well as corrosion caused the TBTs to be stopped.

Pictures of the particulate plugging of two damaged high temperature gas coolers are given in Figures 3 and 4. A side view of one of the plugged high temperature gas coolers is shown in Figure 5. Cooling air flows through the plates and spacing observable in the picture. Figures 6 and 7 show the buildup of particulate on the walls of the ducting ahead of the coolers.

An extensive investigation followed the aborted TBT to try and resolve the gas cooler problems. The cooler block manufacturer was approached to assist in resolution of the corrosion problems. Particulate removed from the cooler was analyzed. The main constituents were barium, lead oxide and sulfate compounds.

FIGURE 3: TOP VIEW OF CLOGGED HIGH TEMPERATURE GAS COOLER

Both plugging and warpage of the plates in hot side of the high temperature cooler block caused major loss of the furnace draft. Warpage of the plates was addressed by rerouting the cooling air through the high temperature gas cooler block. Originally the cooling air made one pass through both the hot (input) and cool (output) cooler block sections. The change routed all of the cooling air first through the hot side and then through the cool side. This change more effectively cooled the plates, thus minimizing warpage of the plates due to overheating.

Proposed changes were presented to the State of Utah and evaluation tests performed to demonstrate the effectiveness of these changes. The changes were to move the cyclone from its original position, to a location between the furnace kiln and the afterburner and to add an expansion chamber with impingement vanes ahead of the high temperature gas cooler.

repositioning of the cyclone between the furnace and the afterburner showed an advantage of removing most inorganics before they enter the afterburner and become molten causing premature damage and failure of the high temperature gas cooler (HTC) block. The addition of an expansion chamber, just ahead of the HTC, removed additional particulate from the flue gas stream and contributed to cooling the flue gas stream and solidification of the lead oxide prior to entering the HTC.

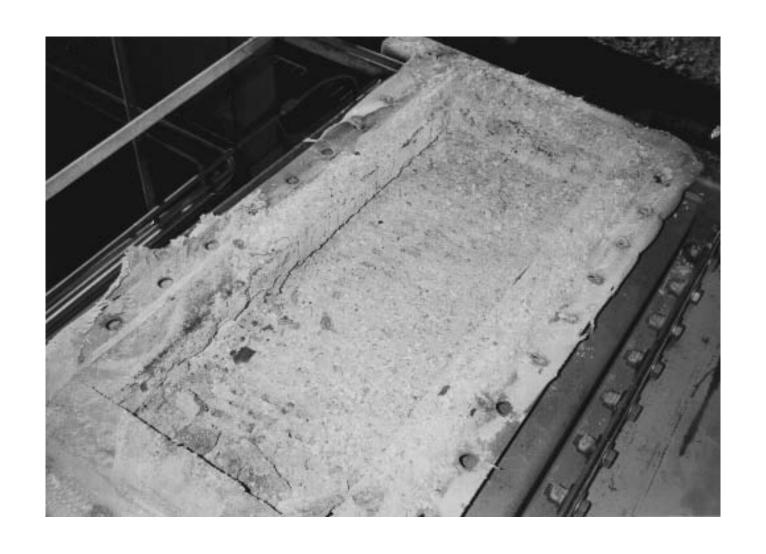
FIGURE 4: TOP VIEW OF ANOTHER CLOGGED HIGH TEMPERATURE GAS COOLER

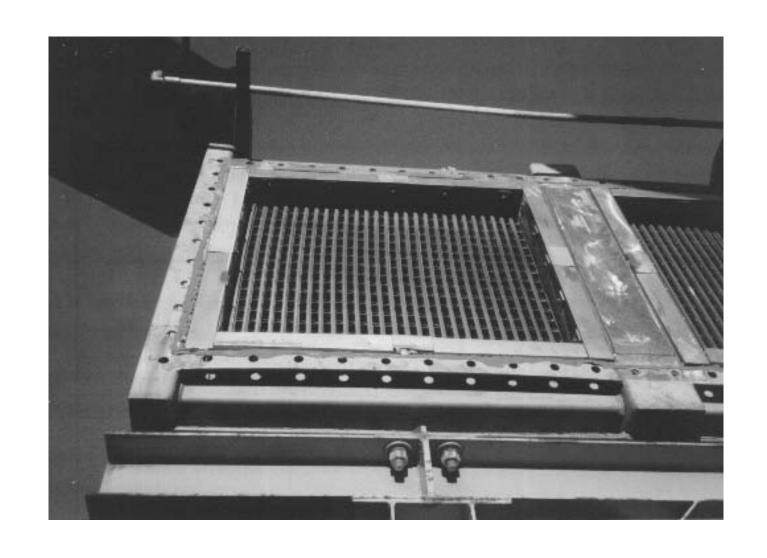
FIGURE 5: SIDE VIEW OF PLUGGED HIGH TEMPERATURE GAS COOLER SHOWING DISTORTED /WARPED PLATES

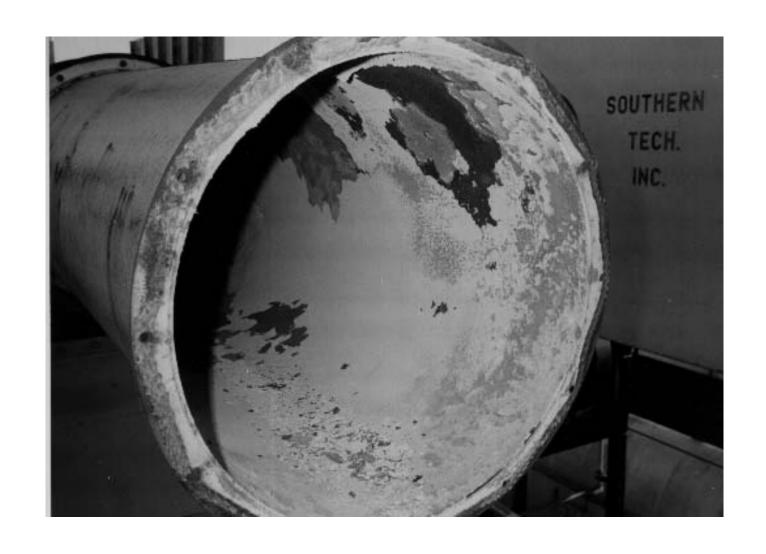
FIGURE 6: PARTICULATE COATING IN FURNACE DUCTING AHEAD OF HIGH TEMPERATURE GAS COOLER

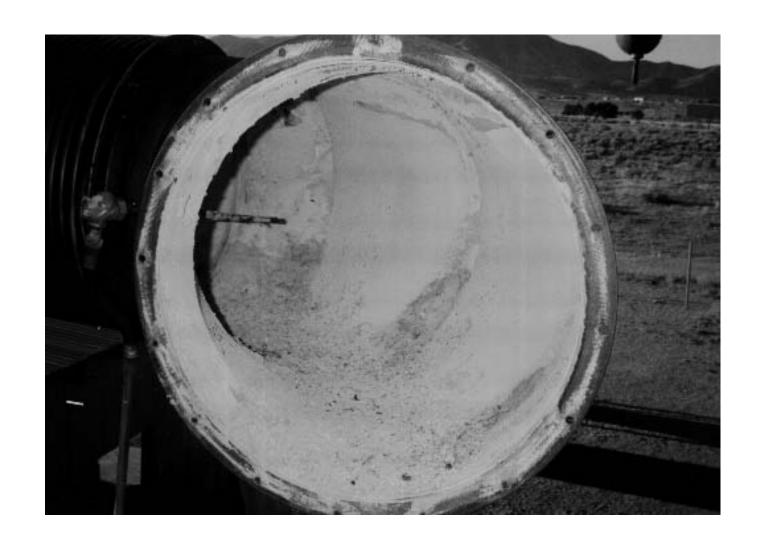
FIGURE 7: PARTICULATE COATING IN ANOTHER SECTION OF DUCTING AHEAD OF HIGH TEMPERATURE GAS COOLER

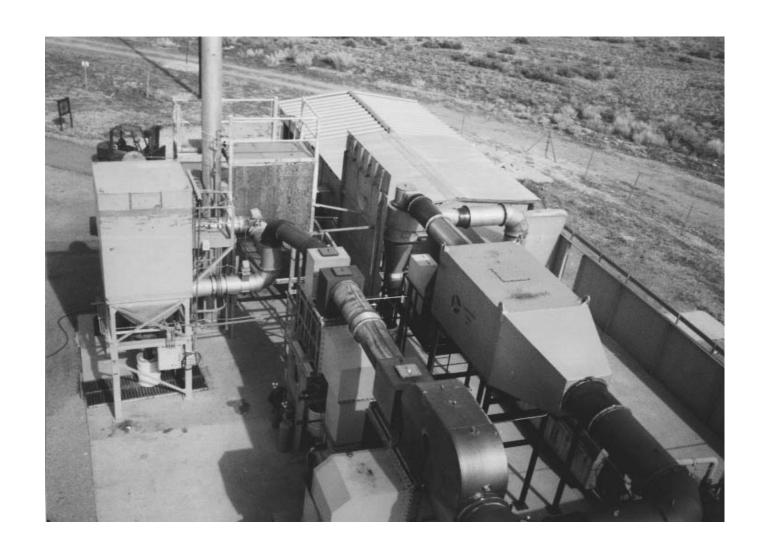
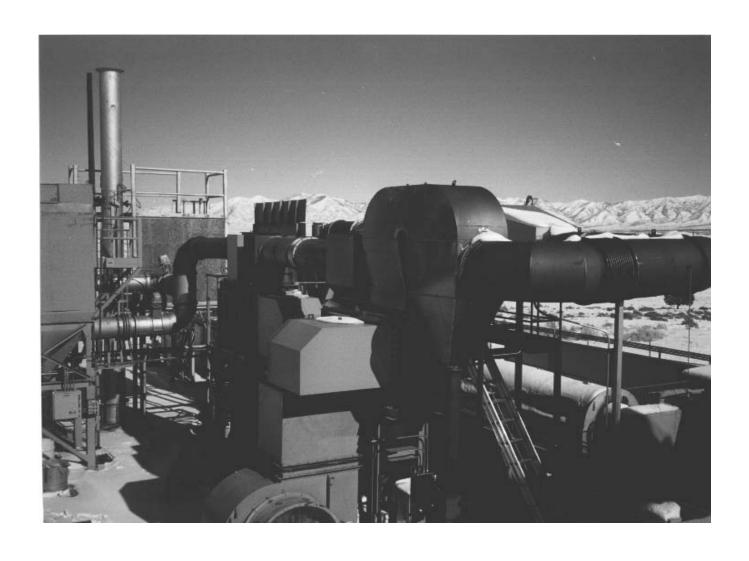
FIGURE 8: OVERVIEW OF DEACTIVATION FURNACE SYSTEM

FIGURE 9: VIEW OF DEACTIVATION FURNACE SYSTEM (EXPANSION CHAMBER AND HIGH TEMPERATURE GAS COOLER IN FOREGROUND)

The moving and installation of equipment at the TEAD Ammo mission furnace was completed in Feb 95. The cyclone was repositioned between the furnace and the afterburner. An AED designed expansion chamber was fabricated and installed just ahead of the high temperature gas cooler. A double tipping valve was installed as part of the expansion chamber. New ducting was fabricated and installed. Thermocouples have been installed at the afterburner and into the new ducting where needed. Conduit was installed and electrical wiring was completed. See Figures 8 & 9 for pictures showing the repositioned and added equipment.
