OFFICE OF THE SPECIAL INSPECTOR GENERAL FOR IRAQ RECONSTRUCTION

IRAQI ARMY FACILITIES UNDER THE IRAQ SECURITY FORCES FUND DIYANAH AND DEBECHA, IRAQ

SIGIR PA-07-114 JANUARY 17, 2008

SUBJECT: Report on Construction and Renovation of Iraqi Army Facilities at Diyanah and Debecha, Iraq (Project Number SIGIR PA-07-114)

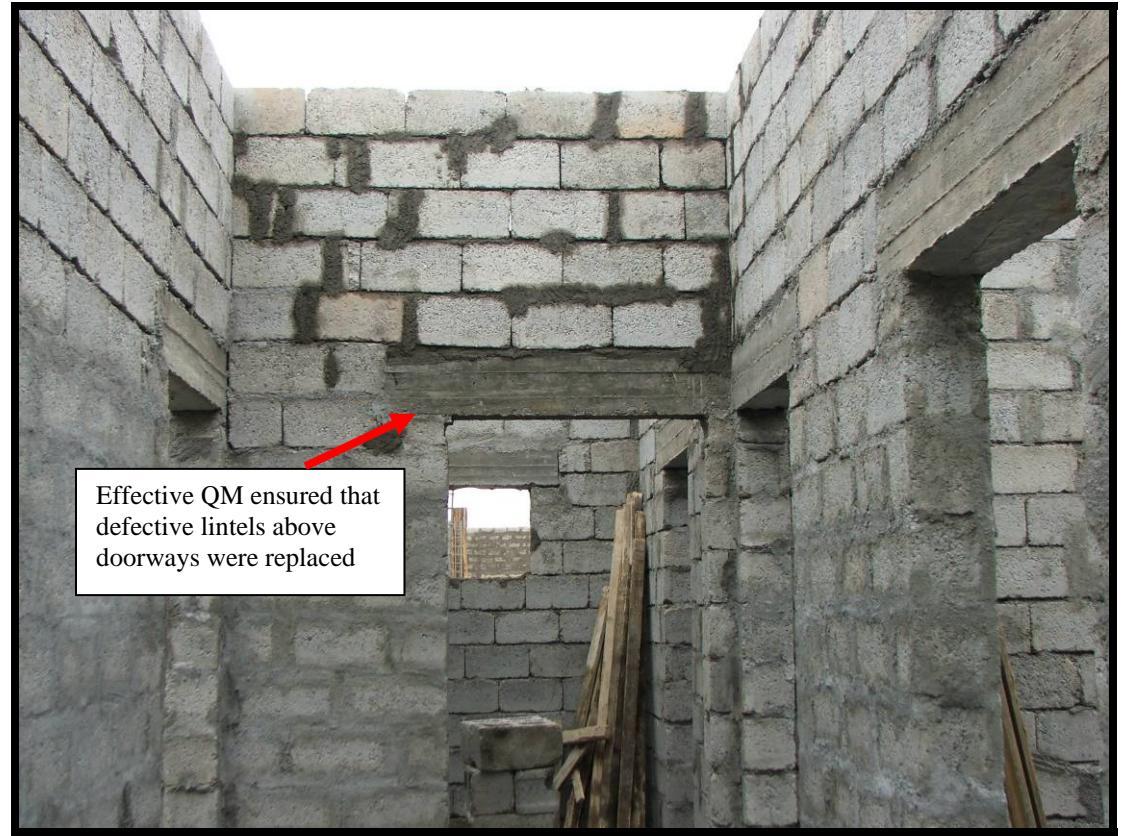
Both QA and QC reporting at Debecha were adequate and effective. For example, the Title II Daily Quality Report dated 21 November 2007 documented that two substantive deficiencies should be addressed. The report cited that lintel beams were not properly placed above openings in block walls (doors and windows) and that backfill and compaction processes were not in accordance with the SORS. The QC and QA personnel have worked together to resolve both issues.

Site Photo 1 shows one of numerous lintel beams throughout the project that was reworked and cast-in-place to comply with specifications. Site Photo 2 shows where backfill and compaction process have been modified to comply with specifications². Subsequent compaction tests verified by an independent laboratory confirmed that soil compaction requirements were met.

Site Photo 1. Subcontractor reworked lintels.

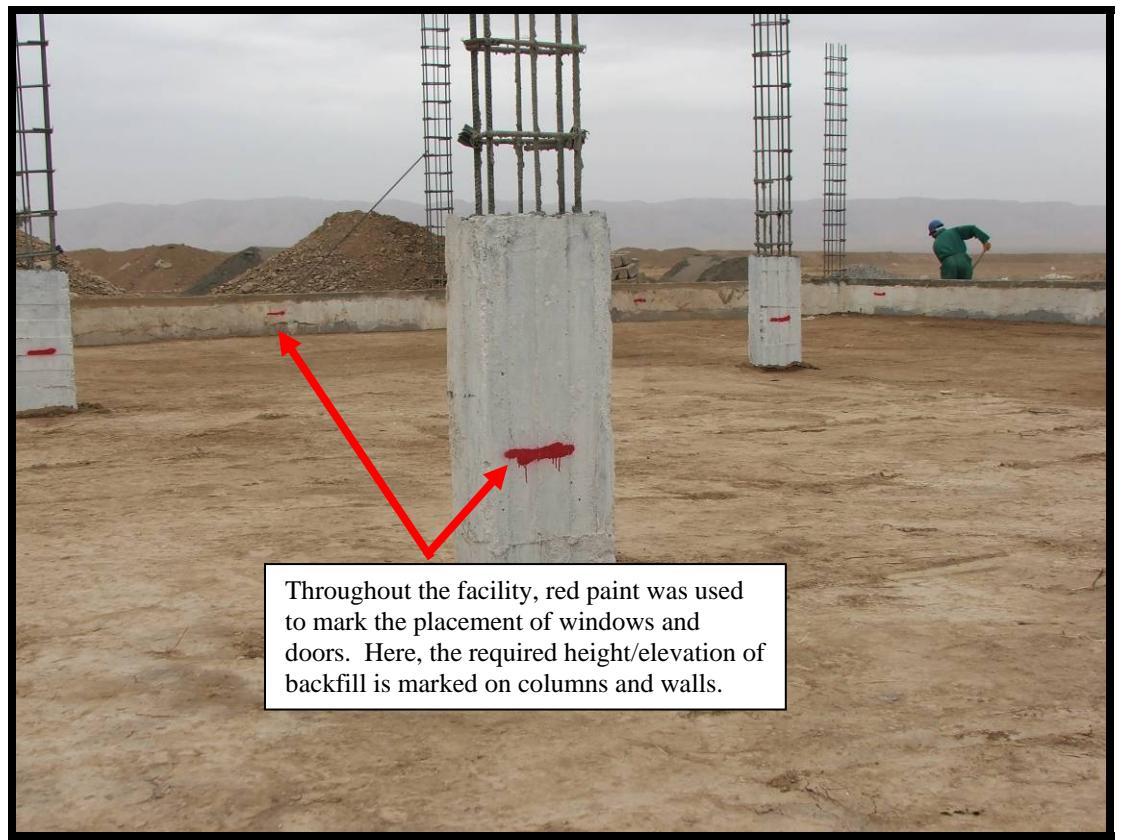
² Specifications required that backfilled layers of soil should be compacted every 20 centimeter (7.8"). However, the Title II representative cited that some layers were as thick as 35 centimeter (13.8"). Accordingly, initial laboratory test results confirmed that some backfill soil was not sufficiently compacted.

Site Photo 2. Backfill requirement marked.

To improve processes to backfill and compact soil, the contractor purchased field soil testing equipment (Kessler Dynamic Cone Penetrometer) to estimate the strength characteristics of fine and granulated soils³. To date, QM practices have been effective and provide for reasonable assurance that construction quality at Diyanah and Debecha should be acceptable.

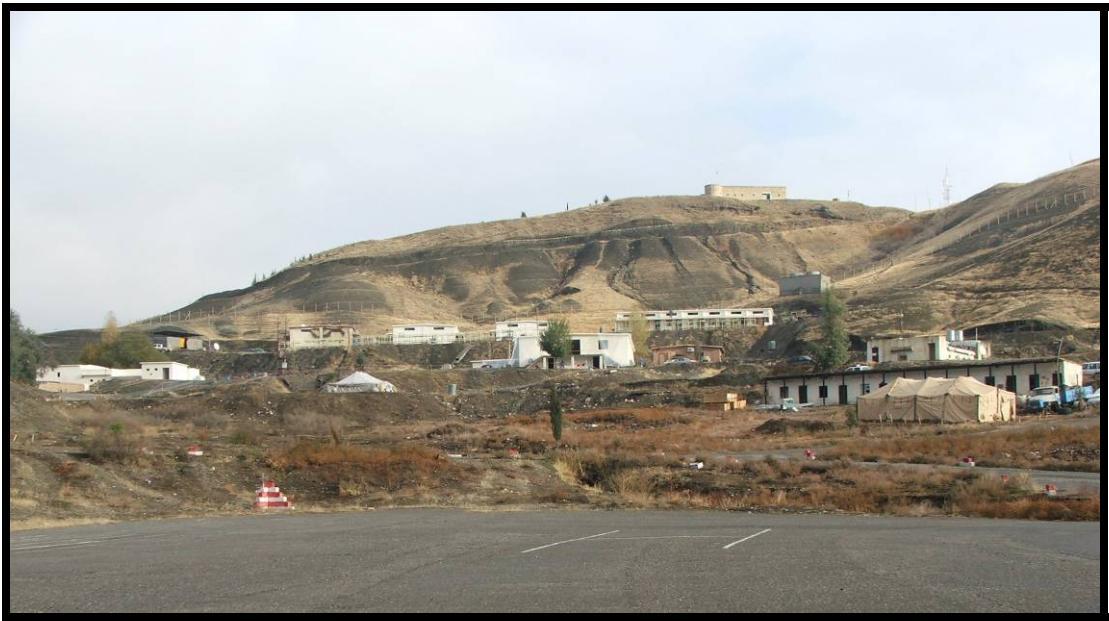
Land and soil conditions between the Diyanah and Debecha facilities varied considerably. Site Photo 3 shows a portion (about half) of the Diyanah project where the bulk of the work involved the renovation of existing facilities that were structurally sound, but in disrepair. Although the Diyanah site was on a hillside, required preconstruction site excavation or preparation was not extensive because most of the work involved the renovation of existing facilities. The project did call for some new construction; however, planned building sites were previously excavated and flat and should not offer any unusual challenge to the contractor.

Soils at Diyanah were medium clay and course sand and there was evidence of some past erosion. Prior to starting the project, some soil had washed and lodged against walls on the up hill side of several buildings. The contractor's Senior Program Manager stated that a drainage plan that included retaining walls had been submitted to the government for consideration in accordance with contract terms.

Site Photo 3. North half of Diyanah facility.

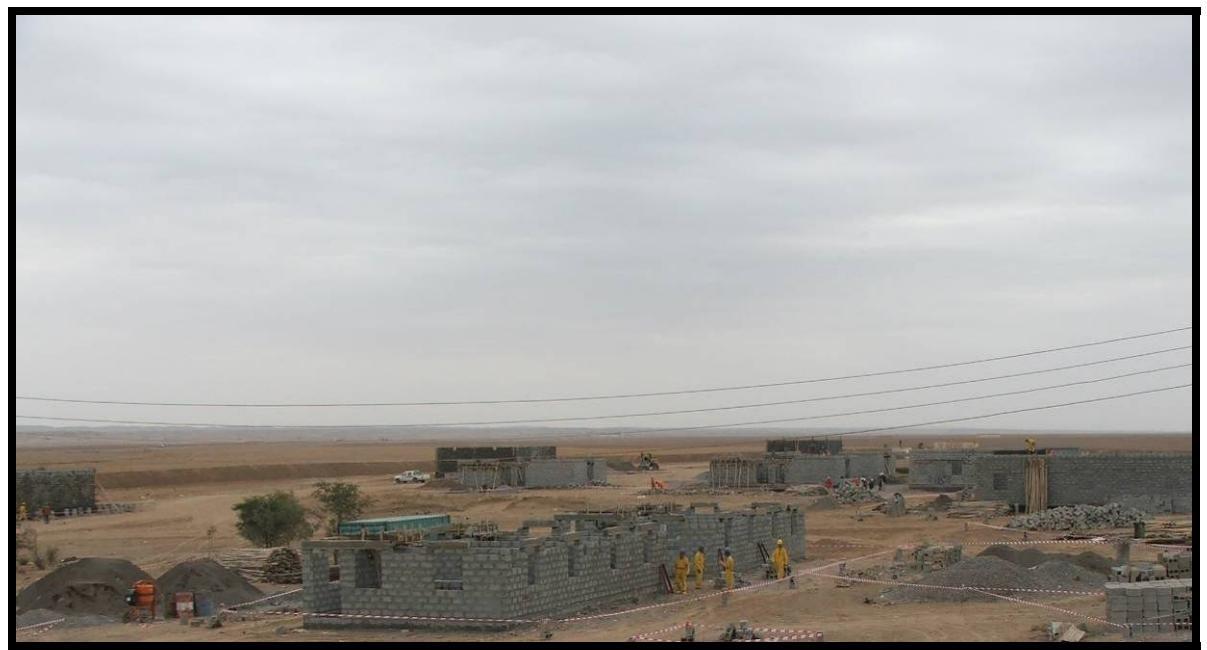
Site Photo 4 shows a portion (about a quarter) of the Debecha project that is comprised almost entirely of new construction. The topography at Debecha was very flat and offered no unusual site preparation challenges.

Site Photo 4. Debecha construction activity and flat building site.

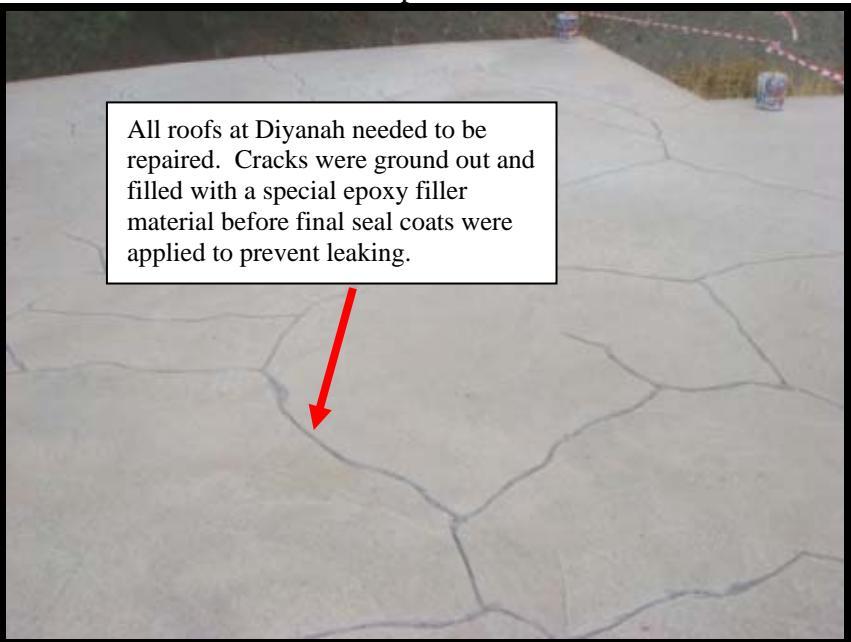
Based on the contractor's technical survey of the Diyanah site, roofs throughout the complex of buildings were in a deteriorated condition prior to renovation. As a result, there was interior water damage to numerous buildings. Site Photo 5 shows an example of existing cracks in roofs most likely caused by shrinkage of the original concrete roof casting. In addition, expansion joints in the original construction were improperly designed and had to be removed, redesigned, and reconstructed. Subsequent repairs and renovation will be addressed later in this report.

Site Photo 5. Before repair, water leaked through cracks in the original roof. (Photo courtesy of Toltest)

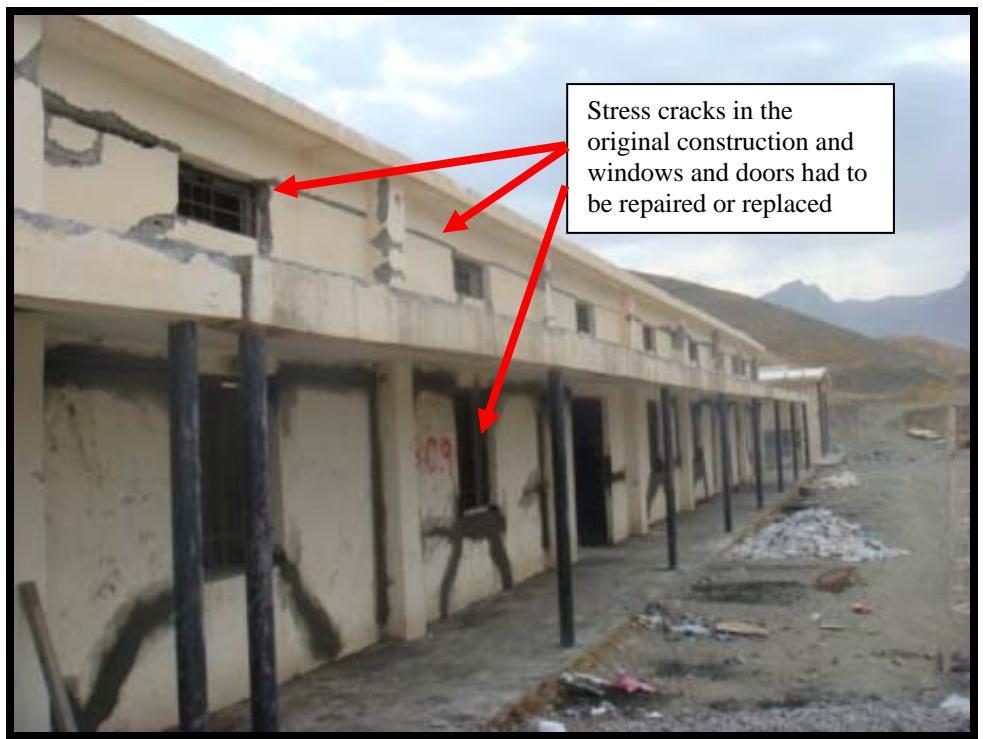
Site Photo 6 shows the "typical" exterior of buildings found to be structurally sound, but in disrepair before renovation at Diyanah.

Site Photo 6. Typical building exterior before renovation at Diyanah. (Photo courtesy of Toltest)

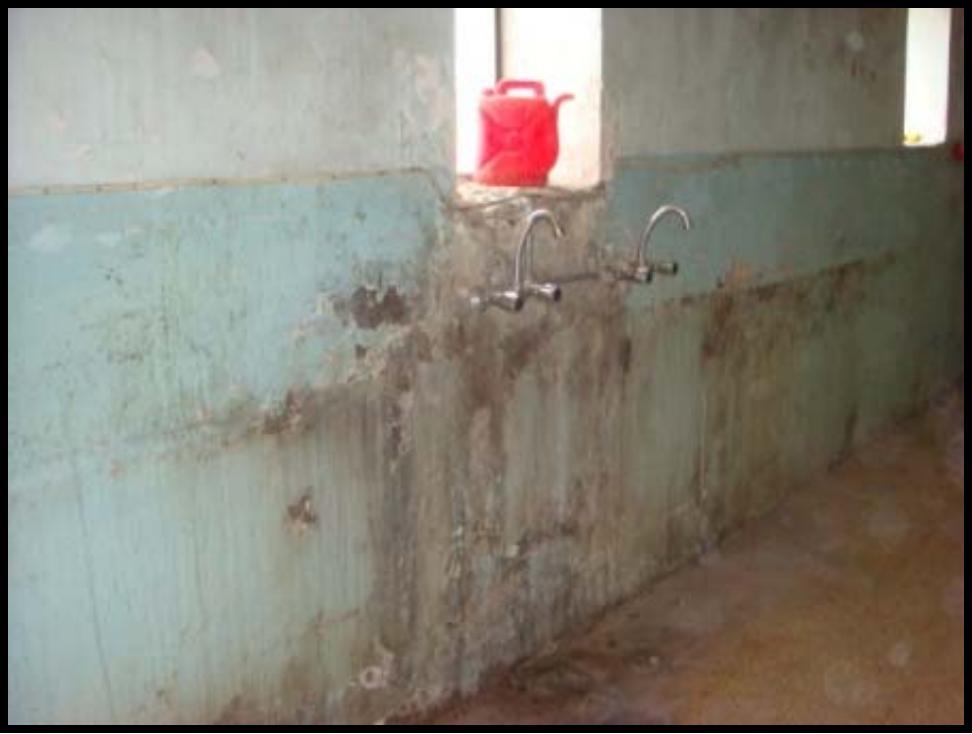
Site Photo 7 shows a food preparation area in a dining facility before the renovation project was started and the absence of a tiled wall surface in the high water use area. The original painted plaster retained moisture and the risk for bacteria growth increased. Subsequent repair and restoration will be discussed later in this report.

Site Photo 7. Before renovation, food prep areas appeared unsanitary. (Photo courtesy of Toltest)

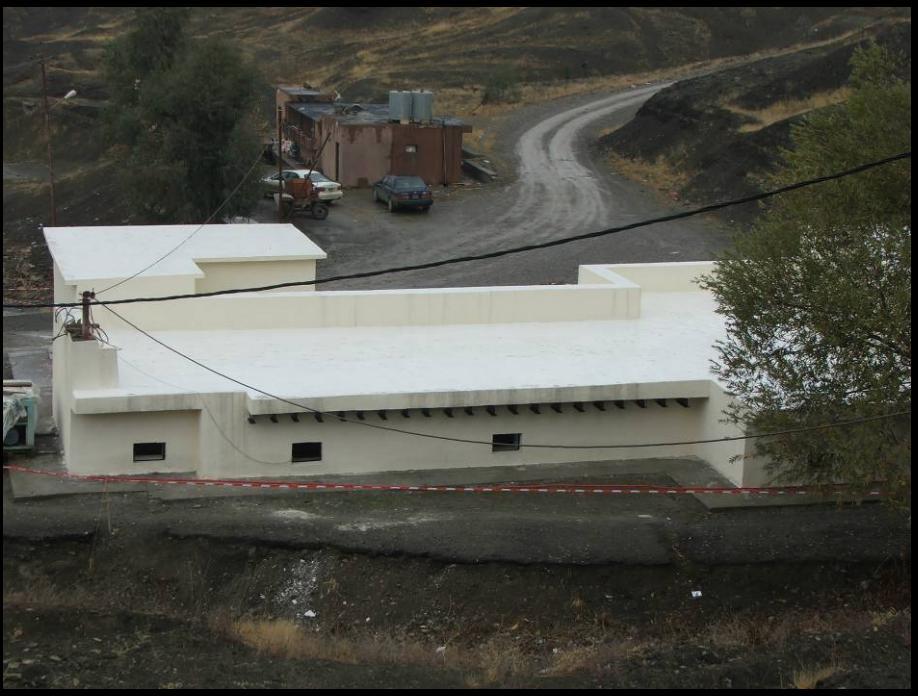
Site Photos 8 and 9 show a repaired roof and expansion joint. Site Photo 8 is representative of the condition of all roofs following renovation. The contractor explained and documented the processes used to repair the roofs throughout the facility. All cracks were opened with a grinder to remove loose material and to obtain a beveled shape (wide at the top and narrow at the bottom). Subsequently, the ground-out cracks were inspected and then filled with an epoxy filler designed for such applications.

Site Photo 8. Typical roof top following renovation.

Some of the original roof edge castings were too high and precluded complete drainage allowing water to leak though cracks in the original roof. To correct the problem, the contractor cut away high edges and grouted to a level that would ensure proper drainage. The roof was inspected by contractor and subcontractor managers before the roof was

sealed with three coats of a roll-on roof sealing material designed specifically for such applications. Site Photo 8 shows a roof top following renovation.

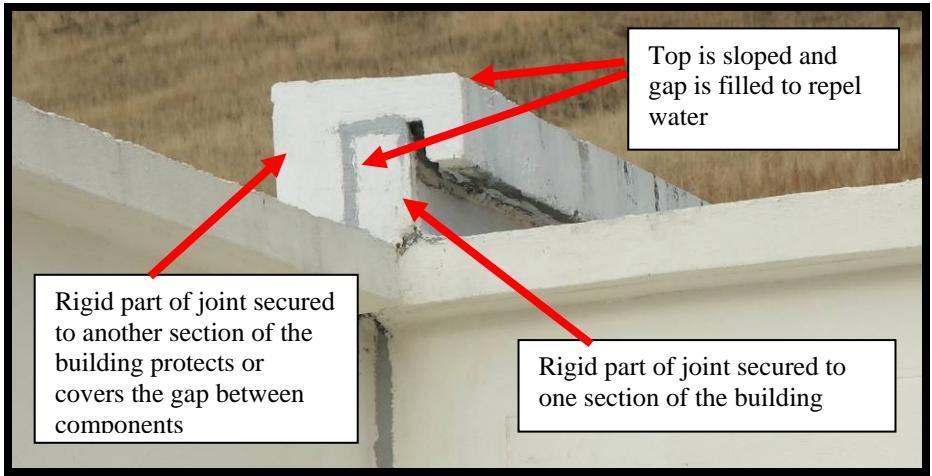
Site Photo 9 shows an expansion joint after renovation. The design of the expansion joint and application of a sealer between the building sections should ensure a water tight joint.

Site Photo 9. Renovation included replacing poorly designed original expansion joints that leaked.

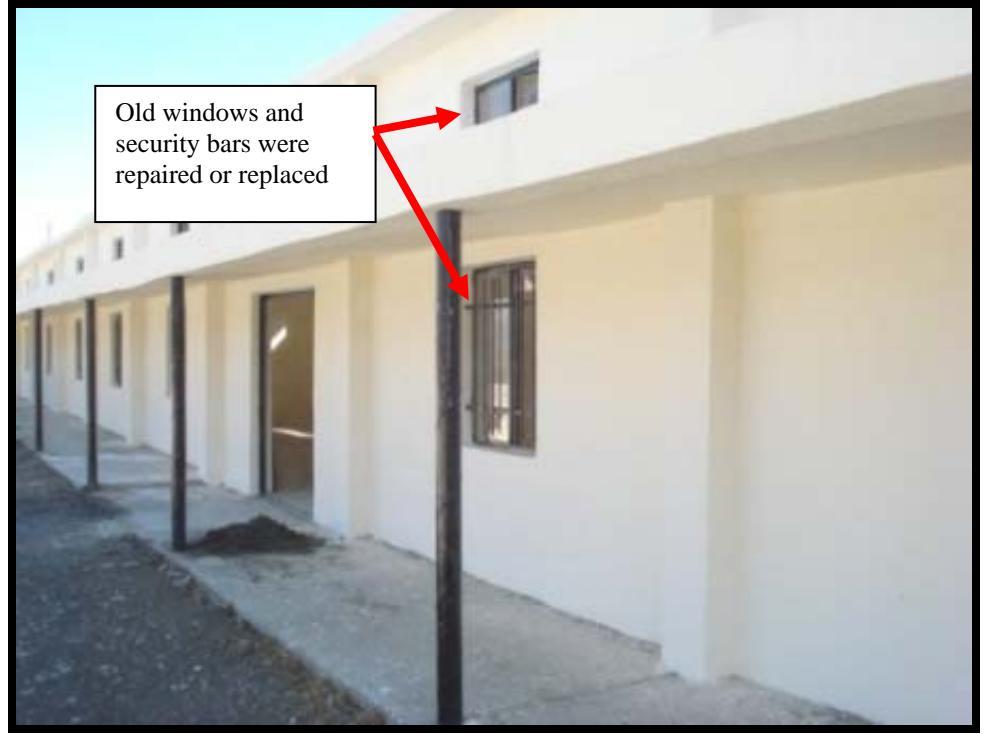
Site Photo 10 is representative of buildings following renovation including exterior painting. Substantial repair work preceded the final exterior painting process. Site Photo 11 shows where workers repaired cracks and removed loose exterior plaster/stucco. Large sections of damaged or loose stucco were replaced with new plaster/stucco in preparation of exterior painting. Patch work over cracks and flat surfaces was covered with wire mesh to ensure bonding between the original wall and the fresh plaster/stucco.

Site Photo 10. Typical building exterior following renovation. (Photo courtesy of Toltest)

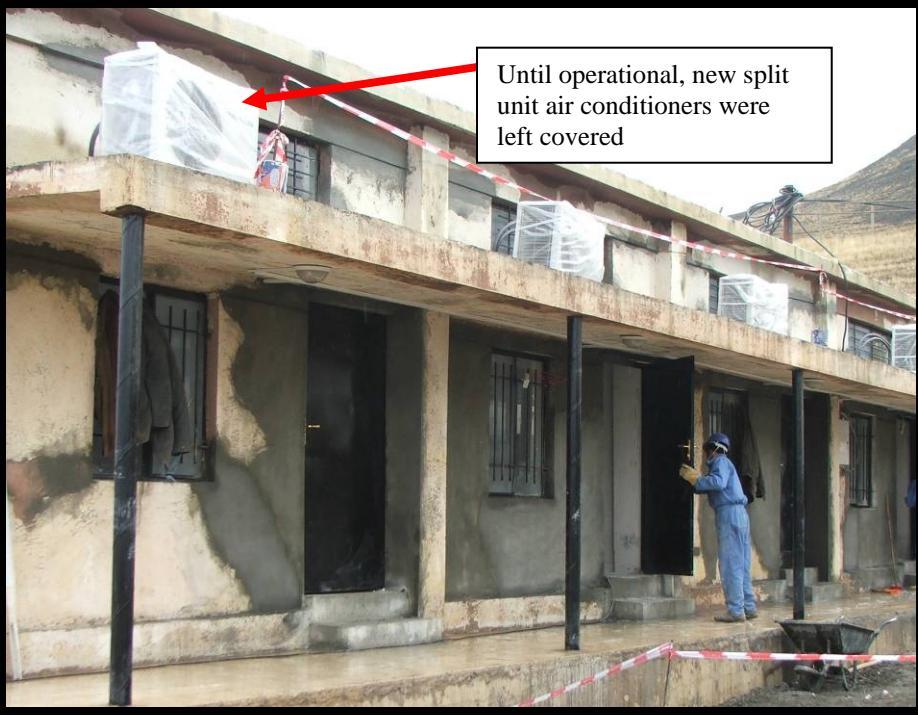
Site Photo 11. Exterior renovation work in progress.

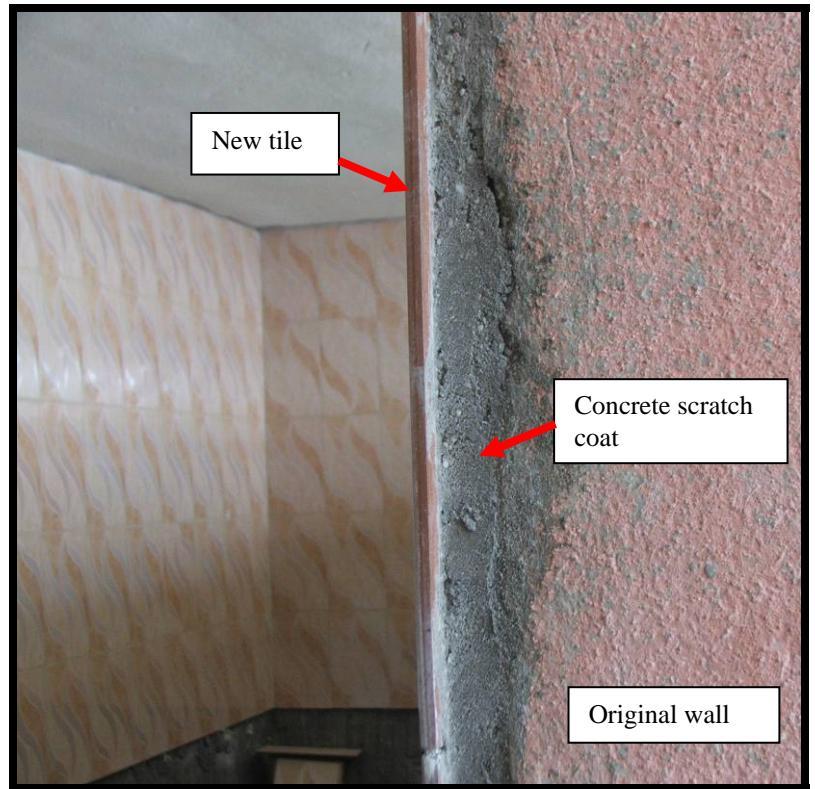
In accordance with contract requirements, tile was used to cover the walls in high water use areas. Site Photo 12 was taken in the food preparation area of one of the two dining facilities at Diyanah. The photo shows that loose material was removed from the original wall. Then a scratch coat of concrete was applied to form a uniform surface for subsequent tile installation. All tile work observed was satisfactory. All tile joints were exactly horizontal or vertical and evenly spaced the entire length of the tile because plastic spacers manufactured to uniform dimensions were used. The plastic spacers were placed in the corner of each tile ensuring alignment with the three other adjacent tiles. In addition, the walls were flat.

Site Photo 12. Wall tile work was high quality throughout facility.

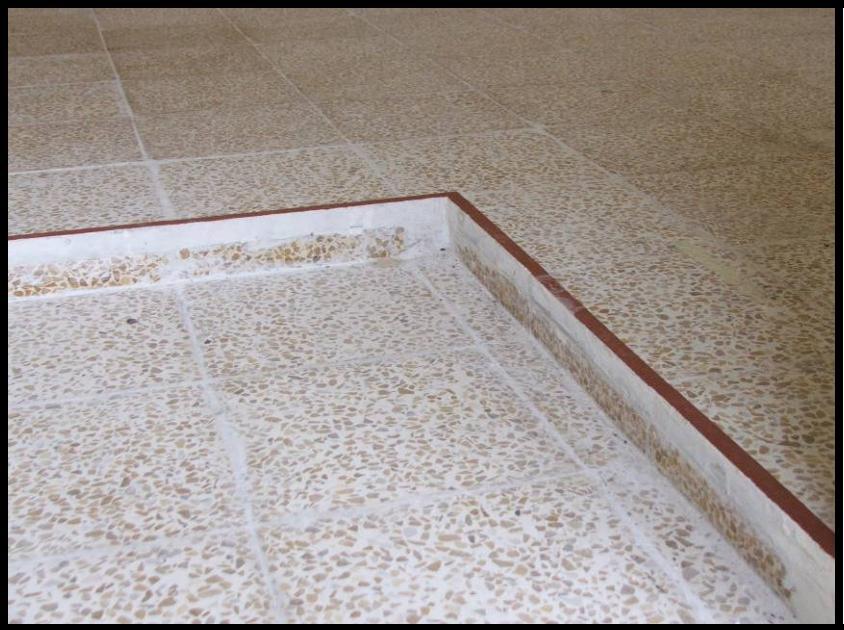
While not all tile floors were yet installed in those areas that required Terrazzo tile, SIGIR observed that work completed to date was satisfactory. Individual Terrazzo tiles were reasonably level and joints were evenly spaced and parallel between adjoining rows of tile. Site Photo 13 shows an example of a Terrazzo tile floor following initial installation.

Site Photo 13. New Terrazzo floor included lowered entry area.

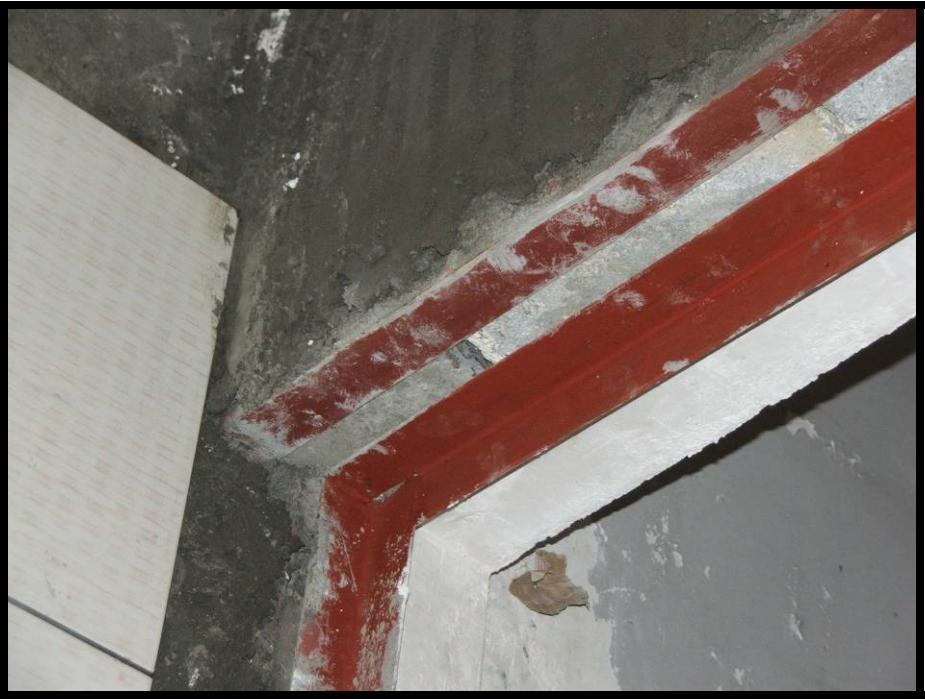
Window frames were renovated and steel door frames were installed. Site Photo 14 shows a steel door frame installed in a food handling area. All door frames appeared to be properly installed. Specifically, the frames were tight, square, and grouted flush with the wall. Therefore, once the doors are installed they should swing level. In addition, SIGIR observed a number of exterior doors with new latch hardware that was compliant with SORS requirements. The hardware was cast of a heavy and hard metal alloy. In addition, the lock assembly was a keyed dead bolt independent of the latch mechanism. Such a design offers durability not generally found in locksets where the latch assembly also functions as the lock.

Site Photo 14. Typical steel door frame installation.

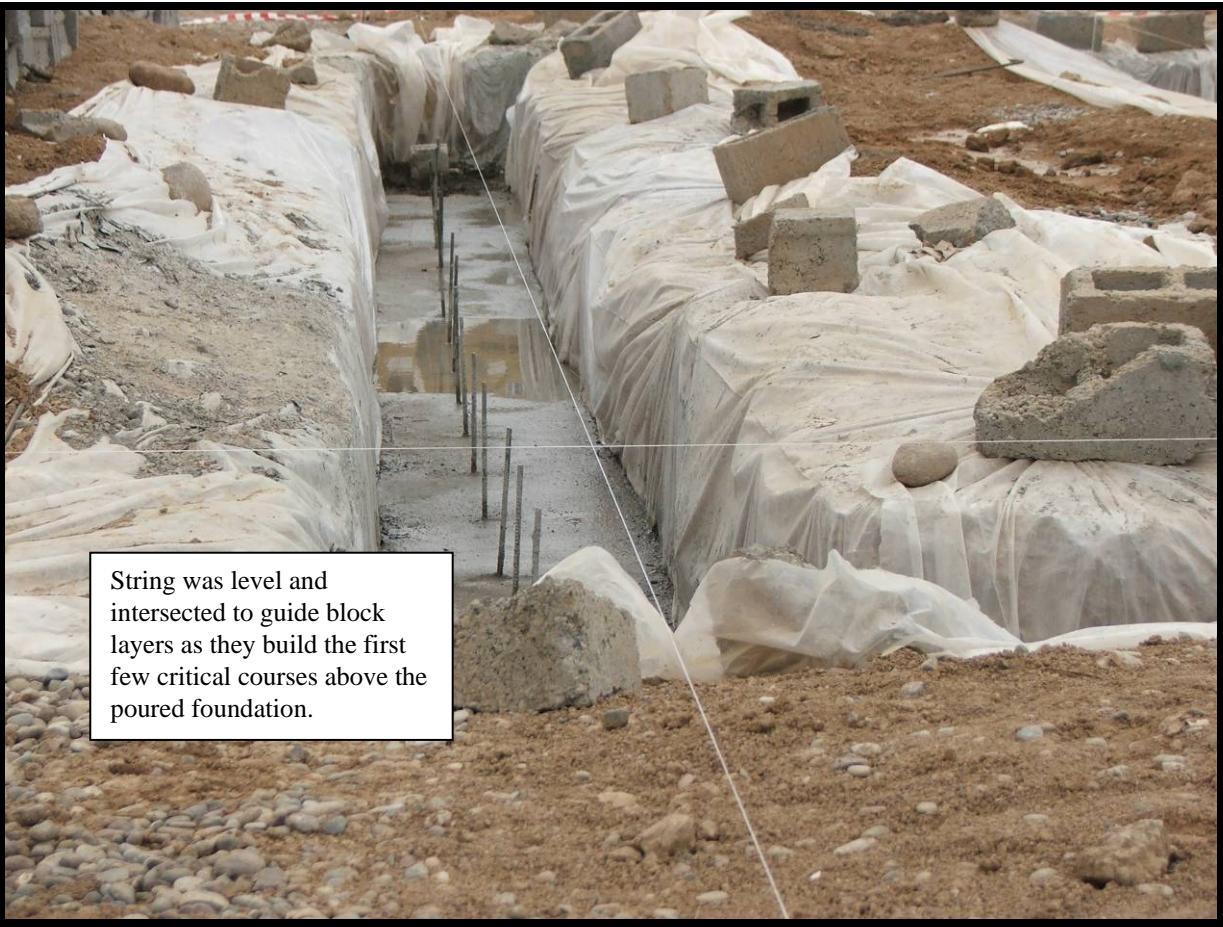
At the Debecha site, the subcontractor laid the first course of concrete blocks to ensure a square cornered building with level blocks placed at correct elevations. Specifically, string was used to show the line that block layers will use to guide the placement of concrete blocks. Using the string as a guide ensures corners are square, blocks are placed level and at the correct elevation (height), and blocks are placed in a straight line. Site Photo 15 shows the layout and string for the hand washing area outside the dining facility while Site Photo 16 shows a transit used to ensure correct elevations.

Site Photo 15. String at proper height with square corners will guide block layers.

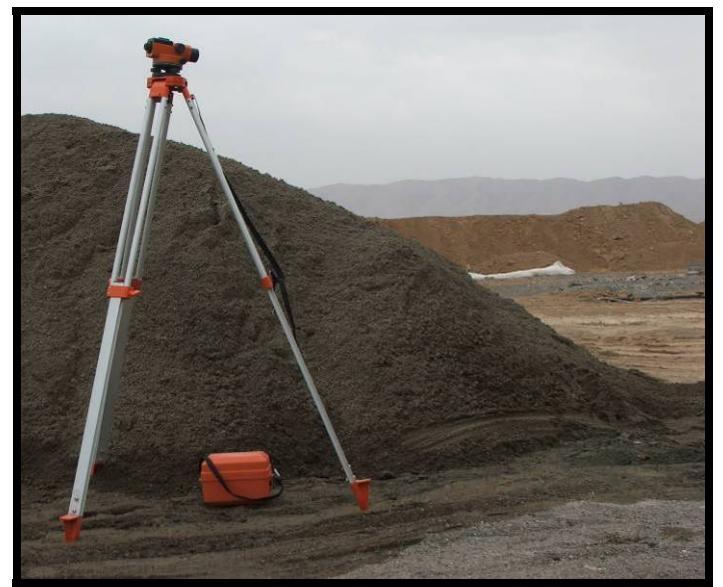
Site Photo 16. Transit was setup and ready when needed.

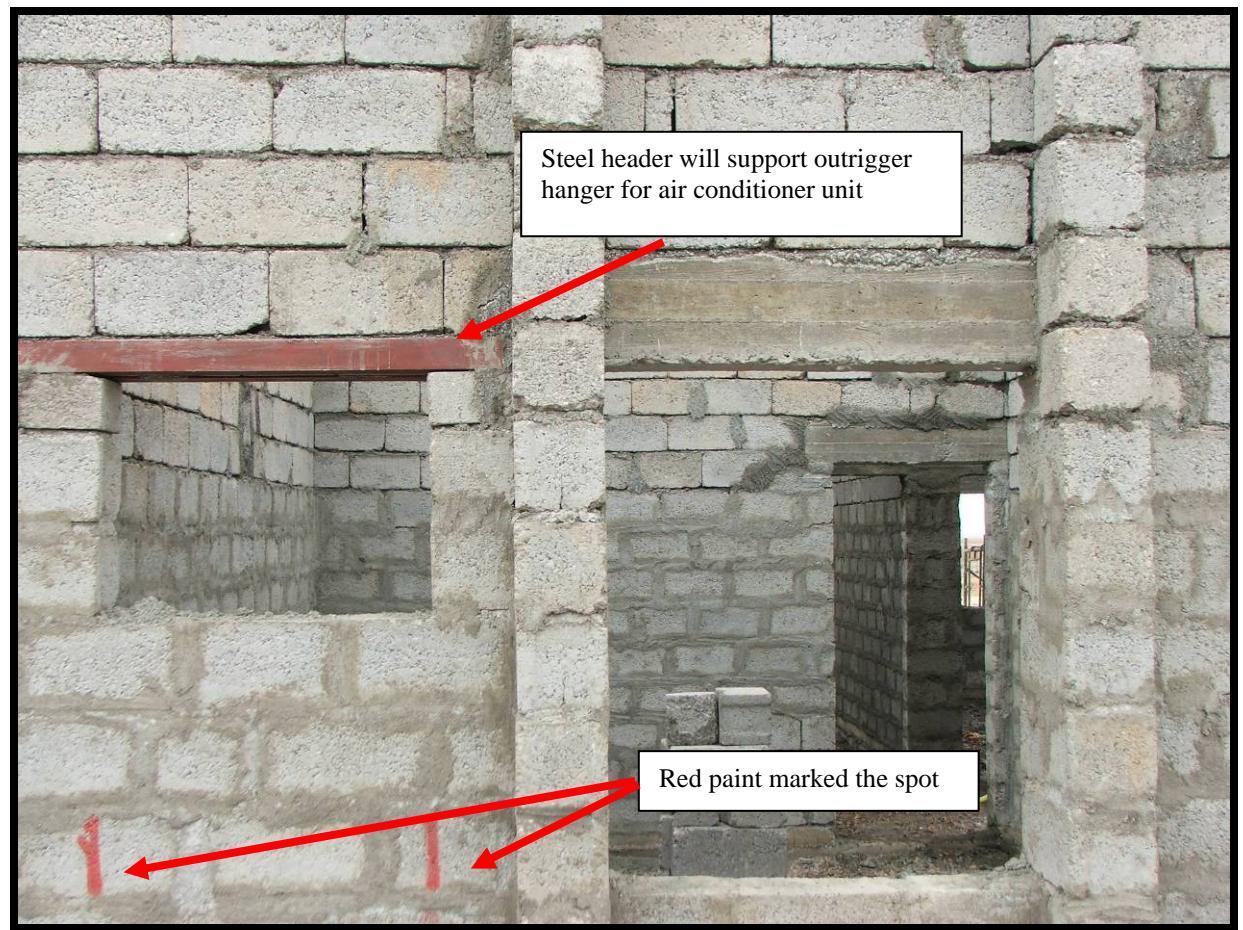
Red paint was used to mark specific measurements necessary for correct placement of window openings, air conditioning units, and elevations. For example, Site Photo 2 included earlier in this report shows that red paint was used to mark the final compacted grade or elevation height of the compacted backfill in the new dining facility. Similarly, Site Photo 17 shows that red marks were used to correctly place the opening for an air conditioning unit. This technique is a practical and effective way for the contractor's managers to observe completed work while lessening the likelihood of future mistakes.

Site Photo 17. Air conditioner location was marked by a supervisor.

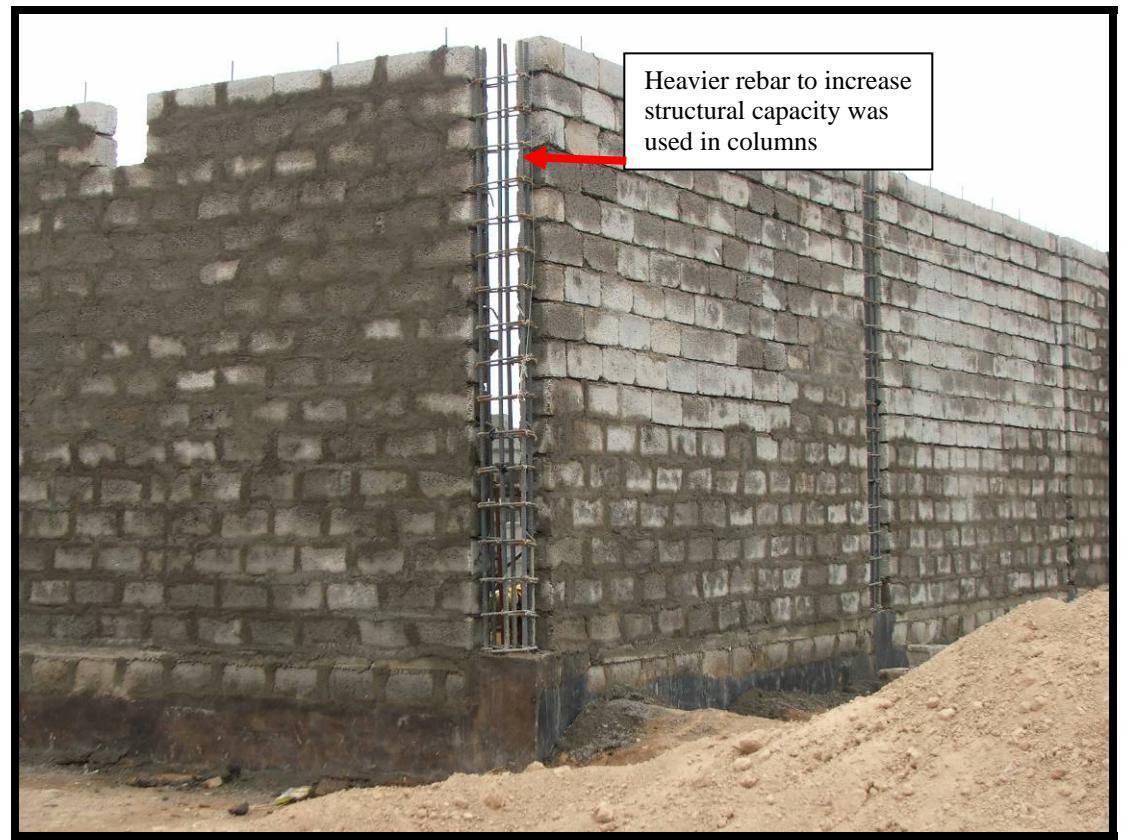
During the site visit to Debecha, SIGIR observed that several buildings were nearing the stage of construction where corner and wall columns would be cast following form work. Site Photo 18 shows the heavier reinforcement bars used in columns. After the columns are cast and sufficiently cured, workers will construct form work, install reinforcement bars and cast each building's roof flatwork and horizontal beams to complete the structural aspects of the roof system.

Site Photo 18. Typical wall construction before forming and casting columns.

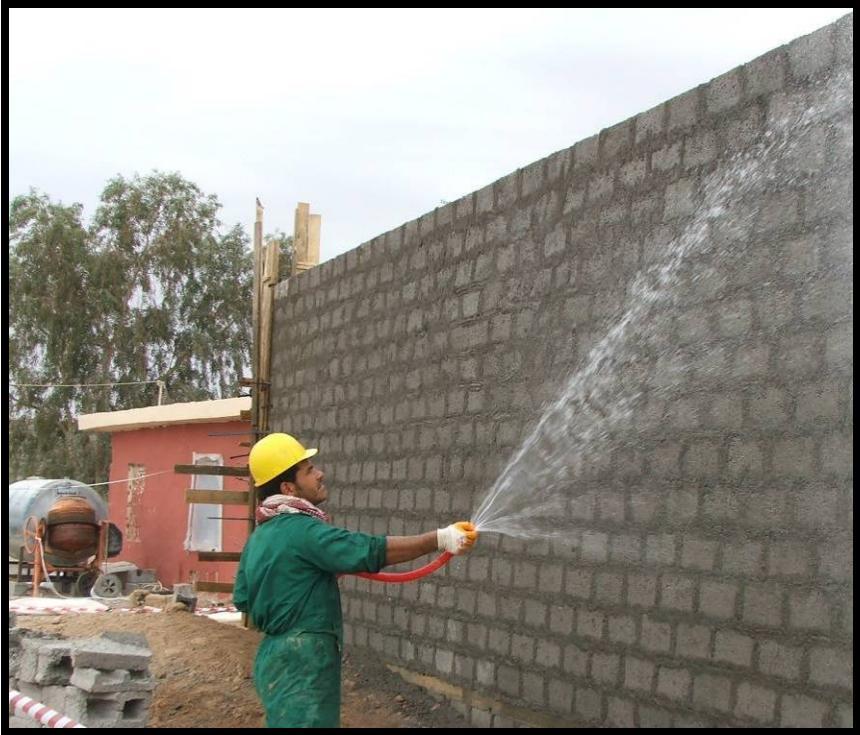
In Site Photo 19, a worker sprays water on the surface of a block wall to ensure that mortar used to fill cracks and spaces between blocks does not dry too fast and shrink. As a result, the walls will be a good surface upon which to apply finish exterior plaster/stucco.

SIGIR Photo 19. Walls were sprayed to prevent excessive shrink in joint mortar.

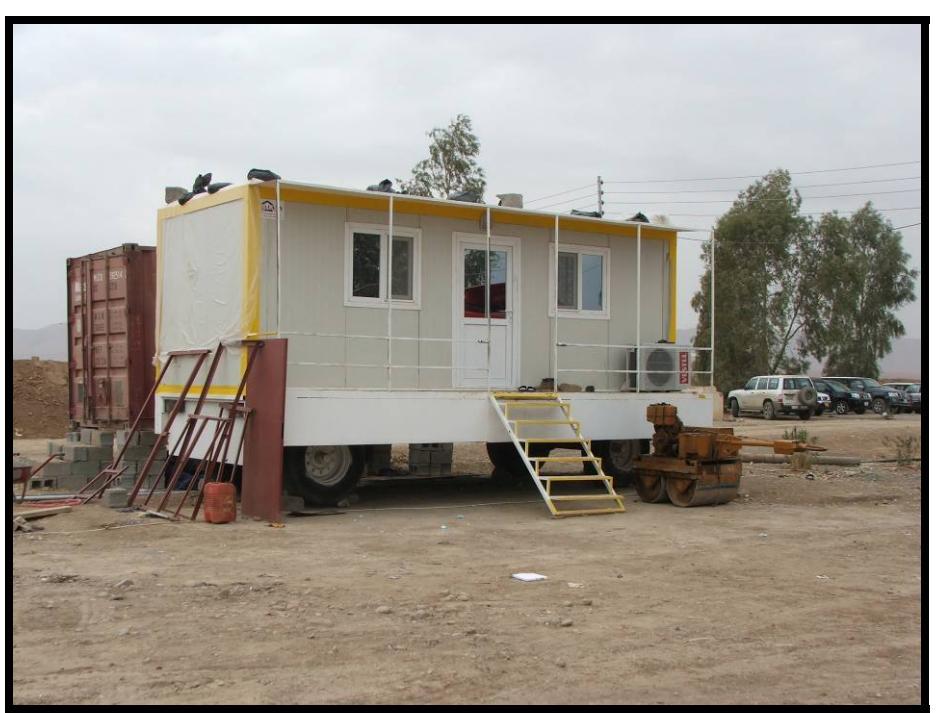
Site Photo 20 shows the construction office placed on site by the subcontractor for engineers and project supervisors. This will help the subcontractor fulfill its administrative and supervisory responsibilities.

Site Photo 20. Subcontractor construction office.
