Considerations for Determining Safe Separation Distances from Mass Fires: a Literature Search

Thomas L. Boggs Jacobs Naval Systems Group, Ridgecrest, CA 93555

Policy Development Division Department of Defense Explosives Safety Board, Alexandria, VA

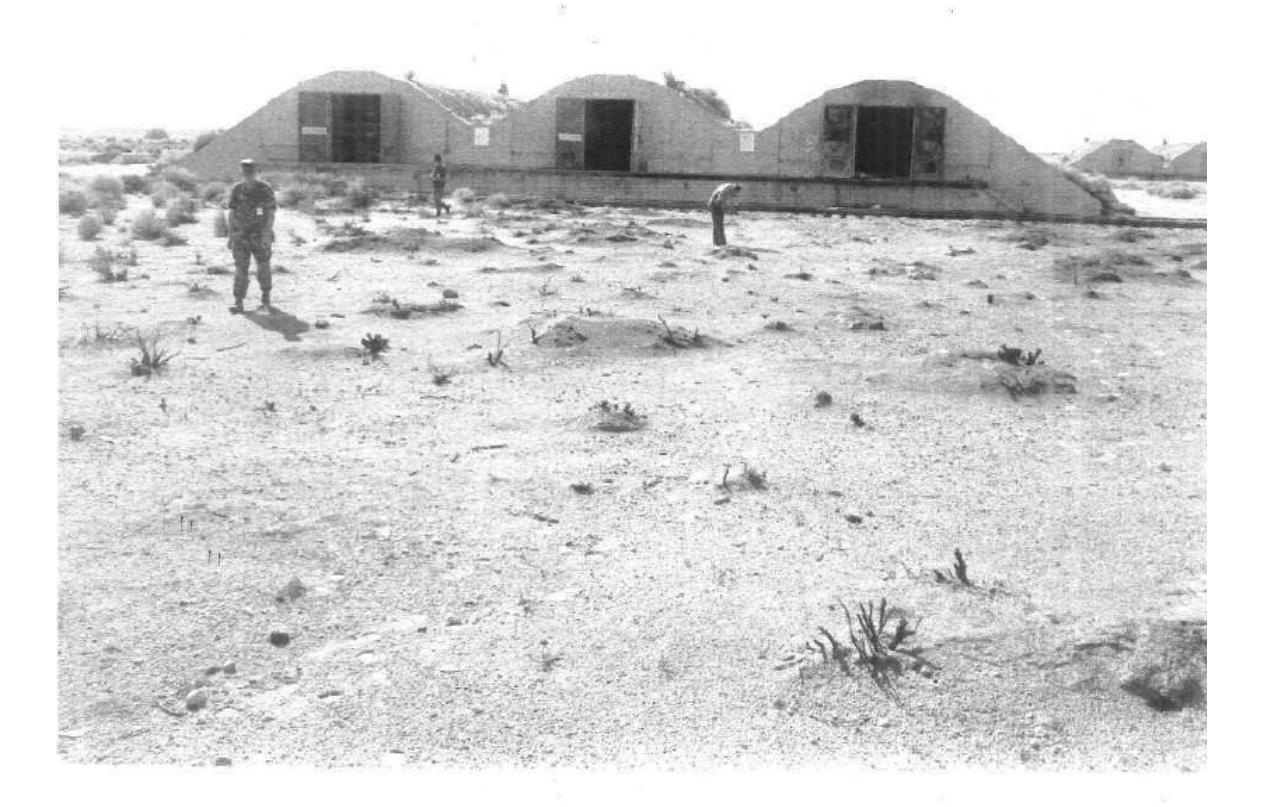
FIGURE 1. Three Arch Earth-Covered Magazine at Hawthorne Army Ammunition Plant. Fire occurred in unit on the right.

The magazine contained 30,715 pounds of Hazard Division (HD) 1.3 Navy propelling charges. Many of the lots had low stabilizer levels, and Hawthorne had requested permission to dispose of the items by open burning. Unfortunately, the State of Nevada denied their request. Fire occurred and blew open the doors. Flames extended out 100 to 150 feet. The very intense burning continued for about 3 minutes and then decreased significantly. During the period of decreased burning, several "pops" attributed to deflagration occurred, but there was no detonation. The fire was allowed to burn itself out. Cartridge cases, unburned propellant grains, and pieces of cork were expelled through the doors and found scattered on the ground directly in front of the magazine; in addition, several cartridge cases were found several hundred feet from the magazine. The fire was attributed to stabilizer depletion in single-base propelling charges.

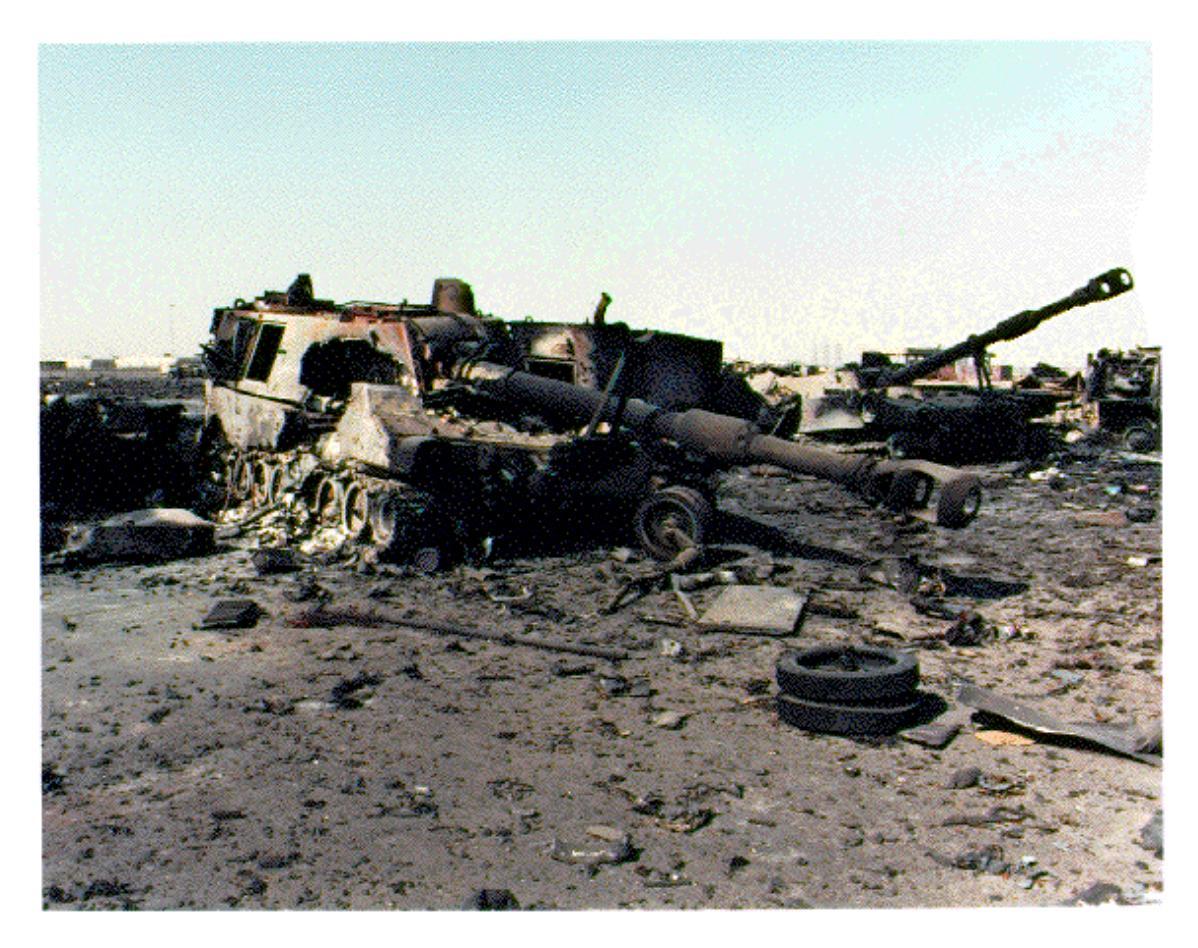
A defective heater in a M992 ammunition carrier loaded with 155 mm artillery shells caught on fire. Unit members tried unsuccessfully to fight the fire before being ordered to evacuate the area. The fire burned for approximately 40 minutes before the burning M992 exploded. This set off an hours-long series of fires and explosions that devastated vehicles and equipment and scattered unexploded ordnance and debris over much of the camp as shown in Figure 2. The fires and explosions destroyed over 102 vehicles, including four Abrams M1A1 tanks and seven M109 howitzers. There were no fatalities (although three fatalities occurred during clean-up activities), and 50 U.S. and 6 UK troops were injured.

FIGURE 2. Destroyed M109 Howitzers at Camp Doha, Kuwait.

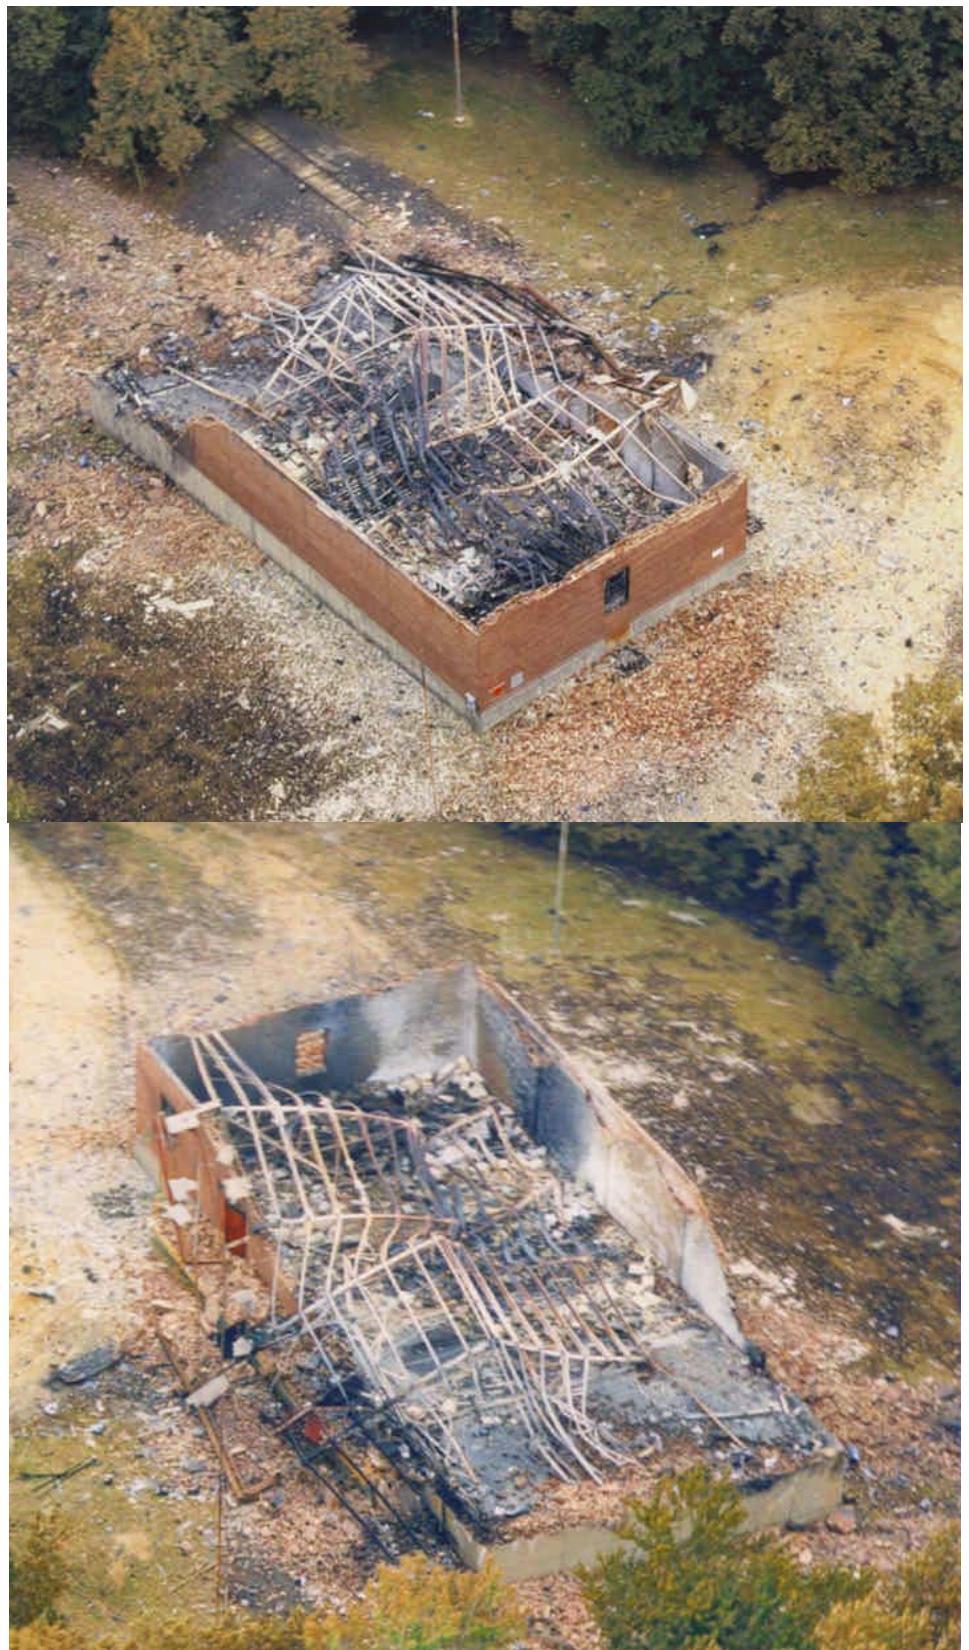
The surmised sequence of events started with auto-ignition of nitrocellulose gun propellant. The fire spread and involved a relatively large quantity of magnesium-teflon-viton flare material, which provided an intense boost to the fire. This in turn led to the first and largest detonation followed by a series of smaller detonations.

FIGURE 5. Magazine 518 after the Fires and Detonations.

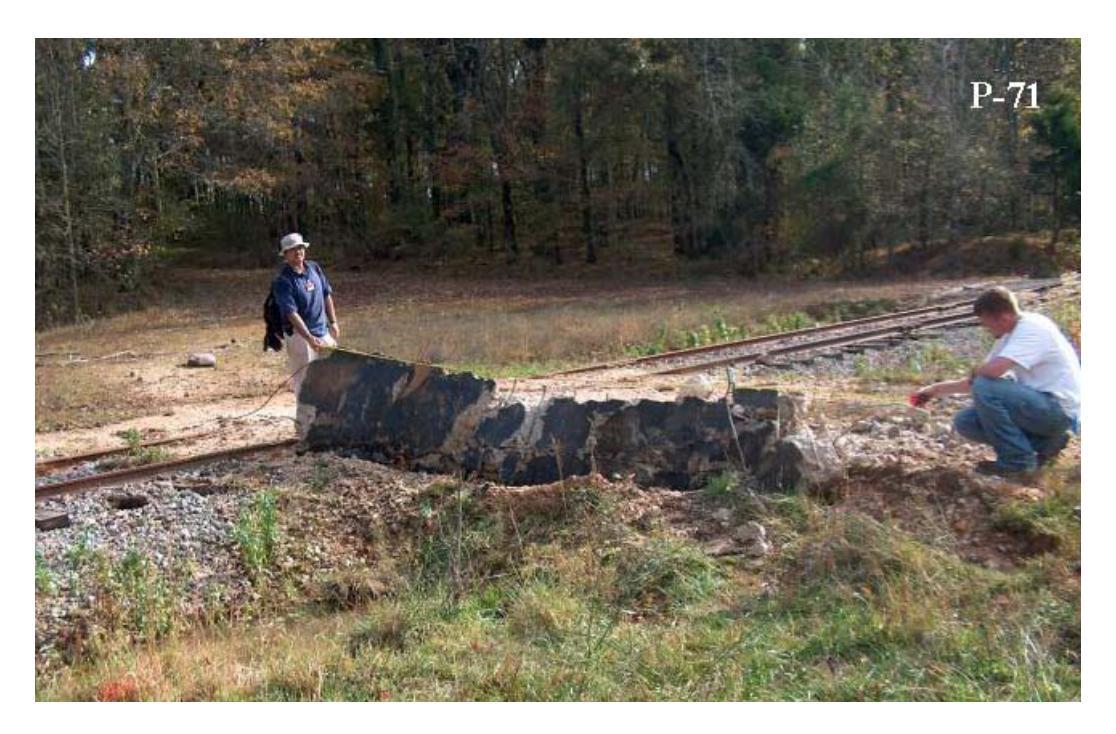
Witnesses reported hearing two blasts in rapid succession, with the second blast being more powerful than the first. Of particular interest was the size of some of the debris and the distances it was thrown. For example, one fragment was steel reinforced concrete 16 feet in length and 3 to 4 feet in width (Figure 6).

FIGURE 6. Large Fragment that Landed Between Magazines P-70 and P-71.

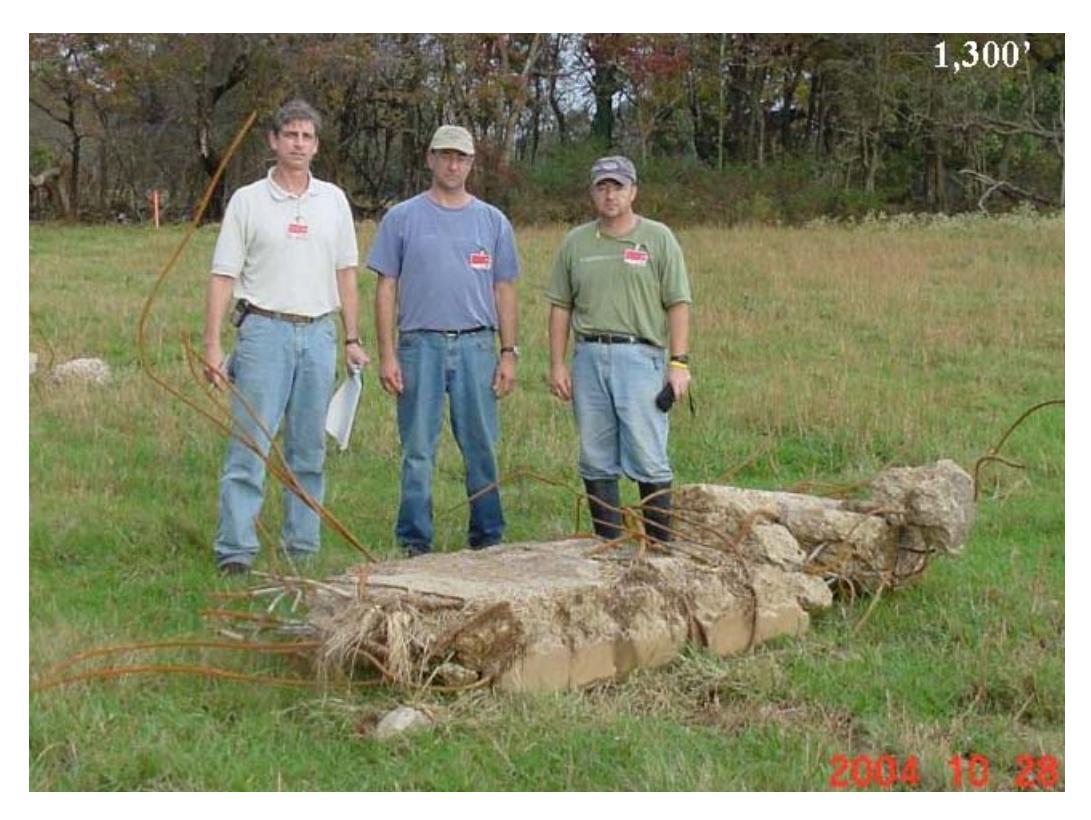
FIGURE 7. Large Fragment that had Been Part of the Headwall Found at Approximately 1,300 Feet from the Magazine.

The large fragment shown above traveled beyond the 1,250 foot radius for inhabited building distance (IBD) arc. Other large fragments were found significantly further than the 1,250 foot IBD arc. For example, there was significant damage to a tree located 2,100 feet in front of the magazine caused by a large fragment impact. Other debris estimated to have been a 6- by 8-foot section from the head wall significantly damaged a tree 3,100 feet from the magazine.

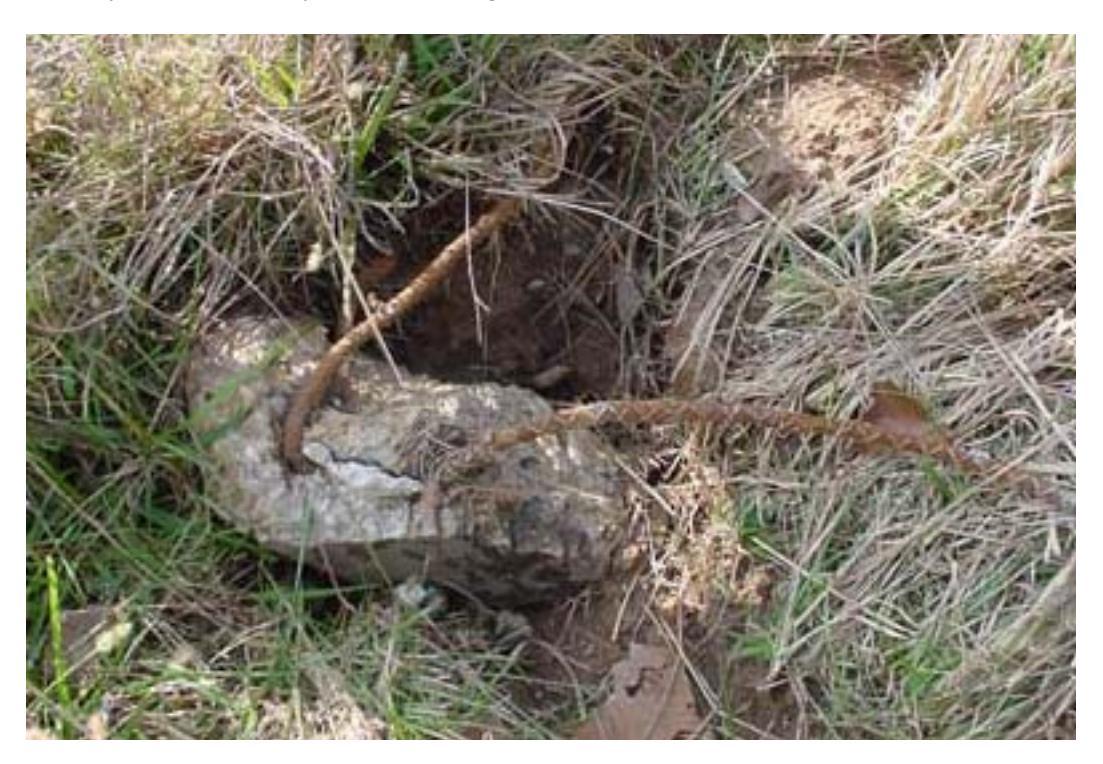
In addition to the sectors described above, the investigators recorded notable fragments outside of the search sectors. These included especially large fragments and/or fragments that traveled unexpectedly long distances. For example, significant debris was found on top of and in front of magazine P-6, which is approximately 2,050 feet away from P-69 (Figure 9).

FIGURE 9 Fragment Found in Close Proximity to ECM P-6, Approximately 2,050 Feet Away from ECM P-69.

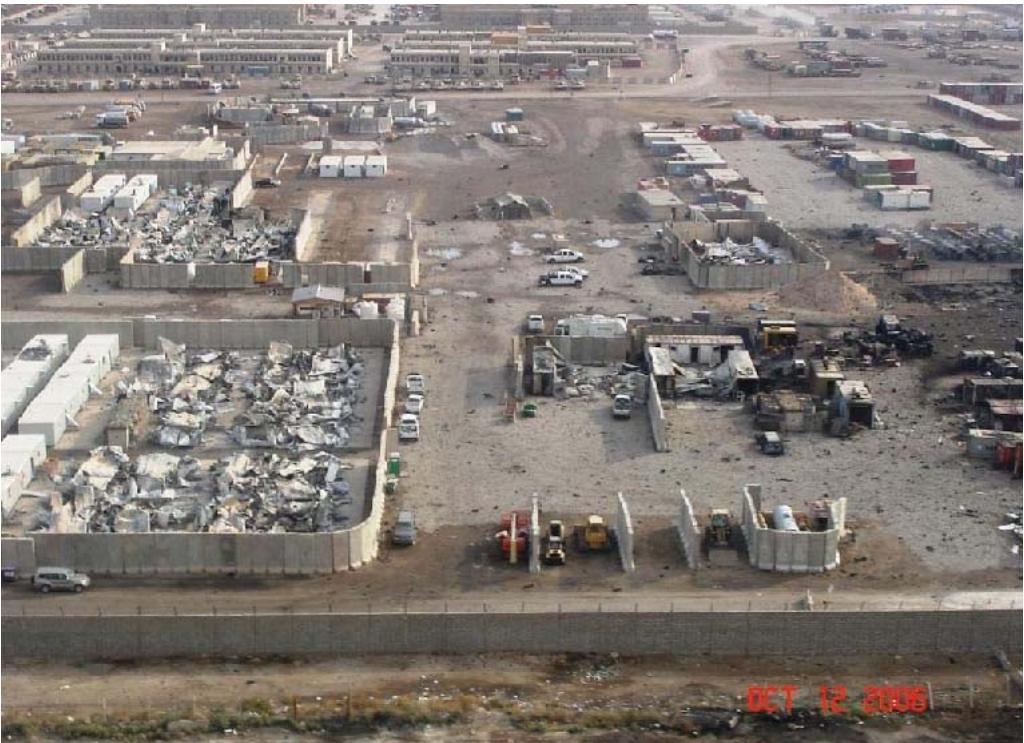
An incoming 82-mm mortar round started a fire at Forward Operating Base Falcon located in a former commercial trucking depot near the southern entrance to Baghdad. There were no injuries reported, but the fire spread and caused fires and explosions in surrounding tank and artillery ordnance and small arms ammunition. The fires and explosions went on for over 12 hours after the original fire. There was significant damage as shown in Figures 10 and 11.

FIGURE 10. Damage at FOB Falcon near Baghdad, Iraq, 10 October 2006.

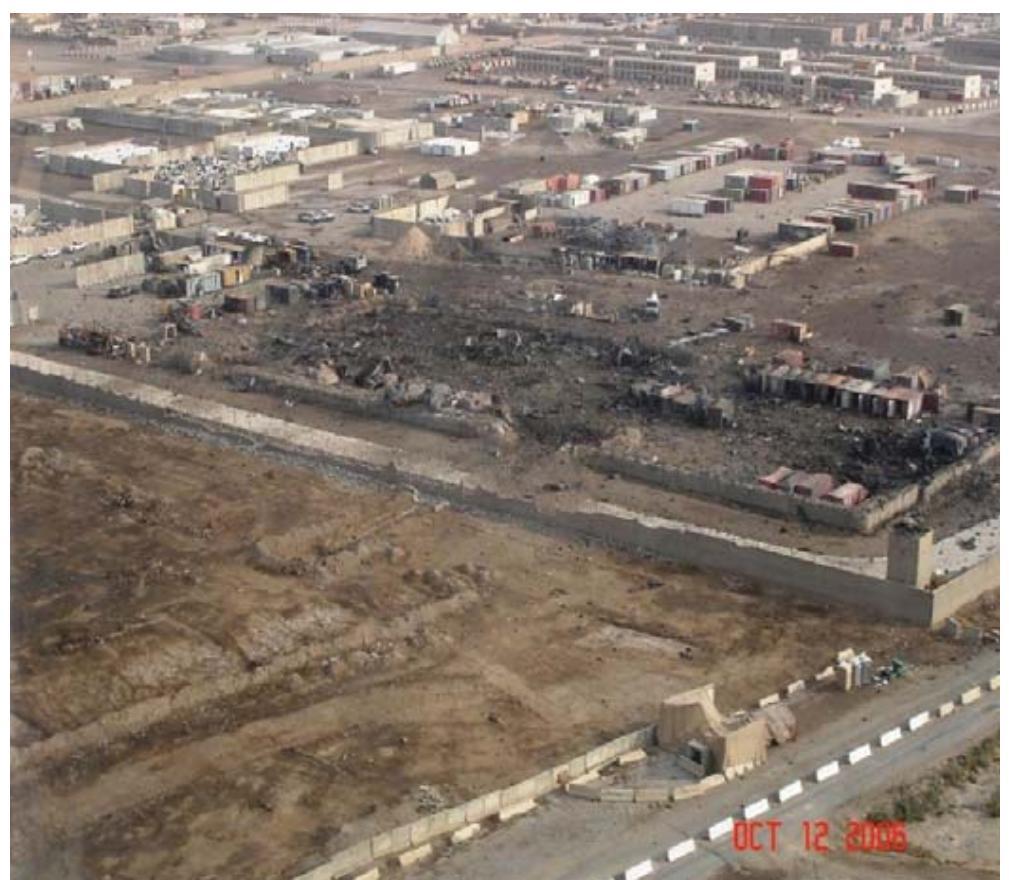
FIGURE 11. Damage at FOB Falcon near Baghdad, Iraq, 10 October 2006.

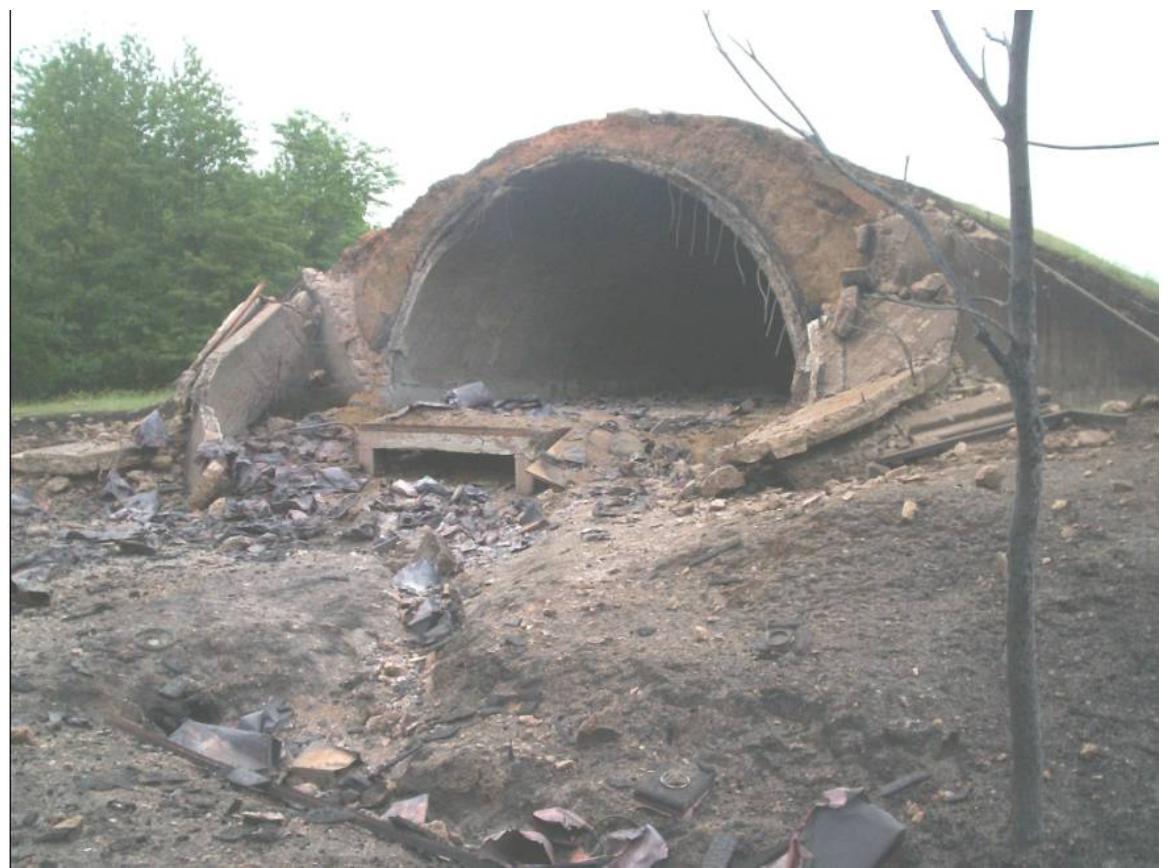
The post-mortem photographs clearly show that the fire blew out the headwall and scattered debris over an area as shown in Figures 12 through 14.

FIGURE 12. Earth-covered Magazine with Headwall Blown Out.

The cause of the accident was likely due to auto-ignition of the M-10 propellant as a result of stabilizer depletion.

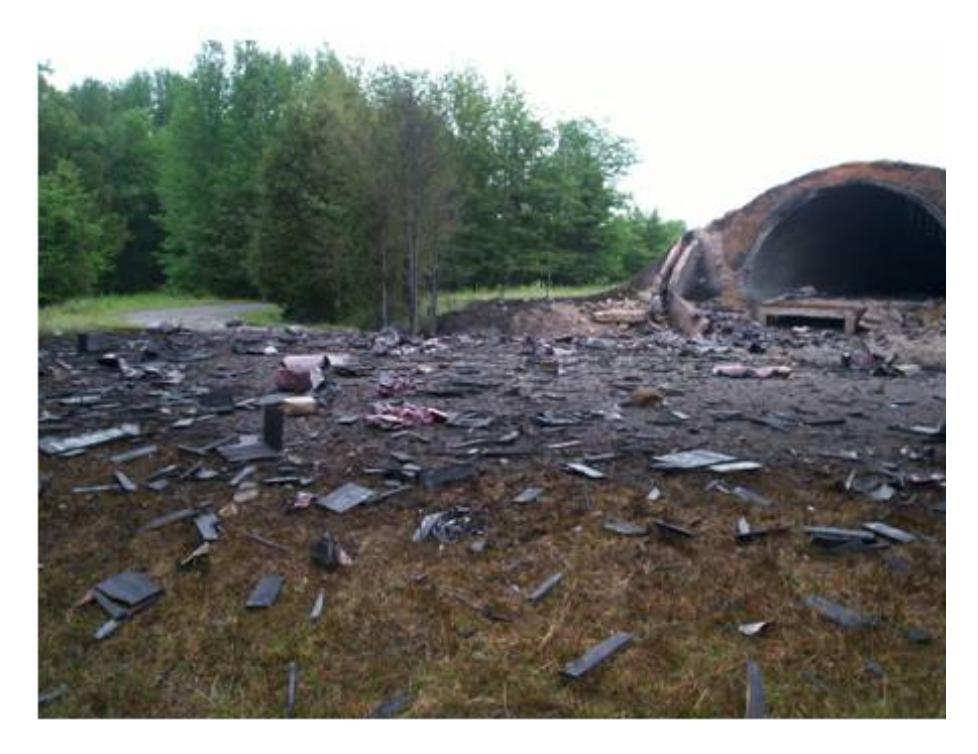
FIGURE 13. Debris from Magazine and Contents.

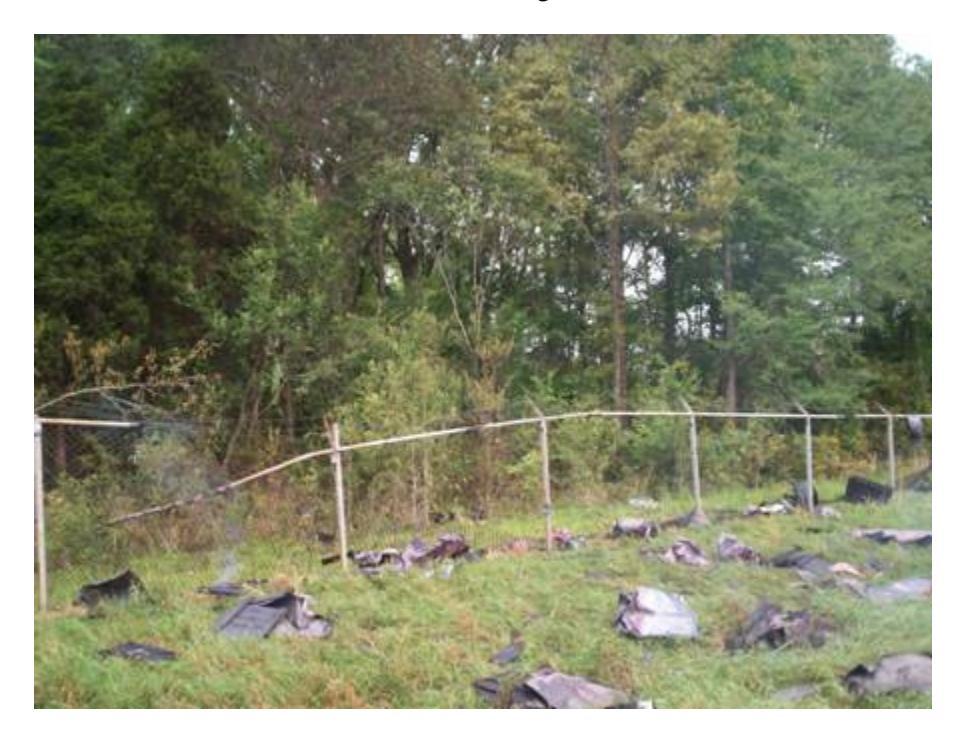
FIGURE 14. Debris Expelled from Magazine.

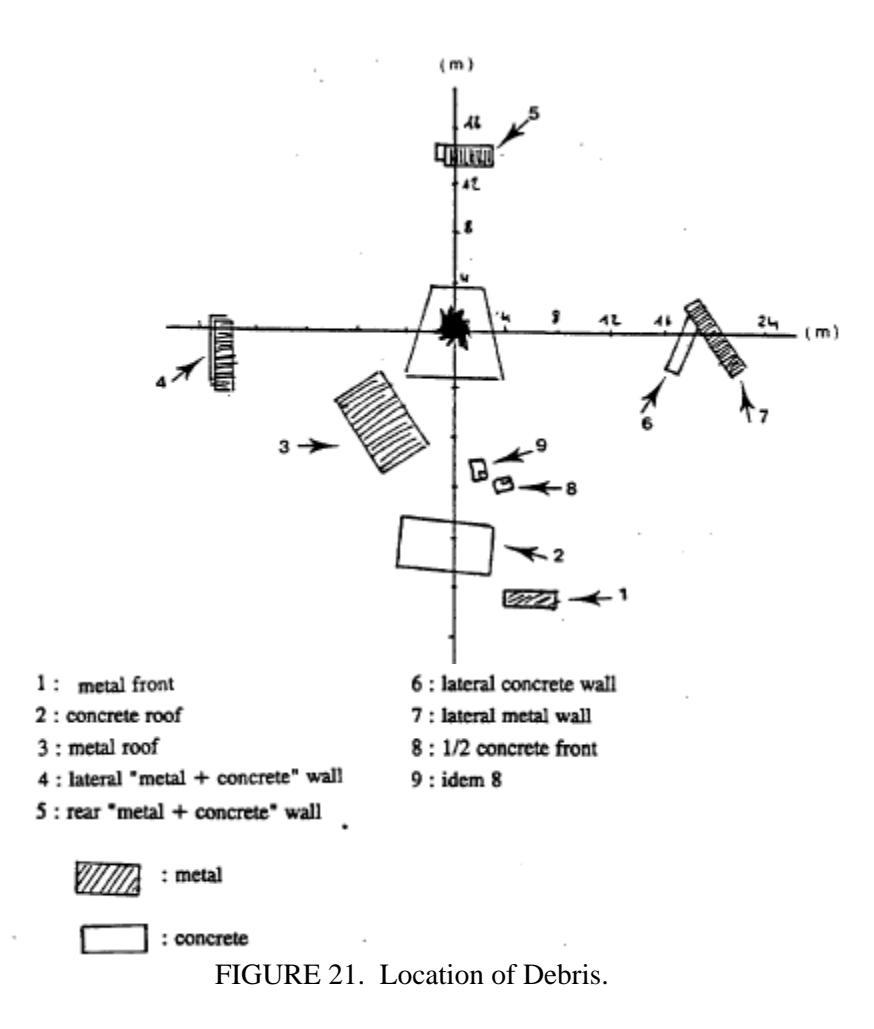
Test 4 resulted in the igloo bursting <u>1 second after ignition</u>, releasing a fireball. At ground level, no trace of a plume was observed. The igloo separated along its structural lines or corners. It separated into five main parts, each comprising two pieces—one concrete and one steel as shown in Figure 21.

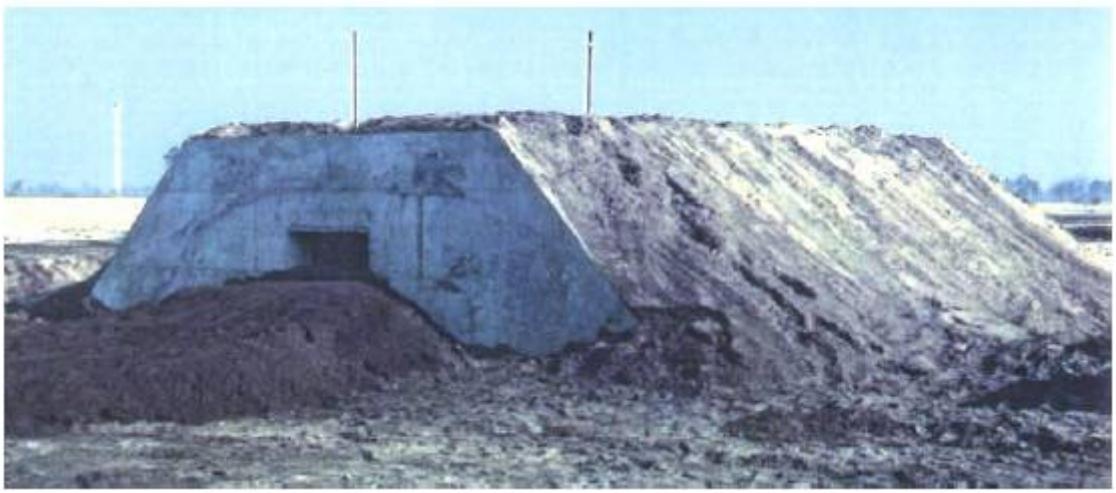
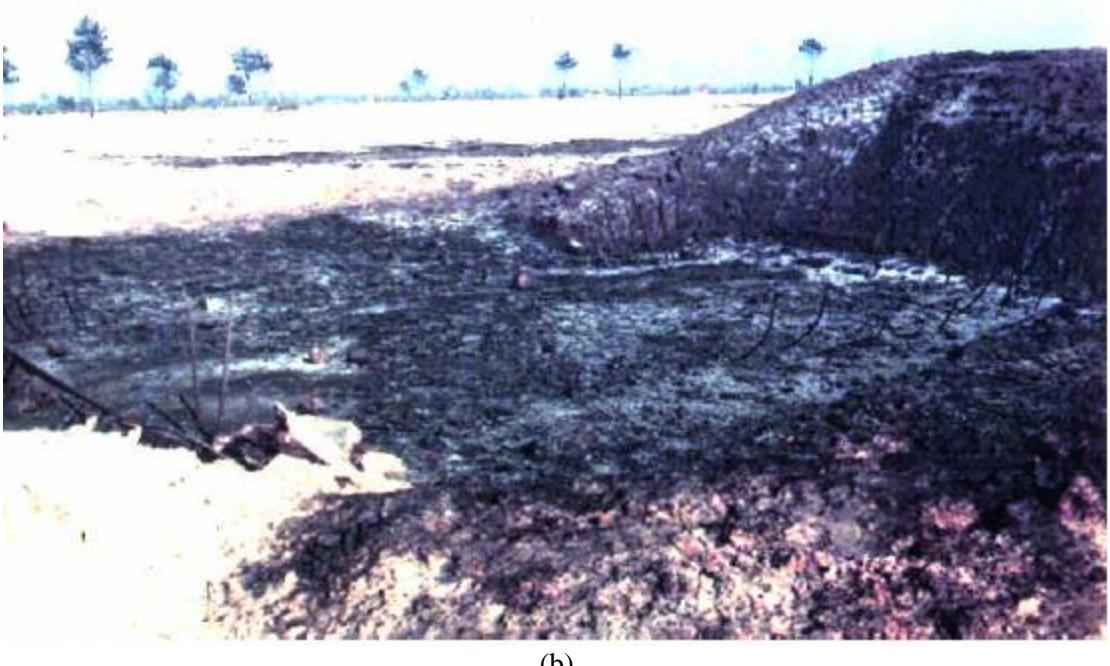
Interestingly, none of the overpressure gauges recorded any signal, nor was any crater formed, indicating neither a strong explosion nor a detonation occurred (Figure 22b). One of the internal overpressure gauges recorded an overpressure of 7 bars before saturating. The authors estimated that the maximum internal overpressure before rupture at 10 to 12 bars.

FIGURE 22. Captieux Trial Shot 4 (a) Before and (b) After.

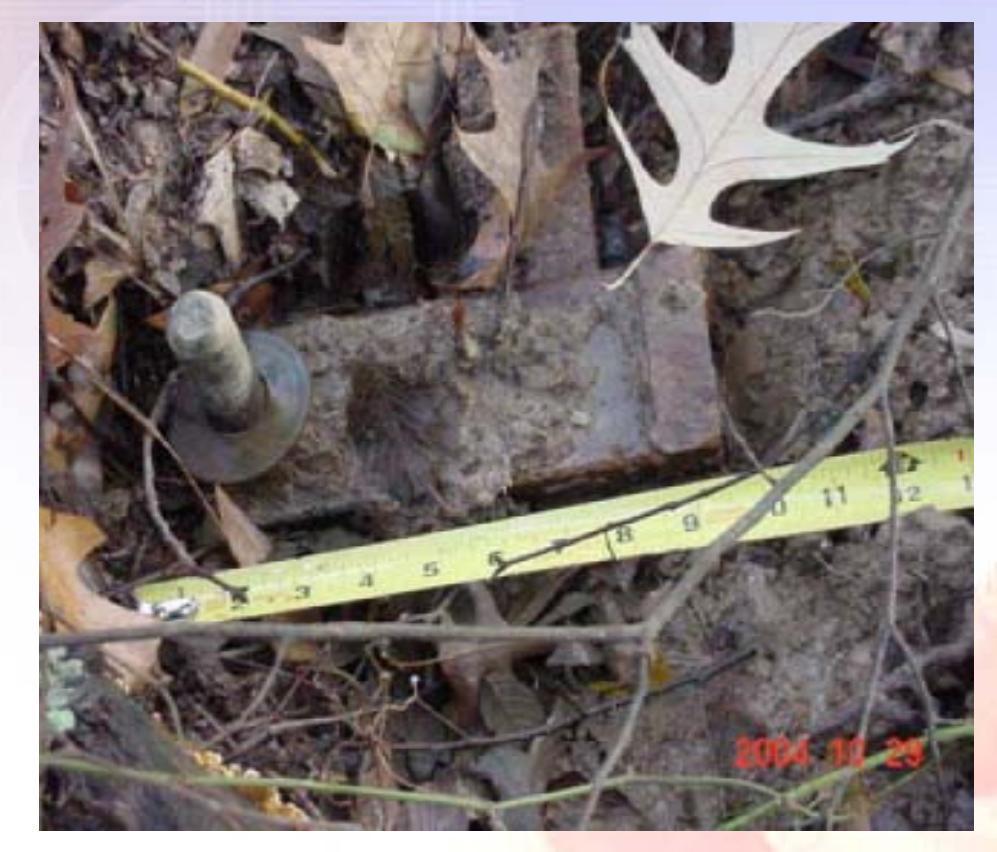
Tree at 2100' impacted by large piece of headwall. Piece of hinge found at base of tree. Rebar and angle iron also found at base of tree. Concrete shattered on impact, concrete debris found beyond tree.
