Observations of Facet Formation in Near- α Titanium and Comments on the Role of Hydrogen

A.L. PILCHAK and J.C. WILLIAMS

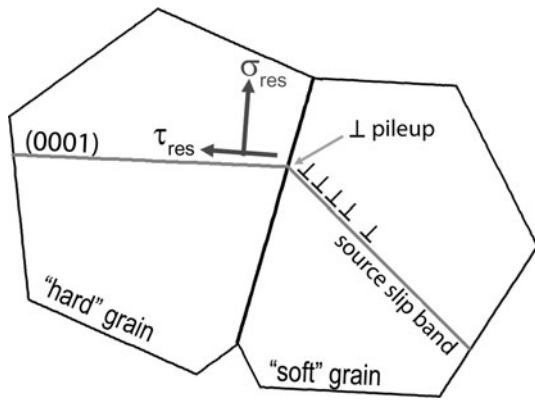
Fig. 1—Schematic representation of the Stroh model as modified by Evans and Bache^[6] for dwell fatigue.

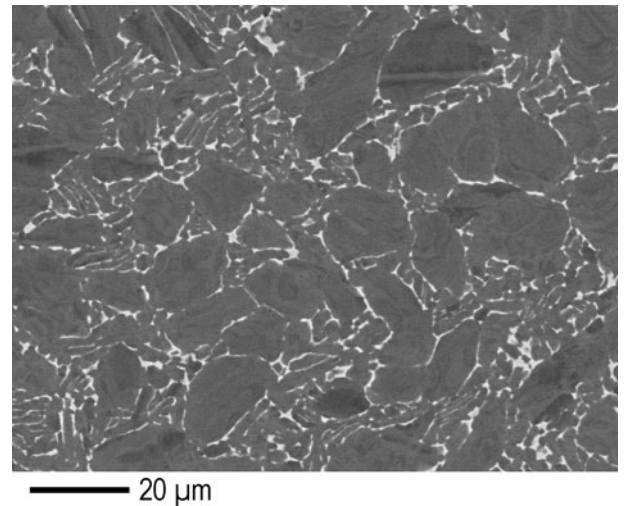
Fig. 2—Microstructure of the as-received Ti-811 bar.

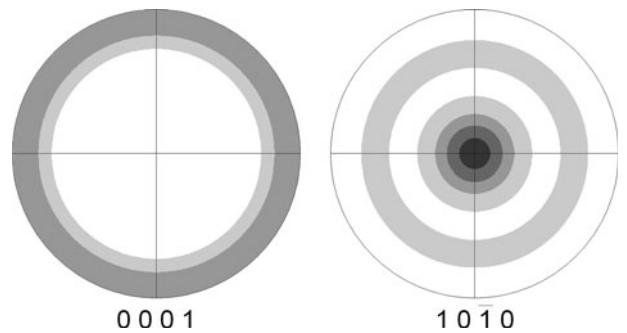
Fig. 3—The texture of the as-received bar indicating the presence of a weak 10 $\bar{1}0$ partial fiber along the bar axis (which is perpendicular to plane of projection). The levels of intensity are in intervals of 0.5 multiples of the probability of a random distribution.

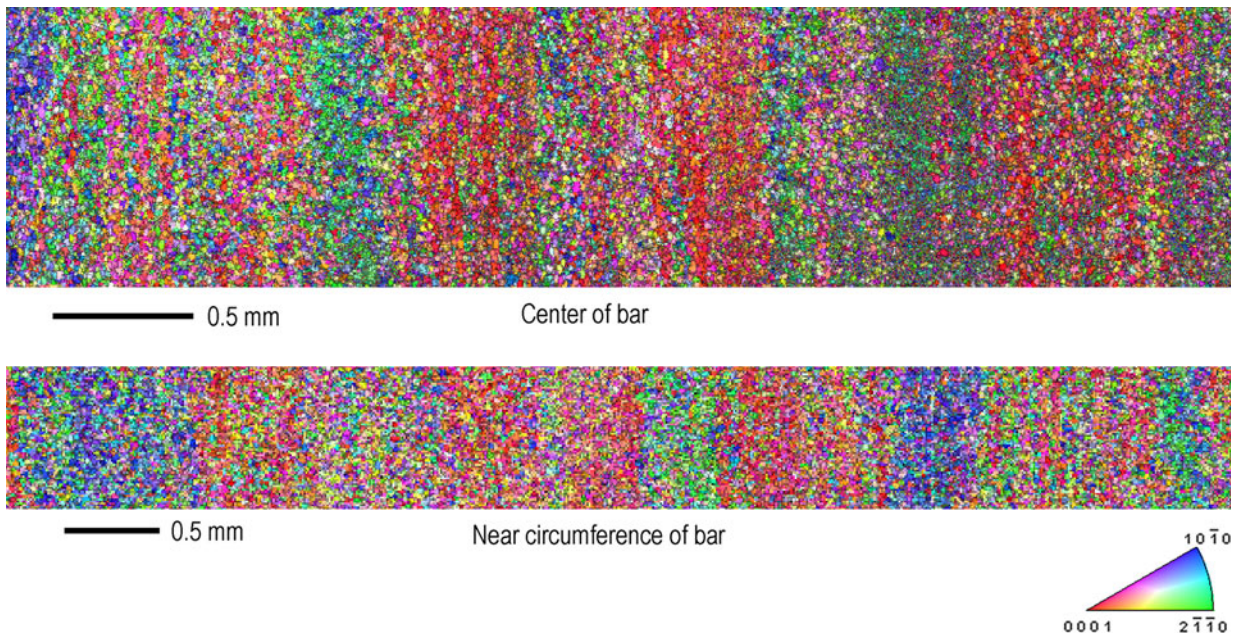
Fig. 4—Normal direction inverse pole figure EBSD maps of longitudinal sections cut from near the center and edge of the bar showing elongated bands of microtexture. The loading direction is perpendicular to the plane of polish. (Color figure online).

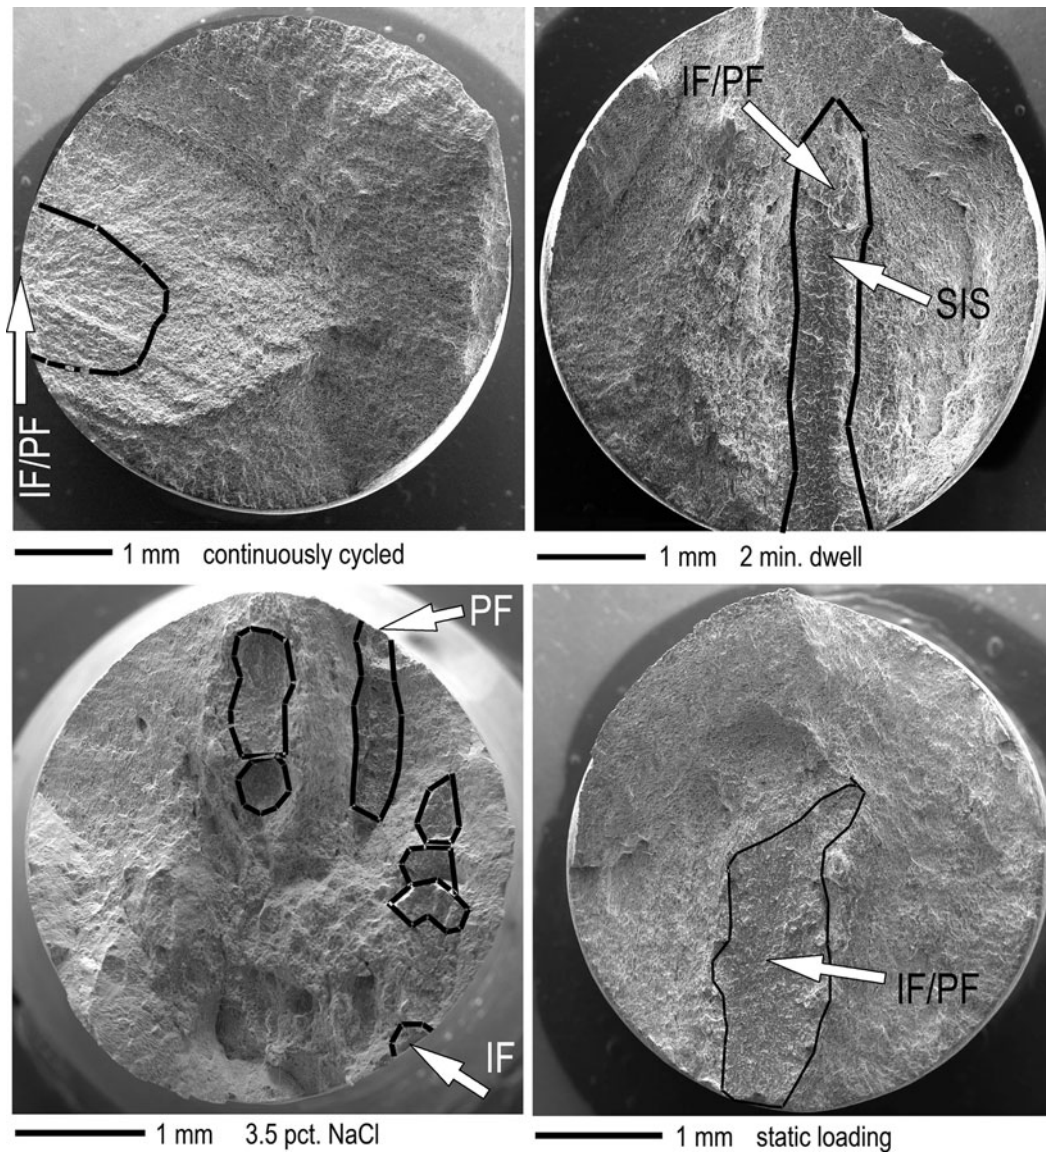
Fig. 5—Low-magnification SEM images of the fractured specimens. The faceted regions on each specimen are enclosed by black lines. The locations of the initiation facets (IF) and propagation facets (PF) discussed in more detail in the text are identified on each fracture surface. The location of a secondary initiation site (SIS) on the dwell fatigue specimen is also shown.

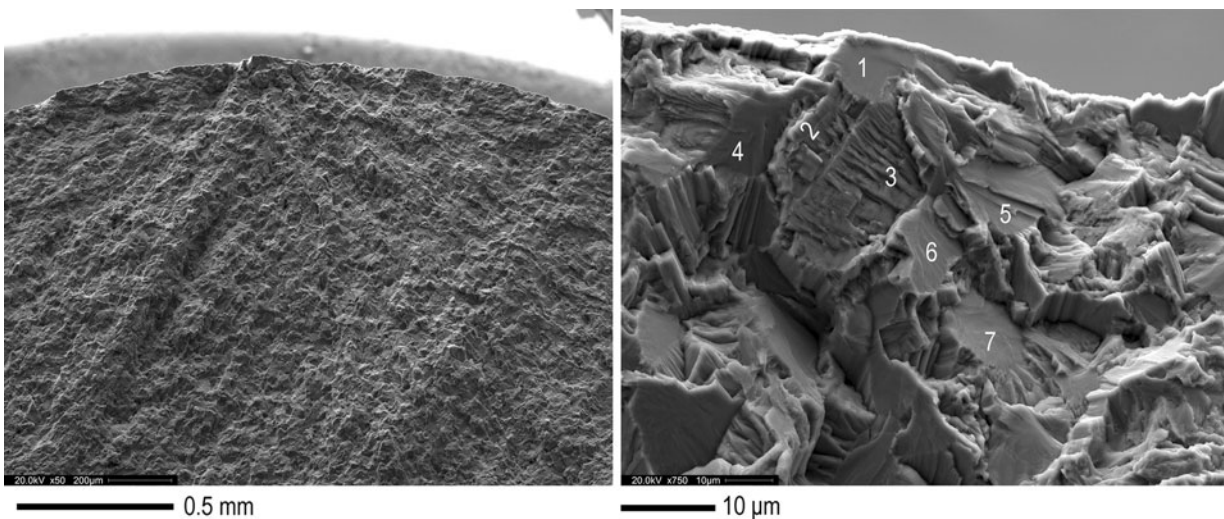
Fig.6—Crack-initiation site in the continuously cycled specimen in the as-received condition. Several facets are identified by numbers 1 through 7 (CY-1 through CY-7).

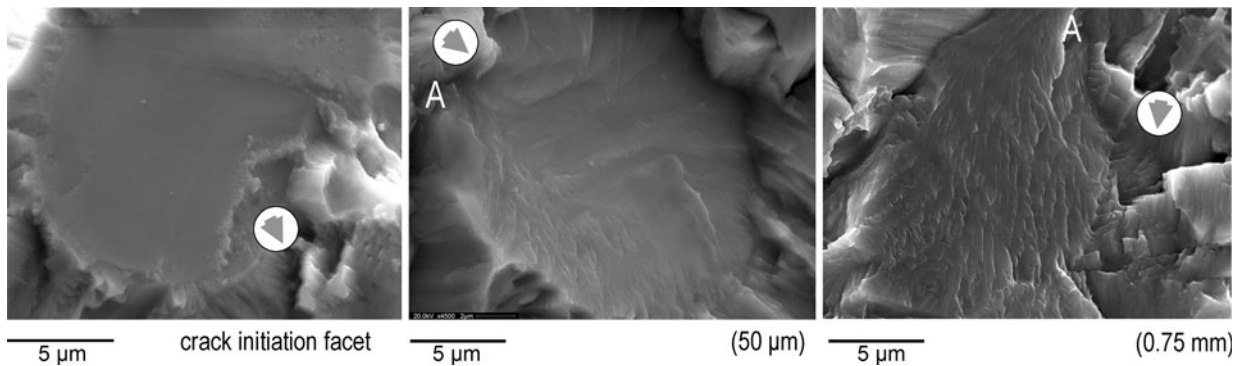
Fig. 7—The effect of crack length on facet topography in the cyclically loaded specimen in the as-received condition. The local crack propagation direction is indicated by the arrows while the letter A designates the point at which the crack entered the grain.

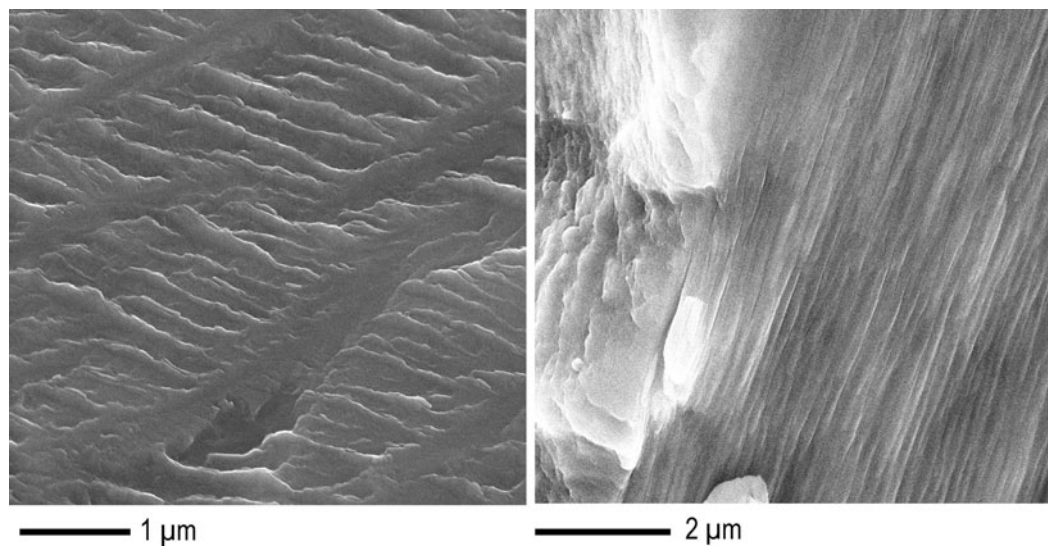
Fig. 8—High-magnification secondary electron images of two different facet surfaces in the continuously cycled specimen at crack lengths $\sim 100 \mu\text{m}$. The markings on the facet surfaces suggest the crack growth rate is on the order of $150 \text{ nm cycle}^{-1}$.

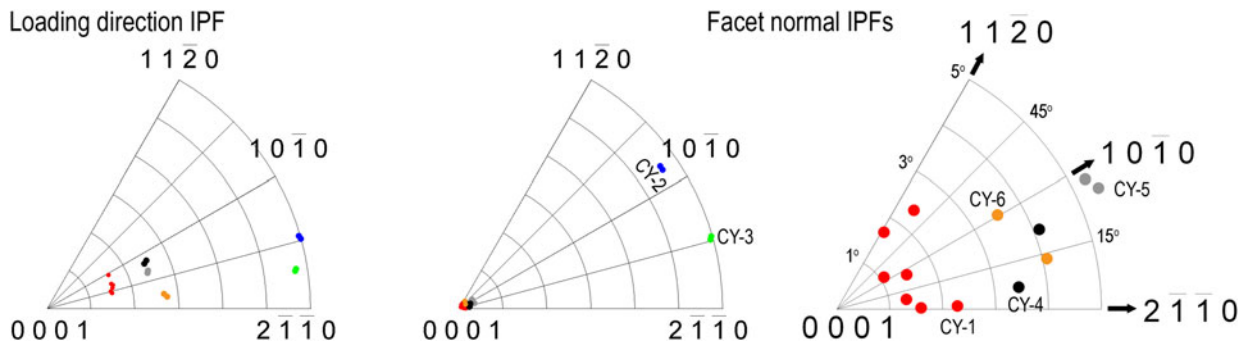
Fig. 9—Results from the facet crystallography analysis on the continuously cycled fatigue specimen. The IPF on the right is a magnified view of the region around 0001 in the center facet normal IPF (also note the change in scale for this IPF). (Color figure online).

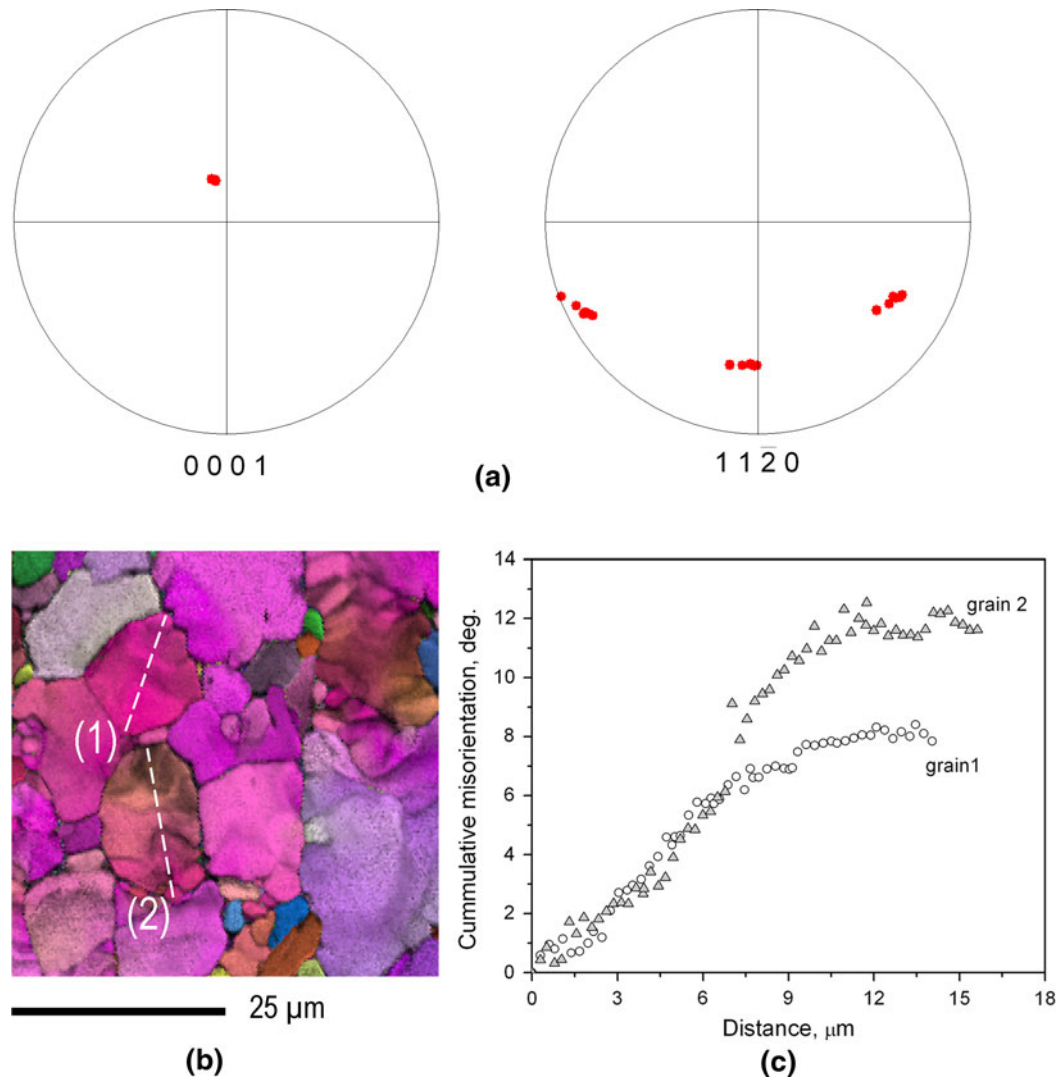
Fig. 10—(a) 0001 and $11\bar{2}0$ equal-area-projection pole figures showing all of the orientations indexed from the crack-initiation facet (CY-1) in the continuously cycled specimen. The basal pole remains in the same position; however, there is a rotation of 10 deg about [0001] over a distance of approximately $7\ \mu\text{m}$ on the facet. (b) High-resolution ($0.35\ \mu\text{m}$ step size) inverse pole figure map (+ image quality overlay) of the as-received material, and (c) cumulative misorientation distributions along profiles (1) and (2) in (b). (Color figure online).

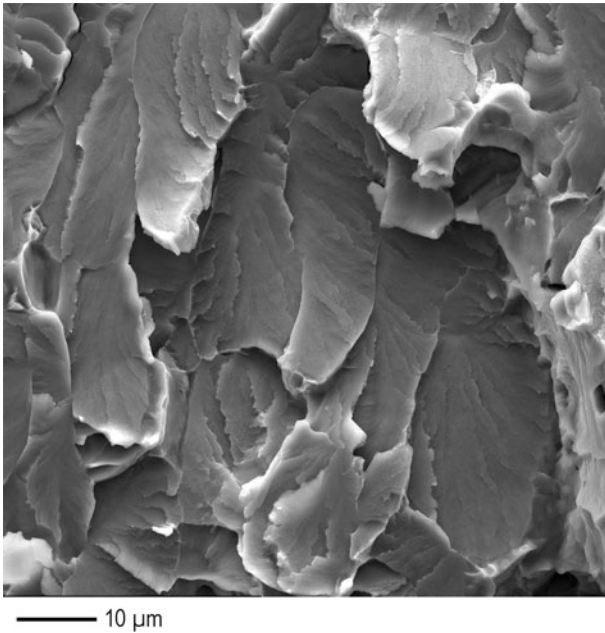
Fig. 11—Typical facet appearance throughout the entire faceted region on the specimen statically loaded in air.

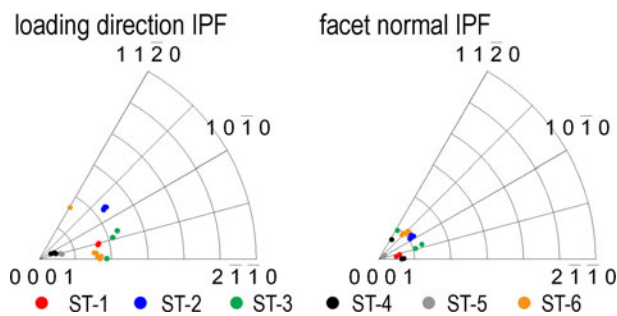
Fig. 13—Results from the facet crystallography analysis on the initiation (ST-1) and propagation (all others) facets from the statically loaded specimen. (Color figure online).

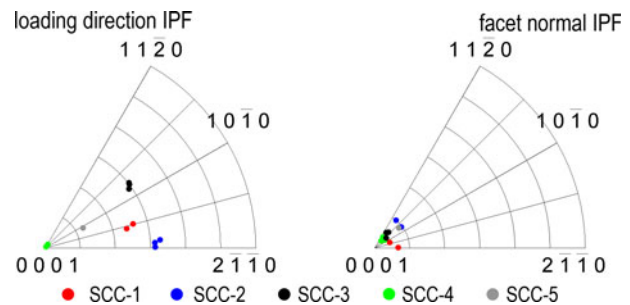
Fig. 15—Initiation and propagation facet crystallography for the as-received SCC specimen. Facets SCC-4 and SCC-5 are propagation facets, whereas the others are the near-initiation site facets. (Color figure online).

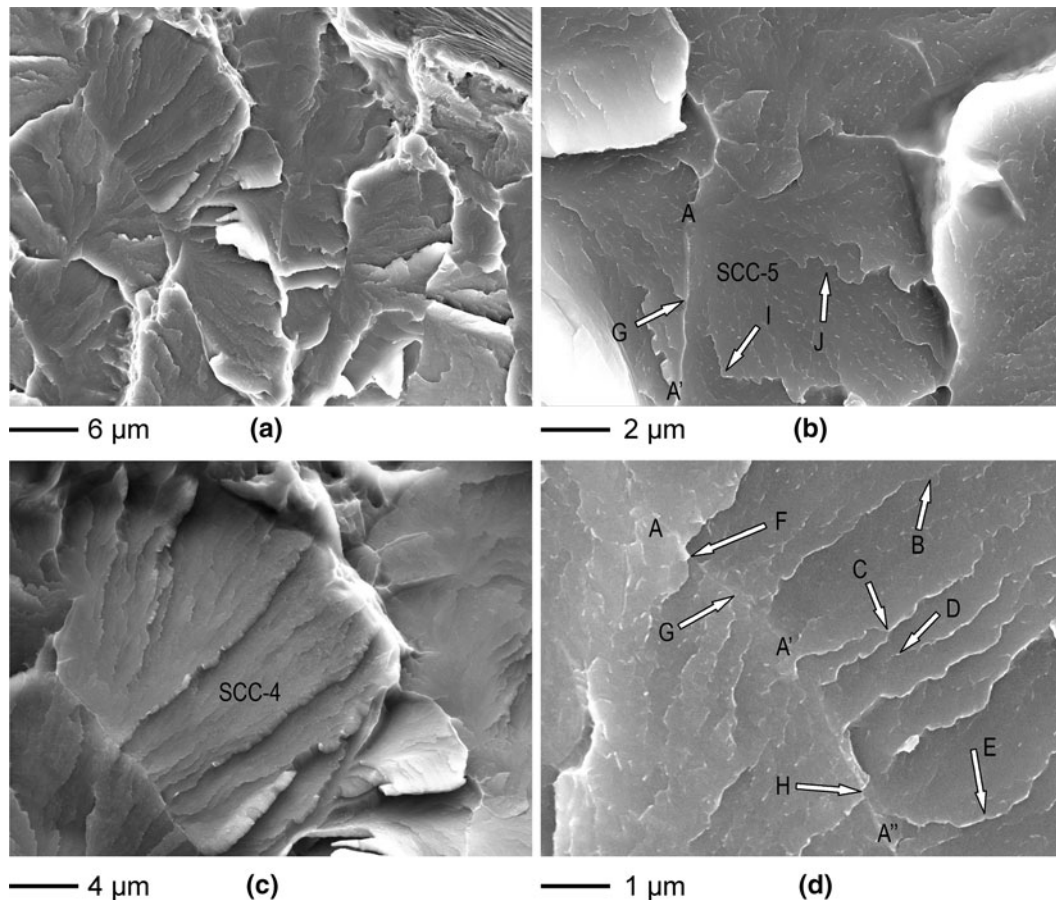
Fig. 16—Propagation facets on the fracture surface of the specimen subjected to static loading in 3.5 pct NaCl at 95 pct of the yield strength. Those facets analyzed in detail have been labeled with unique facet identification numbers. See text for details regarding the features identified by letters in (d).

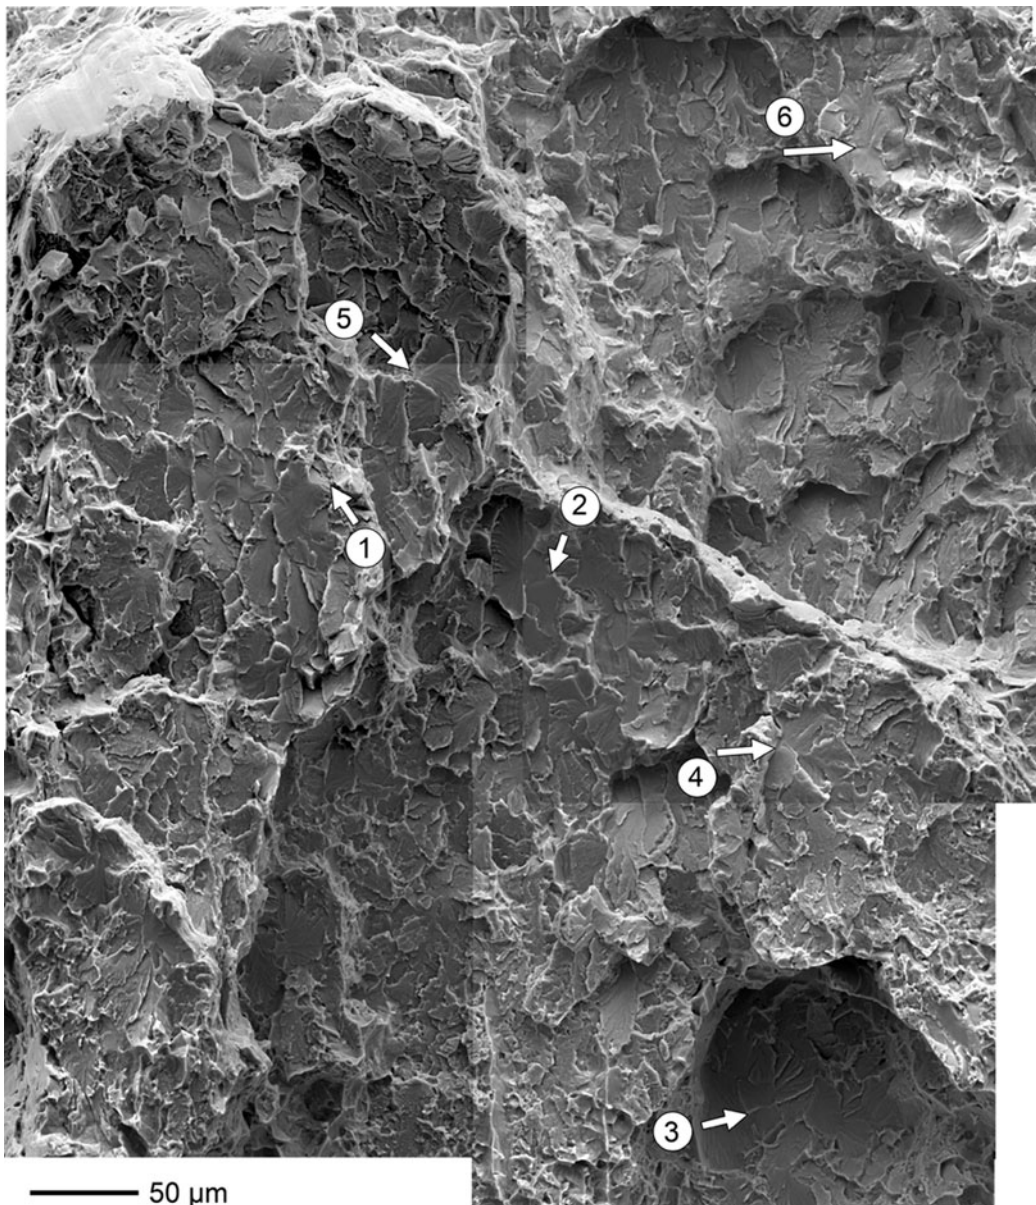
Fig. 17—Higher magnification secondary electron montage of the region around the primary initiation site (1) which reveals several secondary initiation sites (2-6).

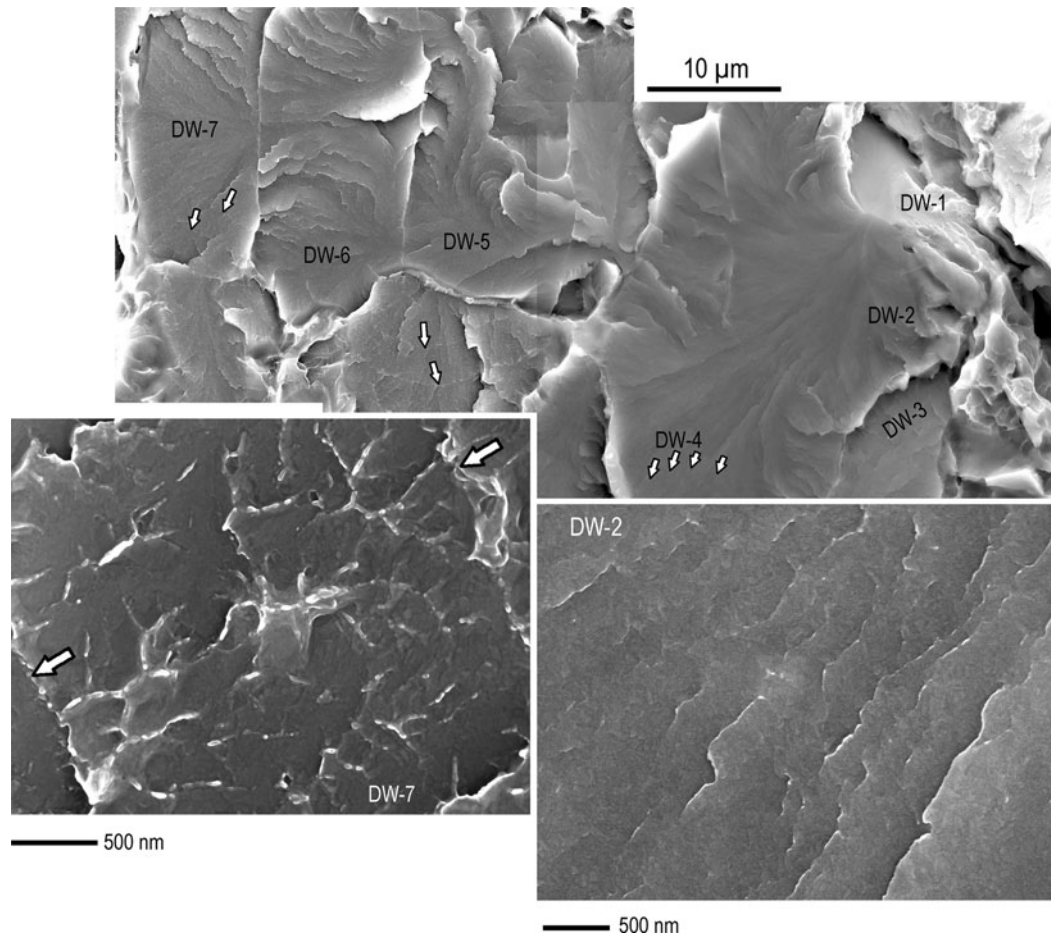
Fig. 18—High-resolution secondary electron images of the fracture surface of the dwell fatigue specimen (all at 0 deg stage tilt). The top image shows the initiation facet (DW-1), which is inclined substantially to the loading axis and subsequent propagation facets (DW-2 through DW-7). The arrows in the top image identify crack front arrest marks.

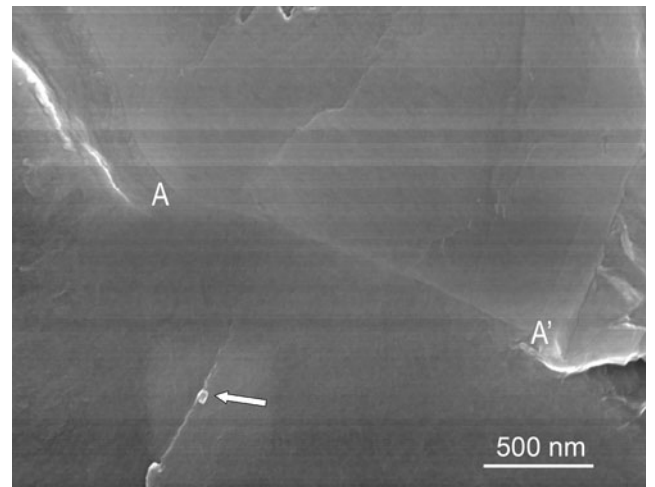
Fig. 19—The intersection of facets DW-1 (top) and DW-2 (bottom) at the primary dwell fatigue crack-initiation site. The arrow identifies a small particle near the first ridge formed on the first propagation facet. The composition and crystallographic structure of this feature is unknown.

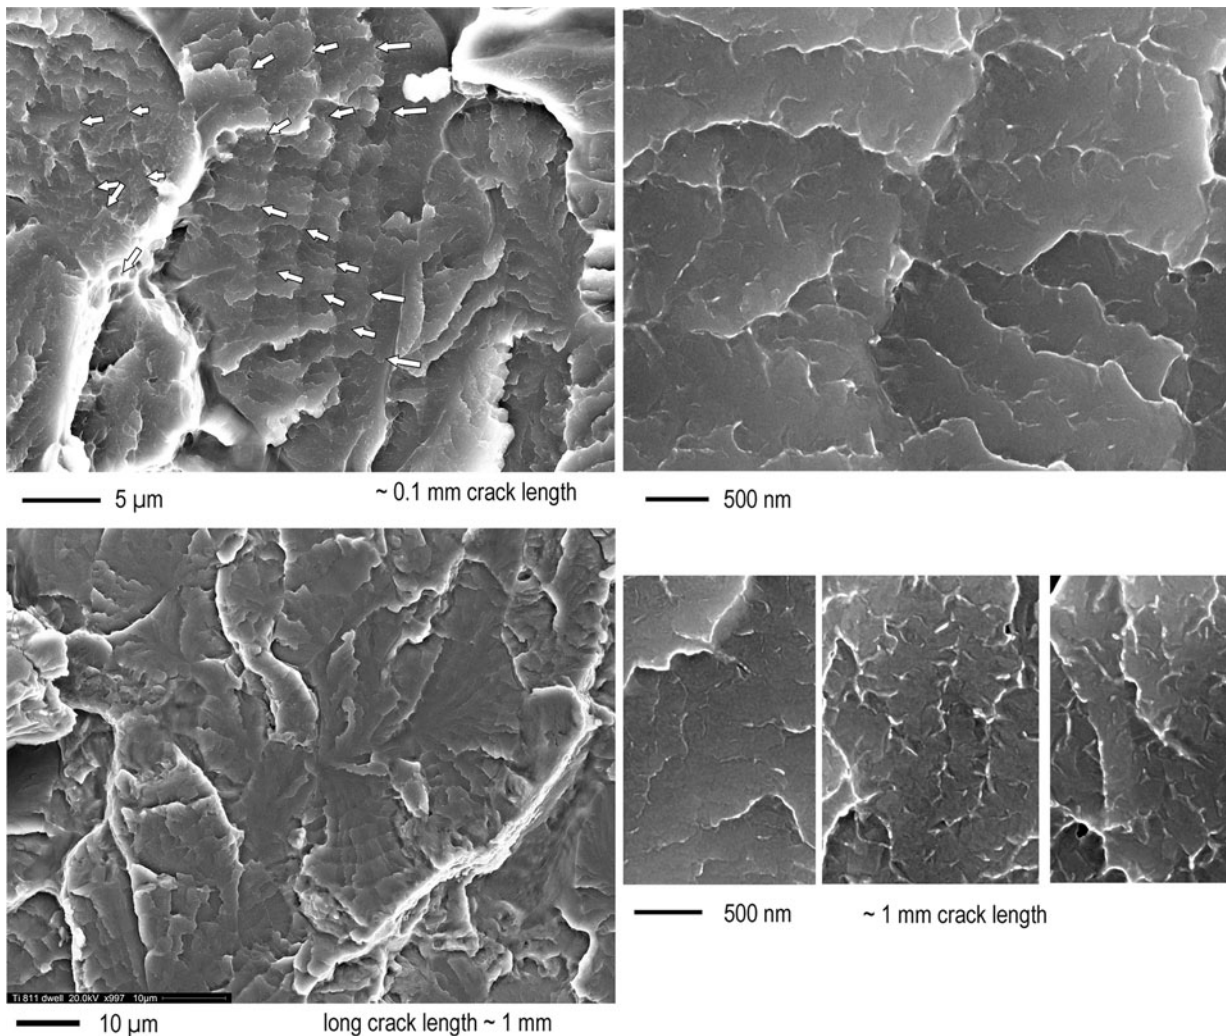
Fig. 20—Secondary electron images showing little variation among the facet surface topography as a function of crack length in the dwell fatigued specimen. A secondary initiation site is also evident in the center of the lower left image.

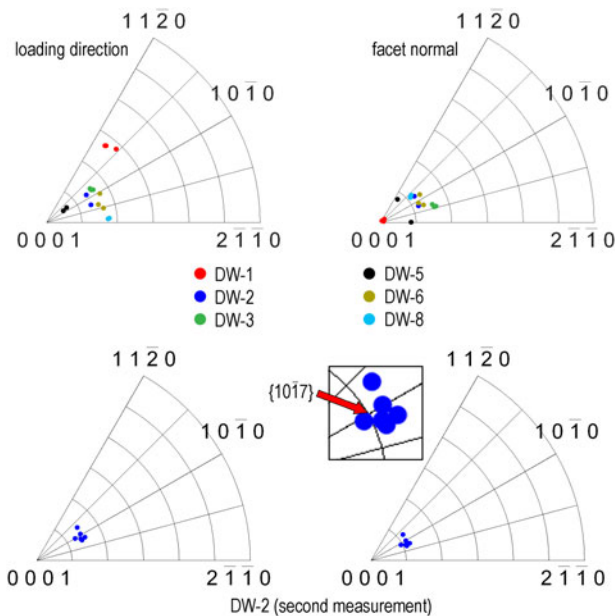
Fig. 21—Dwell fatigue facet crystallography. Equal-angle inverse pole figures showing the orientations of the faceted grains identified in Fig. 18 with respect to the loading direction and facet normal. (Color figure online).

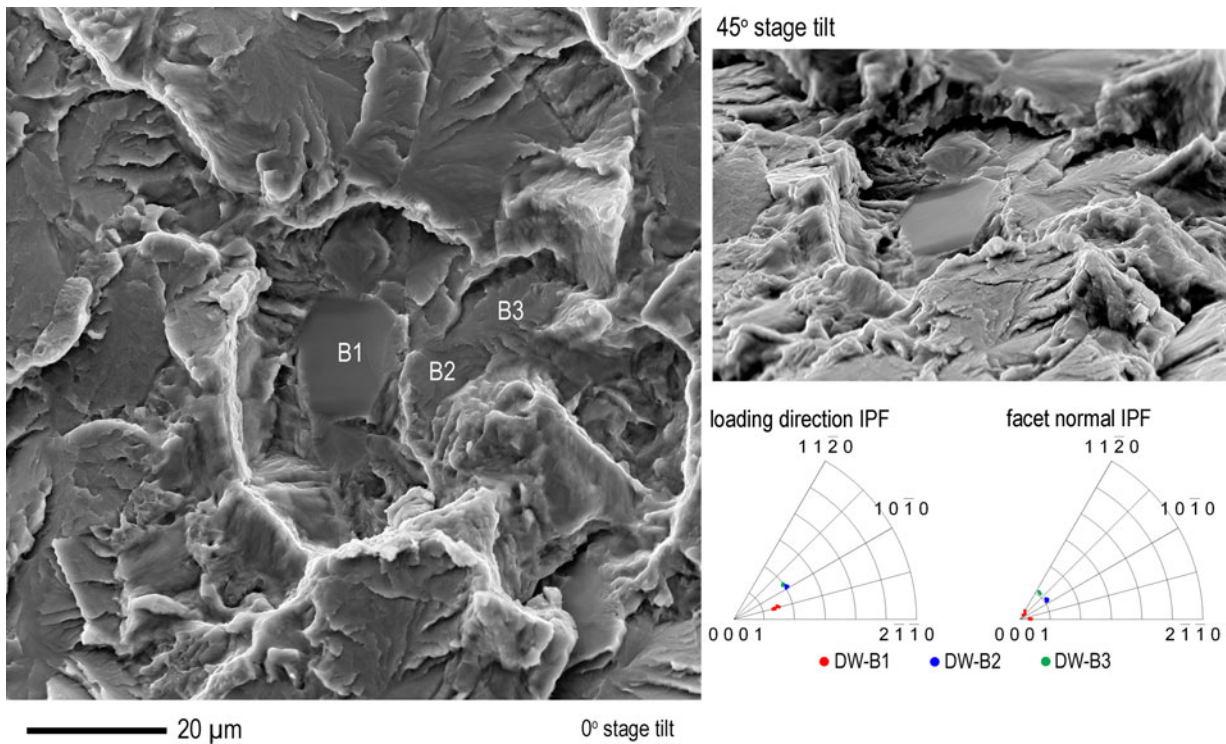
Fig. 22—Secondary electron images and facet crystallography analysis of a secondary initiation site in the dwell fatigued specimen. This location was approximately $380\ \mu\text{m}$ away from the primary initiation site. (Color figure online).

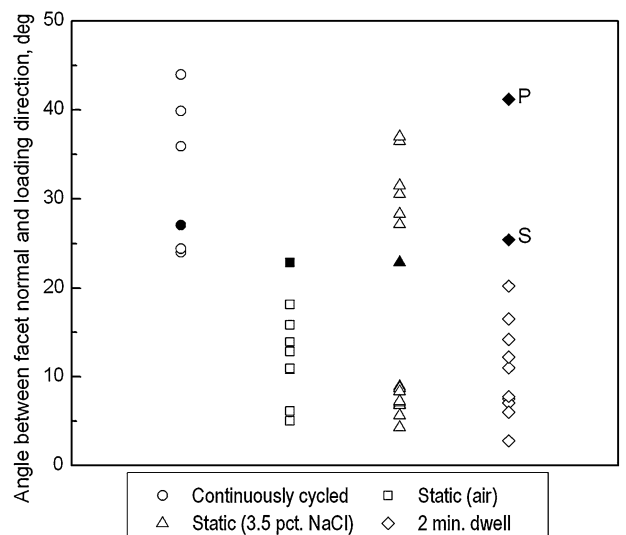
Fig. 23—Angle between facet normal and loading direction. Filled symbols indicate initiation facets, whereas open symbols designate propagation facets. Letters P and S designate the primary and secondary initiation sites studied on the dwell specimen, respectively.

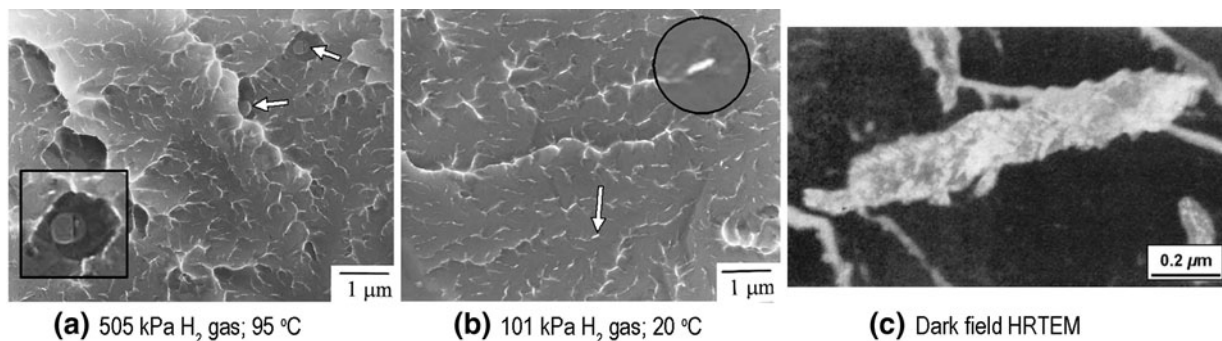
Fig. 24—(a) and (b) Surface topography of facets formed by static loading in Ti-6Al-4V alloy in H₂ gas.^[66] The arrows in (a) point to features that are presumably plate-like TiH₂ precipitates, the top of which is shown at higher magnification in the 1- μ m-wide inset. Smaller, bright particles similar to those observed on the Ti-811 facets in the current study were also observed. One is identified by the arrow in (b) and also shown at higher magnification in the 0.5- μ m diameter inset. (c) A dark field TEM image of a precipitate like the one identified in (b), except in the alloy Ti-8Al-1Mo-2V, lifted from the fracture surface in an acetate replica.^[67]

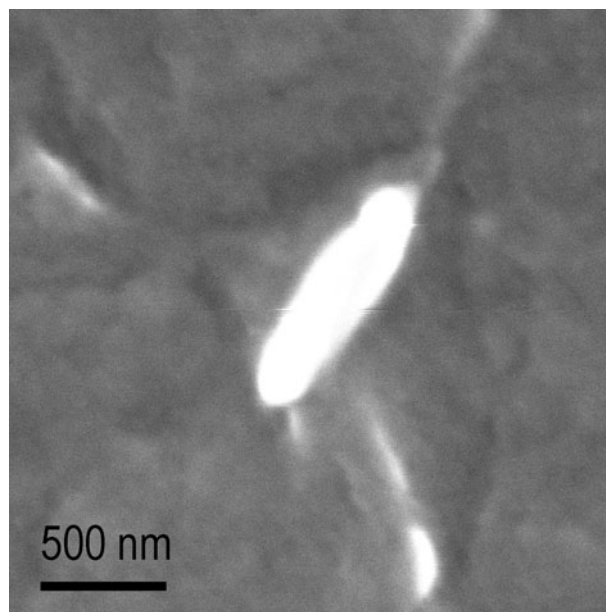
Fig. 25—Secondary electron image (TLD detector, magnification of 256,000 times) of a possible hydride particle from a dwell fatigue propagation facet.

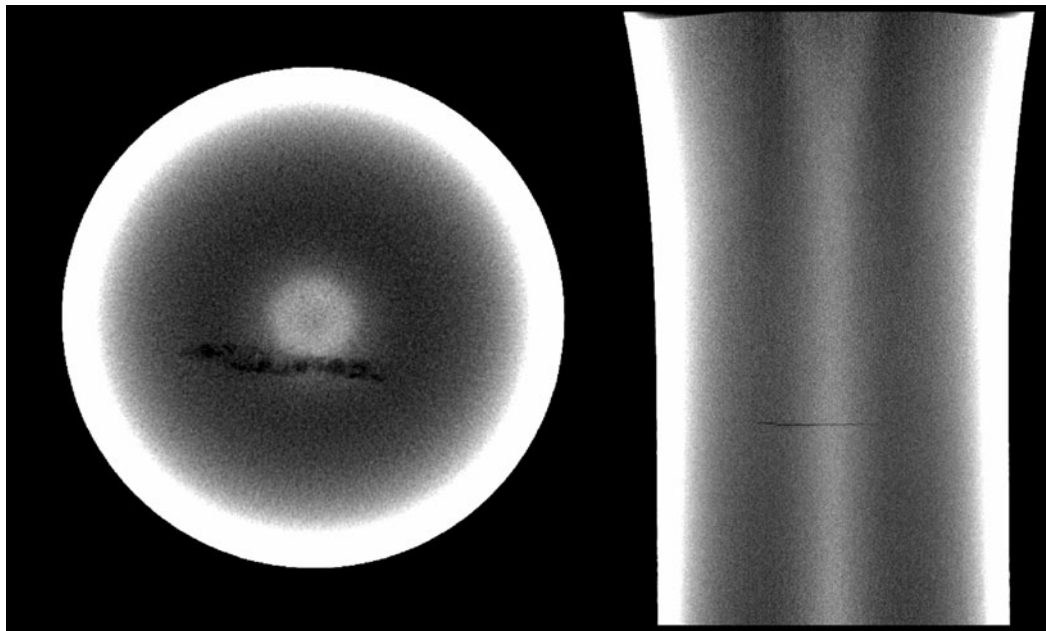
Fig. 26—Two orthogonal views of a subsurface crack imaged with X-ray computed tomography in a dwell specimen that had not failed after 26,263 cycles.

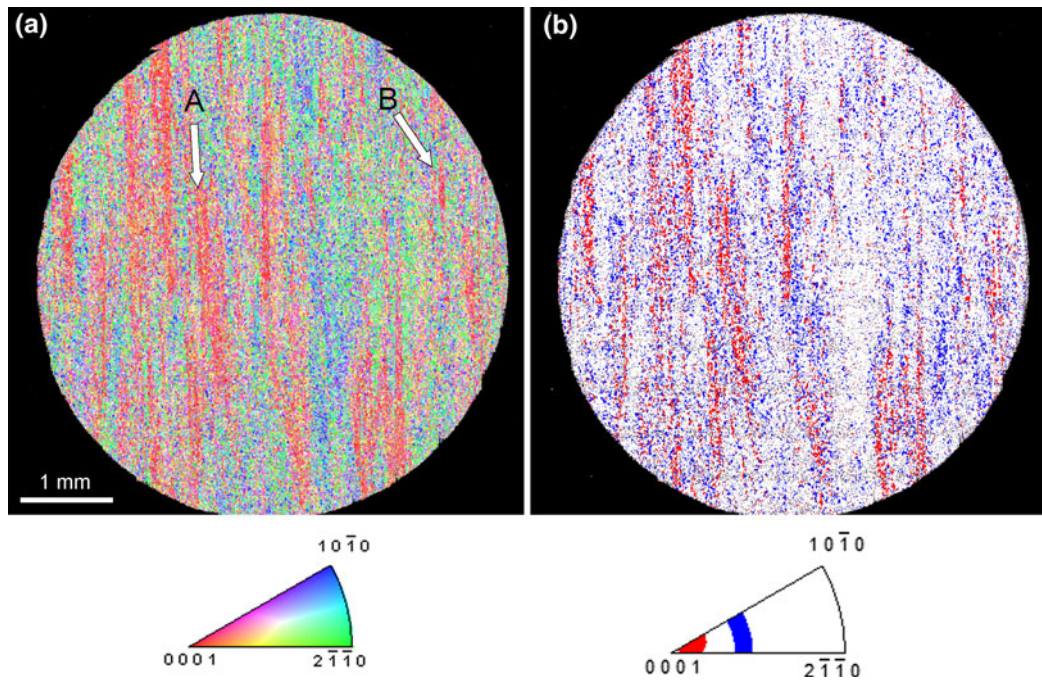
Fig. 27—(a) Loading direction inverse pole figure map of a transverse cross section of the dwell fatigue specimen approximately 1.3 mm beneath the fracture surface. In (b), those grains with basal poles inclined 40 deg to 50 deg from the loading direction have been colored blue, whereas the red grains are those with a $\{10\bar{1}7\}$ plane that is no more than 10 deg away from being orthogonal to the loading direction, as indicated by the inverse pole figures beneath each diagram. See text for details regarding locations A and B in (a). (Color figure online).
