BAGHDAD INTERNATIONAL AIRPORT POWER SYSTEM ENHANCEMENT BAGHDAD, IRAQ

SUSTAINMENT ASSESSMENT

SIGIR PA-07-097 April 26, 2007

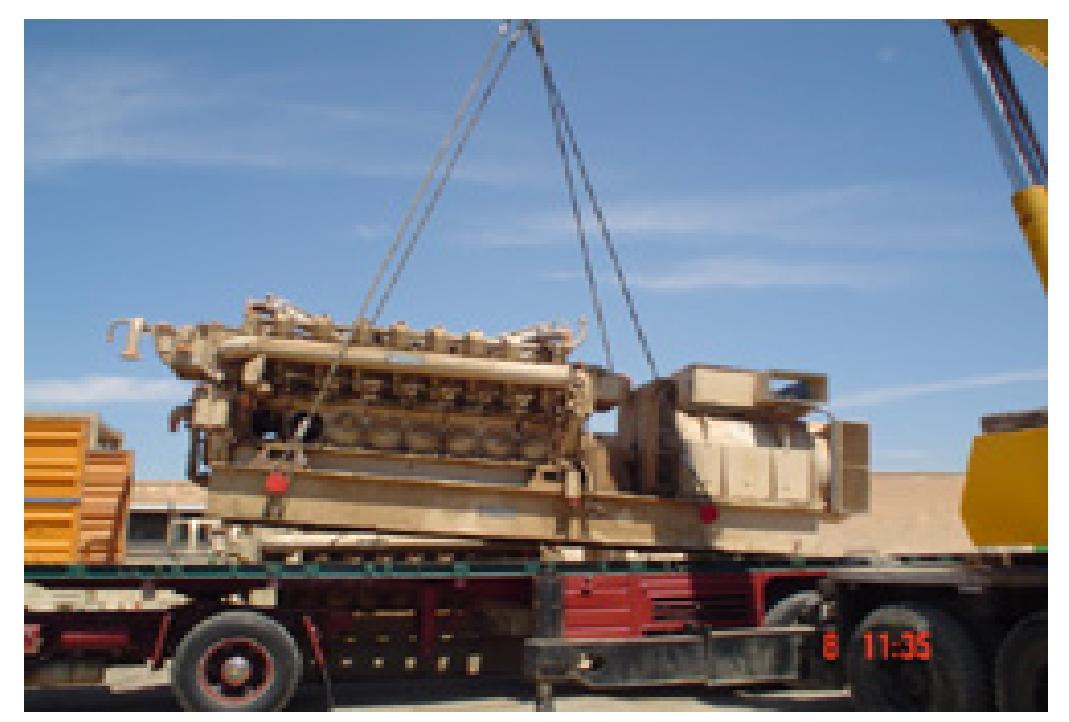
Site Photo 1. Existing Cockrill generator removal (Photo provided by USAID)

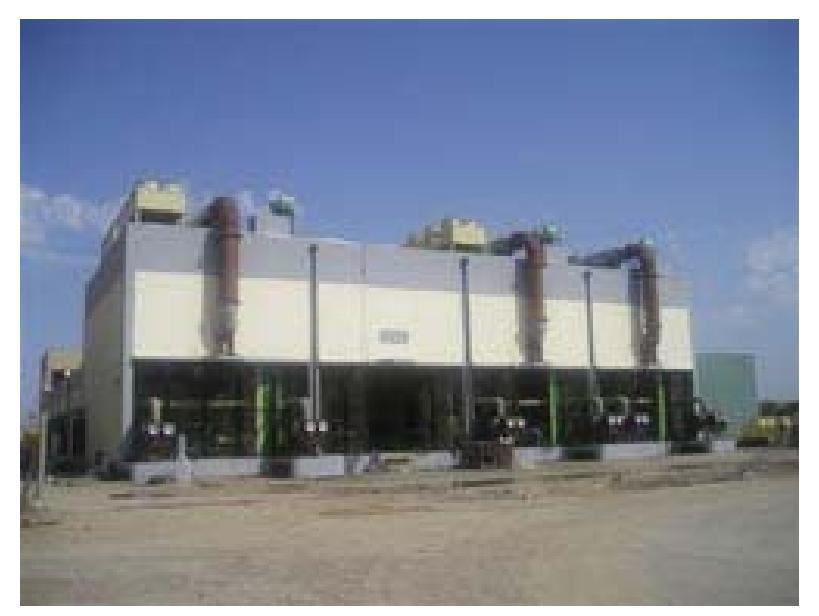
Site Photo 2. Exterior view of the generator's building (Photo provided by USAID)
