TA 09-04  
NEDU TR 11-08  
May 2011

## FIELD EVALUATION OF TOPSIDE DECOMPRESSION MONITOR (TDM) DURING SHIPS HUSBANDRY DIVING AT SWRMC-NI

**Authors:** K. A. Gault  
Principal Investigator

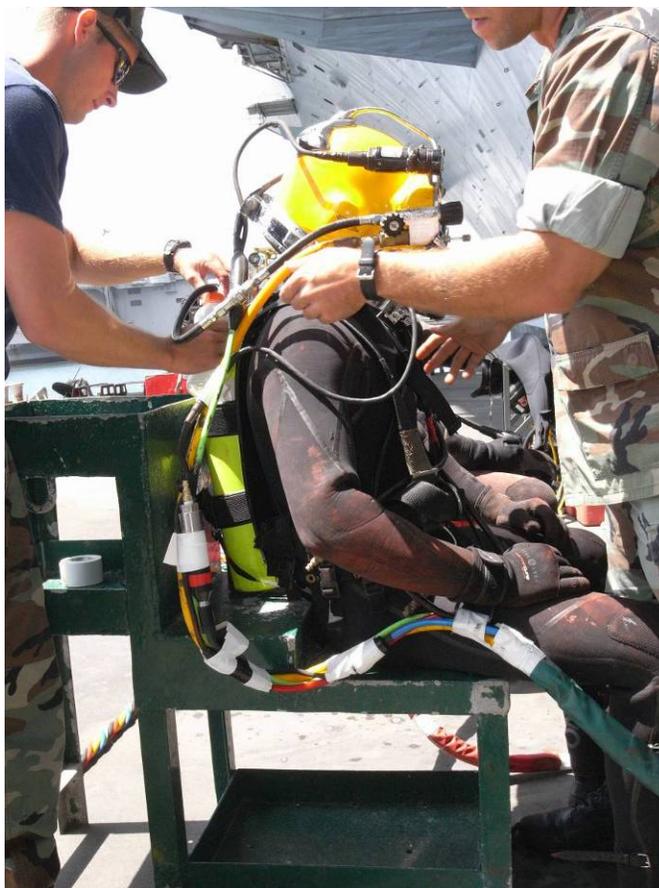
To avoid interfering with normal diving operations, the pressure transducer for each diver was attached to the existing surface-supplied umbilical between the shackle and the helmet behind the diver (Figure 1).

**Figure 1.** Sensor placement on diver's umbilical.

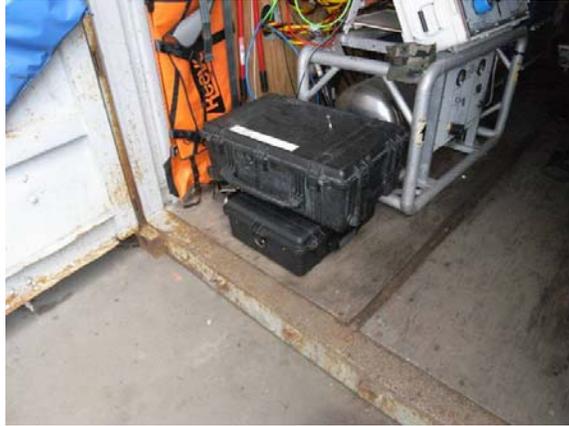
**Figure 2.** Sensor interface box placed inside van and next to FADS console.

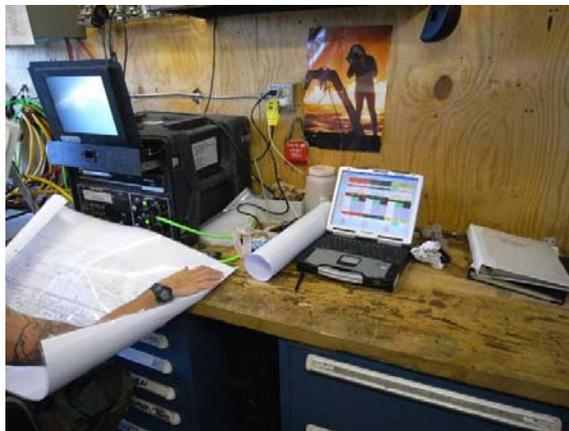
**Figure 3.** TDM laptop on desk next to communications console, to allow it to be operated in conjunction with communications.

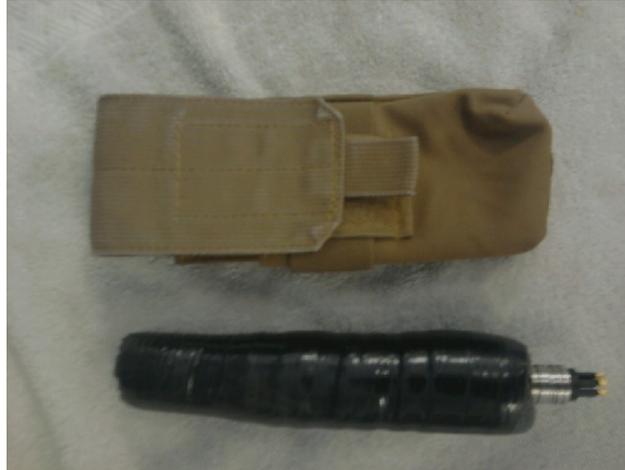
Still another problem associated with using the TDM during ships husbandry will be that of the sensor port becoming clogged with mud or silt from the bottom — or with the Bintsuke that is used to seal cofferdams to ships' shafts. Bintsuke, a sticky substance used to plug holes and keep water from entering between the patch and the vessel, must be kept away from the sensors: Clearing a clogged sensor underwater is already difficult, due to its position and the small size of the opening. M16 double magazine pouches were purchased from a surplus store and modified to make pouches to protect sensors. A hole was cut in the bottom of the pouch to allow entry of the sensor cable, and the Velcro closures at the top of the pouch made the sensor accessible for verification or cleaning. Foam padding ( $\frac{1}{4}$ -inch plumbing insulation) was added to the sensors to reduce damage from impacts (Figure 4).

**Figure 4.** Foam-protected sensor and M16 double magazine pouch.

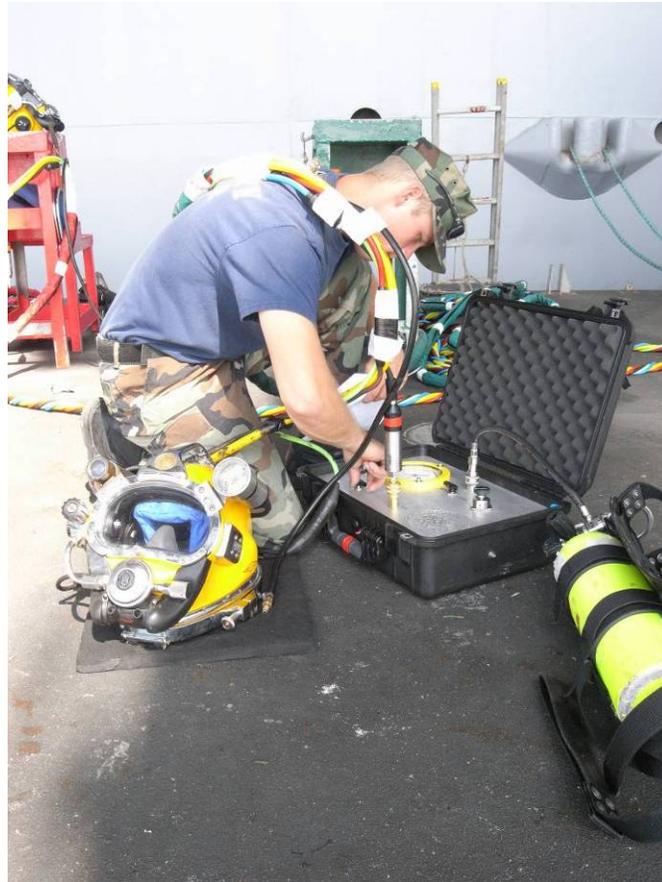
window, accessible through the TDM's configuration screen, was used to match sensor readings to supplied pressures at 6 pressures. One downside to the initial configuration of the SVB was that the sensor needed to be oriented vertically above the SVB in order to perform the verification (Figure 5). The process of verifying a sensor while it remained attached to the diver's umbilical placed unnecessary stress on the flexible whip ends that had already been identified as weak points. A 10 ft adapter cable with a three-way split allowing simultaneous connection of all three sensors reduced the stress on the cable as well as the overhead on the dive side.

**Figure 5.** Diver setting up sensor verification. Care was needed to avoid excessive stress on the cable during verification.
