# Summary of HCAT Helicopter Dynamic Components Project

Keith Legg  
Rowan Technology Group  
Libertyville, IL

| Report Documentation Page | | | | Form Approved<br>OMB No. 0704-0188 | |
|---|---|---|---|---|---|
| 13. SUPPLEMENTARY NOTES<br><b>Surface Finishing and Repair Issues for Sustaining New Military Aircraft Workshop, February 26-28, 2008, Tempe, AZ. Sponsored by SERDP/ESTCP.</b> | | | | | |

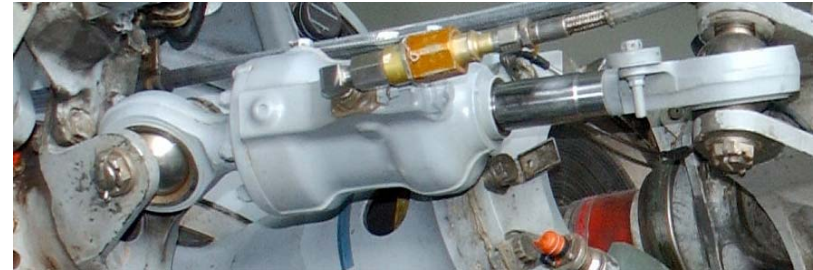
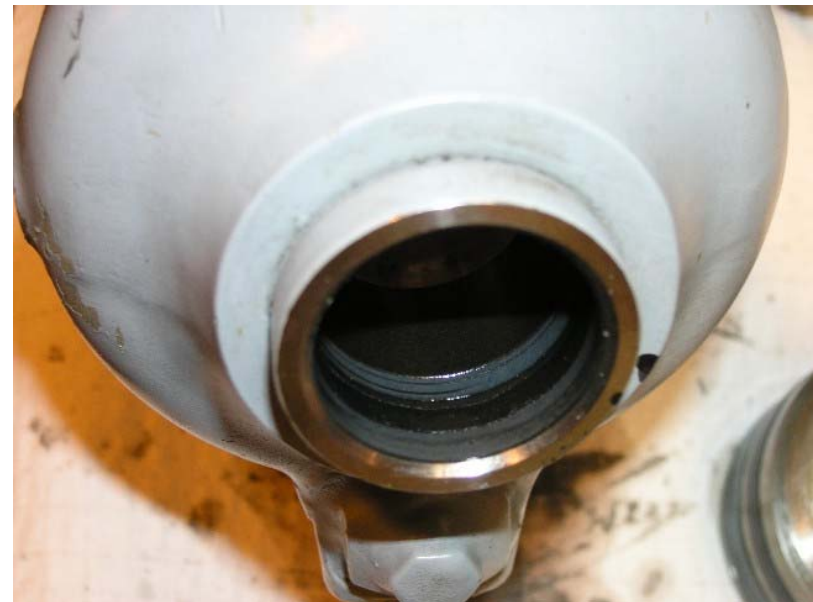
## Lead-The-Fleet testing at FRC-E

- MRH Damper Current MTBR ~ 600 FH.

- Premature dynamic seal failure
- Caused by destructive wear particles from the Beryllium Copper bushing

- Improved seal designs, new coatings, stainless steel bushing coated in Katherm-87.
- Lead-the-Fleet Evaluation began FEB 2004.
