TECHNICAL REPORT
TR-NAVFAC-EXWC-PW-1406
APRIL 2014

**BUILDING INTEGRATED PHOTOVOLTAIC (PV)
ROOFS FOR SUSTAINABILITY AND ENERGY
EFFICIENCY**

BUILDING INTEGRATED PHOTOVOLTAIC (BIPV) ROOFS FOR SUSTAINABILITY AND ENERGY EFFICIENCY COST & PERFORMANCE REPORT

ESTCP Number: EW-200813

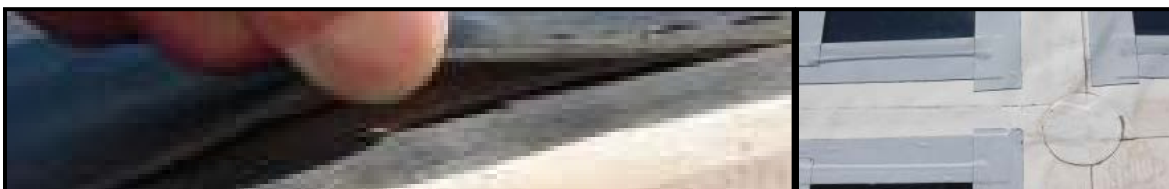
The left photo in Figure-13 shows the bond failure between the PV and PVC carrier sheet. Since the PVC carrier sheet may still provide for a water tight roof assembly, problems experienced by the PV modules may not impact ROOFER scoring. In response to the bond failure, the PV manufacturer taped the frame around the PV to the adjacent PVC membrane in an attempt repair the problem in May 2010 (Figure-15, right). Unfortunately, some of the tape deteriorated less than six months after it was applied. The deteriorated tape exposed adhesive residue, which collected dirt and reduced the overall reflectivity. Figure-14 shows some of the tape deterioration along with soiling of the PV modules. The significant soiling was a result of the low-slope

surface, which does not allow for all the water to completely leave the area and causes any dirt trapped by the water to settle on the roof after the water evaporates. The soiling on the PV modules will reduce the overall roof reflectivity and the energy output of the PV system.

Figure-13: Bonding failure (left) and tape solution (right) between PVL and PVC at Site I (Luke AFB).

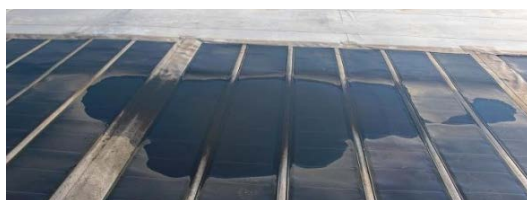
Figure-17: Site II (NAS Patuxent River) water ponding.

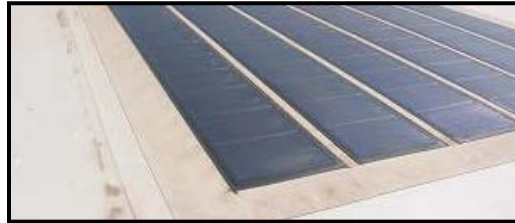
Site III (MCAS Yuma) ROOFER “w/ patch” indices are a result of the PVC samples taken for the tests discussed later (Table-6). ROOFER treats the patch as repair work. For fairness, indices without the patch were generated. The lowered FCI value was due to flashing height not meeting the six-inch requirement, which is needed to reduce the risk of water penetration. Reflectance results are shown in Table-7. October 2011 values were not attained due to the unexpected removal of the ladder needed to safely transport the instrument. However, visual inspections indicated that the soiling had decreased by Oct. 2011. This determination is further supported by the PV conversion efficiency analysis that is presented in the next section. Despite the soiling, the Site III (MCAS Yuma) BIPV roof appeared to have aged well (Figure-20).

Figure-20: Photo of Site III (MCAS Yuma) in October 2011, 16 months after installation.

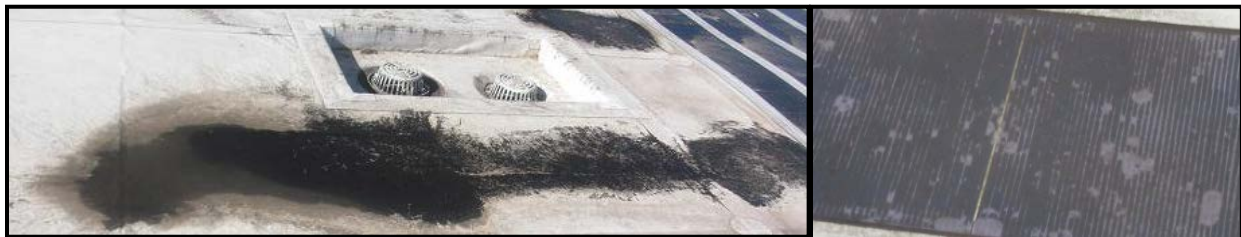
Qualitative inspections of other BIPV roofs similar to those in this study were made. This type of BIPV roof endured well in some areas and some of the notable deficiencies were due to poor construction and practices. In one location, the tape solution prevented water drainage. That same system also experienced significant mold growth due to its tropical environment. Another system experienced localized mold growth due to water ponding (Figure-21, left). The right photo in Figure-21 shows discoloration indicating that the encapsulation of the PV laminate has been compromised. This occurred only in areas where there was significant water ponding, but it is possible that the damage was actually due to snow build-up and the exposure of the encapsulation to freezing temperatures. Interestingly, the tape solution appeared to be unaffected.

Figure-21: Severe, localized mold growth due to water ponding (left) and PV delamination (right).

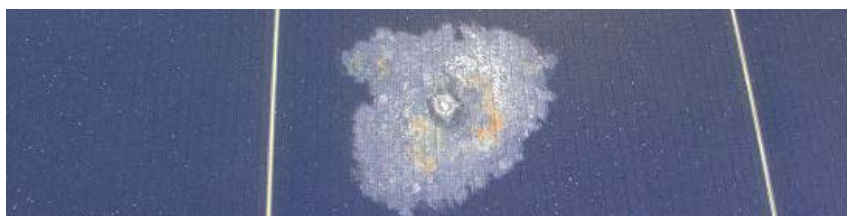
Site II (NAS Patuxent River) did require some maintenance due to a pin-size hole in the PV, but there was difficulty in finding local personnel to perform the maintenance due to the need to operate a small flame to patch the hole (Figure-23). Corrosion is expected to spread to the rest of the cell. Fortunately, the PVL includes bypass diodes connected across each cell, which allows the rest of the cells in the PVL to continue to produce power. The mold growth that was shown earlier is also a concern, but as it was stated earlier, an attempt to remove the mold will likely cause more damage to the roof. The only way to stop additional mold growth is to keep the roof dry, which is impractical, so the only remaining practical course of action is to ensure that the roof remains water tight, such as by surveying the roof every one-to-two years, and replacing the roof at its end of life. The tape solution was not applied to this site due to the lack of the PV bonding problem and the desire to study the BIPV roof as it was originally designed.

Figure-23: Corrosion of PV material due to a pin-size hole at Site II (NAS Patuxent River).
