**AFRL-SA-WP-SR-2015-0011**

# **Composite Material Hazard Assessment at Crash Sites**

**January 2015**

**Air Force Research Laboratory  
711<sup>th</sup> Human Performance Wing  
School of Aerospace Medicine  
Occupational & Environmental Health Dept  
Consultative Services Division  
2510 Fifth St.  
Wright-Patterson AFB, OH 45433-7913**

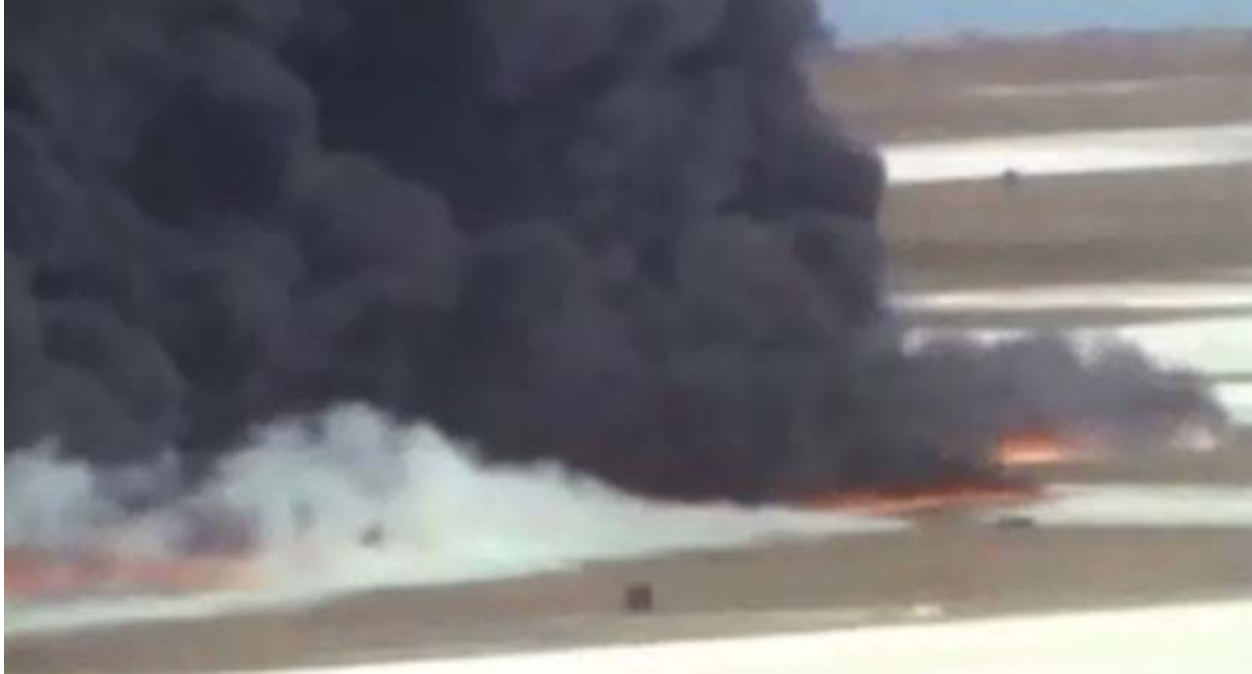
## APPENDIX A: B-2A CRASH (89-0127) ON 23 FEB 2008

1. The following two pictures show the debris from the B-2A crash.

Initial ground contact occurred when the left wing tip hit the ground causing fracture damage to the wing tip and wing tip support structure. The aircraft continued upwind then descended to hit the ground with the nose gear and then the left main landing gear. Upon ground impact the left main landing gear separated from the aircraft releasing fuel. This caused a fireball to travel upwind scorching an area of approximately 29.517 m<sup>2</sup>. The left main landing gear rested 475 m from the final position of the aircraft. The bomb bay and nose landing gear doors, located at 350-400 from the aircraft showed signs of physical damage with little or no scorch markings. Ground scars show the aircraft came to rest 717 m from initial ground contact. The pilot (left) seat rested 458 m from the aircraft. The co-pilot seat rested 431 m from the aircraft. The hatches were located 568 m and 578 m from the aircraft. The debris field was comprised of random pieces and fragments of composite materials ranging in size and shape with very few metal pieces found. Most of the aircraft structure remained intact but with severe impact damage as it came to rest on its bottom outer mold line. The survey determined the debris field area was 18,964 m<sup>2</sup>.

The B-2A was designed with approximately 80% composite material and 20% aluminum and titanium as the substrate materials. The carbon fiber / epoxy composite system is the primary composite materials system; although there are other composite systems found in small quantities like fiberglass / PMR-15. JP-8 pool and fireballs can create flame temperatures in excess of 2000°F and “time at temperature” determines the degree of damage for these materials. As the flame-front penetrates through the composite thickness, layers burn and metals melt. The wreckage showed varying degrees of impact and thermal damage. The B-2A aircraft sustained severe thermal damage.

Aircraft materials show signs of thermal damage that help to determine what the temperatures could have been. Melting point, color change and recognition of surface feature changes were used to evaluate the wreckage. The following materials were used as indicators of temperature exposures: carbon fiber, glass, titanium, aluminum, silver, nickel, iron, copper, epoxy and polyurethane coatings, and polycarbonate. The inboard and outboard wing assembly wing tips, leading and trailing edge showed signs of thermal exposure of at least 1700°F. The crew station assembly showed signs of at least 1200-1500°F. The center body was at least 1200°F. The aft wing assembly, GLAS, hot trailing edge and decks were exposed to at least 900-1100°F. The bottom outer mold line condition will remain unknown until the wreckage is moved.

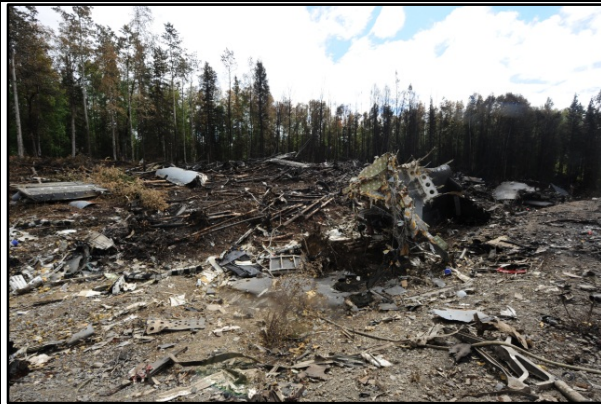
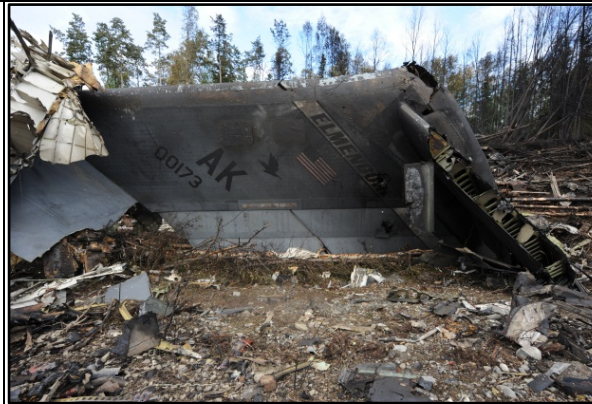
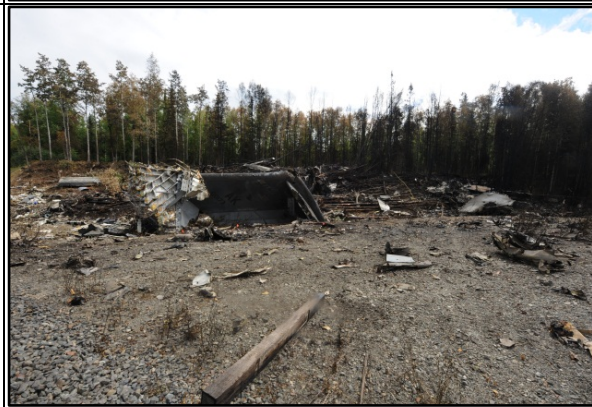
## APPENDIX B: PICTURES OF THE C-17 CRASH FROM 28 JULY 2010

A C-17 aircraft from Elmendorf AFB, Alaska, crashed off base at a remote location on 28 July 2010. Firefighters sprayed a fixant solution of water and wax on any parts that appeared to be ACM. Due to the austere conditions and frequent rain, BEF collected no personal air samples; however, direct reading instruments (DRIs) measured particle and aerosol mass concentrations. A condensation particle counter and optical particle counter were the DRIs measured particle and aerosol mass concentrations, respectively [10]. Sampling continued for 3 days of crash site recovery operations in close proximity to workers who were engaged in cutting operations on the vertical and horizontal stabilizers of the aircraft. The average particulate mass concentration as measured by the DRIs over the 3 days was 1.71 mg/m<sup>3</sup>, which is less than USAFSAM's recommended OEEL for respirable particulate of 3.0 mg/m<sup>3</sup>. Measured concentrations reported for the DRIs include background ambient aerosol particulate, which would also include particulate from the diesel exhaust of an excavator and other equipment operating at the crash site. See Appendix B for pictures of the crash site.

-- The wreckage of a 3rd Wing C-17 that crashed shortly after take-off at about 6:14 p.m. (Alaska time) during a local training mission July 28, 2010.

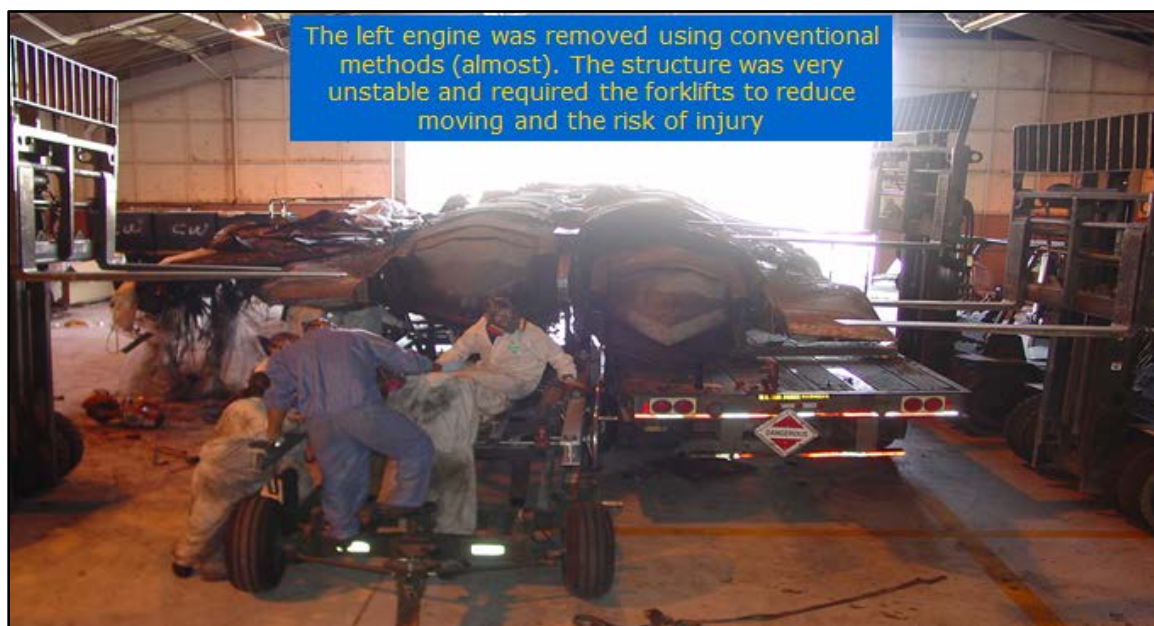
## APPENDIX C: PICTURES OF THE F-22A TEARDOWN

Recommend goggles whenever material or debris is disturbed such that material can potentially become airborne. Refer to pictures of the F-22A debris in Appendix C.
