REPORTS NO. 344/50 -1, -2, -3, -4, -5,
-6, -7, -8, -9, -10, -11.

MONEL METAL REPORTS

Peter R. Kostig
Chemical Engineer

1937

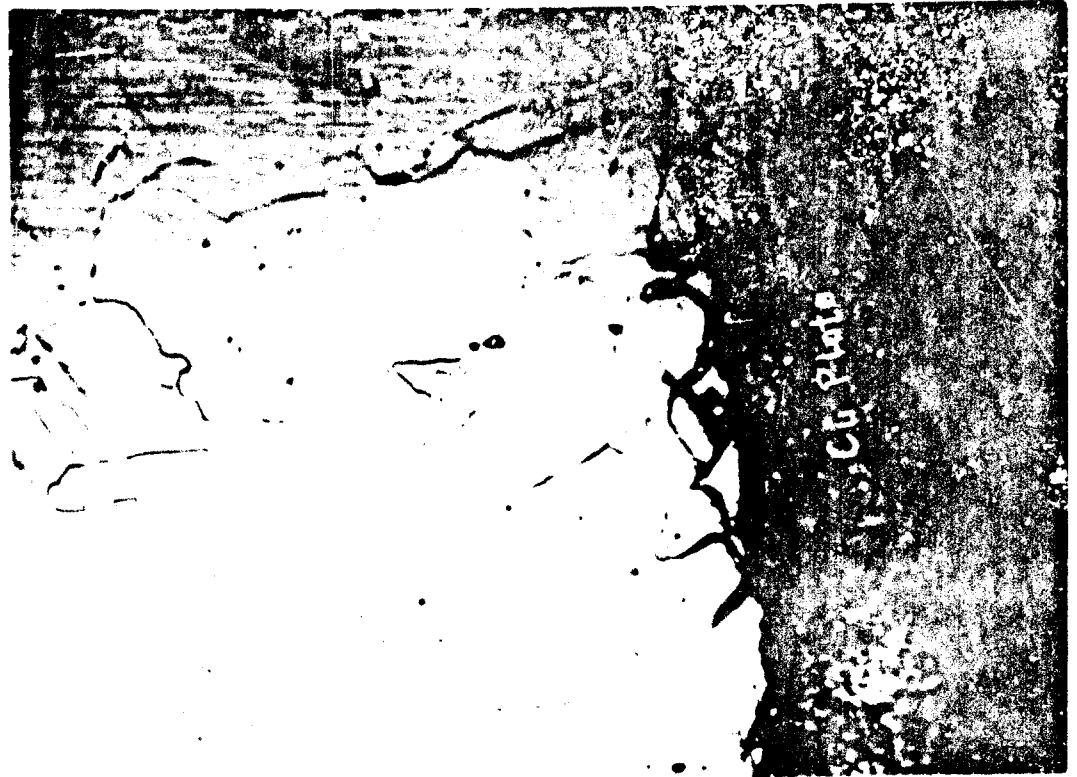
Fig. 1

Sulfur penetrated the grain boundaries, but affected only a layer 2 to 3 grains deep, or 0.0002".

A sample, 1/2 x 3/4 x full thickness, was copper plated, polished and etched with HAc + HNO₃ + H₂O:: 30:30:40. Machined surfaces were satisfactory. Edges with tarnish still in place showed S penetration along grain boundary for 2 to 3 grains, as shown in Fig. 1.

The S in the cutting oil forms sulfides upon the metal surface. Upon heat treatment this S diffuses into the Monel Metal along grain boundaries. In the area affected, ductility will be markedly lowered.

ME577 X500 Etched HAc + HNO₃ + H₂O::30:30:40
Sulfur diffused along grain boundary from sur-
face which is copper plated.

The use of high sulfur cutting oil with monel must be considered a special procedure and not a general one, and in every case where the metal is heat treated, all surfaces must be machined before being put into service.
