Report No. 710/458

ARMOR PLATE

Metallurgical Examination of Section of German  
Face-Hardened Armor from the Front of a Pz. Kw. III Tank

October 15, 1945  
WATERTOWN ARSENAL  
WATERTOWN, MASS 10 23 092

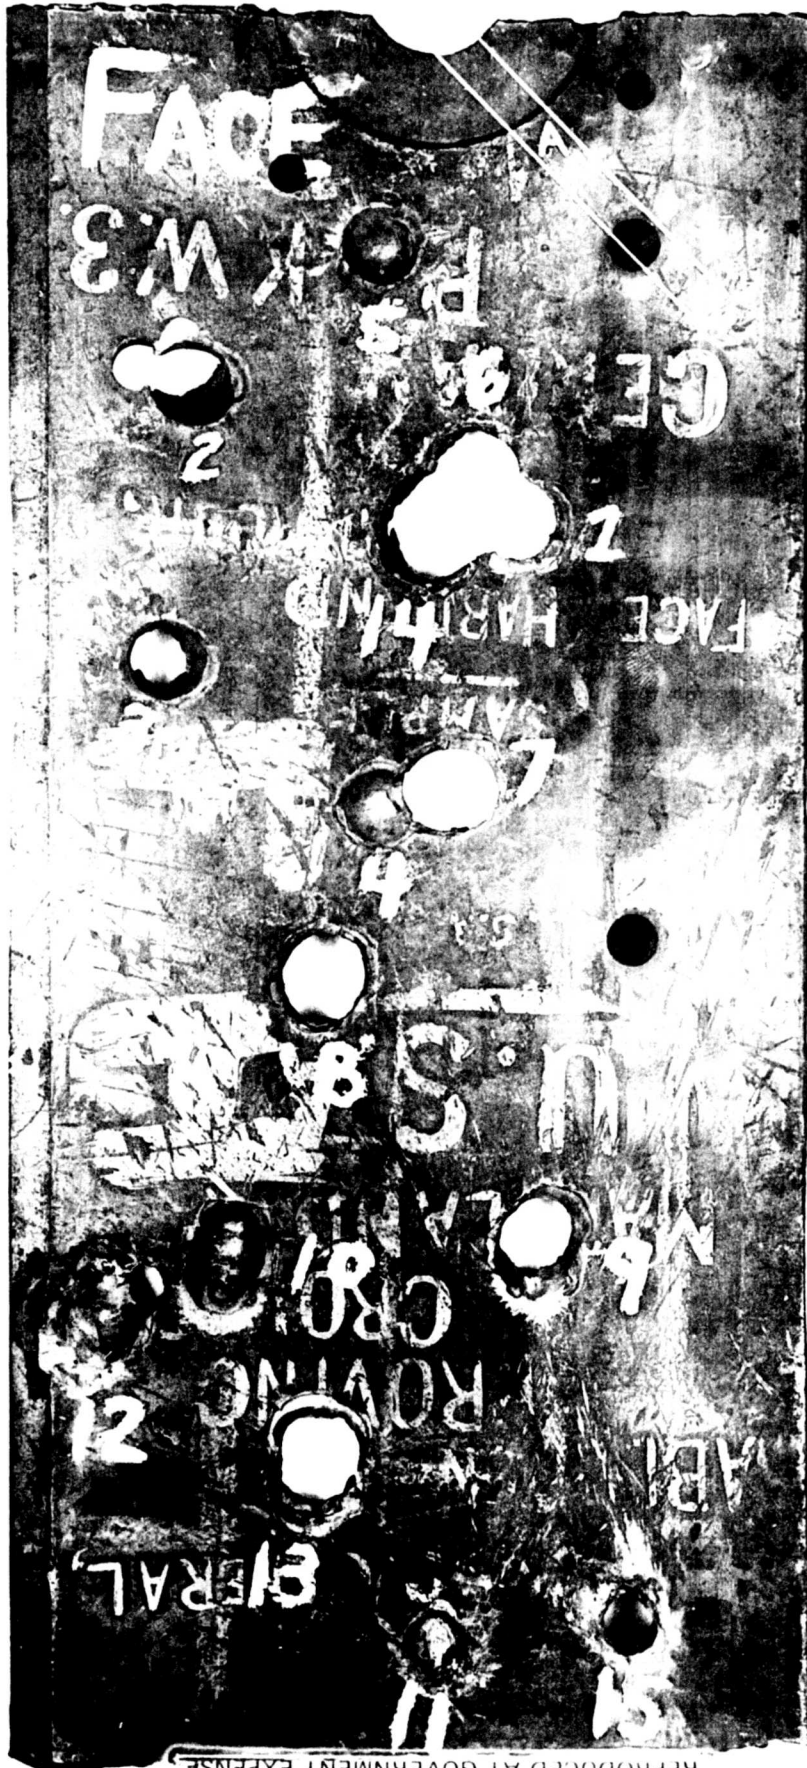
FIGURE

The plate was ballistically tested at Aberdeen Proving Ground. Figures 1 and 2, respectively, show the face and back of the plate after the ballistic test.

FACE OF FLAME HARDENED ARMOR PLATE 14" X 13 1/2" X 3 1/2", FROM THE FRONT OF A GERMAN PZ. KW. III TANK AFTER BALLISTIC TEST PERFORMED AT ABERDEEN PROVING GROUND. AUGUST 14 1942 (FRONT) W.A.710-1924

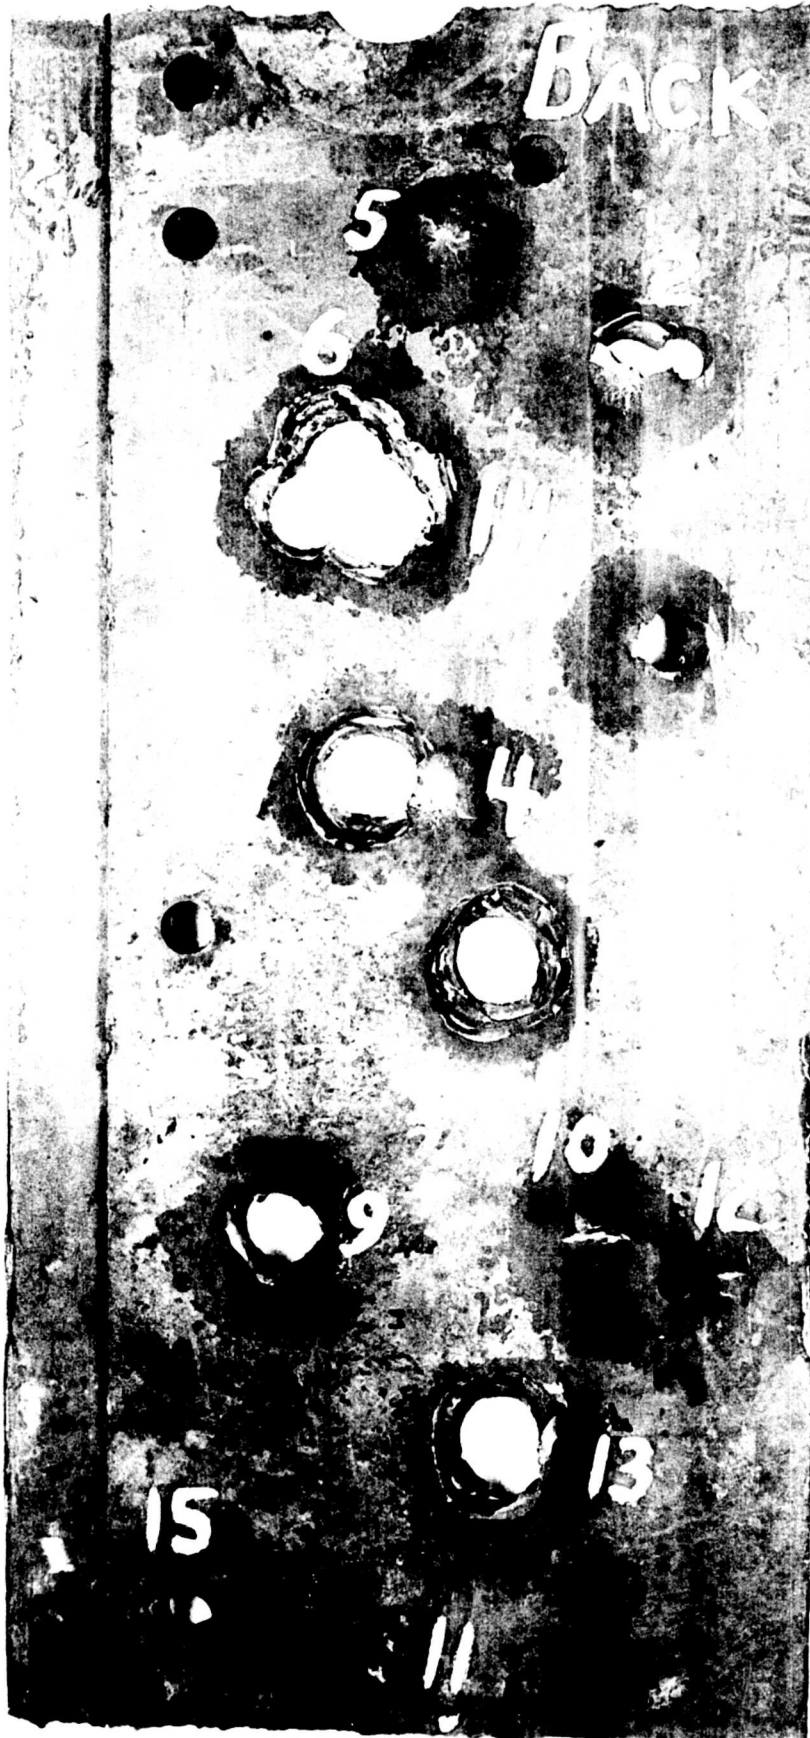
FACE OF FLAME HARDENED ARMOR PLATE  $1\frac{1}{2}$ " X  $13\frac{1}{2}$ " X  $31\frac{1}{2}$ " FROM THE FRONT OF A GERMAN PZ. KW. III TANK AFTER BALLISTIC TEST PERFORMED AT ABERDEEN PROVING GROUND. AUGUST 14 1942 (REAR) W.A.71C-1925

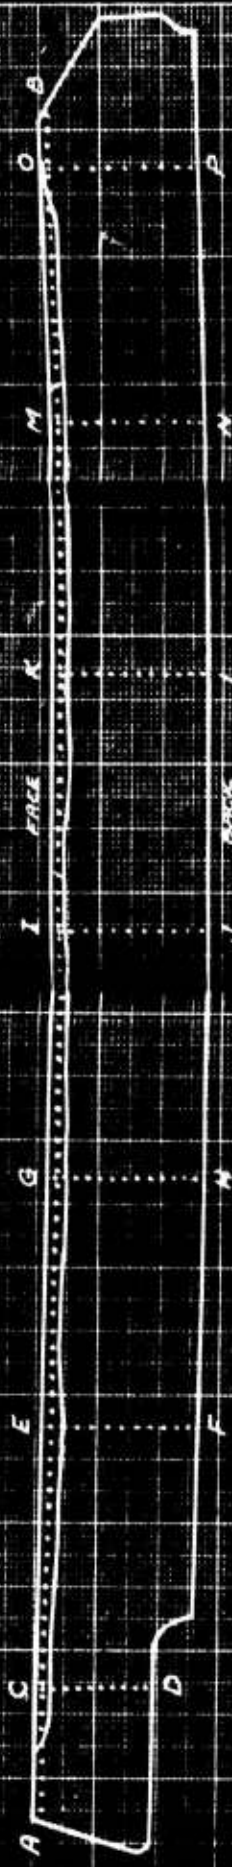
The Rockwell C survey on a transverse section of the armor, Figure 3, shows that the surface hardened zone has an extremely uniform hardness level of Rockwell C 57.5-60. This uniformity of hardness is superior to that observed on numerous flame-hardened plates of American manufacture examined at this Arsenal. A similar hardness survey conducted on a longitudinal section of the subject armor showed results identical to those obtained on the transverse section.

ROCKWELL C HARDNESS SURVEY  
 OF TRANSVERSE SECTION OF FLAME HARDENED ARMOR  
 FROM FRONT OF Pz KW III TANK

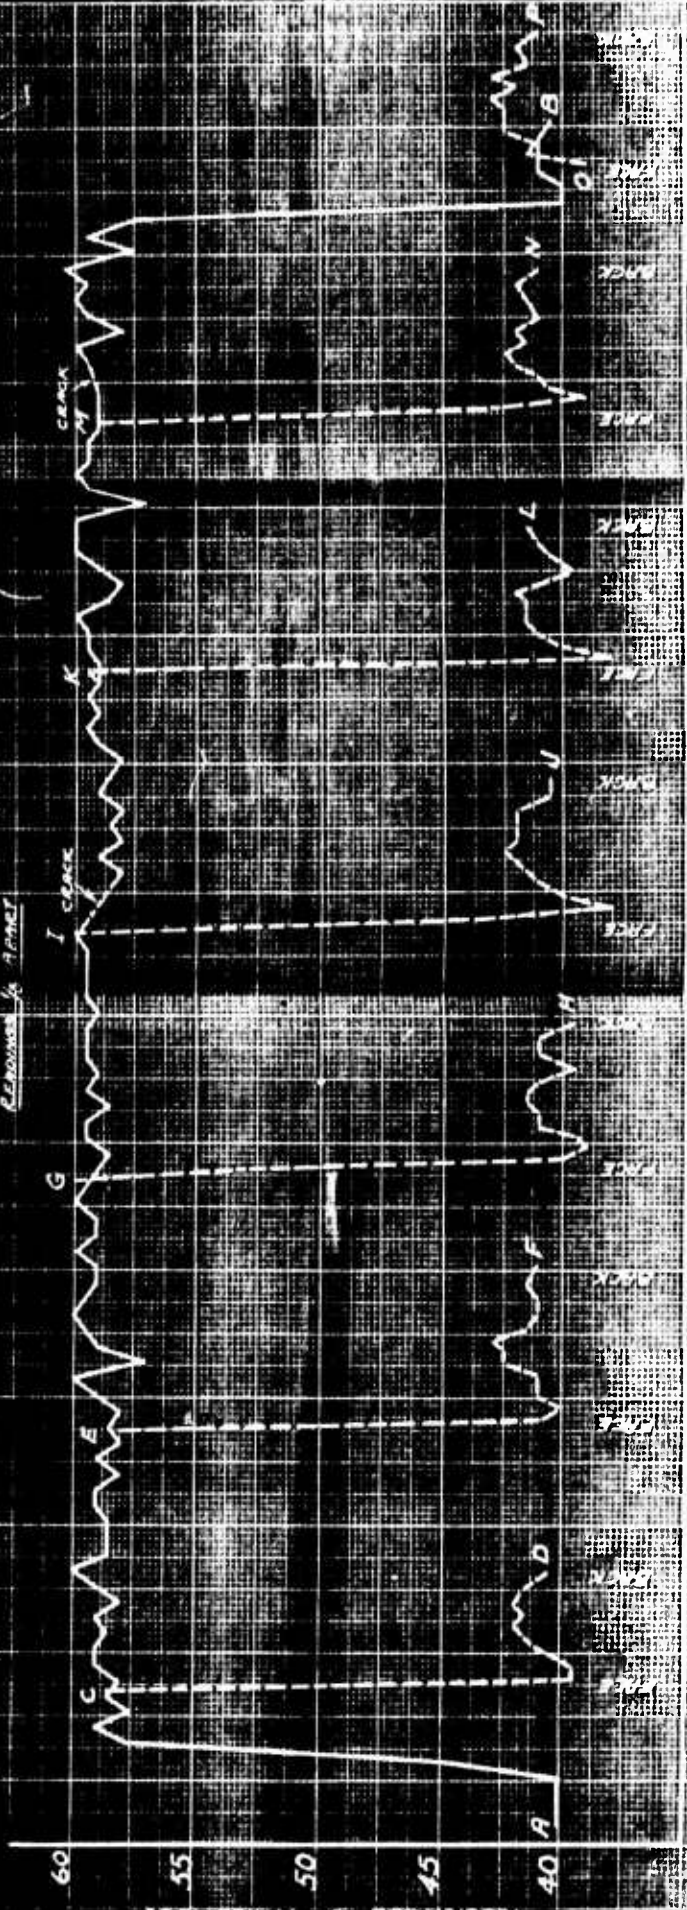
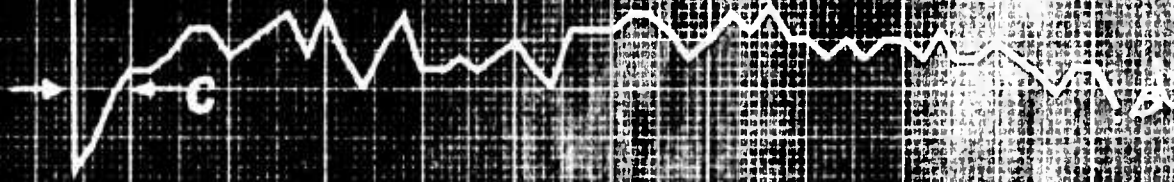
The Vickers hardness survey was conducted to detect the hardness gradient from case to core, see Figure 4. A very sharp hardness gradient from case to core exists, the hardness dropping from 643 to 354 Vickers Pyramid Hardness in 0.02 inches.

VICKERS PYRAMID HARDNESS SURVEY  
 OF CROSS SECTION OF  
 GERMAN FLYING BOMBEN PLATE  
 RECONSTRUCTION

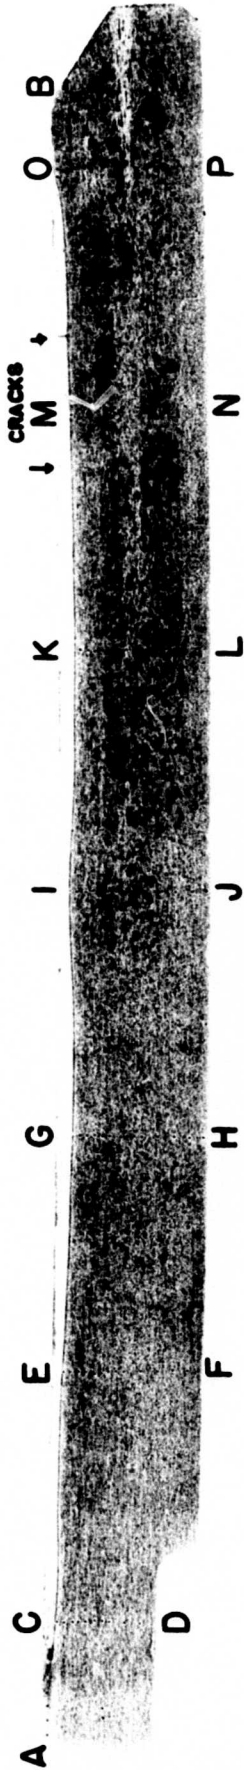
Strips cut from both the longitudinal and transverse directions were macro-etched, see Figure 5. The metal is dense, free from pronounced segregation, except at the right hand end of the transverse section which may represent residual secondary piping. The hardened zone, except where it tapers off at the ends of the transverse section, is extremely uniform in thickness compared to those of flame-hardened plates of American manufacture examined at this Arsenal. Compared to rolled American armor of the same thickness, the subject armor is of excellent quality with respect to soundness of the metal.

The macro-etch, because of the characteristic shape of the hardened layer, confirms the fact that the German armor was flame hardened. Several cracks were observed in the hardened layer, see Figure 5, which were present before macro-etching. It is possible that these cracks resulted from the ballistic testing, because numerous cracks were found radiating from the penetrations. These cracks are confined to the hardened, more brittle, zone.

MACROETCHED SECTIONS OF FLAME HARDENED GERMAN ARMOR PLATE  
 1 1/4" X 13 1/2" X 3/4" FROM THE FRONT OF A PZ. KW. III TANK  
 AUGUST 24 1942 W.A. 710-1931

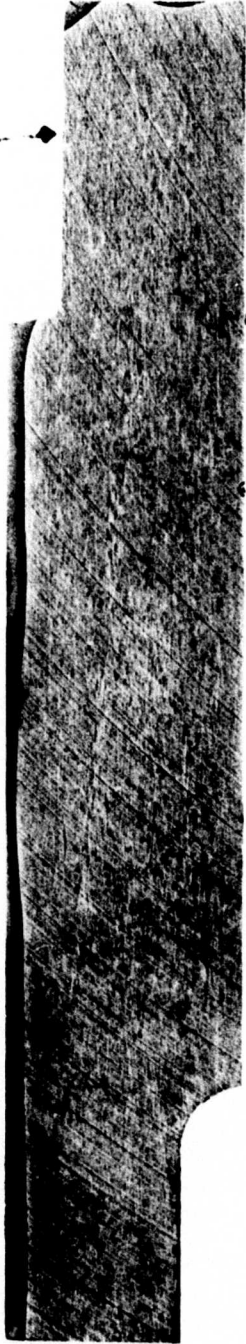
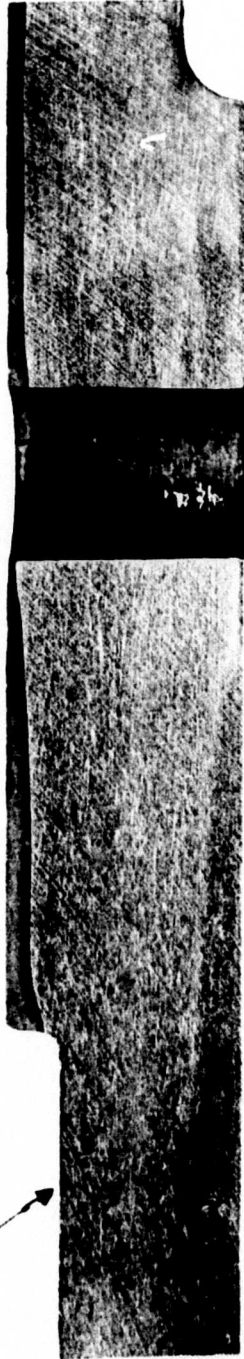
SECTION A

A 1" wide strip, Section A, Figure 1, was cut through the large counter-sunk hole in the center of a flame-cut end of the plate and through a rivet hole. This section was macro-etched on both cut surfaces, see Figures 6A and B.

Figure 6A is a photograph of the etched surface cutting through the rivet hole. Away from the rivet hole, the flame-hardened zone averages 0.09" in depth. At the right edge of the rivet hole the zone is 0.11" deep, and at the left edge the zone is 0.04" deep. In the rivet hole the zone varies in depth from 0.0" to 0.13". Figure 6B is a photograph of the etched surface parallel to and 1" away from the surface shown in Figure 6A. Approximately opposite the rivet hole, the flame-hardened zone decreases to a depth of 0.06" for a distance of approximately .7". This decrease in the depth of the flame-hardened zone may have been the result of having a plug of metal of high heat conductivity such as copper in the rivet holes during flame-hardening. The drilled holes were probably filled with plugs during the flame-hardening to prevent excessive hardening of the interior of the holes and consequent danger of cracking through the holes as a result of projectile impact.

At the edge of the plate surface next to the large counter sunk hole, the depth of the hardened zone increases to 0.20" (Figure 6A) and 0.16" (Figure 6B). The counter sunk surface is not flame-hardened and was presumably covered by a plug of metal during the face-hardening process.

MACROETCHED SECTION OF FLAME HARDENED GERMAN ARMOR PLATE  
 FROM THE FRONT OF A PZ.KW III TANK.  
 MAG. X 1  
 OCTOBER 3 1942  
 WTN.710-1937

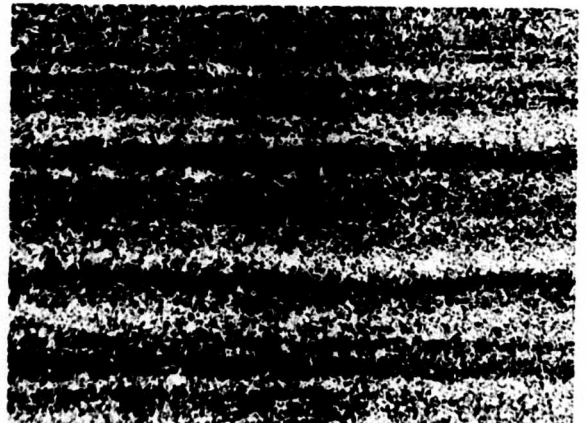
The steel is moderately clean, Figure 7C, with a very few elongated nonmetallics. The back face of the plate was slightly decarburized, and was covered with a layer of scale approximately 0.004" thick, Figure 7D. The metal is severely banded in both the transverse and longitudinal directions, Figures 7E and F.

X100 -F- NITAL PICRAL ETCH  
LONGITUDINAL. BANDED STRUCTURE OF  
BASE METAL.

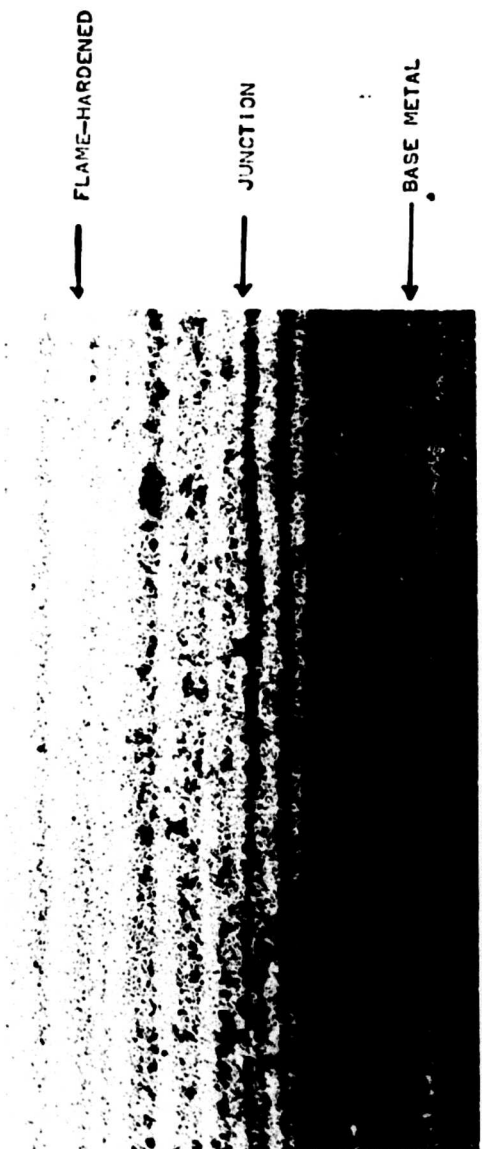
The micro-structure of the junction of the hardened zone and the base metal is shown in Figure 8A. The steel is extremely banded and darker etching bands can be seen on the base side of the junction. These darker etching bands represent a very shallow layer of metal immediately below the hardened zone that was tempered by the flame hardening of the surface layer. Reference to the Vickers Pyramid hardness survey, Figure 4, shows a zone marked "C" that is lower in hardness than the base metal. This zone comprises the darker etching bands seen in Figure 8A.

X100 --A-- NITAL PICRAL ETCH  
 JUNCTION OF FLAME-HARDENED ZONE AND BASE METAL

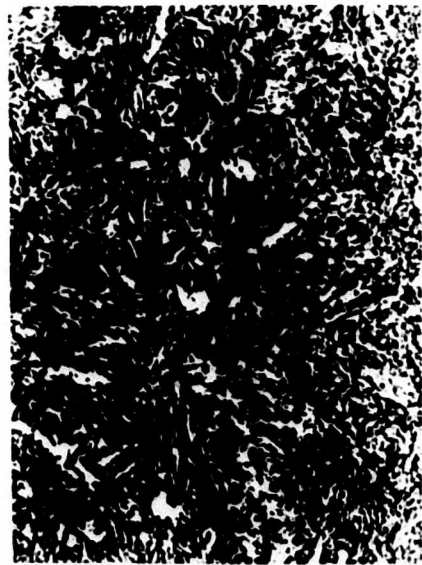
The micro-structure of the base metal consists of a tempered martensite, Figure 8B. The junction zone contains a mixture of a hard untempered martensite and patches of martensite tempered at a temperature sufficiently high to cause spheroidization of the carbides, Figure 8C. The micro-structure of the flame-hardened zone consists of a very hard, untempered acicular martensite, Figure 8D.

X1000 -B- NITAL PICRAL ETCH  
 BASE METAL. TEMPERED MARTENSITE

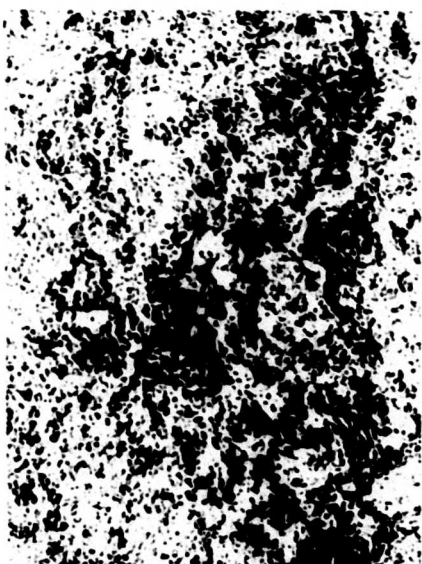
X1000 -C- NITAL PICRAL ETCH  
 JUNCTION. MARTENSITE AND SPHEROIDIZED CARBIDES

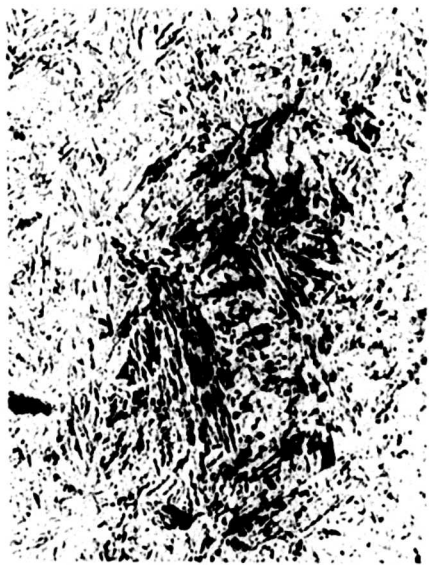
X1000 -D- NITAL PICRAL ETCH  
 FLAME-HARDENED ZONE. MARTENSITE
