Memorandum Report WAL 710/563

Final Report on Problem B-4.17

Metallurgical Examination of Sidewall Section

of Cast Turret for T23 Tank Manufactured

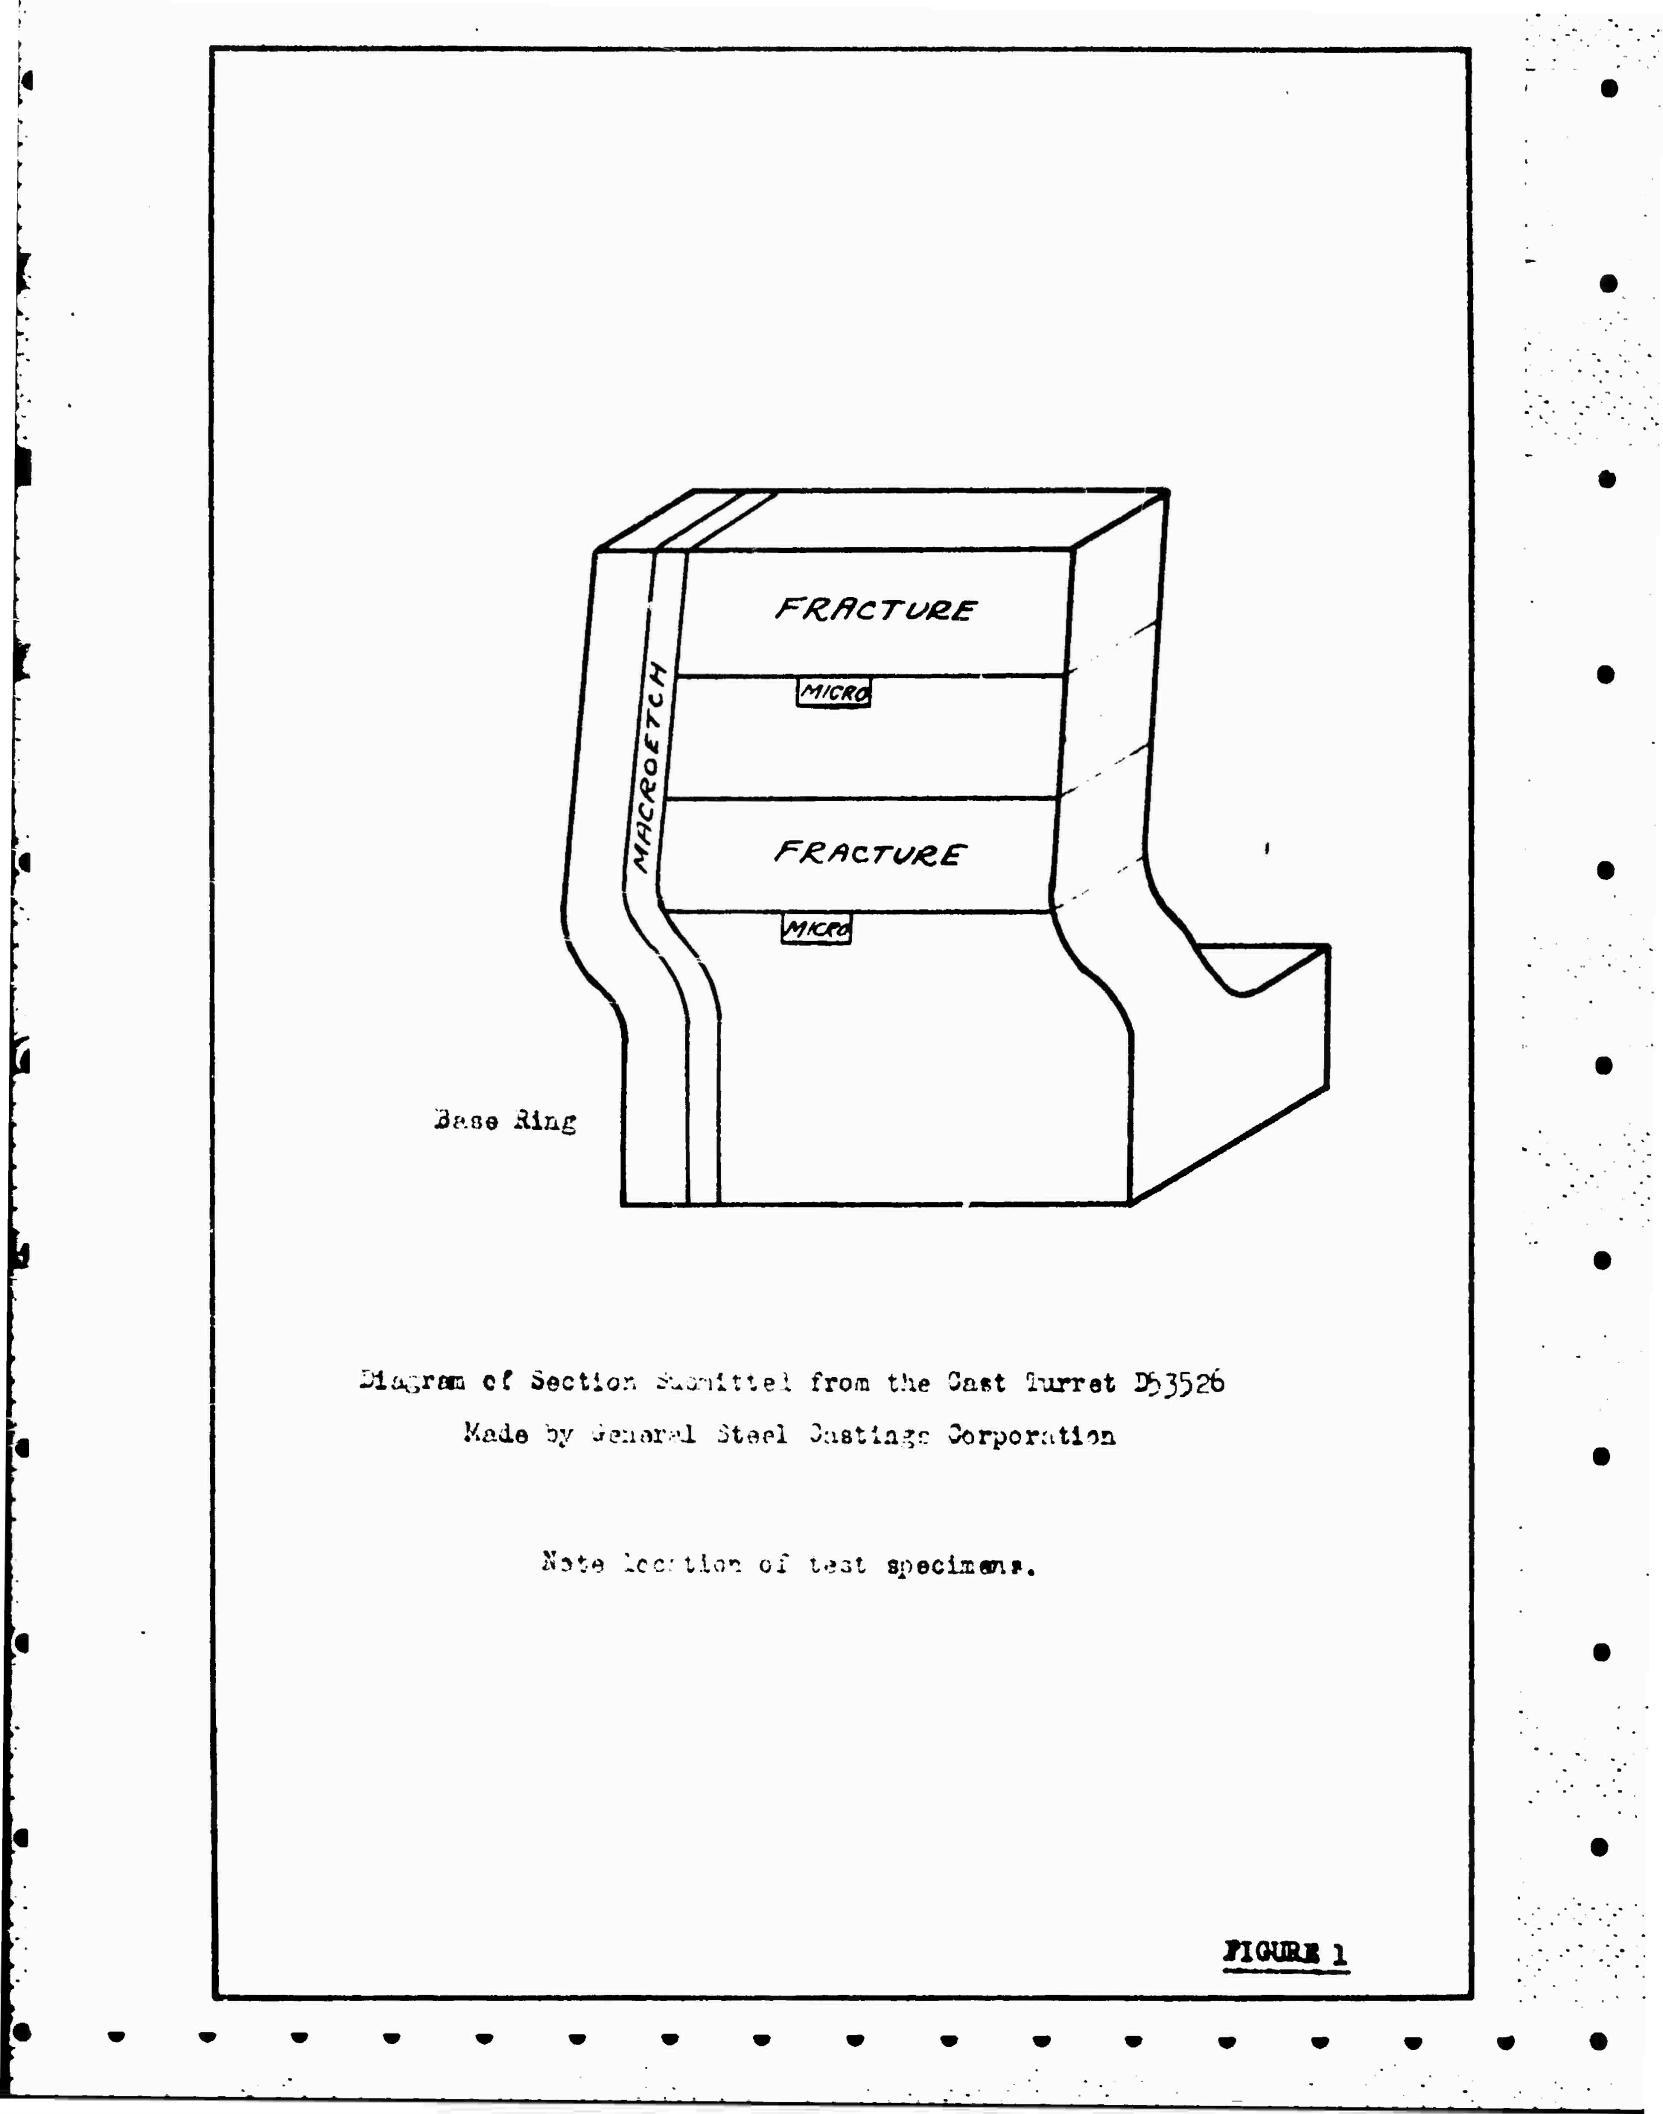
A Brinell hardness survey was obtained on cross sections of the casting at selected stations covering the area from the base ring to the middle of the sidewall. Except for a slightly increased hardness of 255 Brinell at the botton of the base ring, the section possessed a hardness of 235 to 246 Brinell throughout. The locations of the tests are shown on the macroetched section in Figure 2 and the data are recorded in the accompanying Table I.

Macroetching in hot acid revealed a small amount of nonmetallic segregation and porosity which was confined to the central third of the cross section. See Figure 2. Relatively little difference was observed in the two areas under examination.

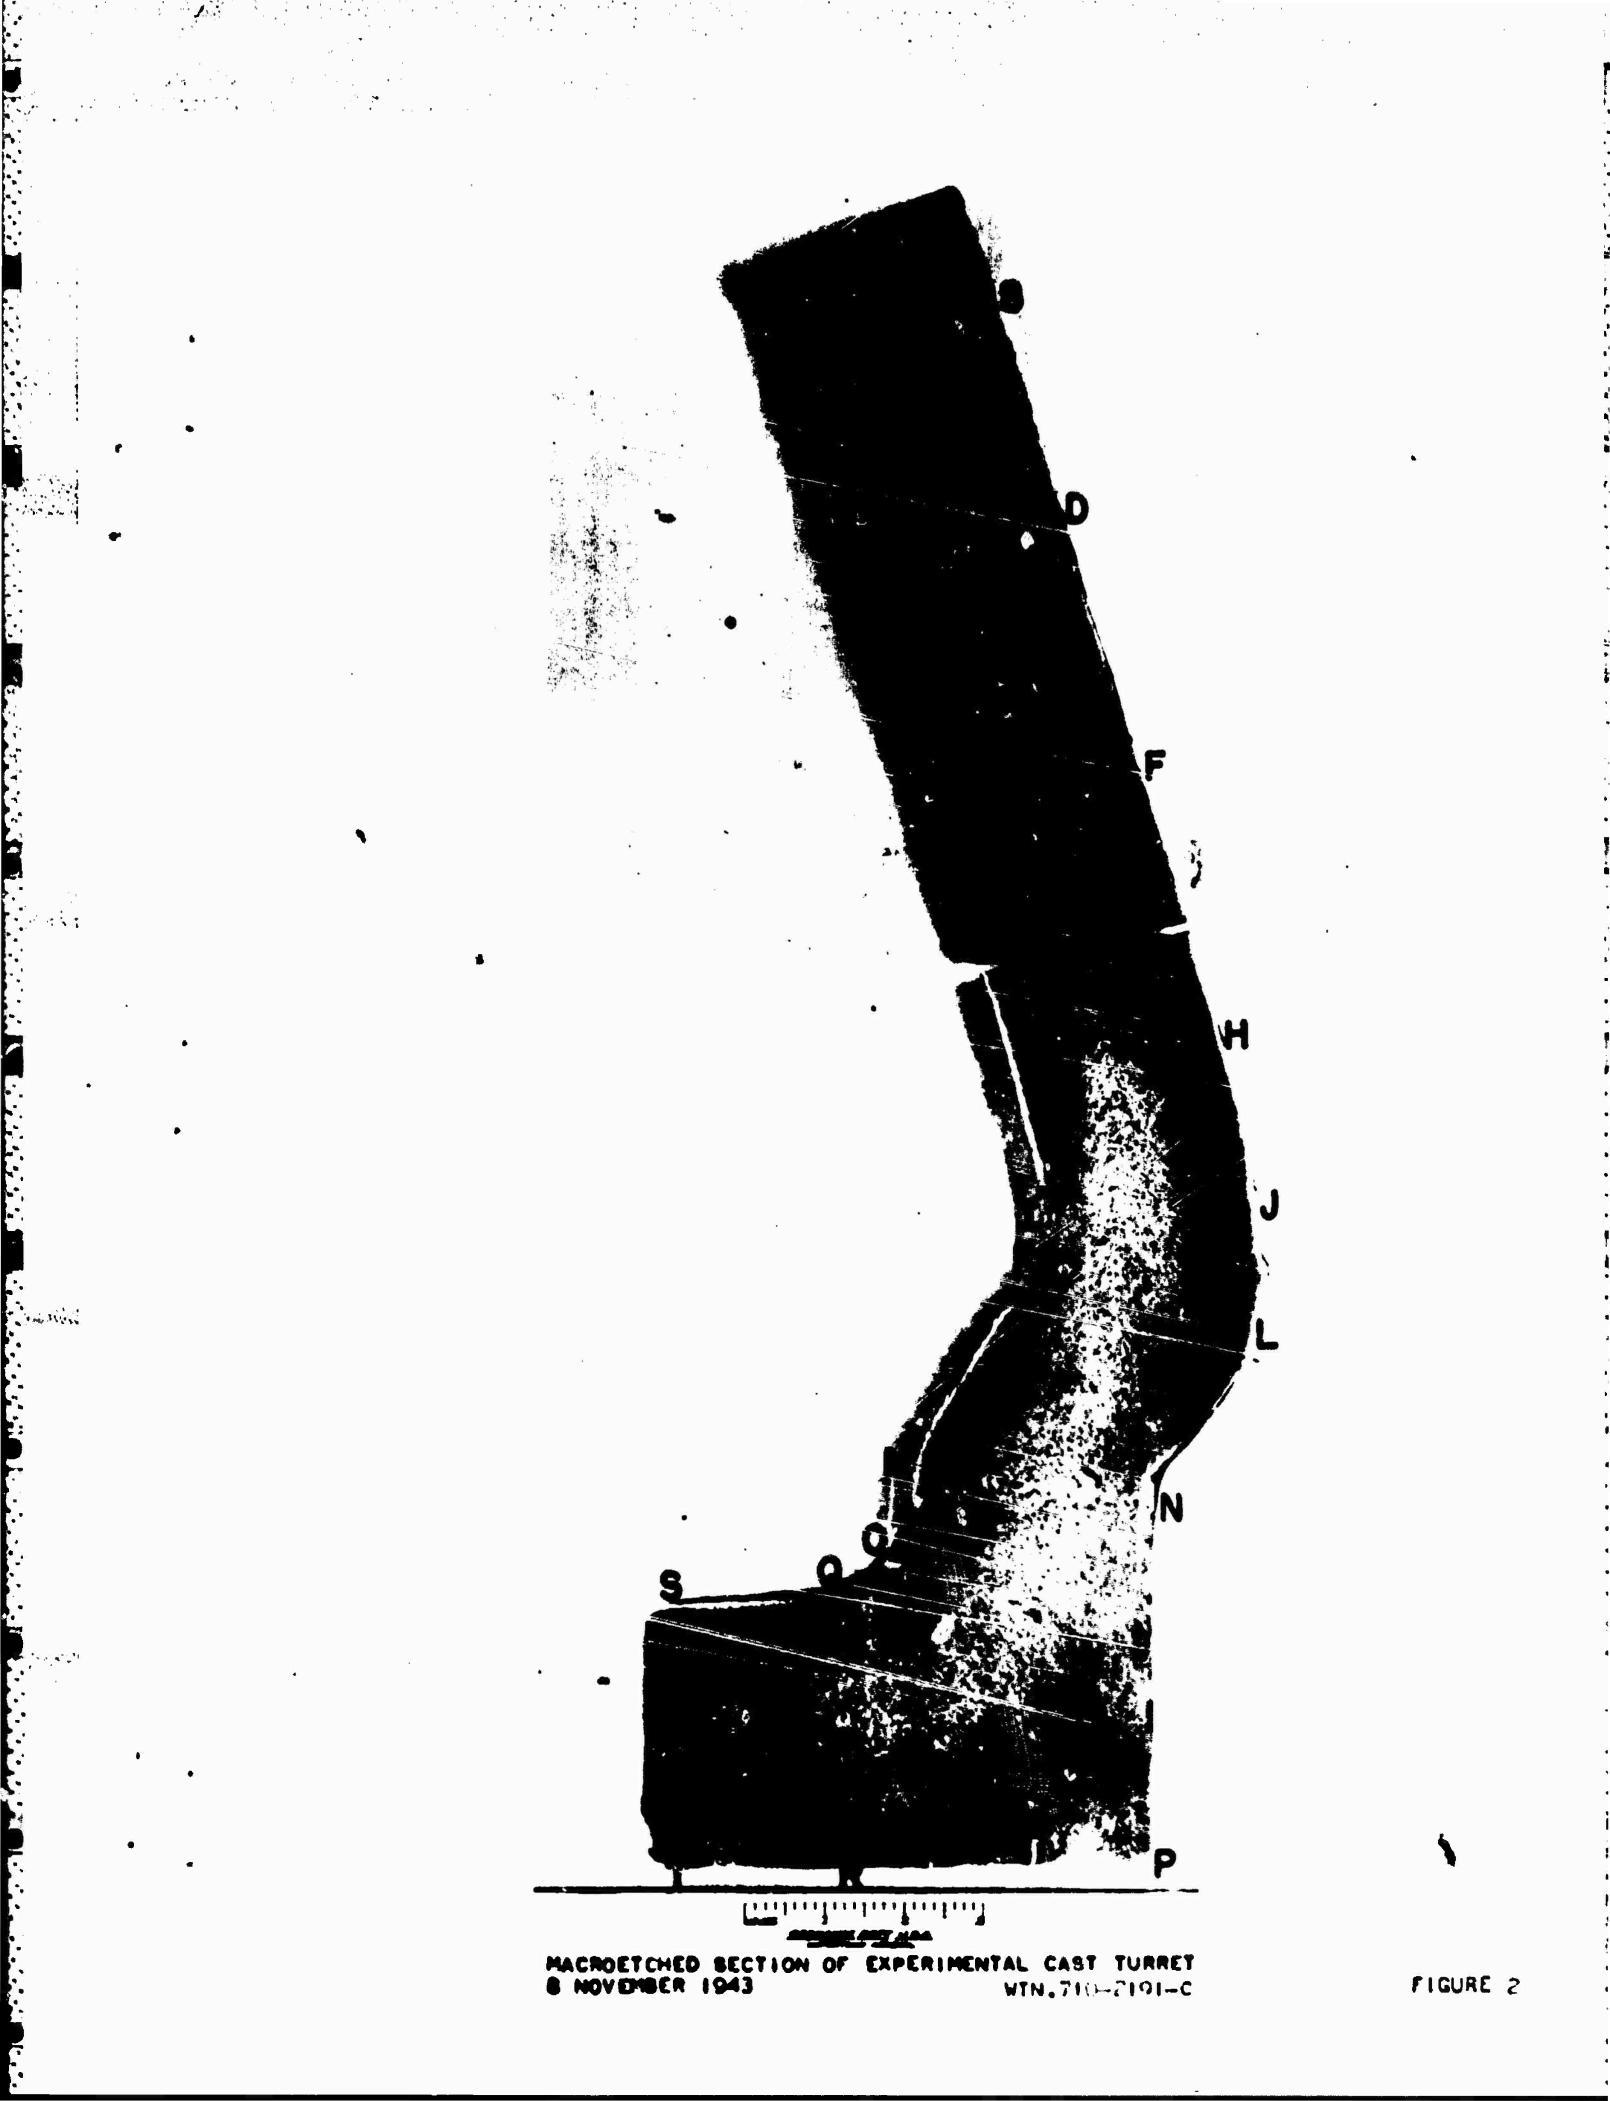
Mag. X1.

A fracture test using a forge hanner for breaking was conducted on specimens from each of the two areas, one adjacent to the base ring, and one in the middle of the sidewall of the turret. Some evidence of a crystalline break was observed in the fractures from both areas. A typical fracture is shown in Figure 3A in which the crystallinity occurs in the form of chevrons at the center of the section.

Fracture of sample in area adjacent to base ring. Some crystalline streaks are present.

The above section was then notched and broken under the forge hammer and the resulting fracture was essentially fibrous. Either increasing the alloy content or improving the quenching practice a small amount should eliminate the formation of high temperature transformation products and thereby improve the toughness of the armor.
