Report 900  
METHODS OF PASSING VEHICLES OVER AREAS  
SIMILAR IN CHARACTER TO RICE PADDY FIELDS

2 January 1945

THE ENGINEER BOARD  
Corps of Engineers, U. S. Army  
Fort Belvoir, Virginia

Project MRS 261

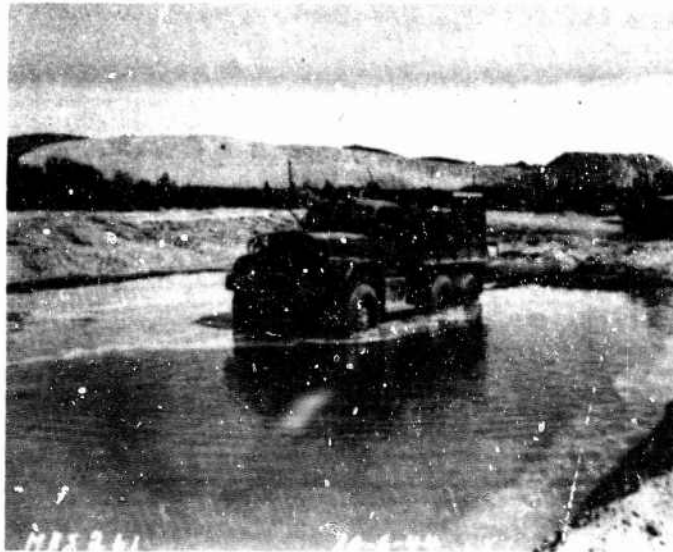
b. Four-Ton, 6x6 Truck (Loaded). This truck, equipped with special 14.00-20, 12-ply single tires for added flotation at emergency inflations, made six trips through the area. It was unable to pass over the dikes, however, because of the lack of axle housing clearance. The same truck with chains was able to negotiate the area and raise the front wheels over the three-foot dike. Lack of clearance rather than mobility prevented further forward action. (See Fig. 2.)

FIG. 2. "GO - NO GO" TEST. A 4-ton 6 x 6 truck equipped with special 14.00-20 tires at emergency inflation pressures on initial trip.

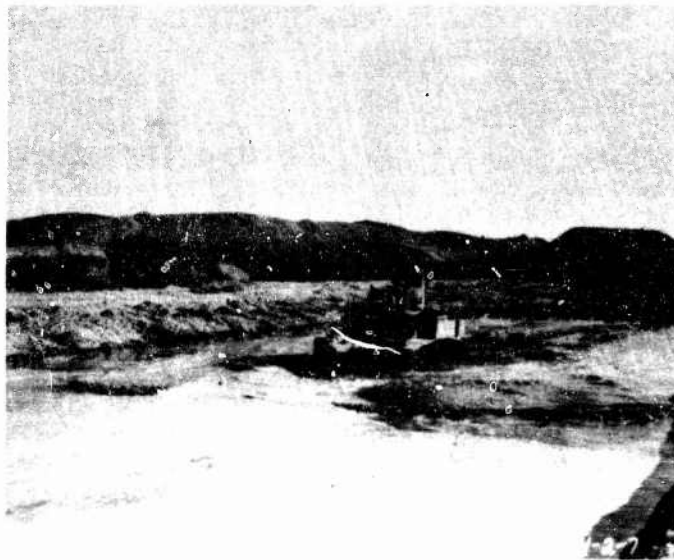
c. Light Tank (16-Ton). This tank made 13 trips through the area before becoming immobilized because of lack of clearance and insufficient traction. The tank rested in 36 inches of mud and water, and was unable to climb the dike due to loss of traction. (See Fig. 3.)

FIG. 3. LIGHT TANK TRAVELING THROUGH THE TEST AREA ON INITIAL TRIP.

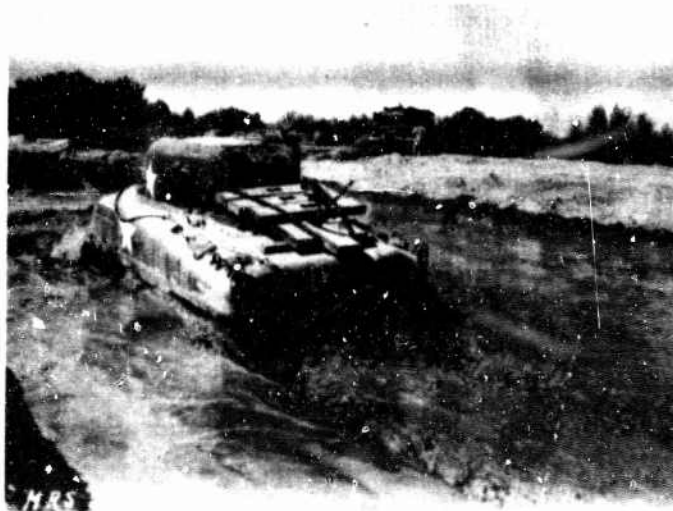
d. Medium Tank (35-Ton). (Fig. 4.) This tank operated in two feet of mud and water on the first trip and in 38 inches after

FIG. 4. REAR VIEW OF MEDIUM TANK PASSING THROUGH THE TEST AREA ON THE TWENTIETH TRIP. It became immobilized after the thirty-fifth trip.

the eighth trip. It became immobilized in 60 inches of mud and water on the thirty-fifth trip, due to loss of traction. The tank passed over the dike on the second attempt. (See Fig. 4.)

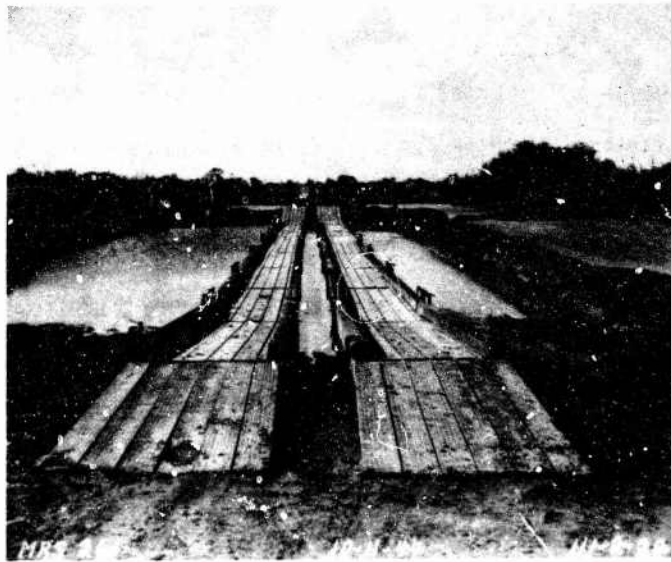
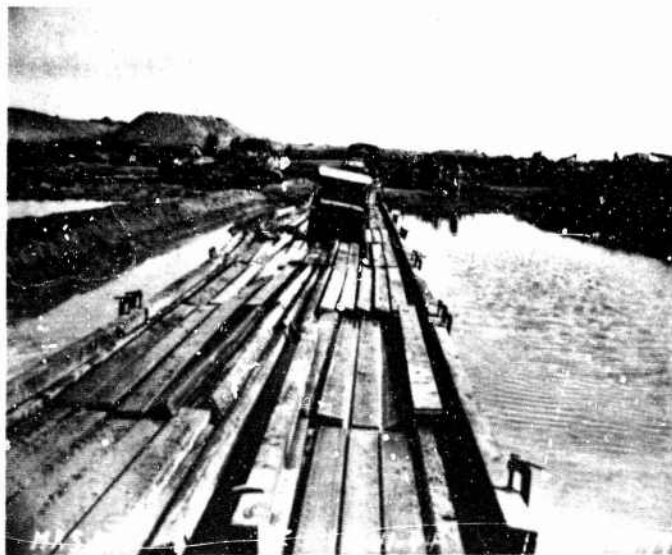
a. Treadways from Deck Balk. Deck balk treadways from components of the Floating Bridge, M4, were constructed over the flooded unplanted area. Two tracks, each 6 balk in width, were laid on removable gunwales resting in the mud. Not all the balk were pinned to the gunwales because of the difficulty encountered in inserting the pins, owing to the mud. Curbs were improvised with 6 x 6-inch timbers held in place by side rail clamps. The clamps for the inside rails were inverted to provide clearance for 1/4-ton trucks. Traffic forced the gunwales into the mud, and the unpinned balk floated out of position after 6 vehicle trips. This installation was considered unsatisfactory. Figs. 5 and 6 show the deck balk before and after test.

FIG. 5. DECK BALK FROM FLOATING BRIDGE, M4, (UNPINNED TO GUNWALES). With 6 x 6-inch curb clamped in position, prior to testing.

FIG. 6. DECK BALK FROM FLOATING BRIDGE, M4, (UNPINNED TO GUNWALES). AFTER 6 TRIPS OF THE CONVOY. The balk in the foreground are floating.

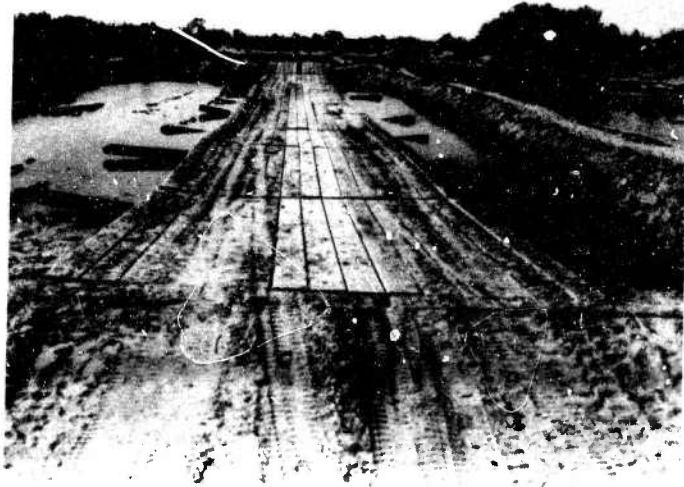
b. Full Track Roadway from Deck Balk. A solid deck of 15 balk was constructed in a flooded area with the outside balk and the sixth balk from each side pinned to the gunwales. The gunwales were placed on 6 x 12-inch timbers to reduce bending. It was found extremely difficult to make the pin connection in the mud, since it was necessary to work under the balk where a hammer could not be used to drive the pin when resistance was encountered. Fig. 7 shows the solid deck, 15 balk wide. The continued movement of the balk, as traffic progressed, caused the pins to work free, causing subsequent additional roadway failure. Traffic was discontinued after 879 trips, due to the roadway conditions. The vehicle trips are recorded as follows:

FIG. 7. ROADWAY OF DECK BALK FROM FLOATING BRIDGE, M4, AFTER 271 TRIPS. The outside row and the sixth row from each edge are pinned to the gunwales.

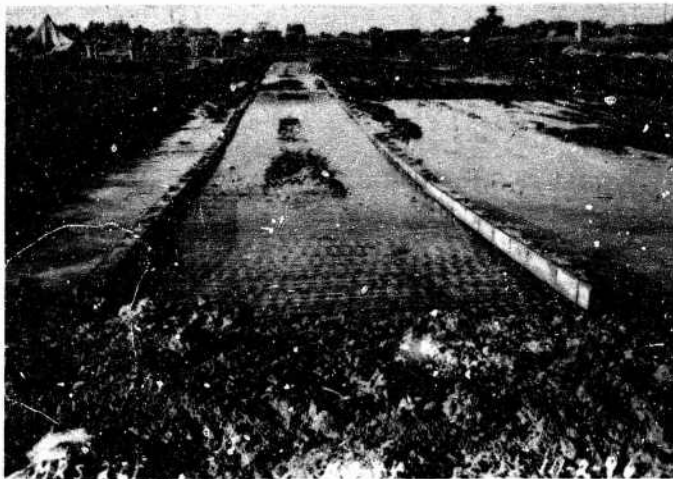
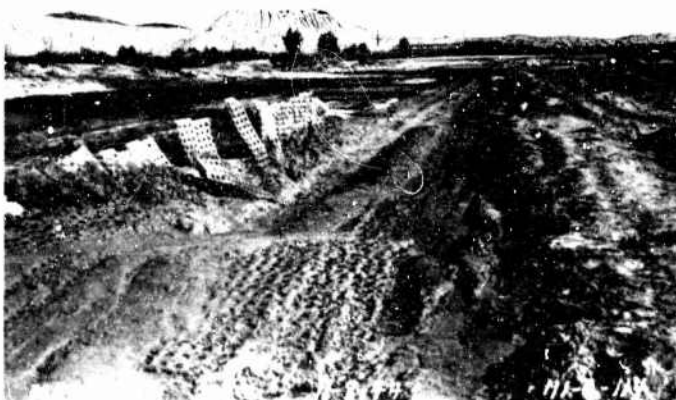
(2) In the unplanted area, a section of pierced plank landing mat (1/2-plank wide) without curb was placed on one layer of PBS with sealed joints. The 5-foot sections of plank were alternated to avoid having all short sections on one side of the roadway. Traffic was begun subsequent to draining and was discontinued over this section after 879 trips because the 5-foot sections of plank began to work loose and impede traffic. See Fig. 8 for a general view of the test section after 100 vehicle trips. Fig. 9 shows the same section after 877 trips.

FIG. 8. ROADWAY OF PIERCED PLANK LANDING MAT AFTER 100 TRIPS. Foreground: Section on longitudinal; plank in trackway; Center: 10-foot width roadway on PBS; Background: 15-foot width roadway on PBS.

FIG. 9. ROADWAY OF PIERCED PLANK LANDING MAT ON PBS AFTER 877 TRIPS. Note position of the 5-foot lengths of plank. Foreground: 15-foot width section; Center: The 10-foot width on PBS; Background: Longitudinal plank in trackway.

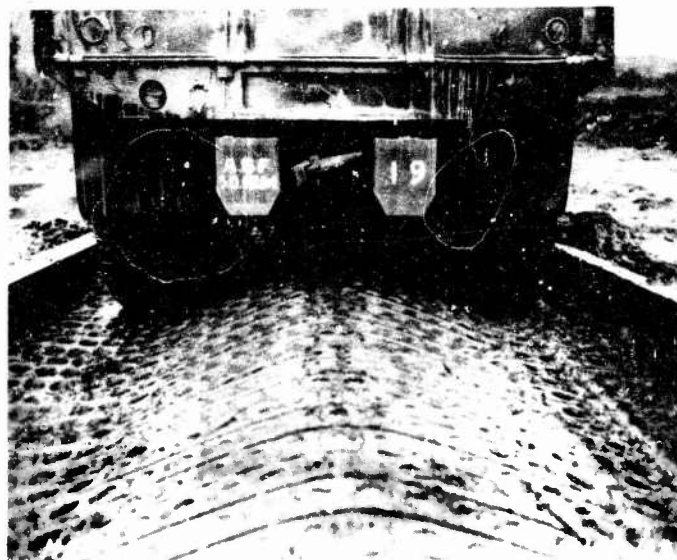
(4) In the area planted with hemp, a section using pierced plank landing mat placed longitudinally two plank wide in the trackway was constructed on one layer of PBS with sealed joints. Plank were then laid crosswise over the longitudinal plank to form the roadway. A 6 x 6-inch curb was wired into place at the extreme edges of the trackway. This section was placed as an extension to the roadway described in paragraph 9b(2), above. Traffic was discontinued after 131 vehicle trips because the truck differentials were becoming entangled in the plank. Fig. 10 shows the condition of the plank at the conclusion of the test.

FIG. 10. EFFECTS OF UNEQUAL SETTLEMENT OF THE ROADWAY. Settlement is caused by confining the mud under the center. The truck differential housing is dragging on the pierced plank.

(b) Mud of Thin Consistency. The use of PBS under plank in mud of thin consistency was not satisfactory for extended traffic. The mud was trapped under the center of the roadway and forced from under the trackway at both ends of the plank. As a result, the center of the roadway did not subside as rapidly as the trackway, causing a ridge

to develop in the center to such an extent that traffic was impeded. It was definitely proven that mud of thin consistency should not be confined under the center of the roadway.

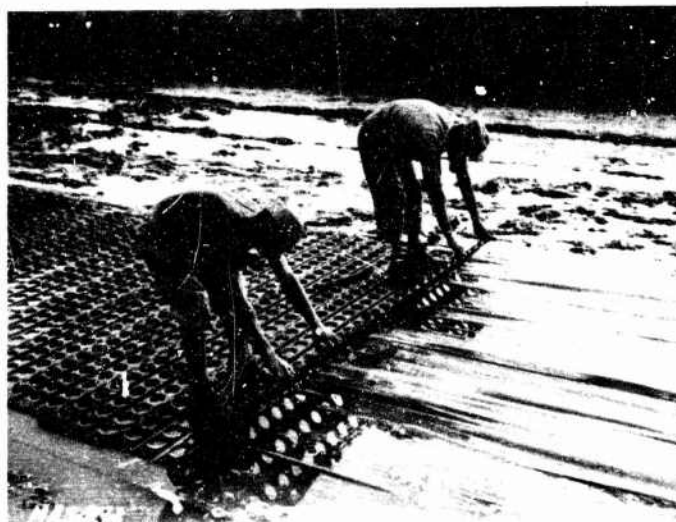
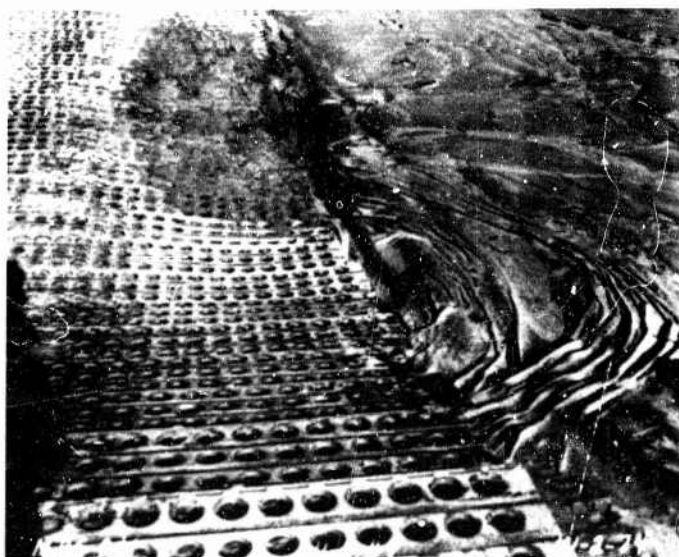
10. Pierced Plank Landing Mat on Burlap (Untreated). Sections of pierced plank were laid over the flooded unplanted area on burlap (Hessian) of one, two, and four layers (Figs. 11 and 12). It was found that the single layer was of little value, and tended to float from under the plank as well as to shred into small pieces under the pumping action of the plank. The two and four layers of burlap, respectively, gave good results, although the tendency of the burlap to float from beneath the plank was still prevalent. It was noted that the plank on the four layers of burlap was less deformed at the end of 760 vehicle passages (no tanks were used) than with two layers, and also that the subsidence was less in the mud. The sections were in good condition at the end of the 760 trips.

FIG. 11. LAYING PIERCED PLANK LANDING MAT ON UN-TREATED BURLAP.

FIG. 12. PIERCED PLANK LANDING MAT ON BURLAP. Showing outside strip washed from under the plank by traffic action.

(2) Untreated Burlap. Two or more layers of untreated burlap under pierced plank are necessary in order to achieve beneficial results on mud of stiff consistency. Its use in mud of thin consistency is of little value, since the mud is readily forced up through the material. The flexing and pumping action of the plank under traffic readily shreds the burlap to pieces, and also tends to force the outside strips from under the plank.

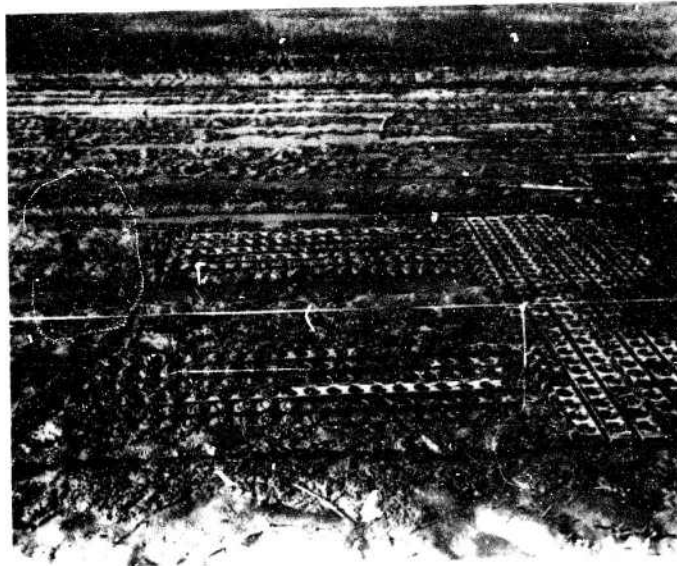
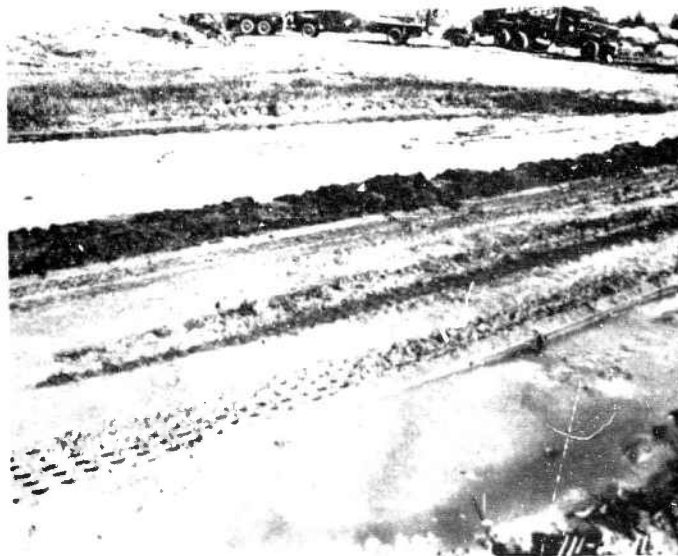
11. Pierced Plank on Longitudinal Plank Trackway. A section was constructed by placing longitudinally in each trackway pierced plank landing mat (two planks wide) on top of which plank was placed crosswise. (Fig. 13.) A 6 x 6-inch curb was wired in place at the extreme edge of the roadway. This combination performed as well as any section tested using pierced plank. This section was drained immediately before traffic was started and reflooded and drained at the end of 877 vehicle trips in order to produce more severe conditions. A total of 1178 vehicle trips were made over this section before traffic was discontinued. The roadway was still in good condition and would have accommodated considerably more traffic. Fig. 14 shows the condition of this section after 800 vehicle trips.

FIG. 13. PIERCED PLANK LANDING MAT PLACED ON LONGITUDINAL PLANK (2 PLANK WIDE) IN THE TRACKWAY.

FIG. 14. PIERCED PLANK LANDING MAT PLACED ON LONGITUDINAL PLANK (2 PLANK WIDE) IN THE TRACKWAY. Condition after 800 vehicle-trips.

g. Pierced plank landing mat over longitudinal plank (two planks wide) in each trackway, with curb, accommodated the largest number of vehicle trips of the plank roadways tested. At the end of 1178 vehicle trips the roadway was in good condition. However, in the test area planted with hemp the same combination plus a layer of PBS accommodated only 131 vehicle trips.
