Report No. FAA-SS-73-10

# SST Technology Follow-On Program-Phase II

## DEVELOPMENT AND EVALUATION OF FUEL TANK SEALANTS

**FINAL REPORT**  
Task II

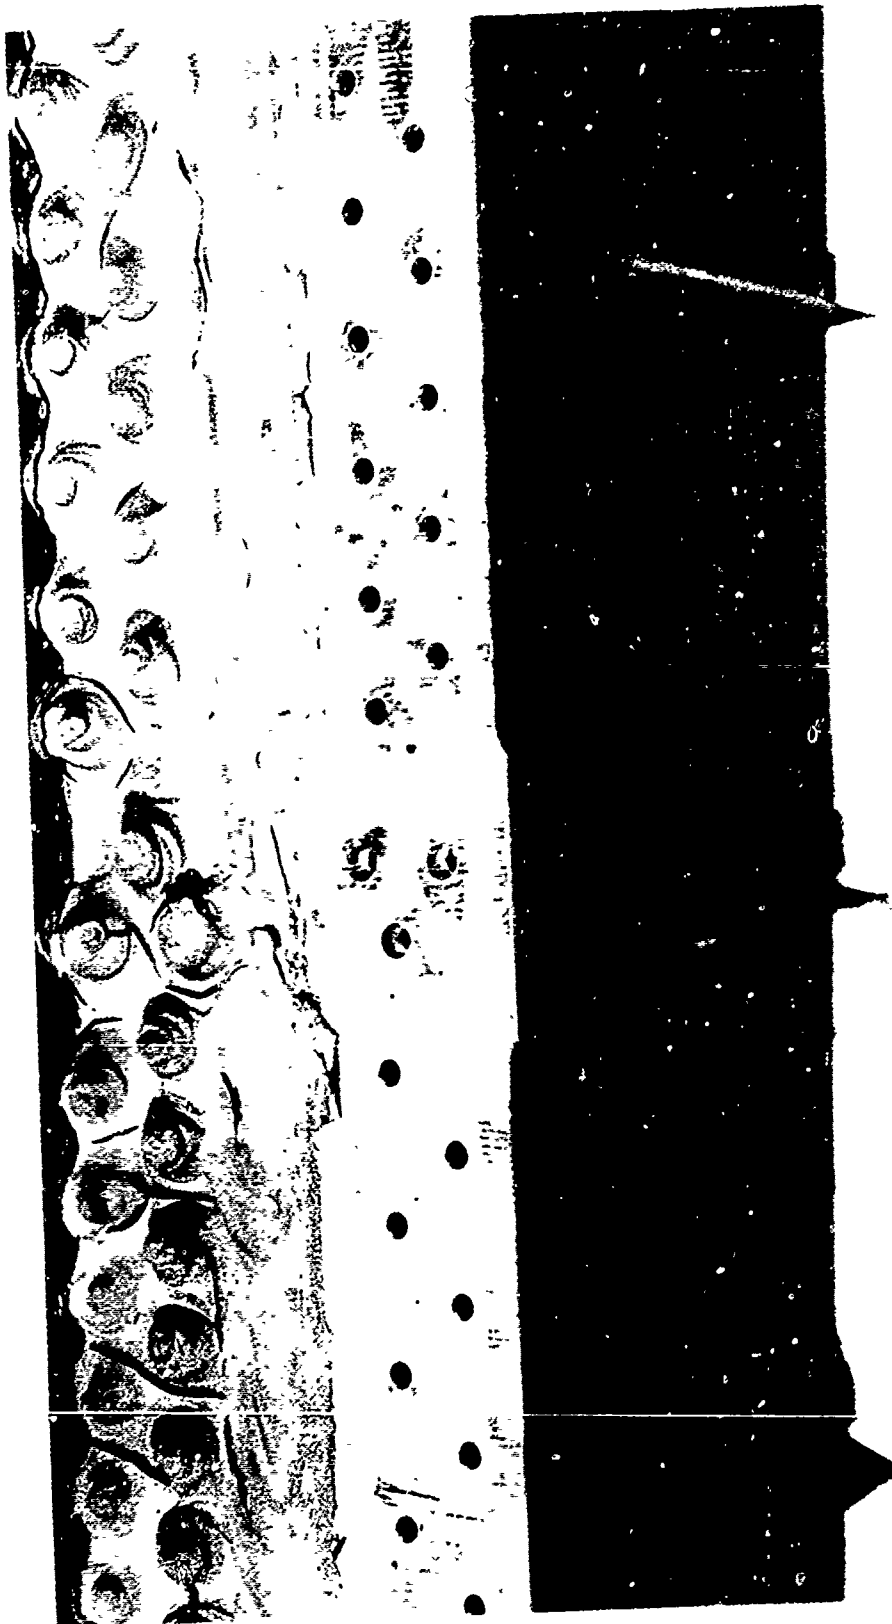
Figure 30. -- Sealant Condition After Exposure

It had been noted previously that cracks in the sealant, such as those shown in figure 30, were more prevalent when the sealant fillet was thick, so a small section was

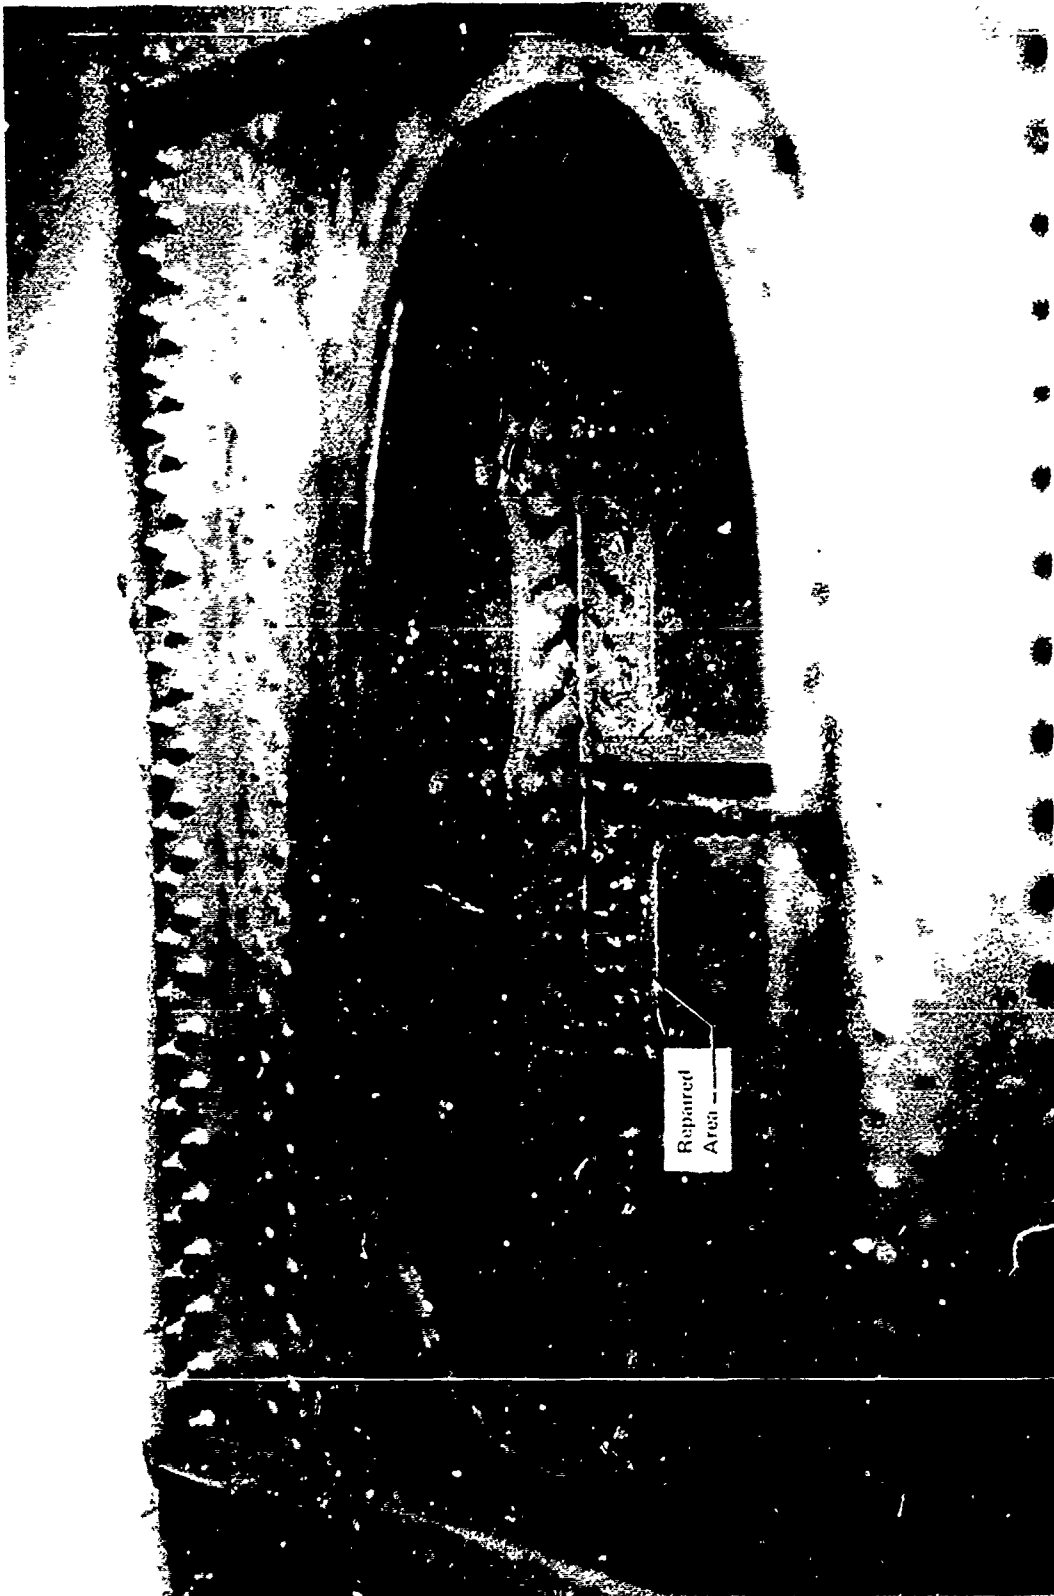
Figure 31. — Repaired Area

repaired using small fillets. The section was repaired after 7238 hr of 219° to 227° C (426° to 441° F) fuel vapor exposure in February 1973 and had no splits and no leaks. Adhesion was retained to the old sealant as shown in figure 31.

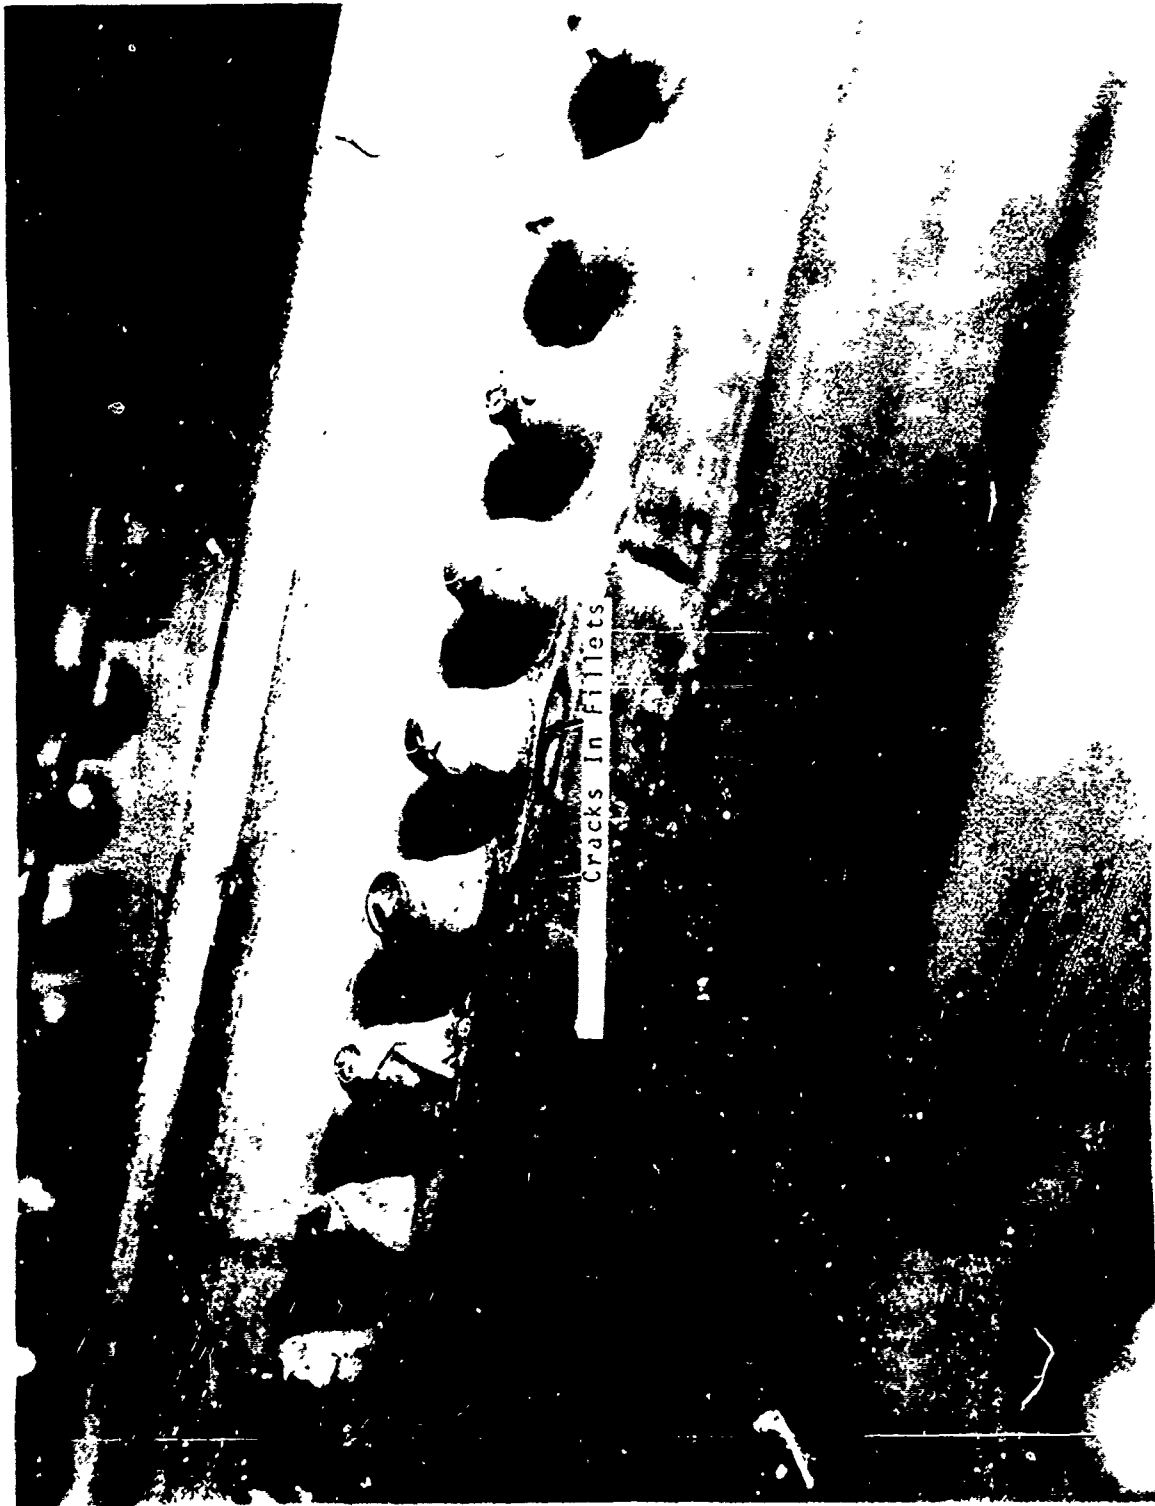
FIGURE 14 - CRACKS IN FILLETS AT BASE OF FASTENERS

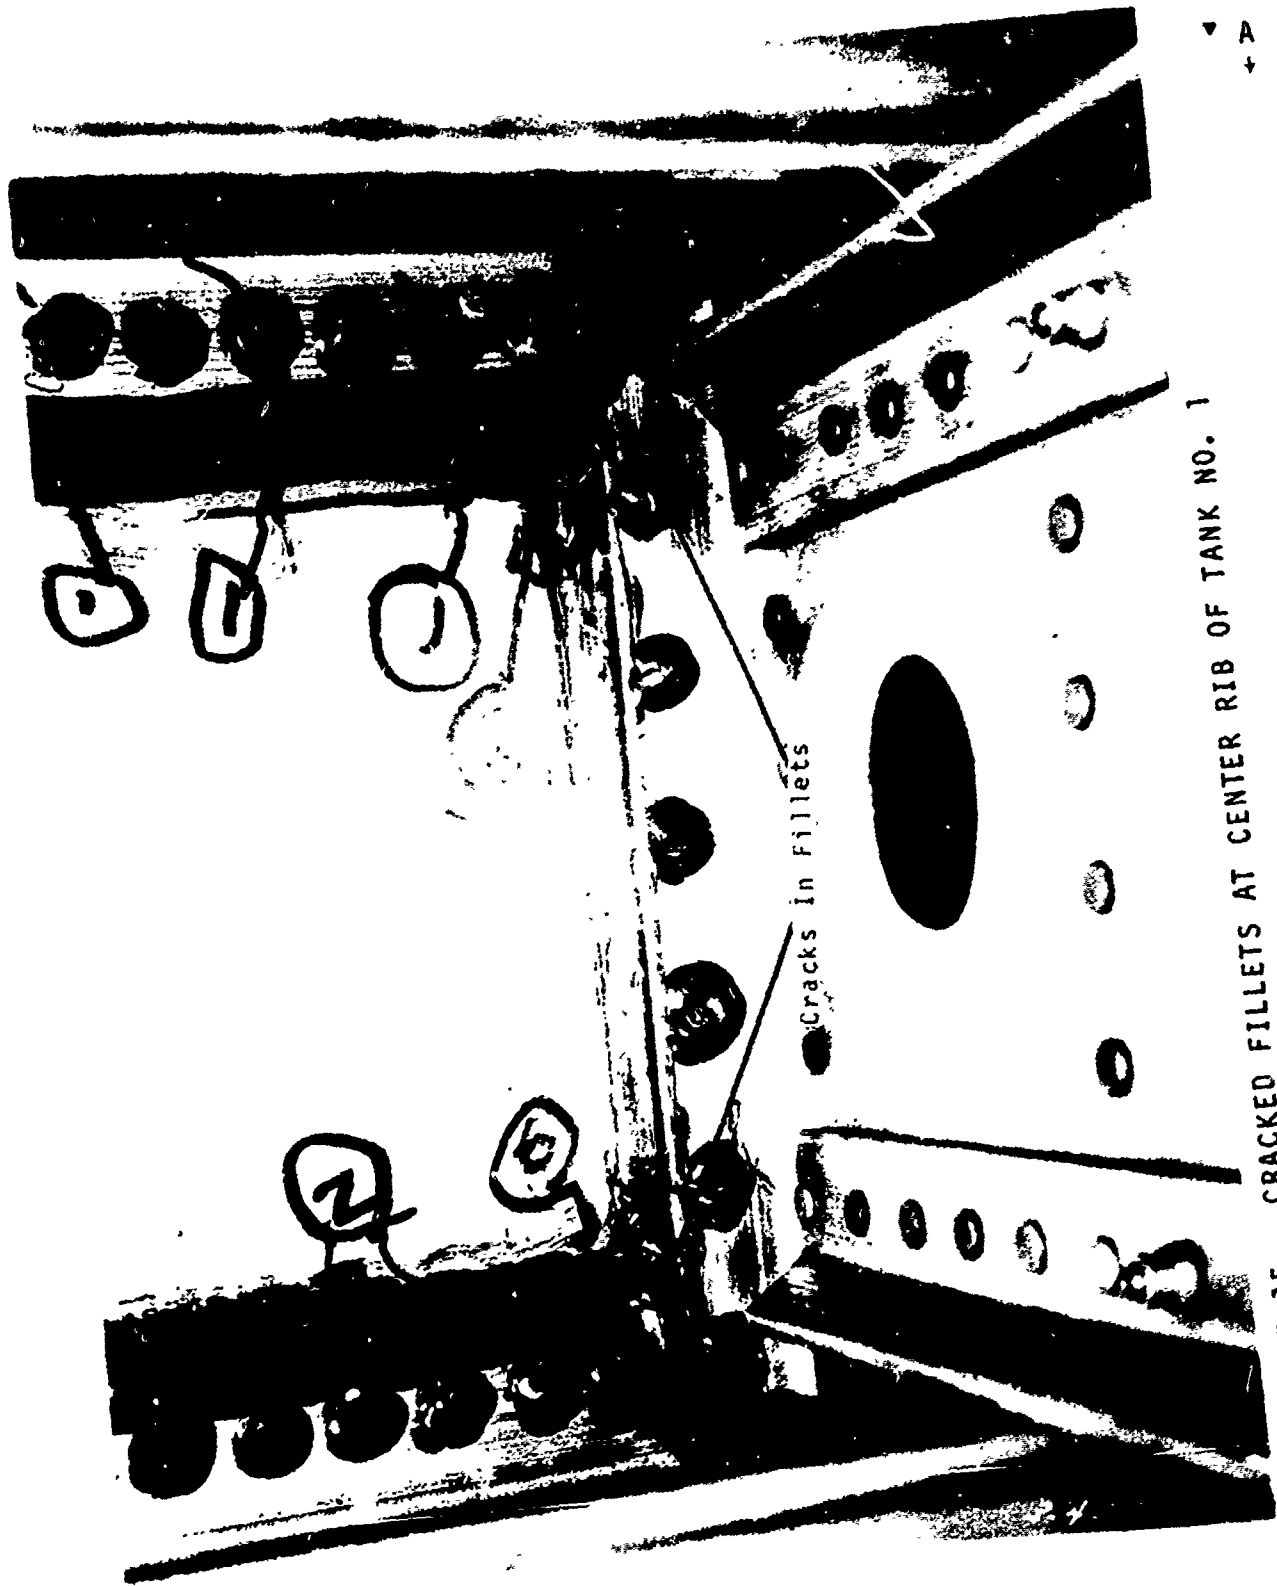
FIGURE 15 - CRACKED FILLETS AT CENTER RIB OF TANK NO. 1

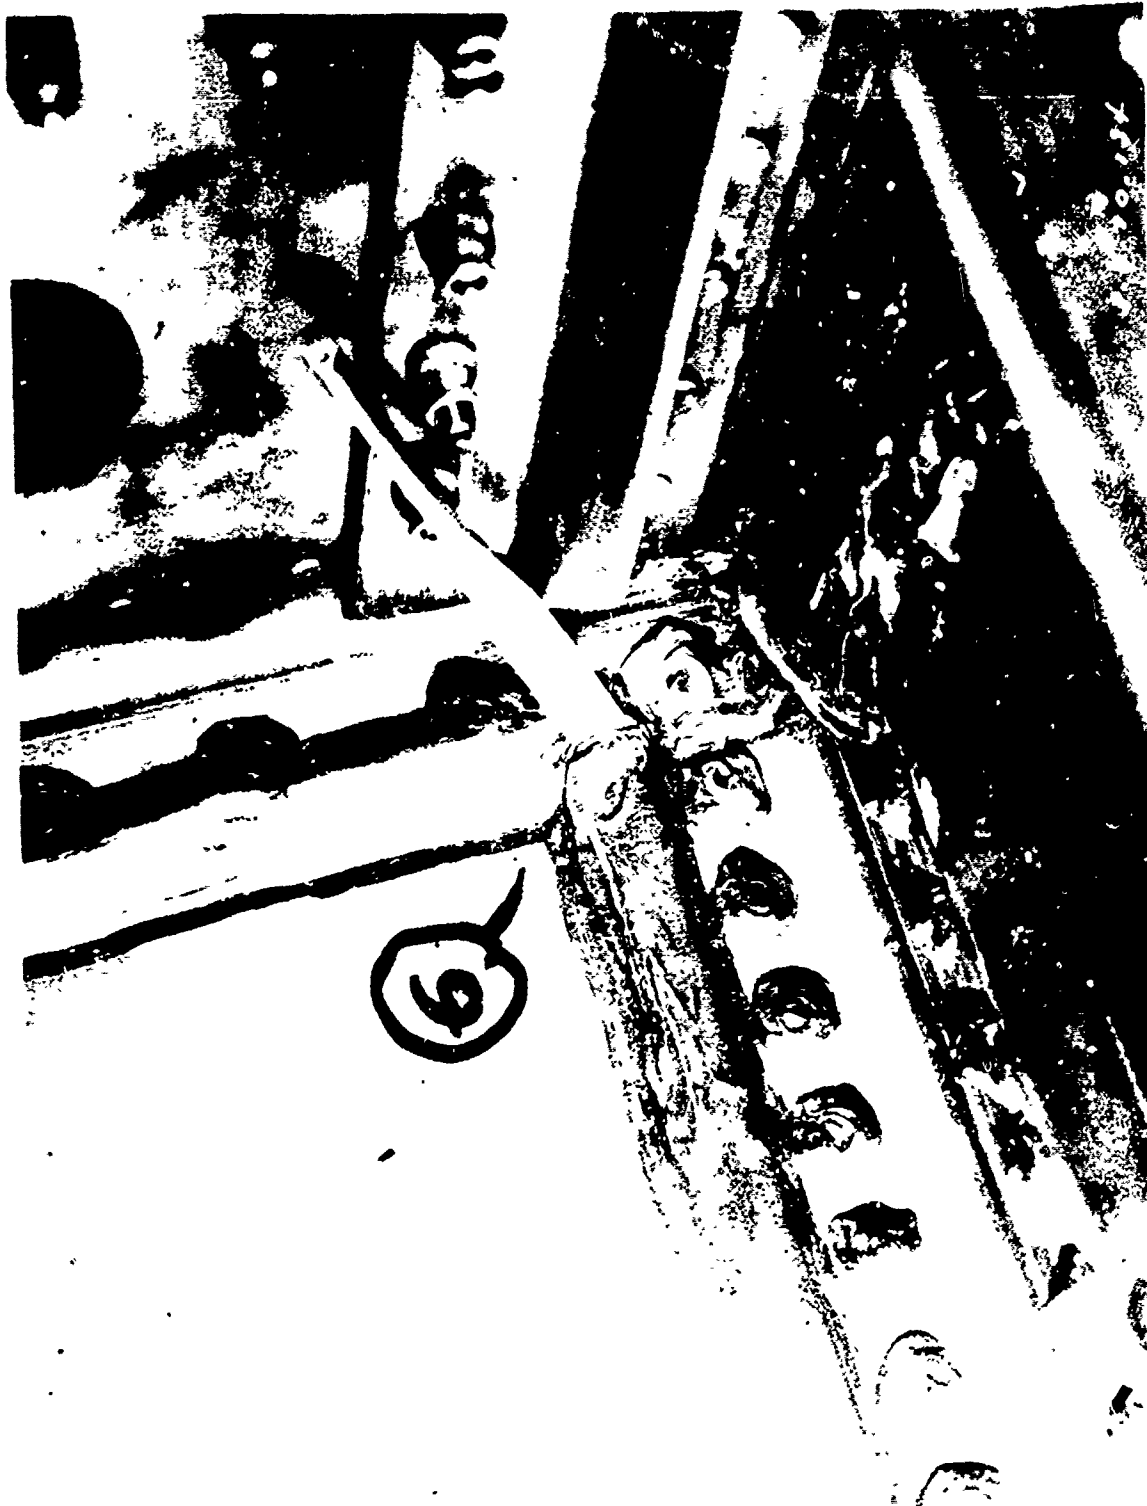
FIGURE 16 - CRACKED FILLET AT CENTER RIB OF TANK NO. 2

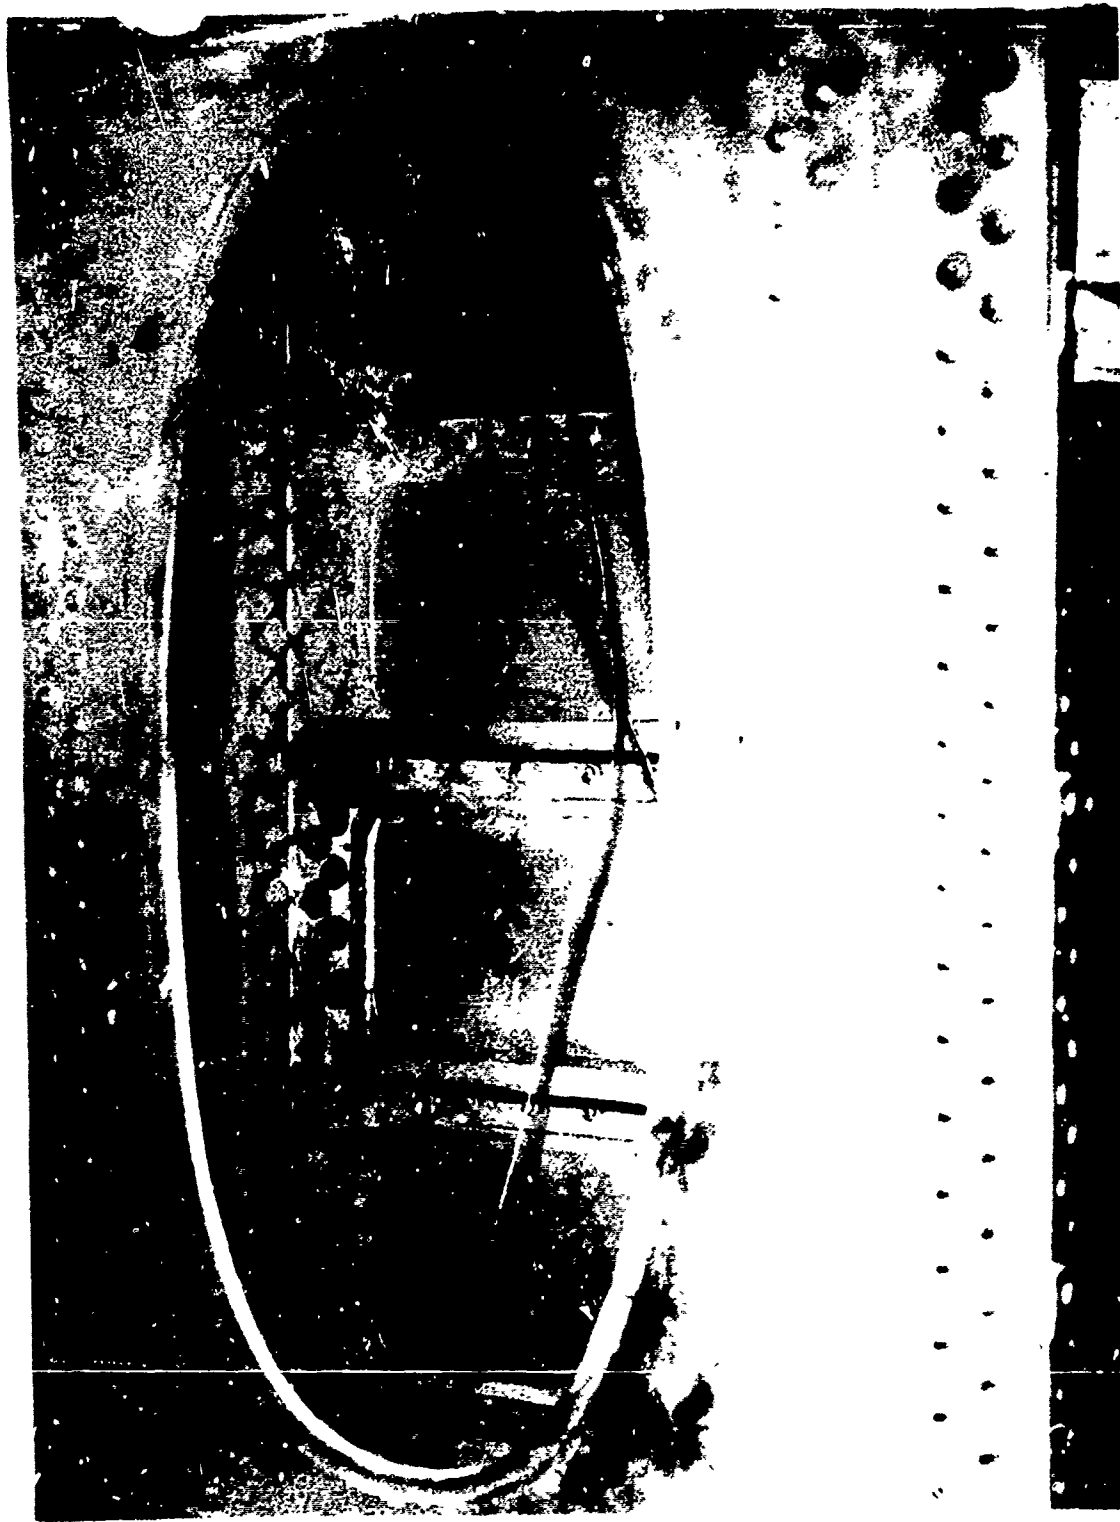
FIGURE 18 - AREA OF TANK NO. 3 REPAIRED WITH SMALL FILLETS IN FEBRUARY 1974

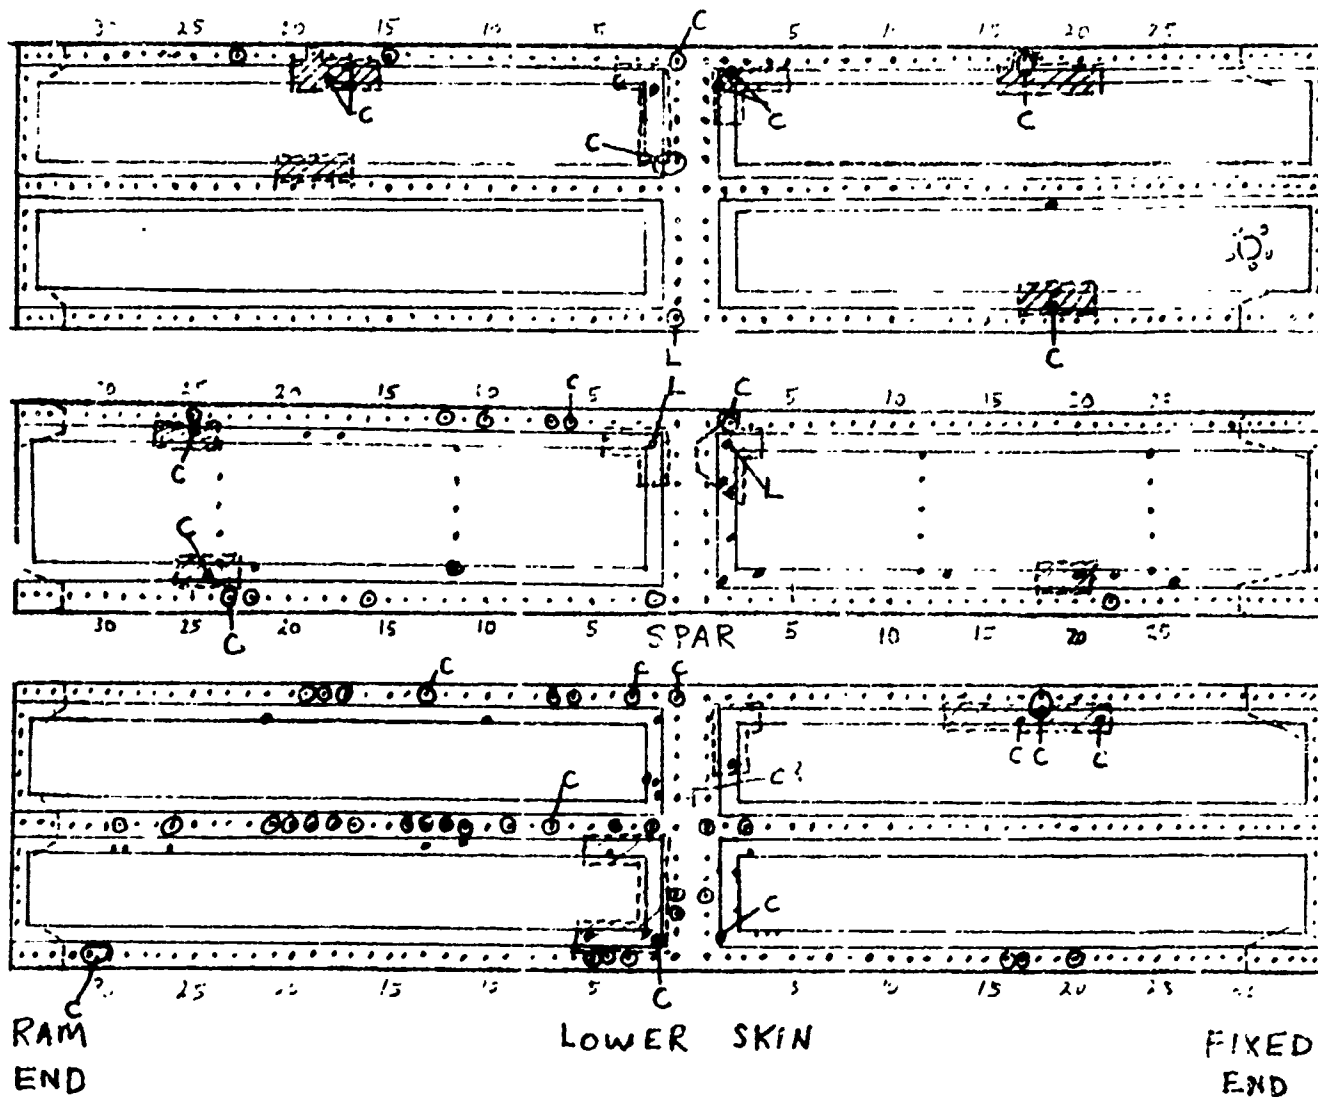
A "C" POINTING TO ABOVE AREA INDICATES A SMALL LEAK WITH CONTINUOUS BUBBLING.  
 AN "L" INDICATES A LARGE LEAK WITH VIGOROUS BUBBLING.

TANK NO. 1 INTERIOR LEAKAGE ANALYSIS CONDUCTED AFTER 12 ENVIRONMENTAL CONDITIONING CYCLES. ANALYSIS CONDUCTED USING 5 PSIG NEGATIVE (VACUUM) PRESSURE IN TANK WITH WATER LAYER ON INTERIOR TO VISUALLY INDICATE LEAKAGE BY BUBBLING.
