NWC TP 5921

# Reduction of Fuel Fire Cook-Off Hazard of Rocket Motors

by  
Ronald F. Vetter  
*Propulsion Development Department*

JUNE 1977

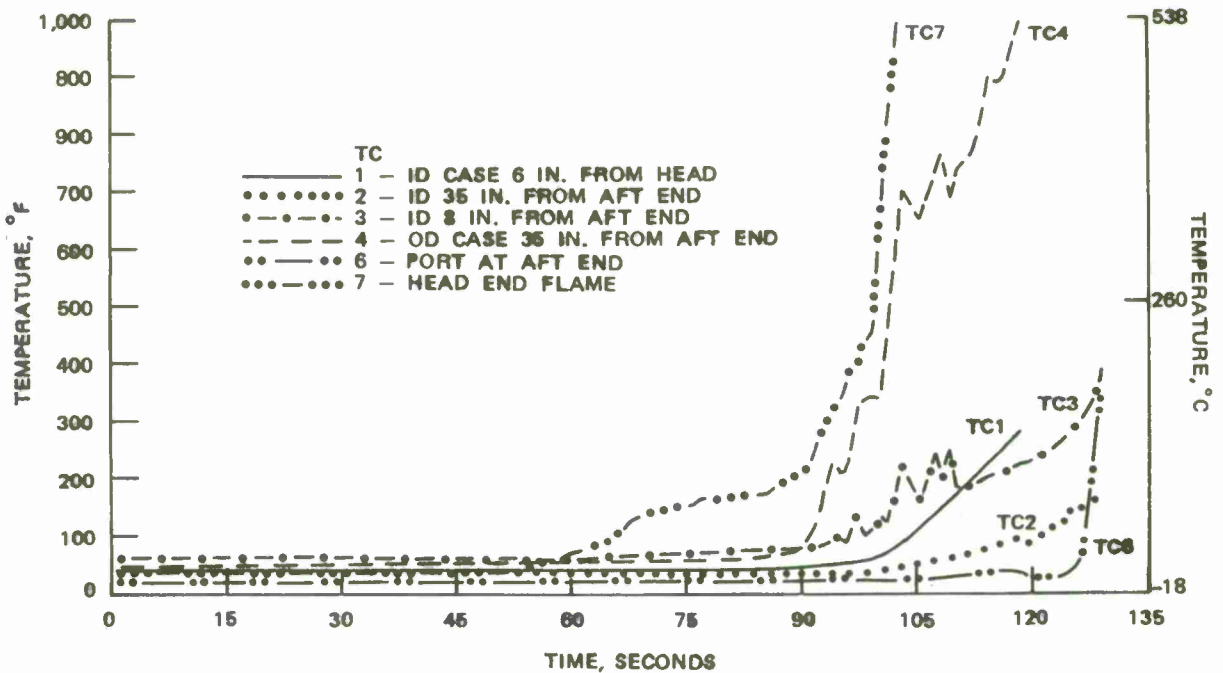
FIGURE 3. Mk 36/50 With Aluminum Rivets.

on one side. There was no enlargement or melting evident at these empty holes. The entire grain appears to have ejected when case rupture occurred. Movie coverage showed nothing except slowly building fire until rupture. The rupture caused ejection of small pieces (many burning) in a manner typical of pressure vessel failure; some of these pieces would have traveled over 15 meters (50 feet). More or larger holes might allow sufficient venting but then case weakening would worsen.

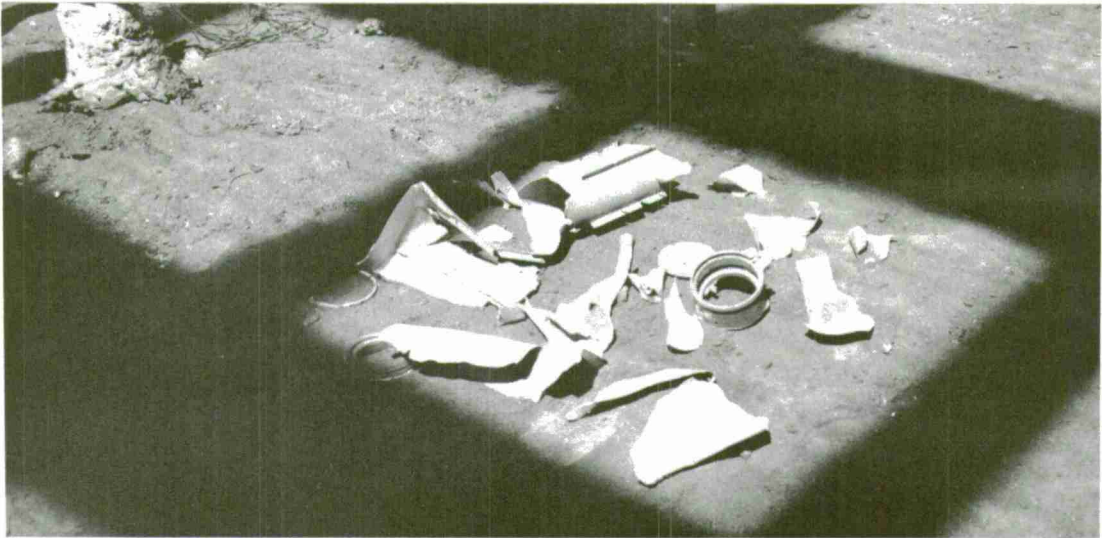
FIGURE 4. Collected Pieces of Mk 36/50 Case (LHL 187166).

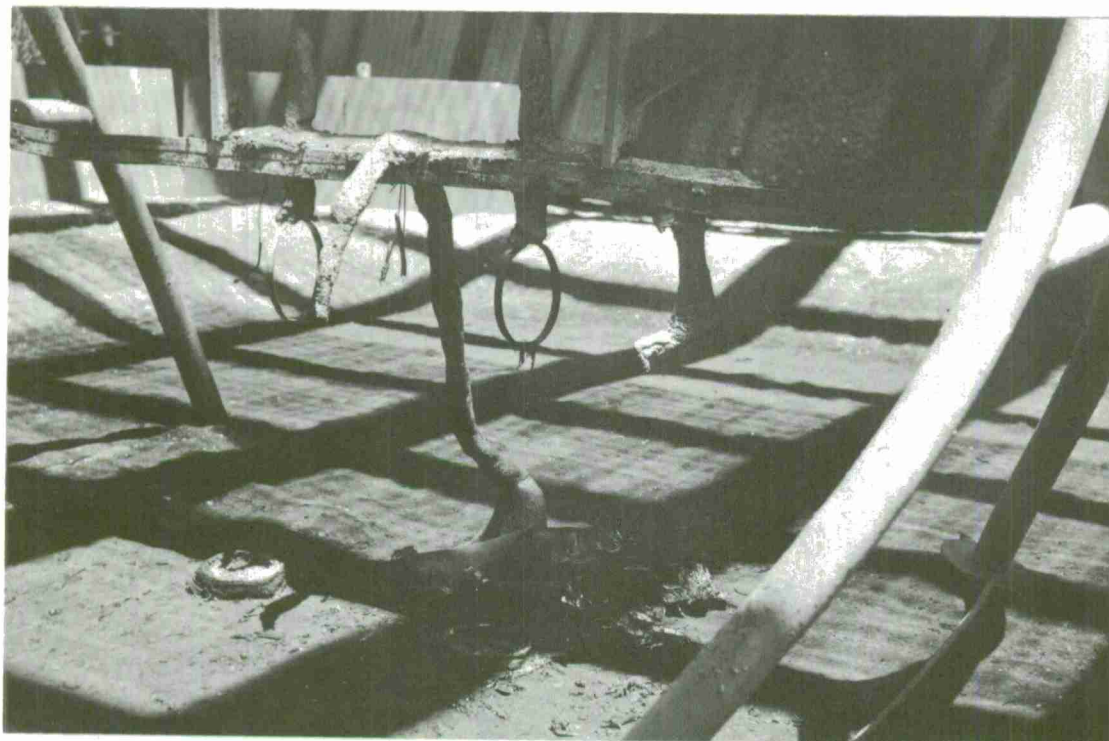
FIGURE 8. Fiberglass Cook-Off Remains (LHL 188029).

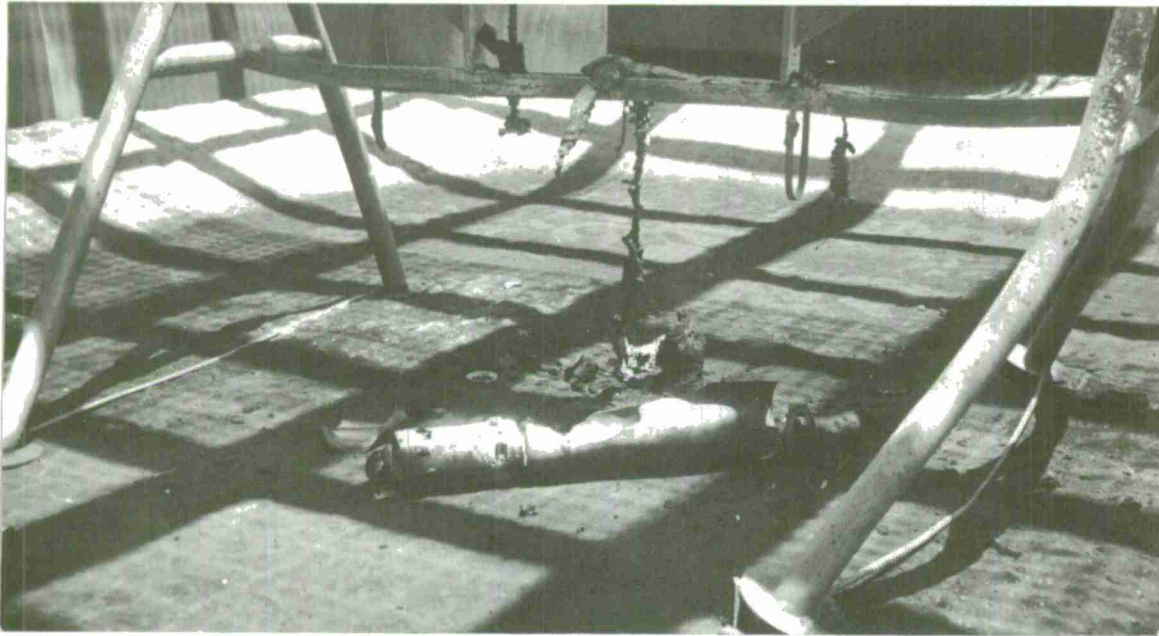
A bulge of heated, thinned steel on the right side of the head end may have been the initial rupture point; apparently causing the motor to jump forward and left, removing it from the small simulated "rail" and loose strap around the nozzle which

FIGURE 10. Post-Test View of Mk 52 With LR-13 Liner (LHL 188114).

suspended it from the A-frame. At any rate, when the motor fell it pulled the nozzle plug and thermocouple wires out and opened a path to the propellant bore. A single hot piece of case wall, which included some of the thinned metal, was ejected from the forward top right side of the motor and hit the horizontal beam of the A-frame causing the hot piece to deform to the shape of the beam. This could have been either when the soft area initially opened (causing the hot case wall material to be flung up to the beam, wrapped around it and held by it when the rest of the motor was pushed away by the pressure of the propellant grain and burning, expanding gas) or after the motor was on the deck.

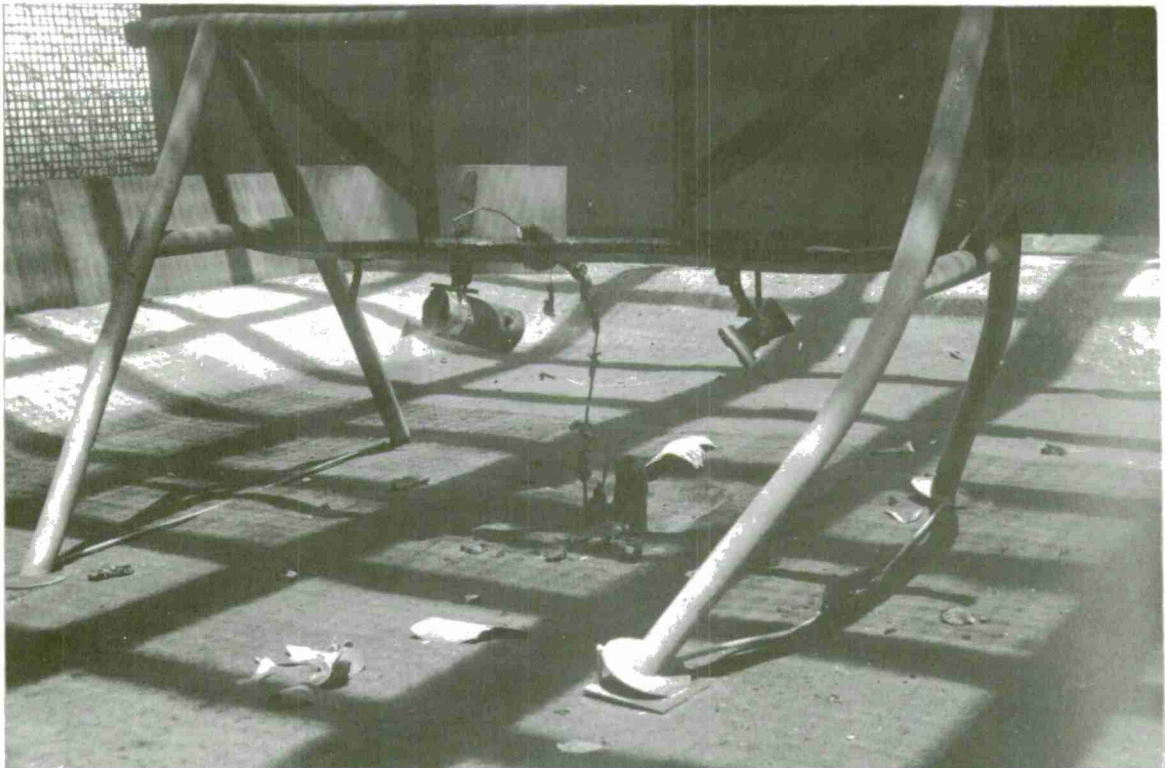
FIGURE 12. Mk 52 Case With CTPB Liner and Low Smoke Propellant After Cook-Off (LHL 188175).

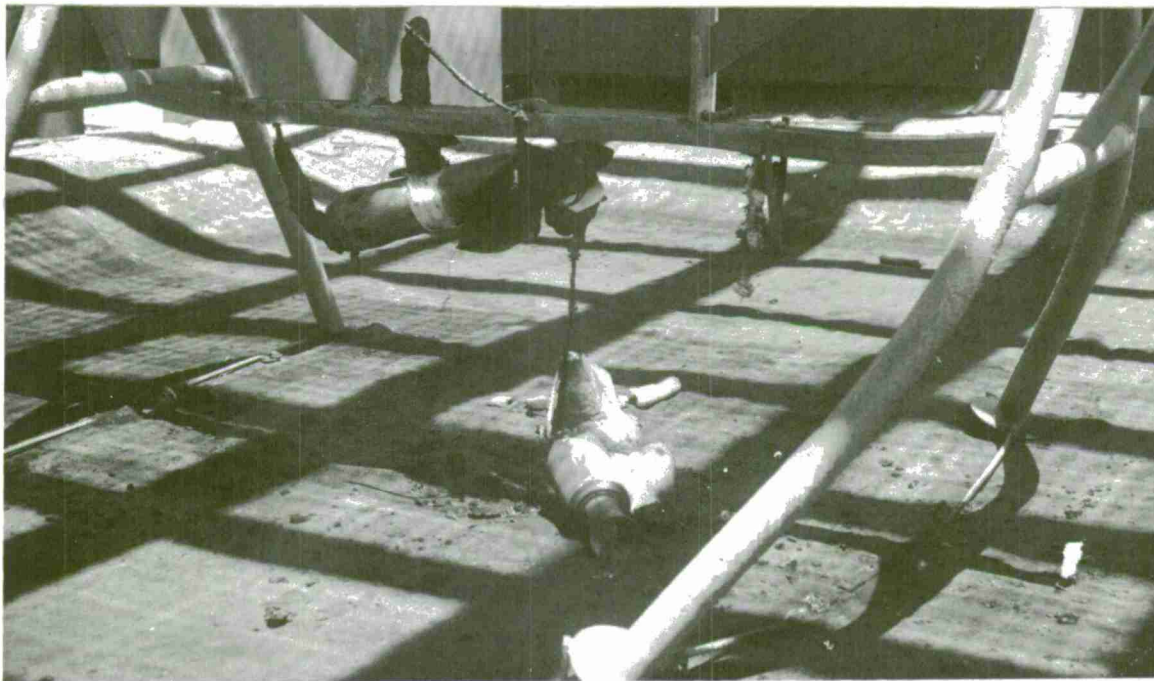
The expectation that this liner would yield the least violent reaction was not met nor was the liner/case pressure measurement as expected. The latter may well be due to equipment and technique shortcomings. The reaction must be considered a deflagration since the grain segment could have traveled on the deck more than 15 meters (50 feet). The flight of the nozzle, case and grain thus means the test failed to meet the goal.

FIGURE 15. Mk 52 With LRV-1 Liner and RV-13 Propellant After Cook-Off Fire (LHL 188176).

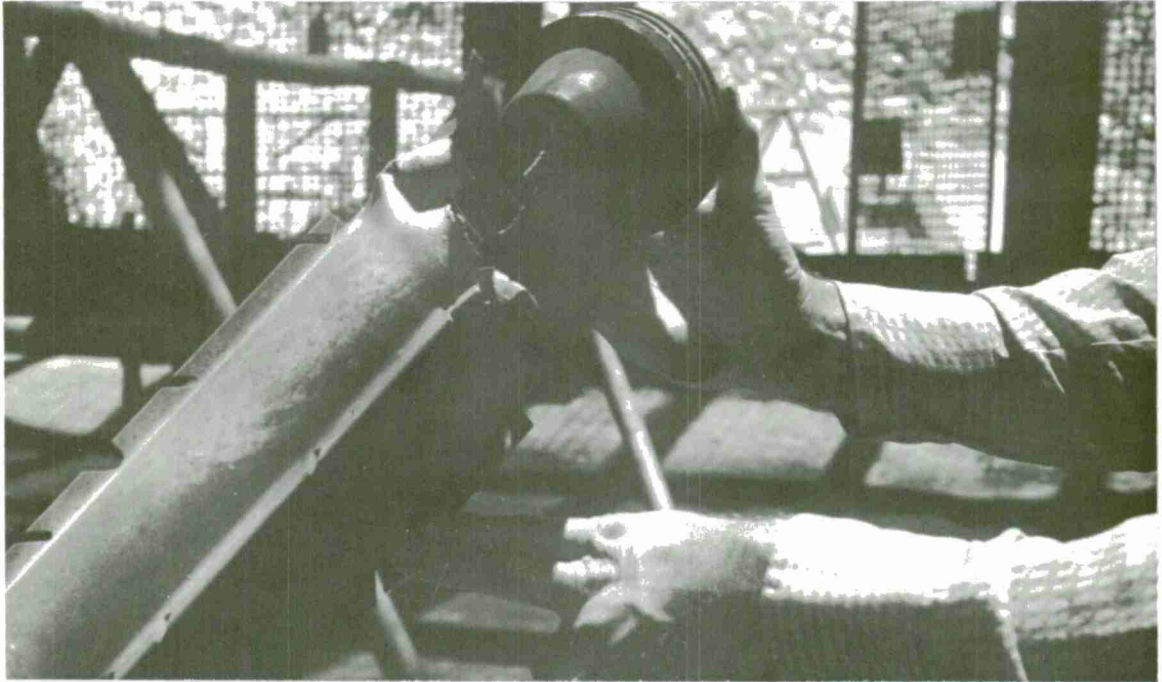
The pressure gauge was attached to a fitting welded to the case OD 63 cm (25 inches) from the head end with a hole through to the liner OD. It showed a small pressure (approximately 51 kPa) from 163 to 183 seconds. At 184 seconds it went negative. The nozzle seal was gone and char was formed on a portion of the outer insulation. A small amount of metal-edge-rounding over this same quadrant indicates some hot gas leaked aft past the lockwire groove. The absence of an O-ring may, therefore, have contributed to a pyrolysis gases leak path which relieved pressure and grain deformation.

FIGURE 16. Mk 36/50 Case After Cook-Off Using HTPB Liner and Smokeless Propellant (LHL 188214).

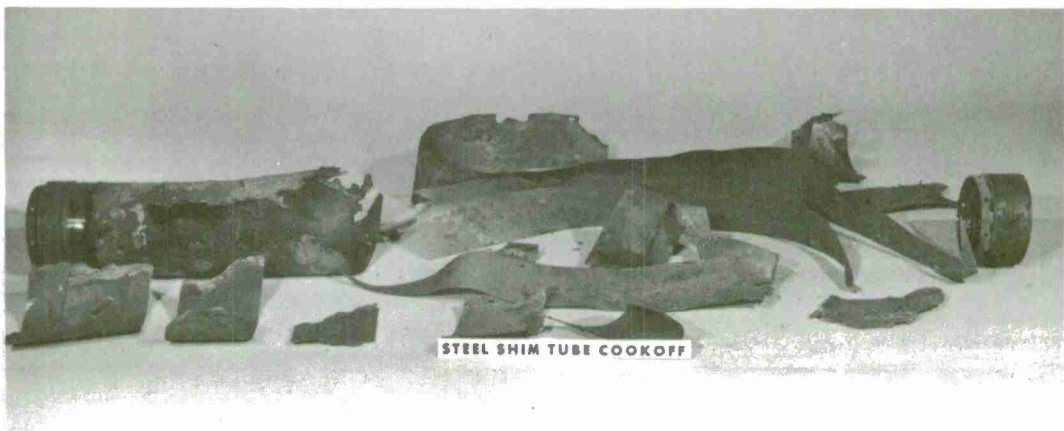
FIGURE 21. Remains of Laminated Steel Spiral Wrapped Tube Cook-Off Test No. 1 (LHL 192362).

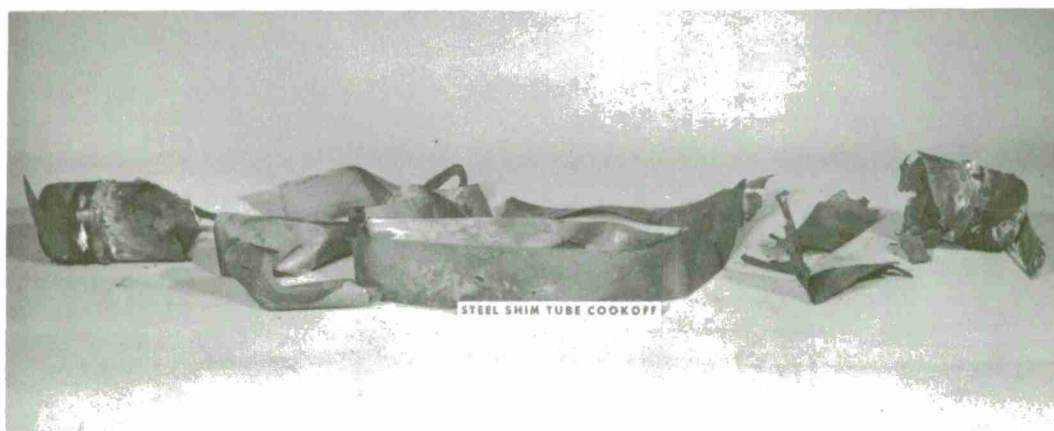
FIGURE 25. Remains of Laminated Steel Spiral Wrapped Tube Cook-Off Test No. 2 (LHL 192361).

In summary, a very mild burning reaction was obtained from this steel shim wrapped motor. This was due to the fire having softened and ignited the adhesive which, in turn, led to pressure vessel integrity disintegration prior to propellant ignition. Strong consideration should be given to using this type of construction for all rocket motors and perhaps bombs and warheads as well. Reduced damage and hazard in fire environments would be expected from using this type construction.

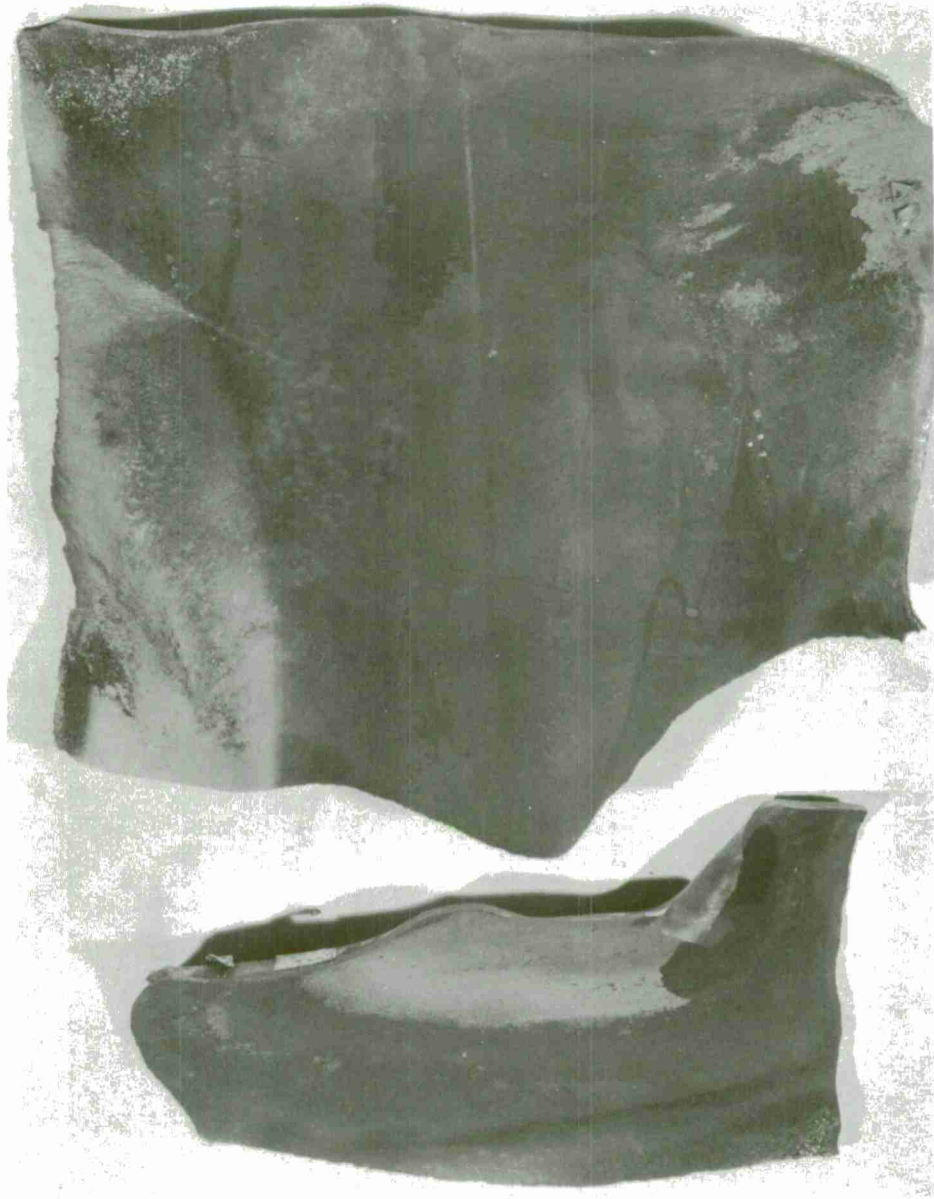
FIGURE 31. Test Section Case Well Ejecta (LHL 192377).

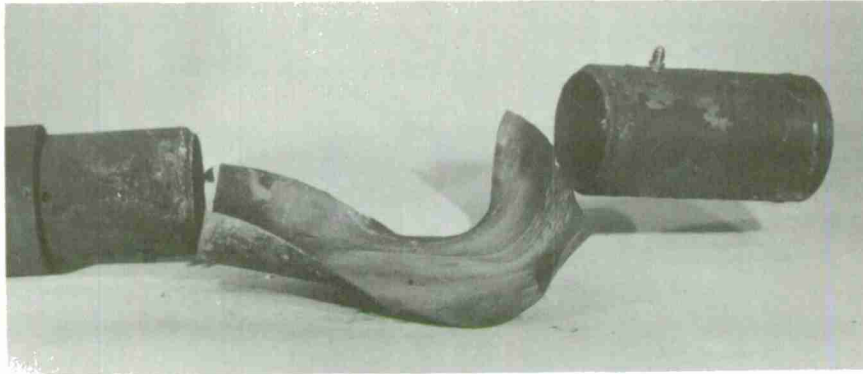
A steel model motor lined with thin painted coatings of SD-723 polyether polyurethane and then HTPB-based liner and cast with low smoke HTPB propellant was "cooked" over the propane burners. Figure 35 is a post-test photograph showing the split along the entire bottom of the test item. A small area of the metal was stretched (thinned) at the initial failure site. The rupture occurred at 73 seconds with bottom forward case/liner pressure exceeding 3.4 MPa (500 psig) just prior to the bore reaching 3.25 MPa (472 psig). At 72 seconds, a higher rate of pressure rise started and was postulated as due to a small area of propellant igniting with a much higher rate of gas production. The bore was collapsed by this external pressure on the propellant cylinder which continued until the case ruptured. This round-bore test item is not typical of rocket motors in the sense that there is no stress concentration upon bore collapse such as that involved with a typical star-shaped grain perforation. This means that the model motor has mechanical strength failure modes that are different from a tactical rocket: (1) stronger intrinsic grain as elaborated, (2) excellent fore and aft sealing on the grain OD, and (3) a solid closure rather than a weather seal closure in the nozzle. The nozzle closure will normally fail at a nominal bore pressure of perhaps 1.2 MPa (200 psi) and thus reduce the grain support by removing the internal bore pressure. This means that some tactical motors would react more violently than the

FIGURE 35. Dual-Lined Extended Model Motor Case After Cook-Off Test (RV-7 Propellant)(LHL193542).

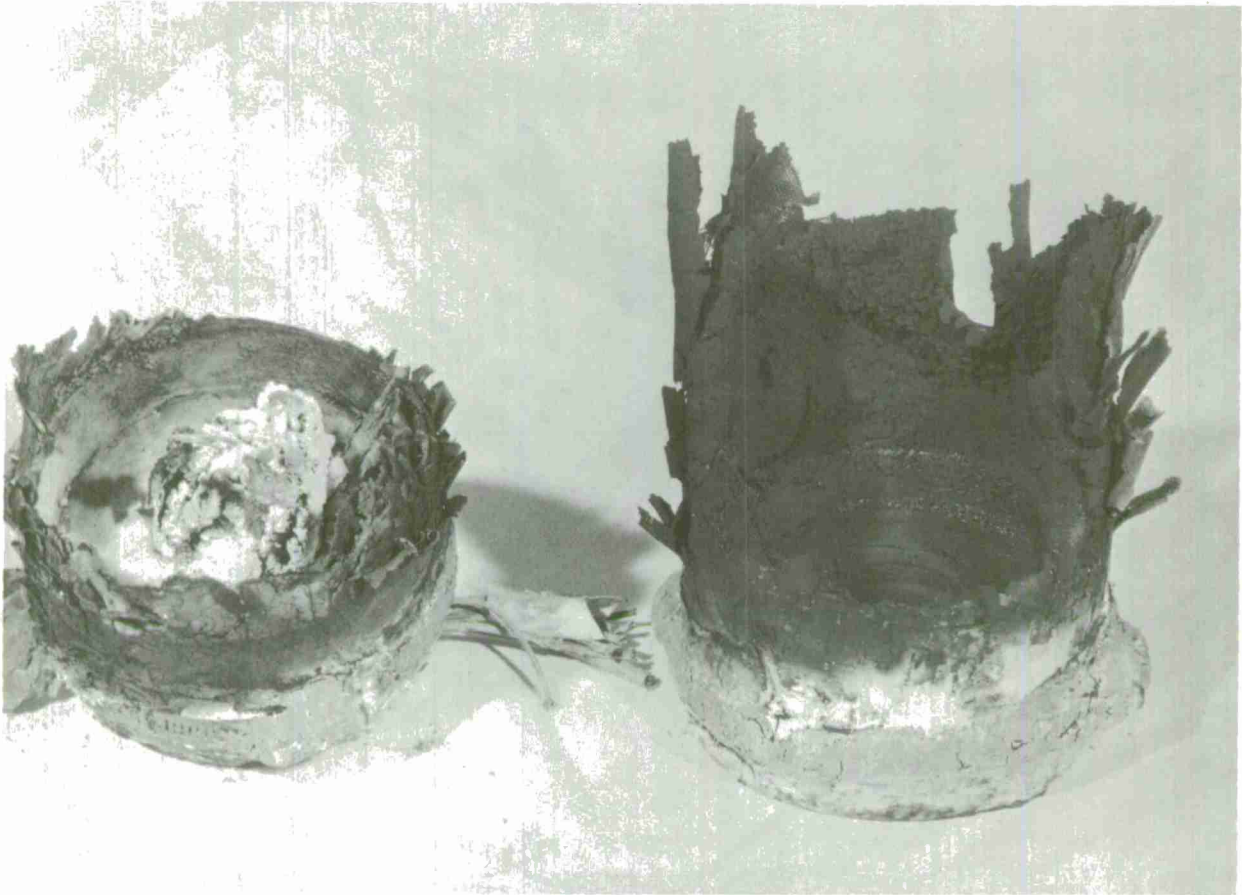
FIGURE 38. Post-Test Remains of Kevlar-Cloth-Reinforced Plastic Motor Tube (LHL 193541).
