MODEL XB-36

REPORT DEVF 275-551

STRINGER AND SKIN SPLICE TESTS XB-36 OUTER WING.

LOWER SURFACE

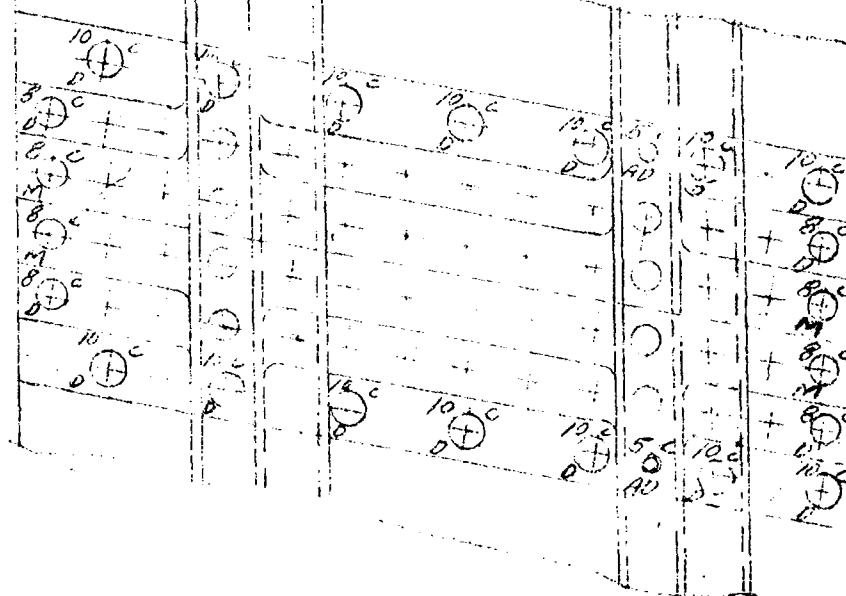
SPLICE RIVET DIAGRAM SPEC. 551-2

At high loads a definite "rocking" motion of the splice rivets permitted the skin to slip. This condition, while relieving the skin, allowed an increasing amount of the load to pass to the stringer. Ultimate failure, however, was caused by a complete transfer of load to the stringer, following a shear failure of the splice rivets.

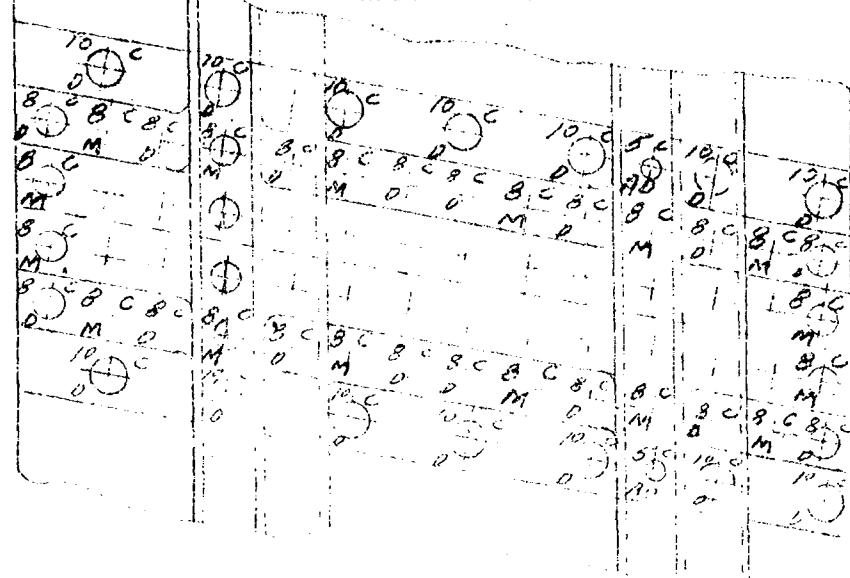
SPLICE RIVET DIAGRAM SPEC. 551-3

Specimen 551-3 was able to accept a greater load than Specimen 551-2 because of the increased number of monel rivets at the splice. By replacing twelve (12) of the 1/4 in. diameter 17ST rivets with 1/4 in. diameter monel rivets, the slipping effect of the skin was retarded, thus enabling the skin to carry more load than it did in Specimen 551-2. In this Specimen, failure of the skin was accompanied (followed) by the tension failure of the skin, the monel rivets holding though severely deformed.

Inasmuch as Specimen 551-2 failed after holding 100% design load for only two minutes, it was found necessary to replace some of the 1/4 in. diameter 17ST rivets with 1/4 in. diameter monel rivets in the splice of Specimen 551-3 so as to reduce the rocking effect of the rivets and the slippage of the skin. Specimen 551-3 was warranted in preference to Specimen 551-2 because it failed at 112% design load.

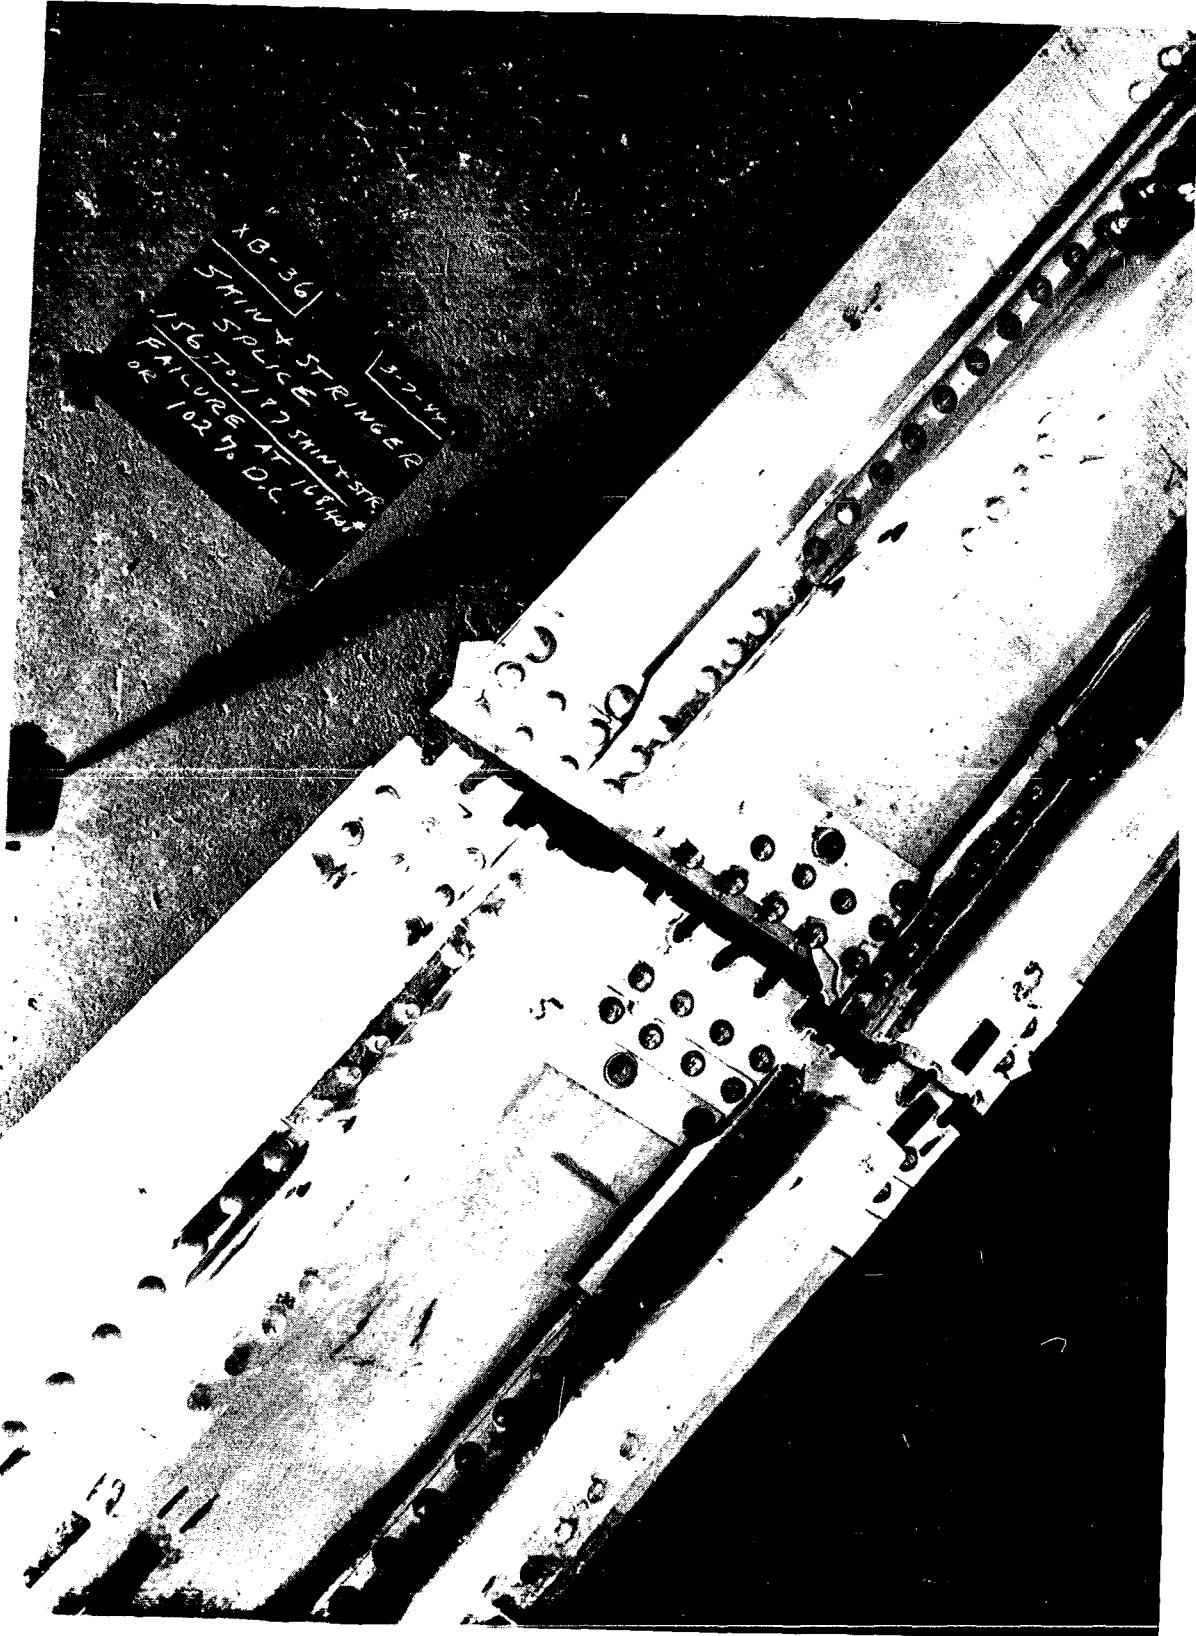
PHOTOGRAPH NO. 114369

Specimen	Design Load	Ultimate Load	Failure at % D. L.	Description of Failure
551-1	164,800	168,400	102%	Specimen failed in tension at splice (See Photo. #314369, Page 18, and #114387, Page 19).
551-2	131,500	131,500	100%	One of the Zee section stringers failed in tension at splice (See Photo. #114246, Page 22), and splice rivets failed in shear (See Photo. #114243, Page 23). Ultimate load maintained for approximately two minutes before failure.
551-3	131,500	147,800	112%	(See Sketch, Page 9) In this specimen stringers and skin failed in tension (See Photo. #114256, Page 24, and #114257, Page 25).
551-4	55,300	60,800	114%	The stringer failed in tension at splice. The skin failed in tension at section where holes were drilled simulating the effect of a rib (See Photo. #114260, Page 26, and Photo. #114261, Page 27).
551-5	30,700	35,200	115%	Skin and stringer failed in tension at stringer splice (See Photo. #114203, Page 28, and Photo. #114202, Page 29). Note that failure of skin did not occur at the section where holes were drilled so as to simulate effect of rib.

FRONT VIEW OF FAILURE (SPECIMEN 551-1)

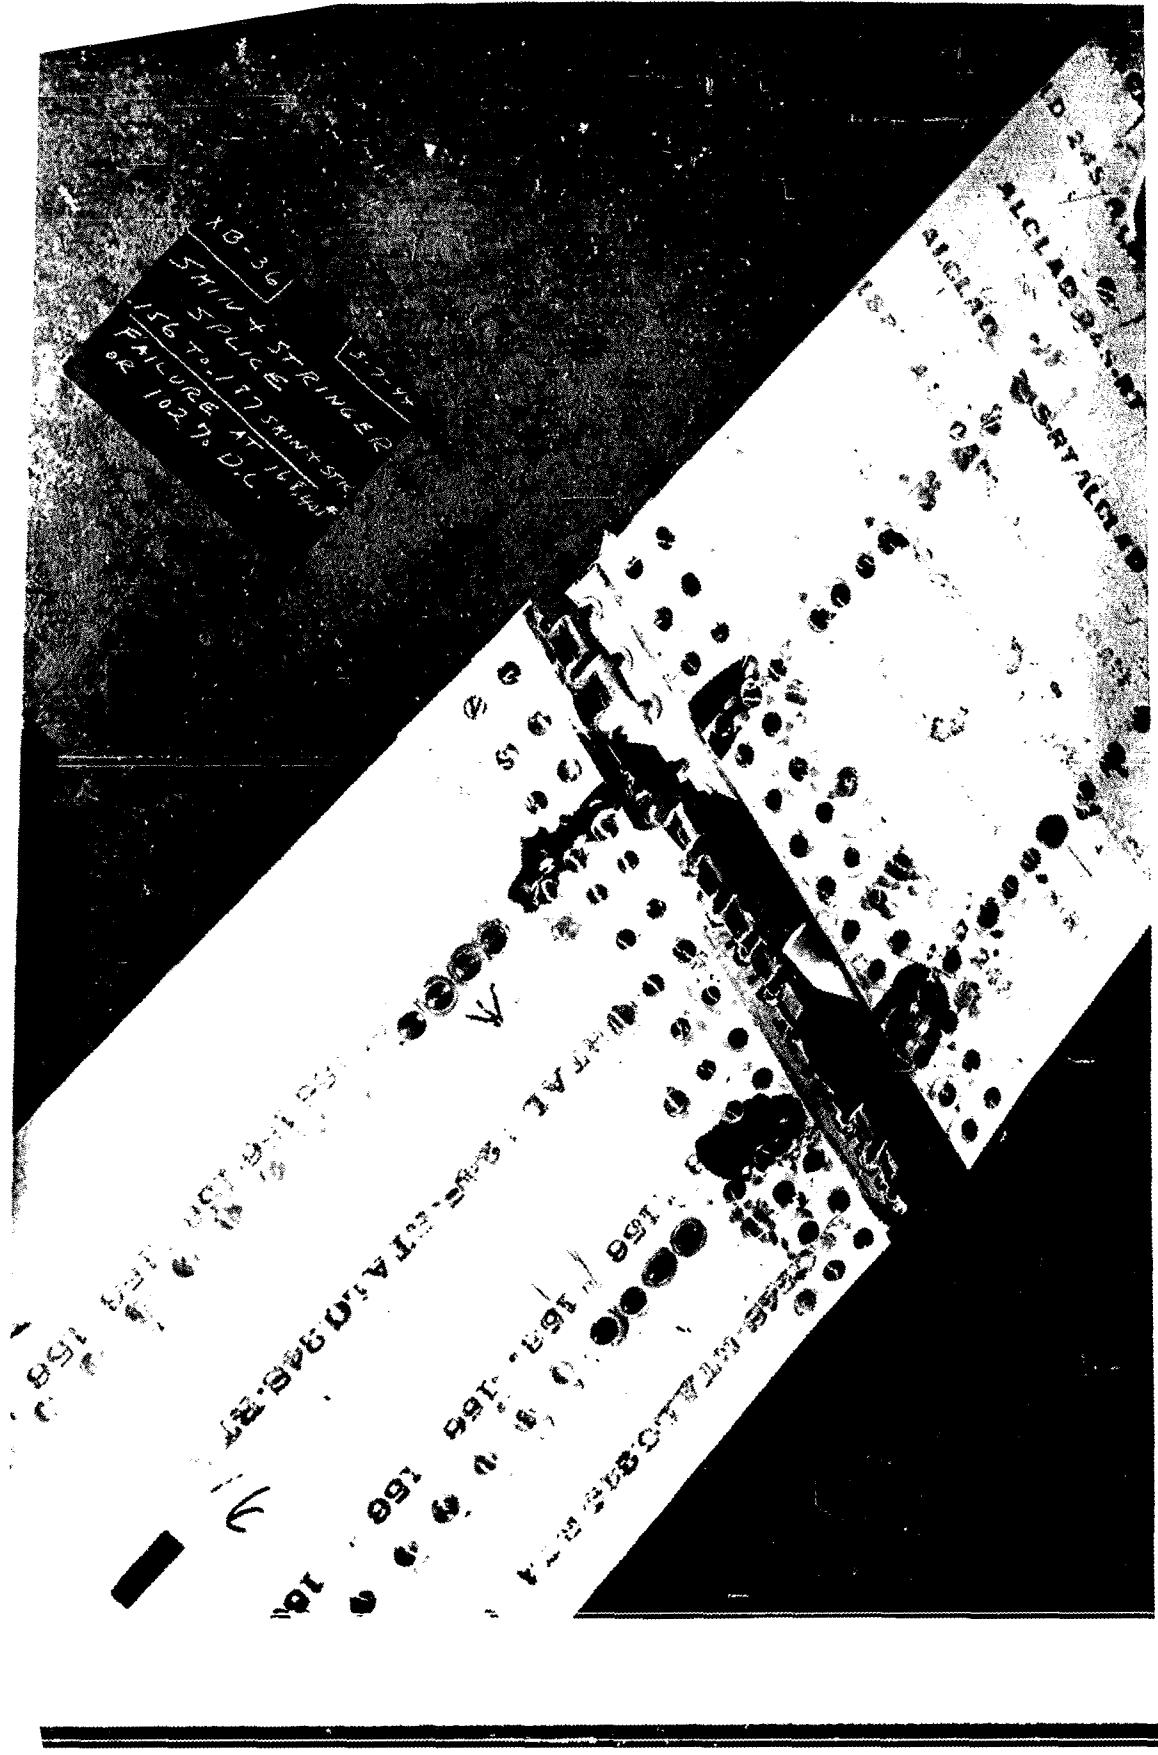
PHOTOGRAPH NO. 114367

REAR VIEW OF FAILURE (SPECIMEN 551-1)

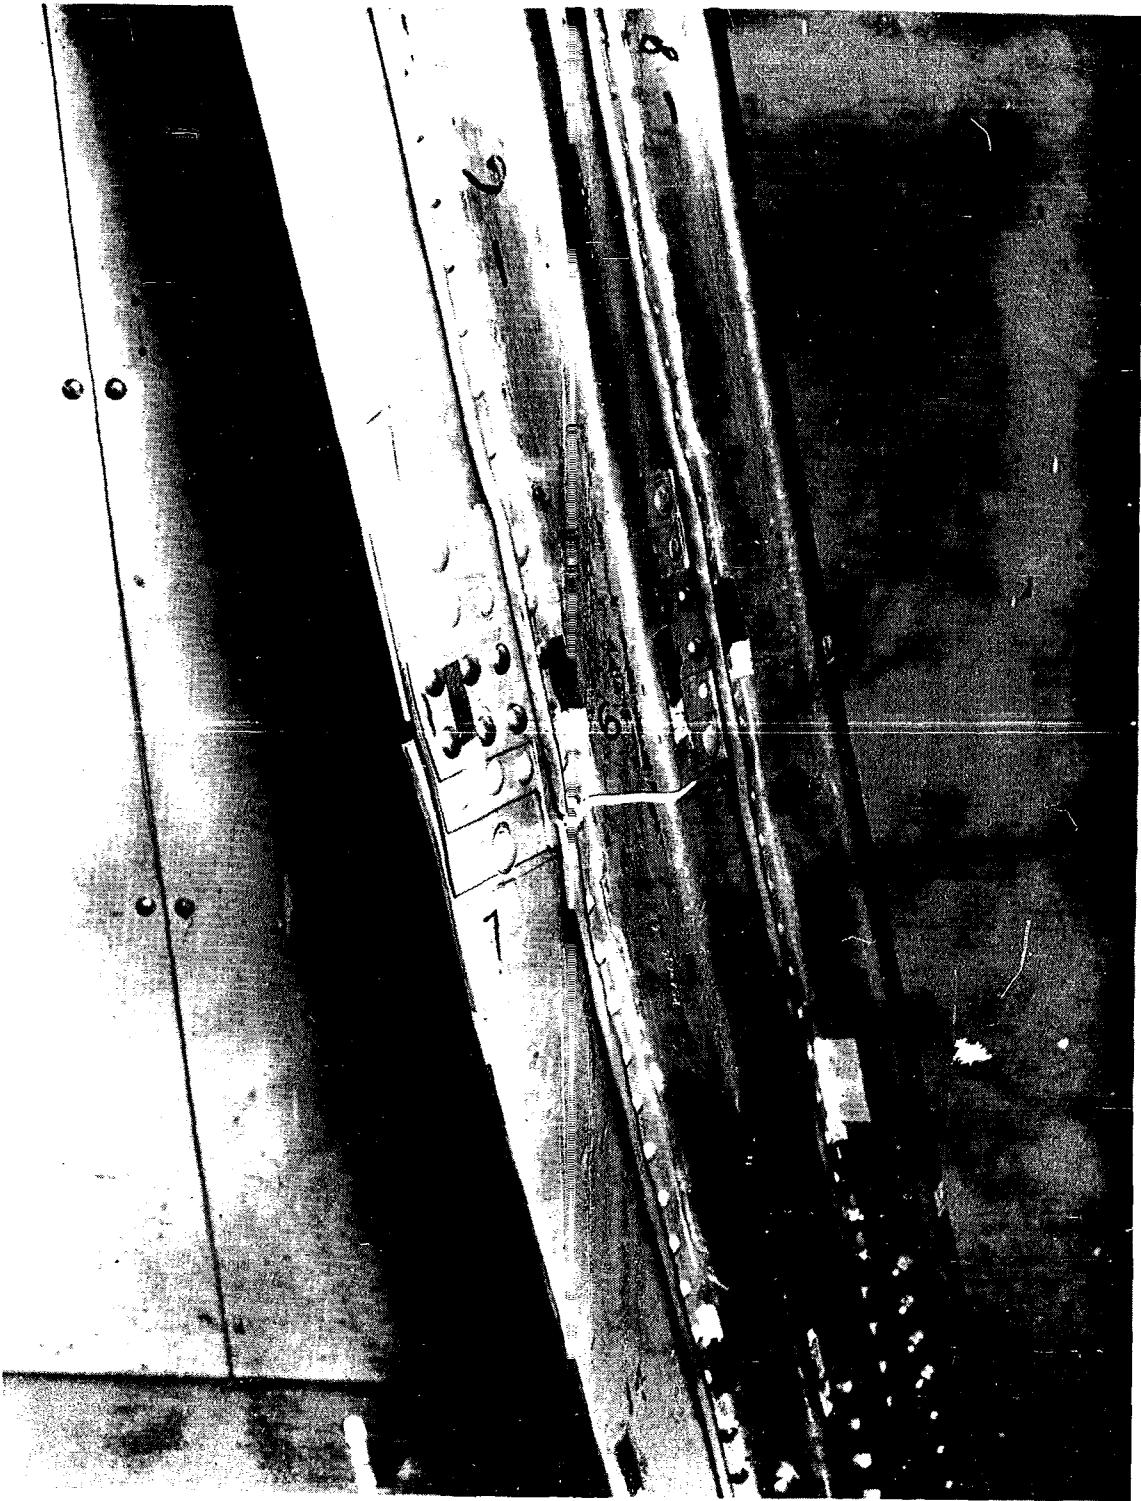
PHOTOGRAPH NO. 114346

Eccentric loading of the skin and doublers at the splice was noted in Specimens 551-1, 551-2 and 551-3. Strain gages #1, 4 and 7 on doublers read compression during the entire loading. (See Photographs No. 114364, Page 17, and No. 114246, Page 22.)

FRONT AND SIDE VIEW OF SKIN SPLITS (SPECIMEN SHOWS STRENGTH
FAILURE AND BENDING OF SKIN AND JOINTS)

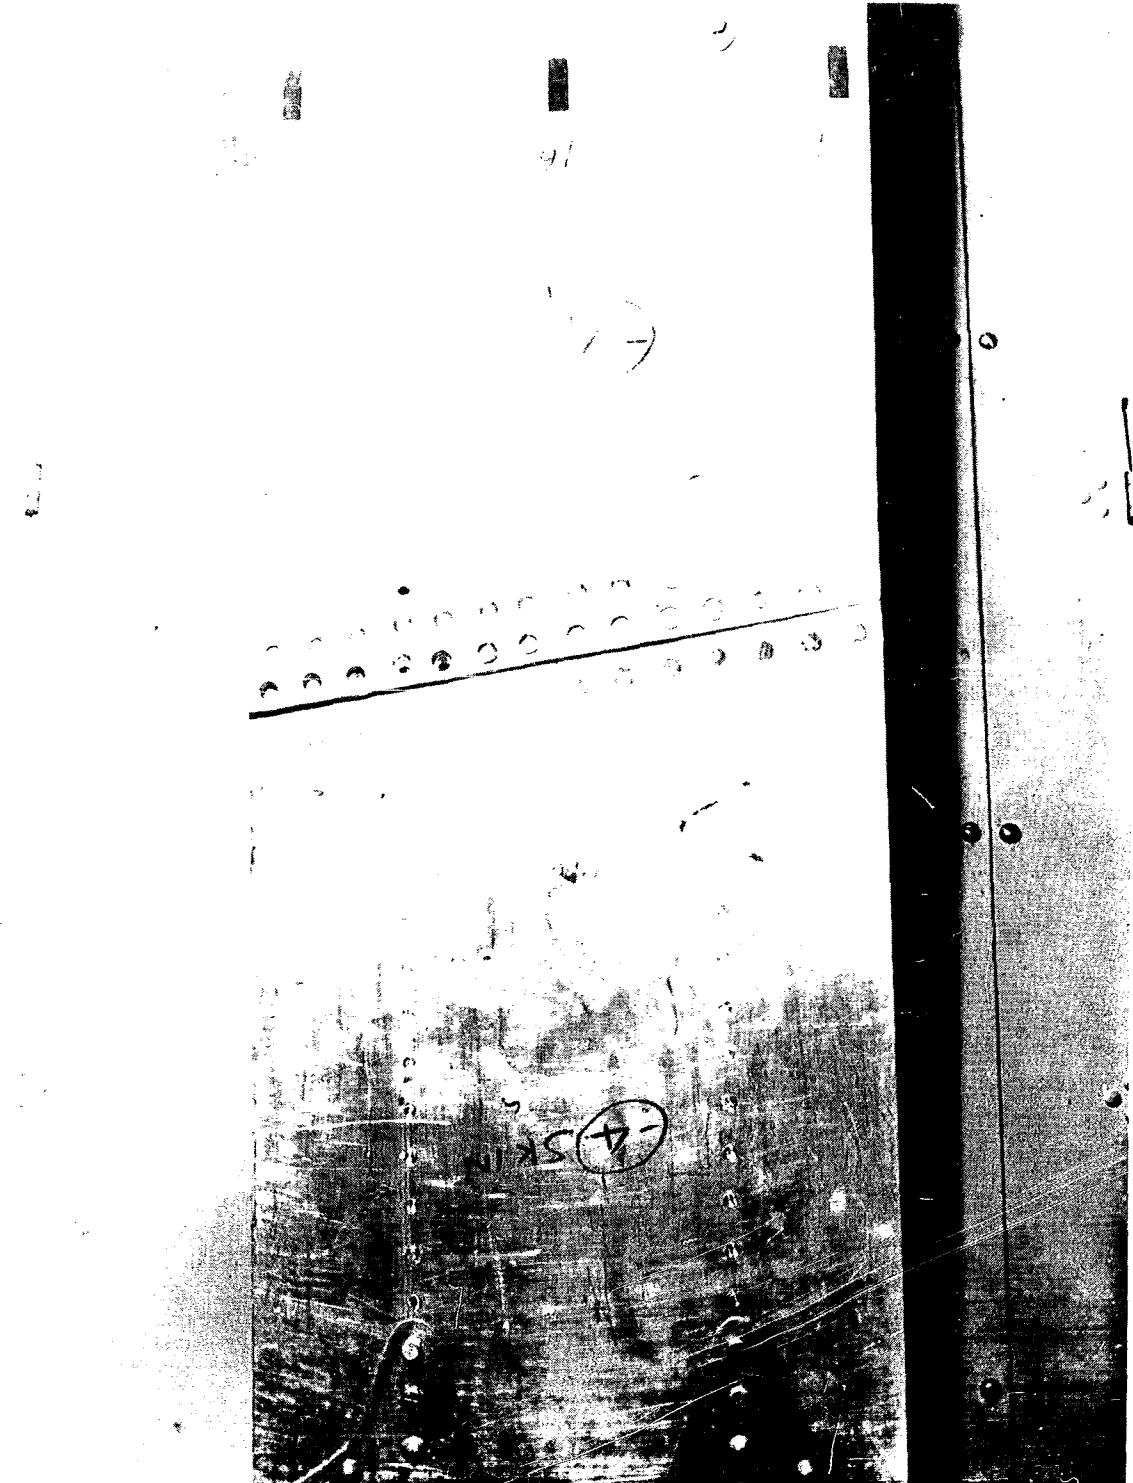
PHOTOGRAPH NO. 114243

REAR VIEW OF SKIN SPLICE SPECIMEN (551-2) SHOWING
FAILURE OF SPLICE RIVETS

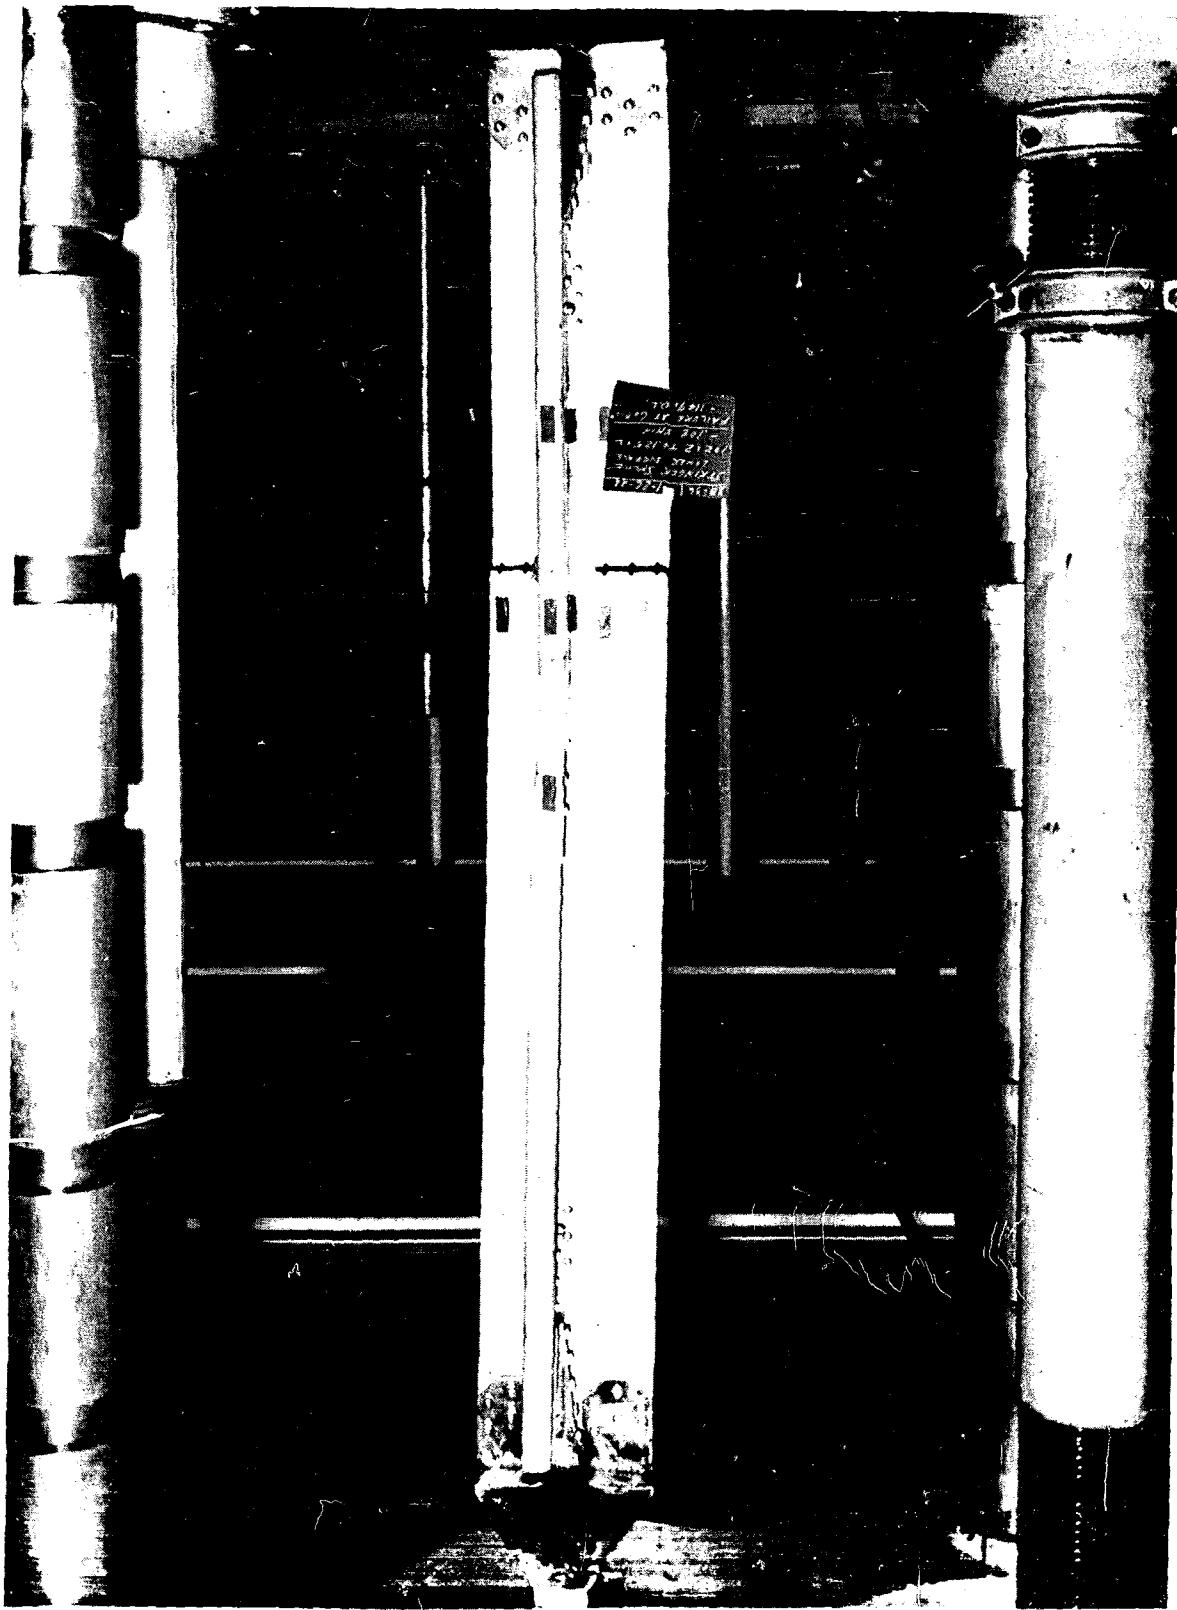
PHOTOGRAPH NO. 114200

FRONT VIEW OF STRINGER SPLICE (SPECIMEN 551-4)

IN TEST MACHINE SHOWING FAILURE

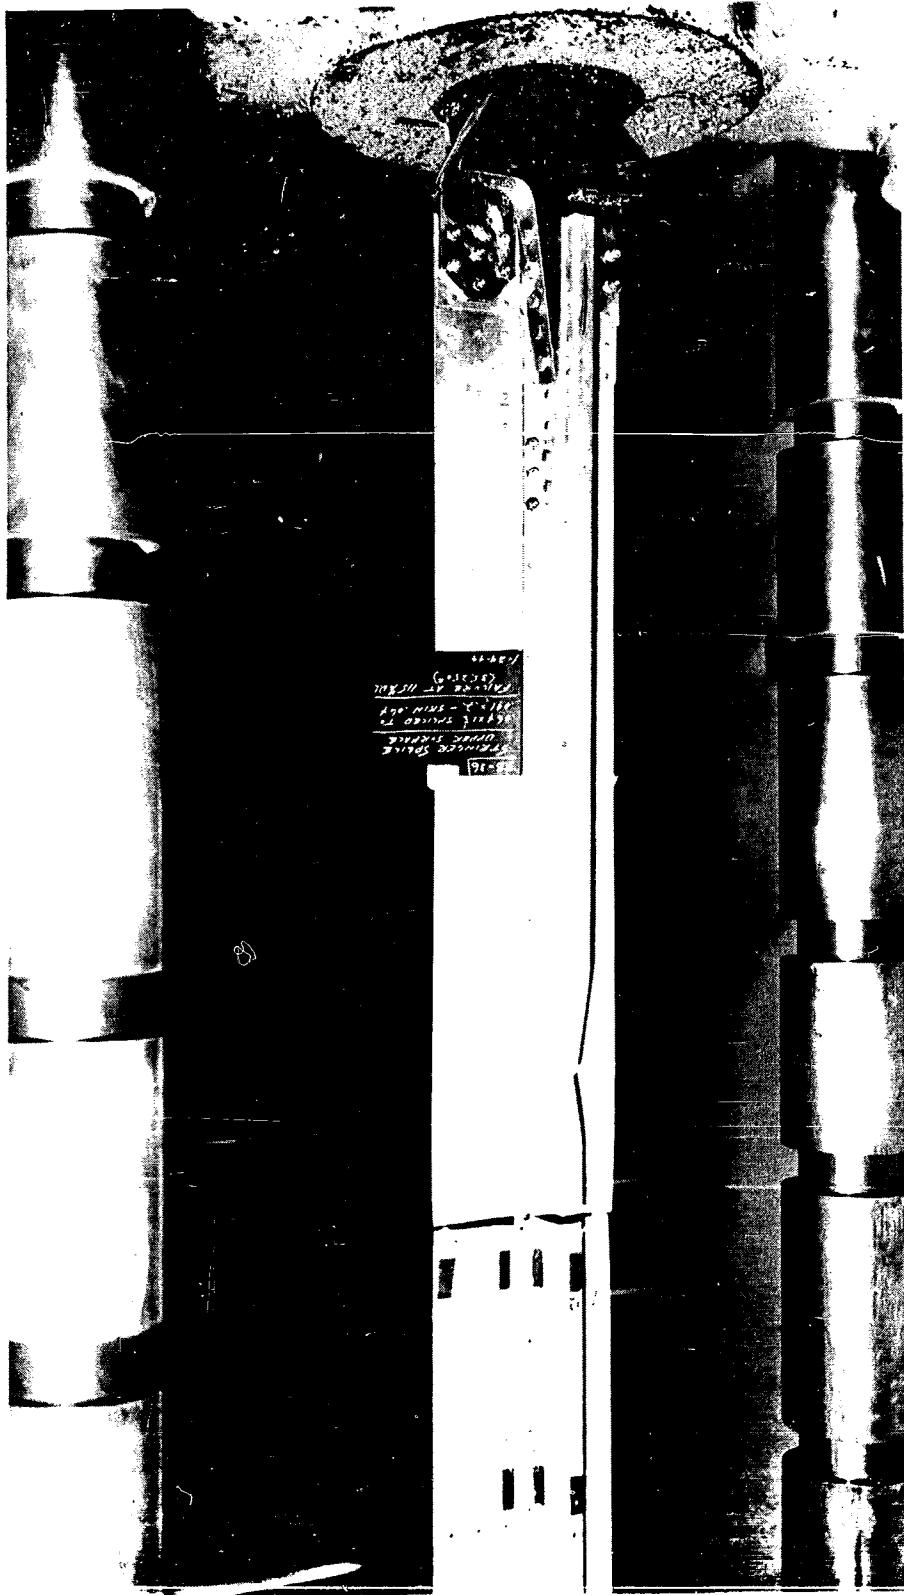
PHOTOGRAPH NO. 114201

CLOSEUP SHOWING FRONT AND SIDE VIEW OF STRINGER SPLICE.
(SPECIMEN 551-4) FAILURE

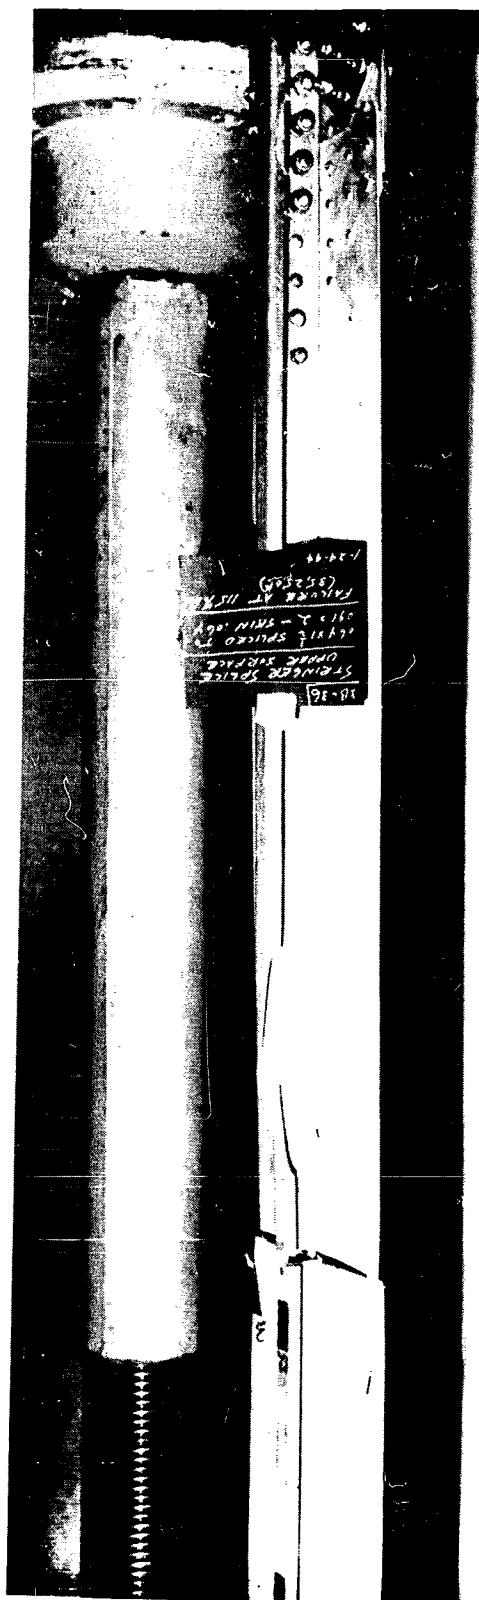
PHOTOGRAPH NO. 114202

SIDE AND FRONT VIEW OF STRINGER SPLICE (SPECIMEN 551-5) SHOWING
FAILURE
