COMPARISON OF BULLET RESISTANCE OF NEW AND AGED POLY-CARBONATE

J.B.R. Heath, R.W. Gould, E.B. Stimson
National Aeronautical Establishment
National Research Council of Canada
Ottawa, Canada, K1A 0R6

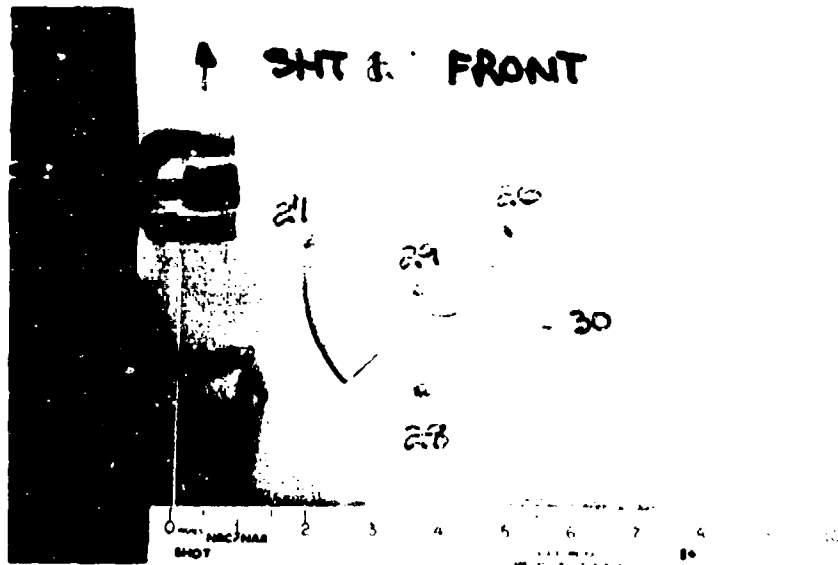
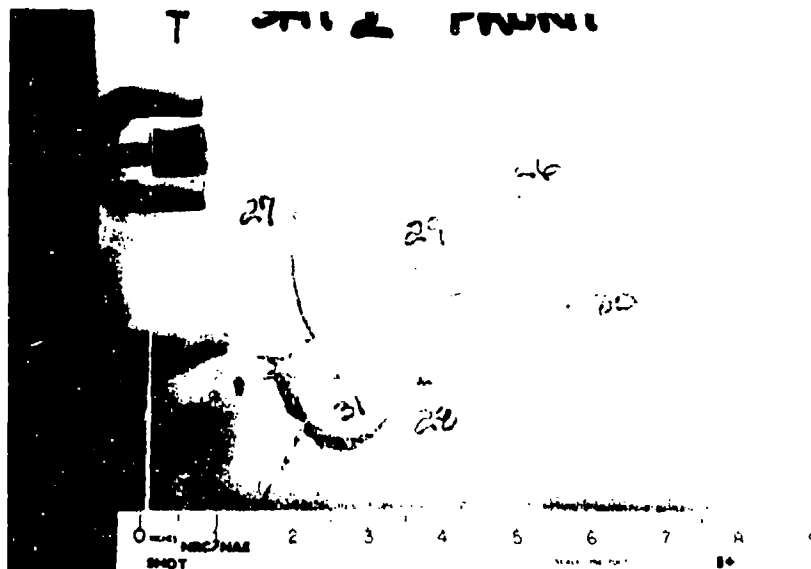
FIG. 24 TESTS 26 TO 31 - PANEL P1 - PART II

Results of tests 26 to 31 inclusive showed that the outer panel can withstand four impacts approximately 1½ inches apart, but on the fifth, fractures began to initiate from previous damage. Eventually after six impacts the outer panel suffered major damage rendering the set-up non resistant to additional impacts. Figure 24 shows panel 1 after the fifth and sixth impacts. The results from Tests 32 to 35 and Tests 36 to 39 showed fracturing of the outer panel occurring on the third impact with spacing approximately 2-3/4 inches (Figs. 25 and 26). It would be unlikely that an additional impact without bullet penetration of both panels could be carried out.

(a) DAMAGE AS A RESULT OF TEST 30

(b) DAMAGE AS A RESULT OF TEST 31

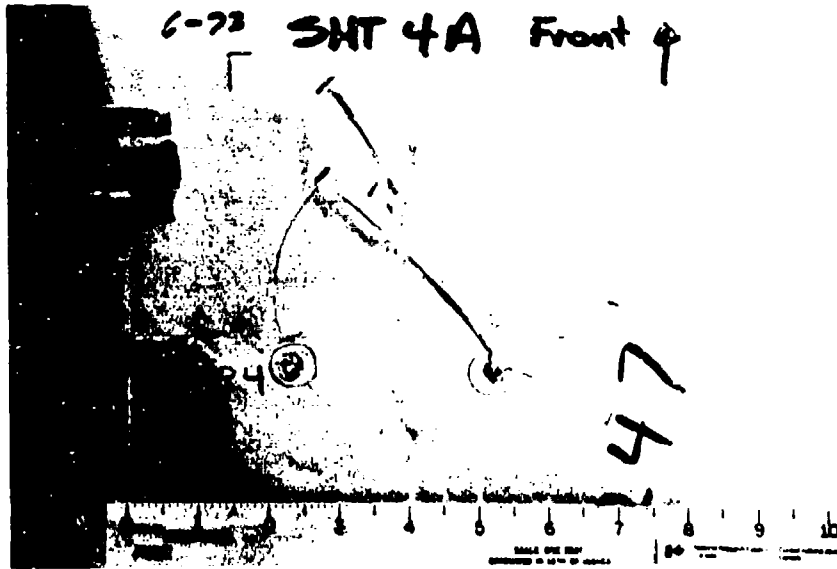
FIG. 28 TESTS 23 TO 25 - PANEL P1 - PART II

In tests 23 to 25, with impact spacing similar to that on new material 8 x 8 panels, fracturing occurred in the naturally aged (8 year) material on the second impact, with major damage occurring on the third as shown in Figures 28 and 29. As a result of the damage from the third impact, a fourth would obviously result in bullet penetration of both panels. The aged panels suffered major damage on the third impact compared to the new material, where major damage occurred on the fourth impact in two cases and on the sixth in one case.

Signs of material degradation occurred with the 8 year old 8 x 8 panels (Tests 23, 24 and 25). Fracturing of the outer panel resulted on the second impact, while with the new material 8 x 8 panels the outer panel did not fracture until the third impact in two cases and on the fifth impact in one case.

(a) DAMAGE AS A RESULT OF TEST 24

(b) DAMAGE AS A RESULT OF TEST 25

Obviously more work should be undertaken with naturally aged material, preferably with 12 x 12 panels to minimize possible panel size effects.

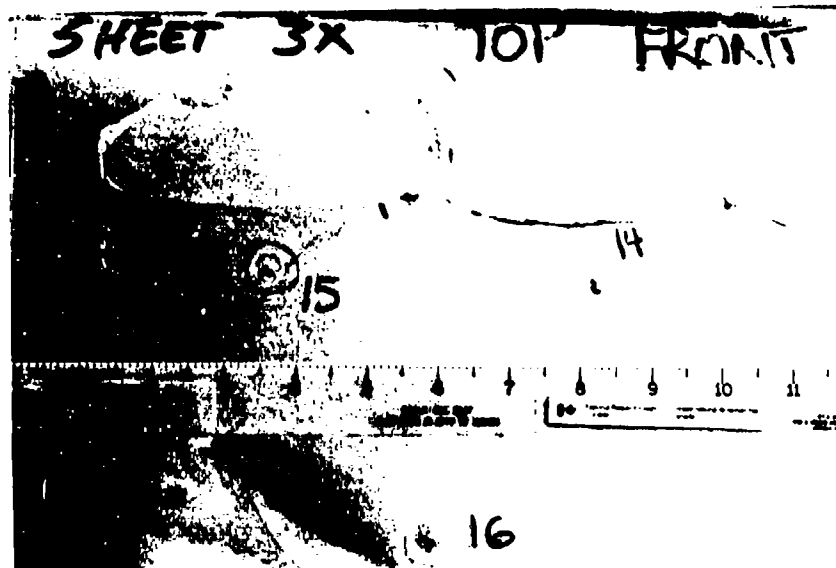
FIG. 31 TESTS 14 TO 16 - PANEL P1 - PART II

The results of the impacts carried out on these panels were very inconsistent. New material that had been heat aged six months prior to the ballistic tests suffered major damage after just one or two impacts. In Test 3 a large section of panel 2 separated as a result of the single impact. The damage is shown in Figure 30. Fracturing occurred in panel 1 (Test 14, 15 and 16) on the second impact and major damage occurred on the third (Test 16) as shown in Figure 3.

The results from the tests carried out on this material were inconsistent. Material that had been heat aged six months prior to ballistic testing showed degradation as major damage occurred to test panels on only the first or second impact (Tests 14, 15 and 16). However, material that had been heat aged days prior to testing showed no signs of degradation (Tests 40 to 49). This material should be tested at some future date to see if degradation continues after the heat aging process.

(a) DAMAGE AS A RESULT OF TEST 15

(b) DAMAGE AS A RESULT OF TEST 16
