# AN INVESTIGATION OF ELECTRODEPOSITED ALLOYS FOR PROTECTION OF STEEL AIRCRAFT PARTS

### AF TECHNICAL REPORT 5692 SUPPLEMENT 4

Battelle Memorial Institute

July 1953

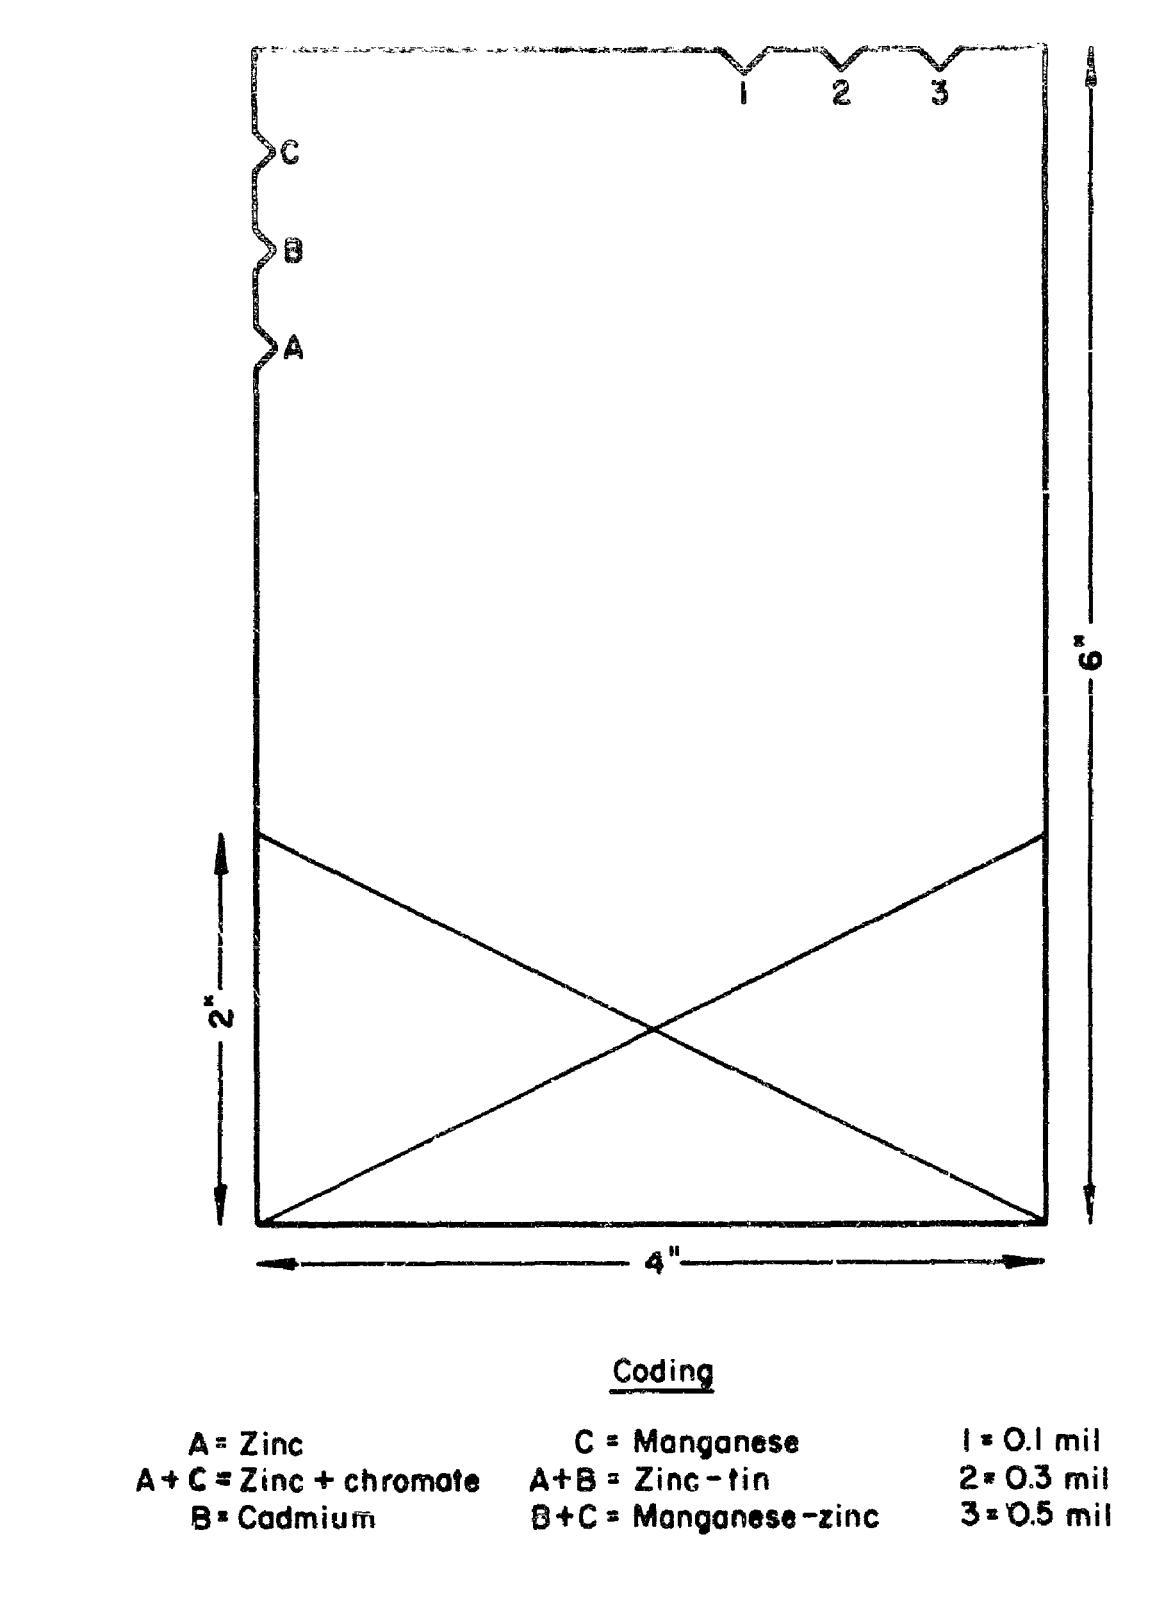
FIGURE 3. SCALE DRAWING OF TEST PANEL SHOWING CODING SCHEME FOR IDENTIFICATION AND LOCATION OF DIAGONAL SCRATCHES

Identification of the type of coating and thickness was made on each panel by a series of V notches cut in the edge of the panel prior to plating. The code used is explained in Figure 3. The observer is looking at the top (side which faced the sky during the test) when the coating code notches are at the upper left and the thickness code notches are at the upper right. Figure 3 also shows the position of the scratches or scribe marks. The latter were made after the panels were plated. They were cut accurately on a milling machine to a width of 0,006 inch and a depth sufficient to expose the underlying steel. The milling was facilitated by use of a specially prepared jig. The diagonal cuts were made on each side of each panel.
