HEADQUARTERS AIR PROVING GROUND COMMAND Eglin Air Force Base, Florida

> FINAL REPORT ON OPERATIONAL SUITABILITY TEST OF THE RB-57A AIECRAFT

PROJECT NO. APG/TAS/122-AB

20 April 1955

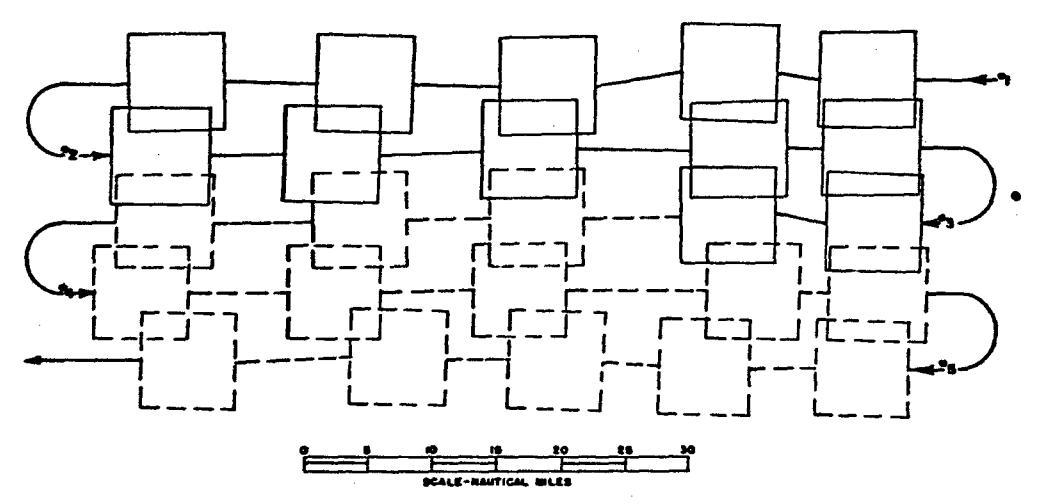
UNCONTROLLED _____ EGLIN RESERVATION T-II CAMERA 6" F/L _____ ALTITUDE 30,000 FT 24 SEPT 1954 _____ PHOTO SCALE 1:60,000 FLIGHT LINE CONTROL: APW-IIA WITH APA-90 & MSO-1

BROXEN LINES INDICATE PROBABLE PHOTO COVERAGE ONLY. CAMERA MALFUNCTION OCCURRED ON FLIGHT LINE *3. PHOTO POSITIONS (BROKEN LINES) BASED ON MSQ-1 GROUND CONTROLLER'S OVERLAY OF FLIGHT PATH OF AIRCRAFT.

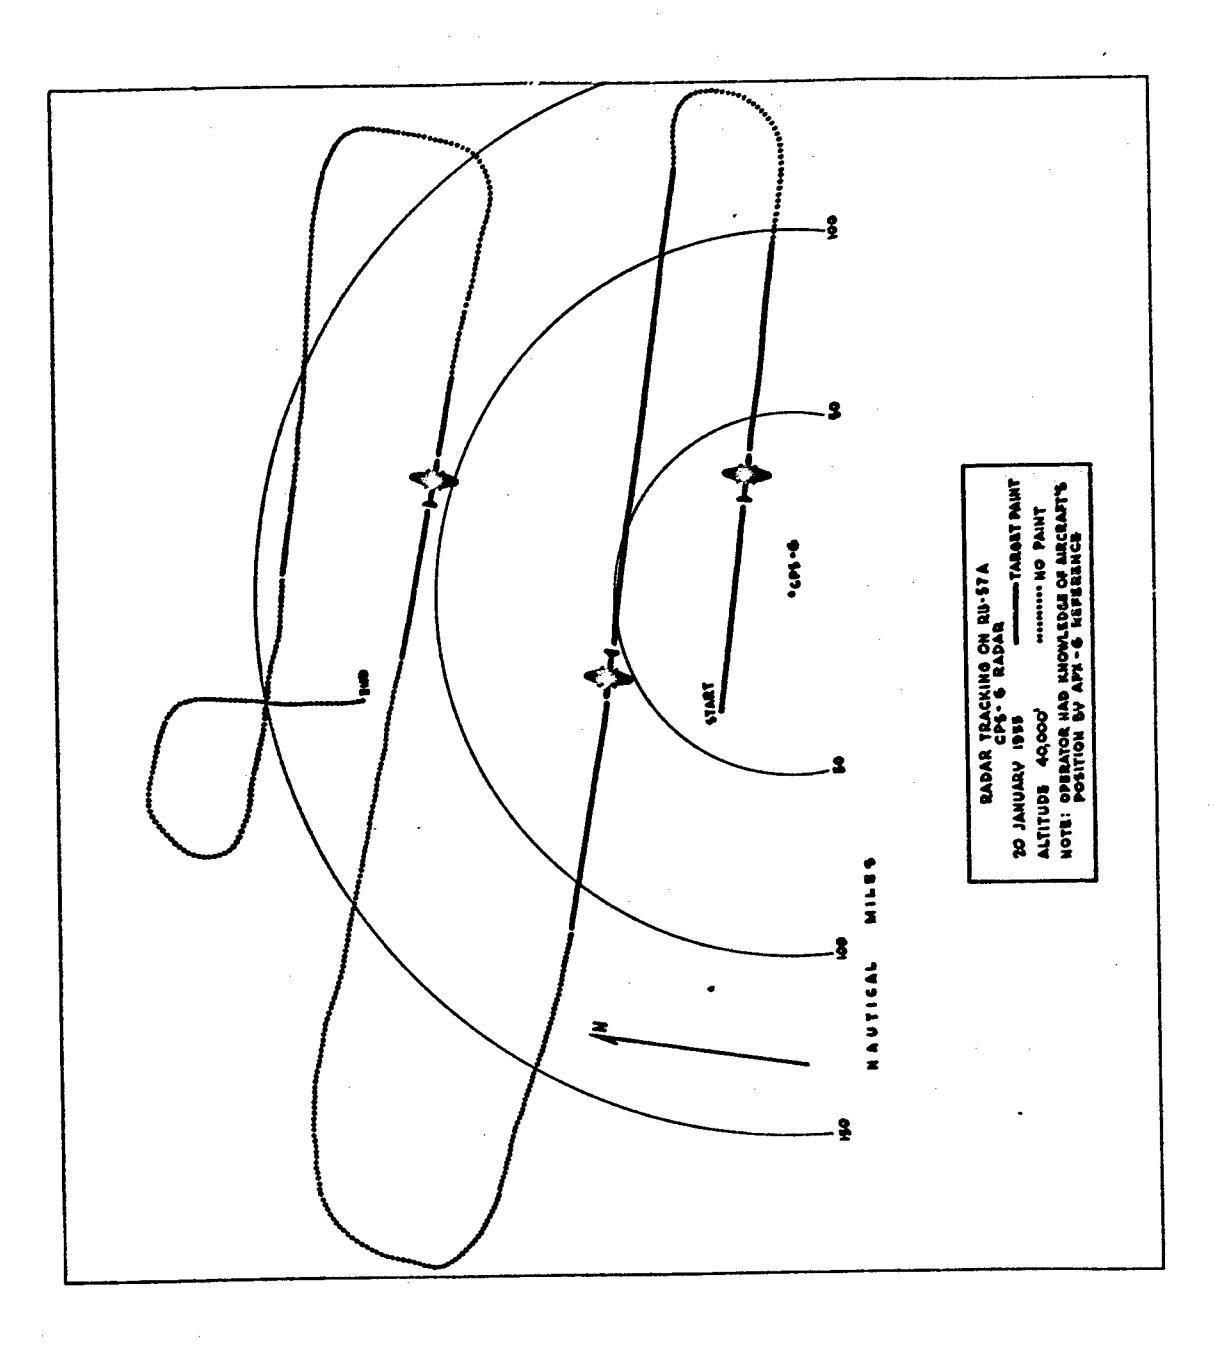
Figure No. 28. CPS-6 Radar Tracking RB-57A (40,000 feet) Appendix D, Page 33 70 SECRET

- (2) The results of these flights are presented in Figure Nos. 25, 26, 27, 28, 29, and 30. It should be understood that these results were derived under ideal conditions for the radar operator, in that he could refer to the position of the test aircraft by its APX-6 beacon response which limited his area of search for a skin paint to approximately 1/4 square inch, and therefore would know where to search for skin paint conditions. However, this does not lessen the validity of the results, but provides the best possible detection conditions. (S)

- (3) Upon study of the radar tracking illustrations (Figure Nos. 25 through 30), consideration should be given the following:

- (a) The aspect of the aircraft in relation to the ground radar station
- (b) The altitude of the test aircraft
- (c) The detection ranges
- (d) The type of ground radar equipment used. The CPS-6 radar corresponds to the "Token" radar of the USSR. (S)
