MISCELLANEOUS PAPER S-69-13

EVALUATION OF HARVEY ELECTRON BEAM WELDED AM2 LANDING MAT (AM2 MOD 2)

April 1969

U. S. Army Engineer Waterways Experiment Station CORPS OF ENGINEERS

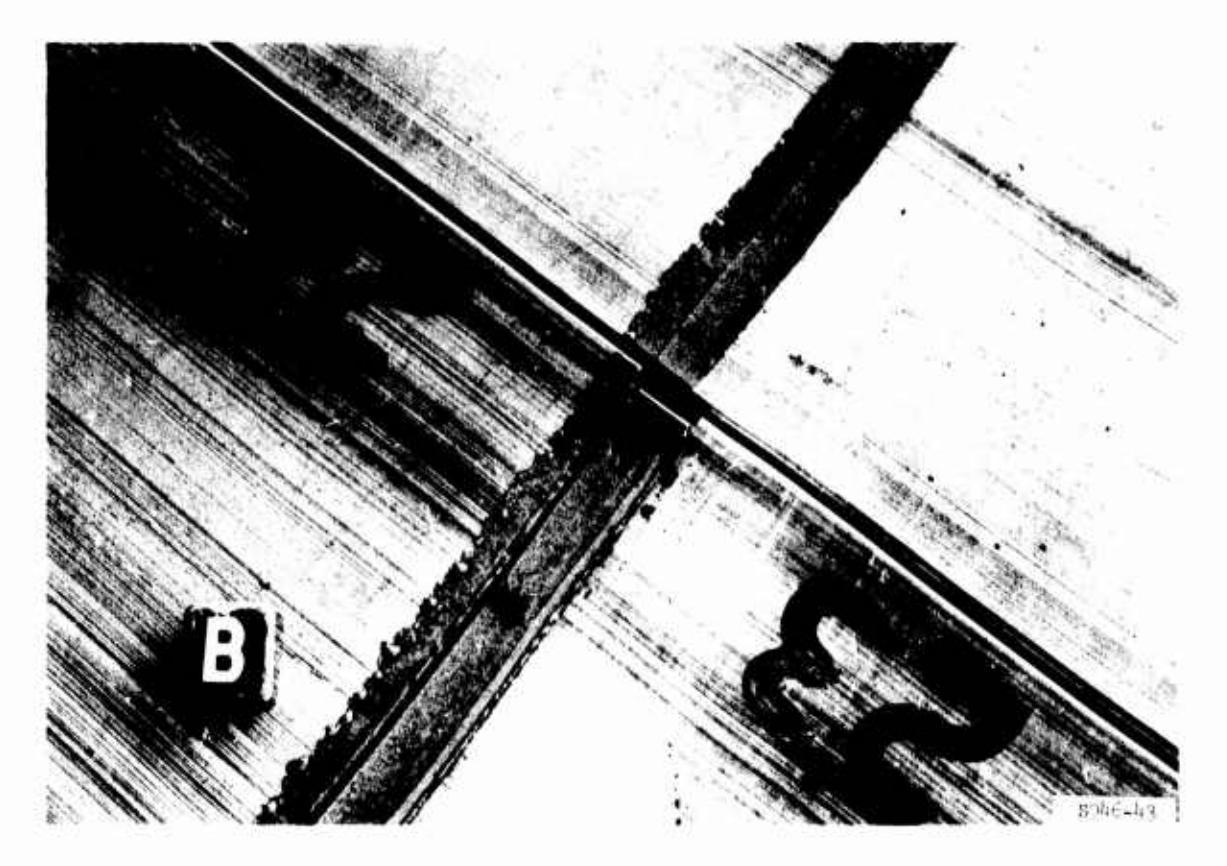
18. A general view of the test section prior to traffic is shown in photograph 1. Mat breakage was first noted at 10 coverages, with hairline weld cracks developing along the underlapping end connector at the C-rail corner. At 40 coverages, eight planks were damaged in this manner, and the length of the cracks averaged about 5/8 in. Weld cracks had also developed in the same location along the overlapping end connector in five planks and averaged about 3/8 in. in length. The weld cracks progressed very little after 40 coverages, and at 188 coverages had increased to about 3/4 in. in length. Curling of the overlapping end-connector corner was observed in six planks, but neither the weld cracks nor the curling was considered a hazard to aircraft operations. A view of typical curl and weld cracks at 188 coverages is shown in photograph 2. The mat in the traffic lane was considered in good condition at 188 coverages (photograph 3).

Photograph 2. Corner curl and weld cracks along overlapping and underlapping end connectors

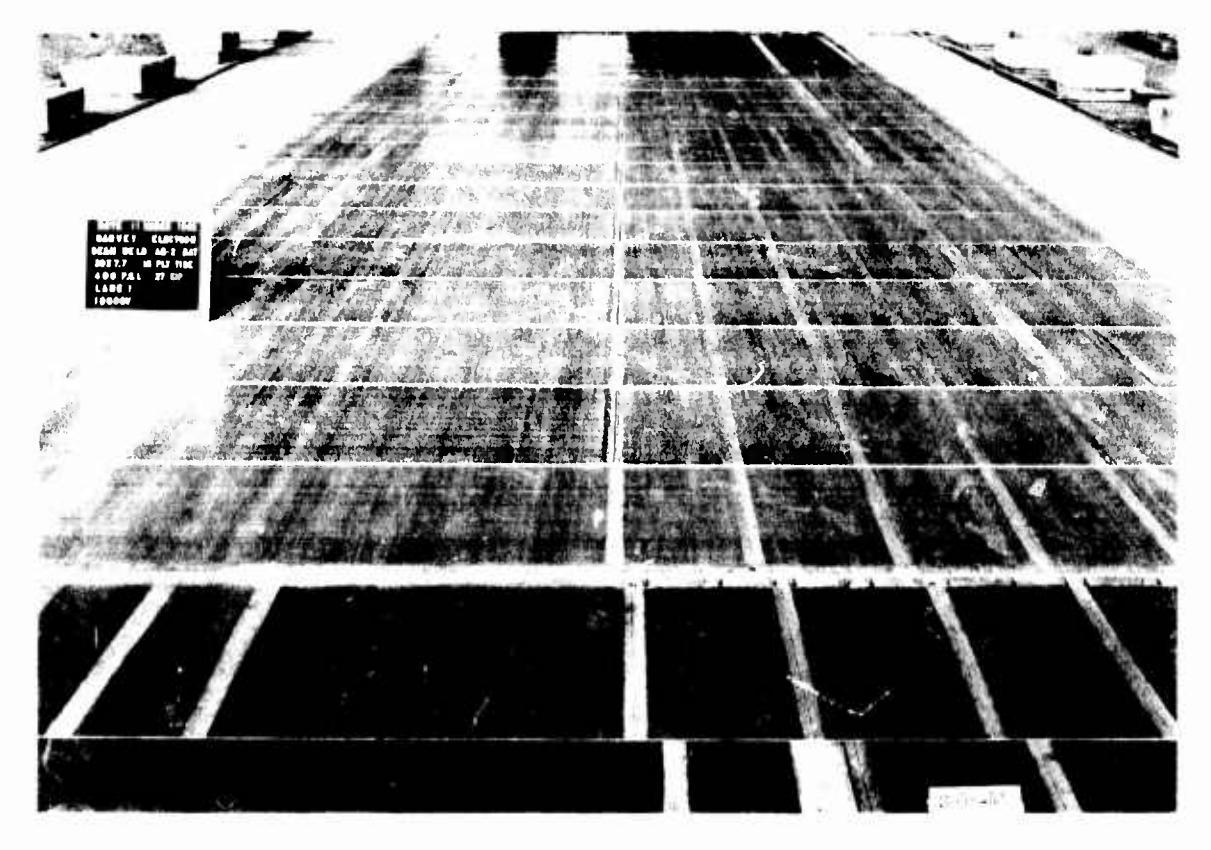
25. The test section performed satisfactorily through 188 coverages and met the service criterion outlined in paragraph 2. Although several planks had developed small hairline weld cracks and some curling of plank corners was noted, the condition of the test section was not considered a hazard to aircraft operations at this time. Traffic was continued to determine the number of coverages required to fail the test section. After 346 coverages had been completed, the test section was considered failed due to internal rib failures and excessive breakage of the top skin.

Photograph 3. Test section after 188 coverages

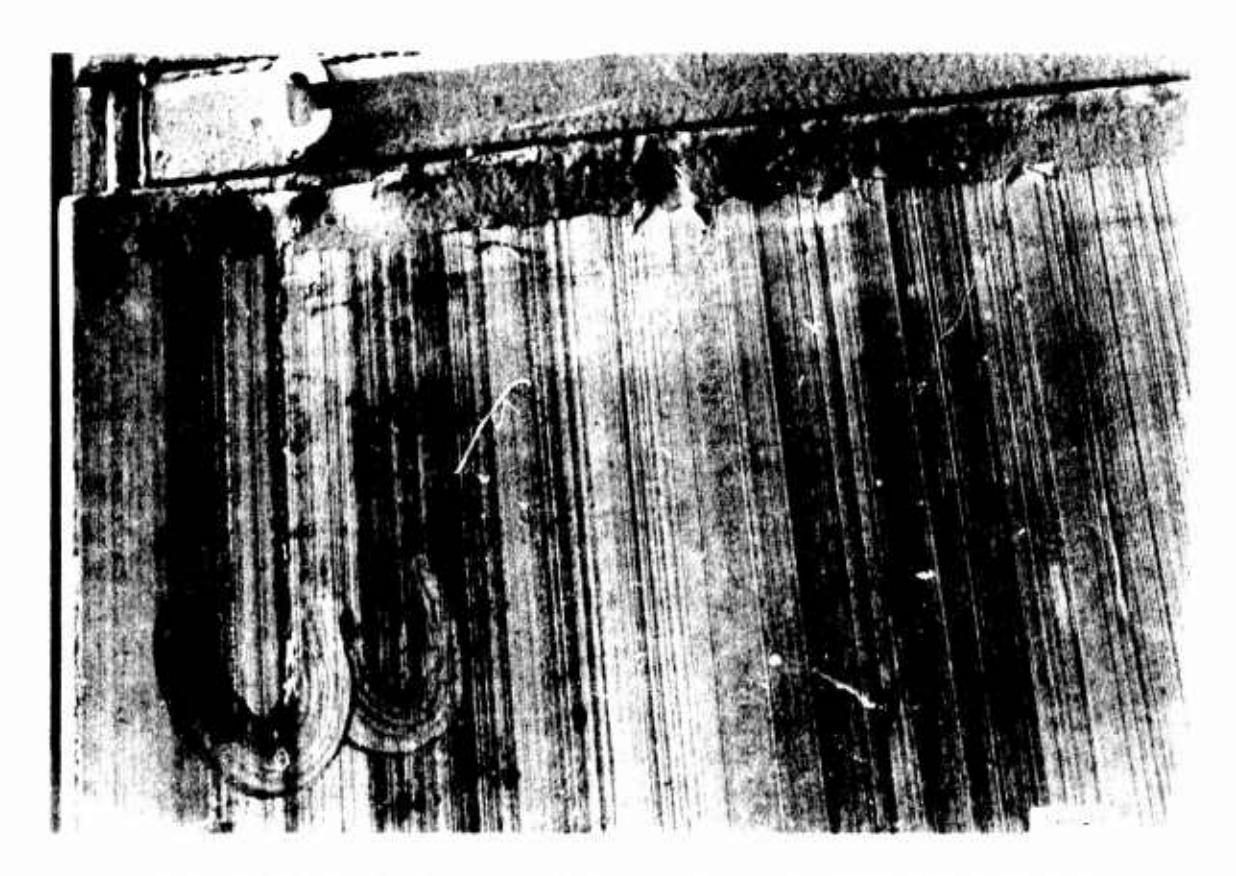
19. Traffic was continued to determine how many coverages would be required to fail the entire section. The first sign of major distress occurred at 238 coverages, with an underlapping end-connector failure and a top skin tear on plank 32, as shown in photograph 4. The plank was replaced, and traffic was resumed. Similar breaks developed in six more planks and had become so severe at 346 coverages that the test section was considered failed. Photograph 5 shows skin tears along the C-rail side at both the overlapping and underlapping end connectors. Six planks also showed signs of internal rib failure. Photograph 6 shows a cross section of a plank with interior damage along the C-rail connector. A general view of the test section at failure is shown in photograph 7.

Photograph 4. Top skin tear and underlapping end-connector failure at 238 coverages

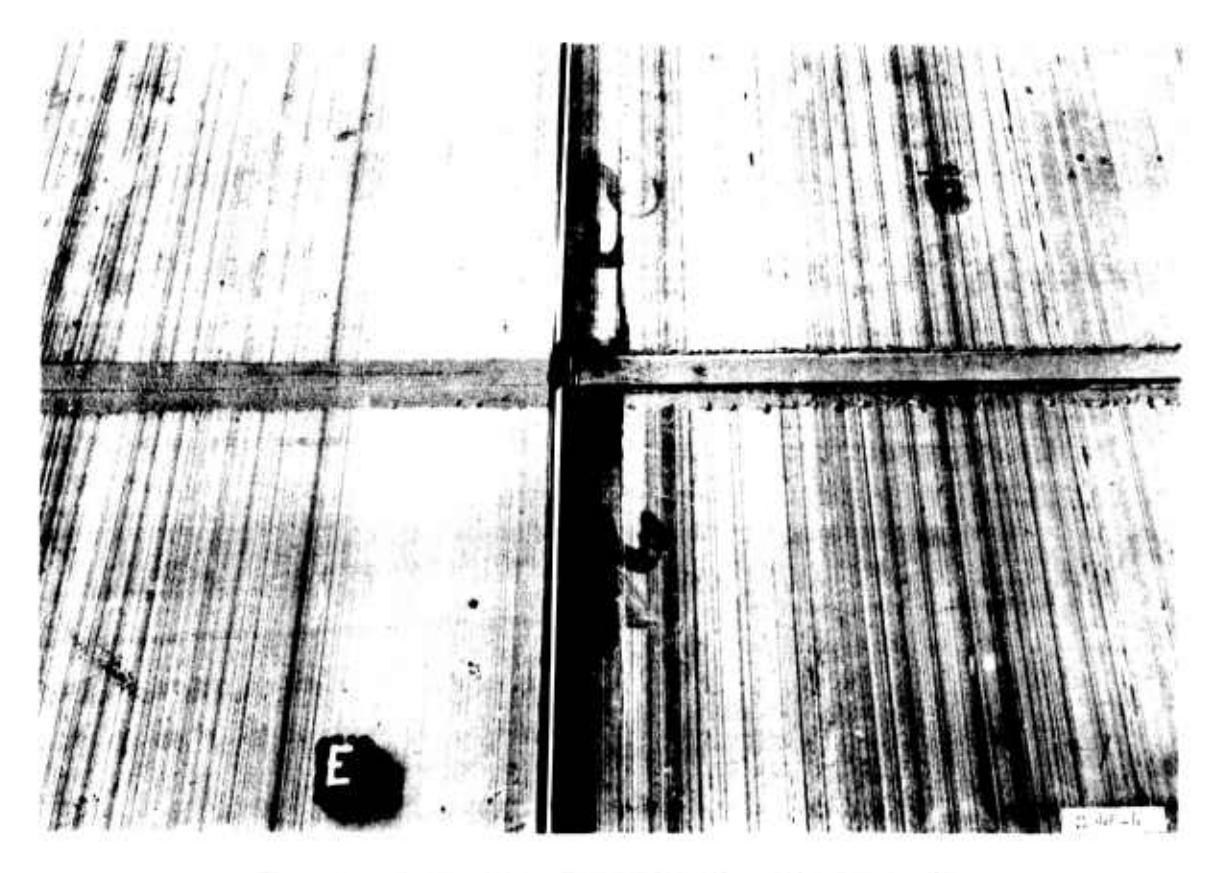
Photograph 5. Typical top skin tears at 346 coverages (failure)

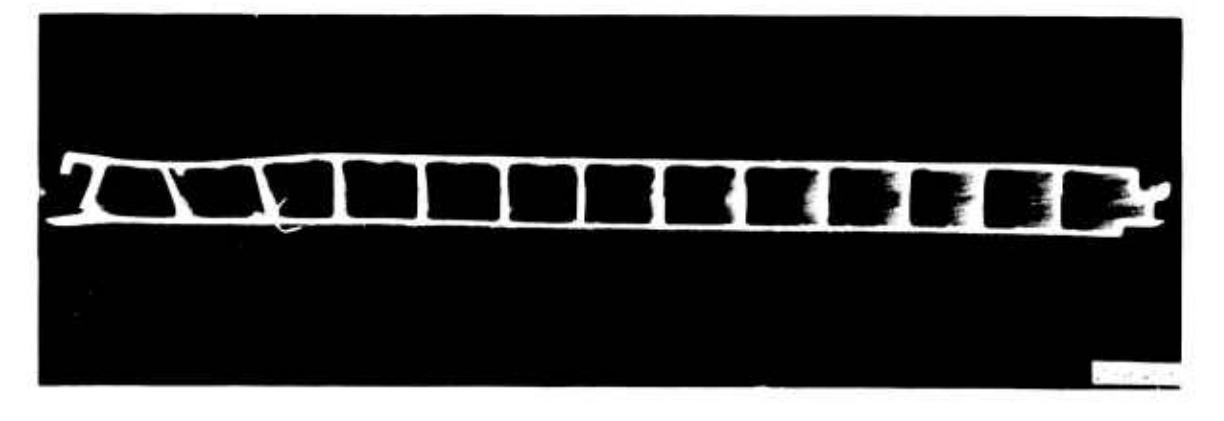
Photograph 6. Cross section of plank showing rib failure at 346 coverages

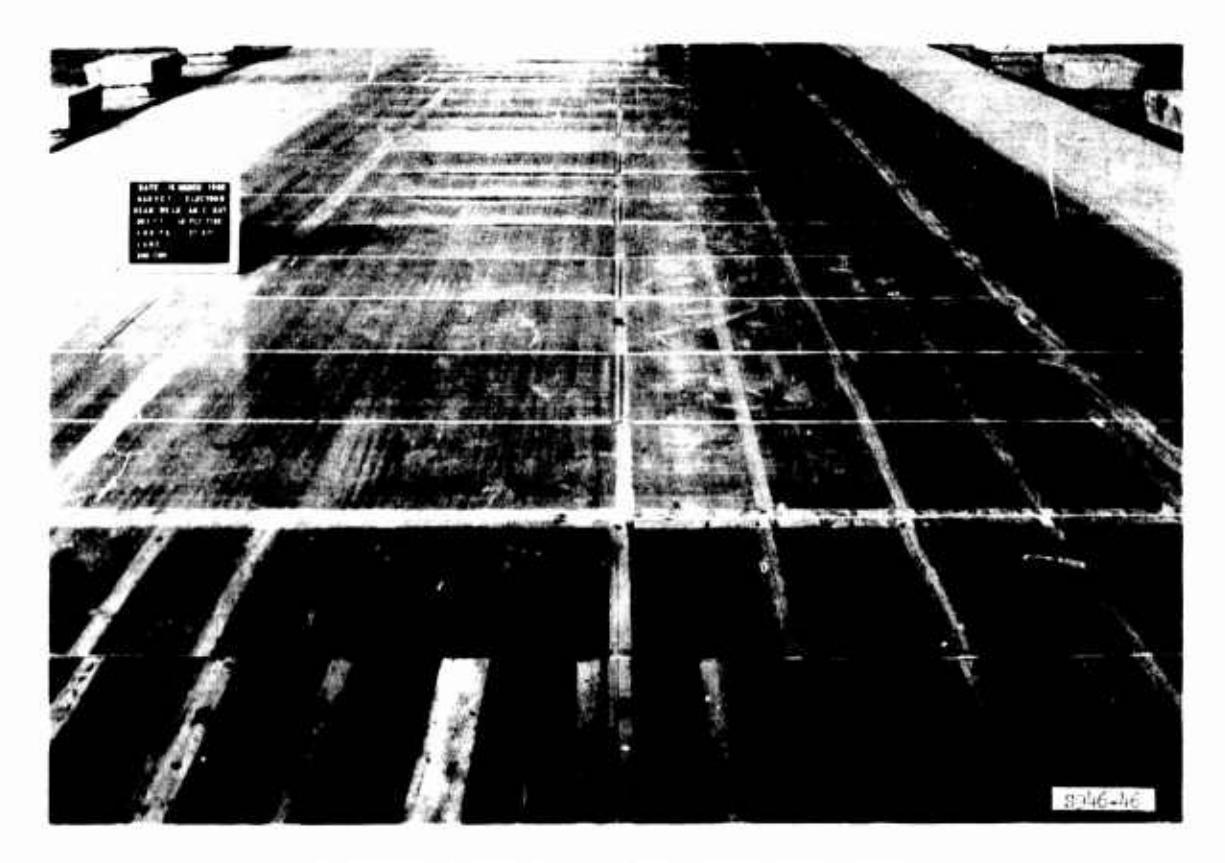
Photograph 7. Test section after 346 coverages (failure)

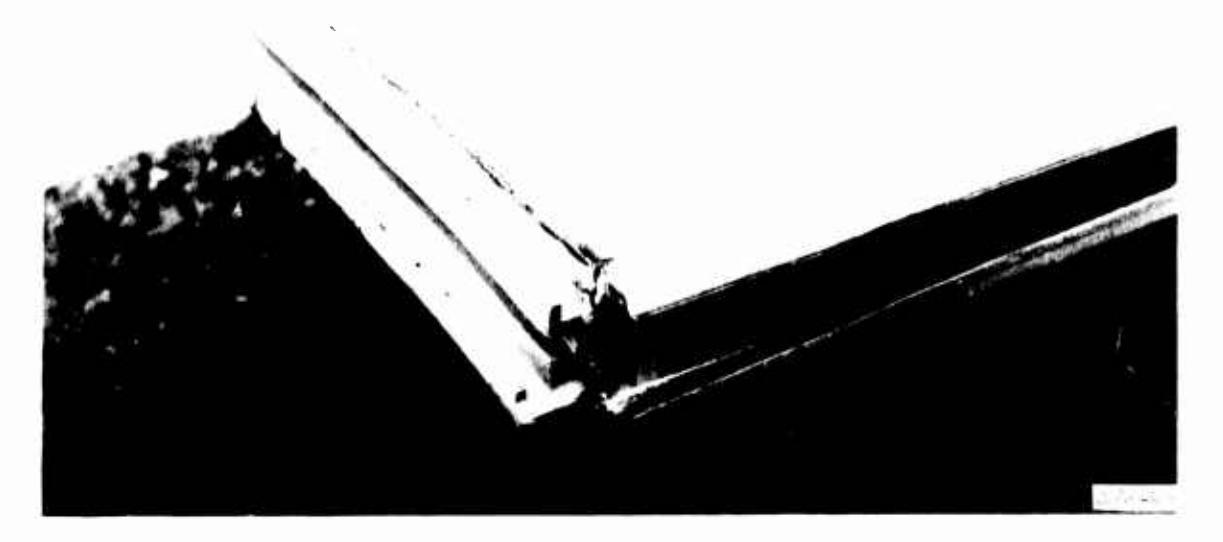
20. An inspection of the mat after removal from the section revealed the C-rail had split in five planks, as shown in photograph 8. These breaks averaged about 10-1/2 in. in length. The C-rail was also damaged at the corner of the overlapping and underlapping end connectors in 15 planks. These breaks averaged about 15 in. in length. Bottom skin tears, averaging 3/4 in., were also noted in six planks. A typical view of these breaks is shown in photograph 9.

Photograph 9. Weld crack, bottom skin tear, and C-rail split after 346 coverages

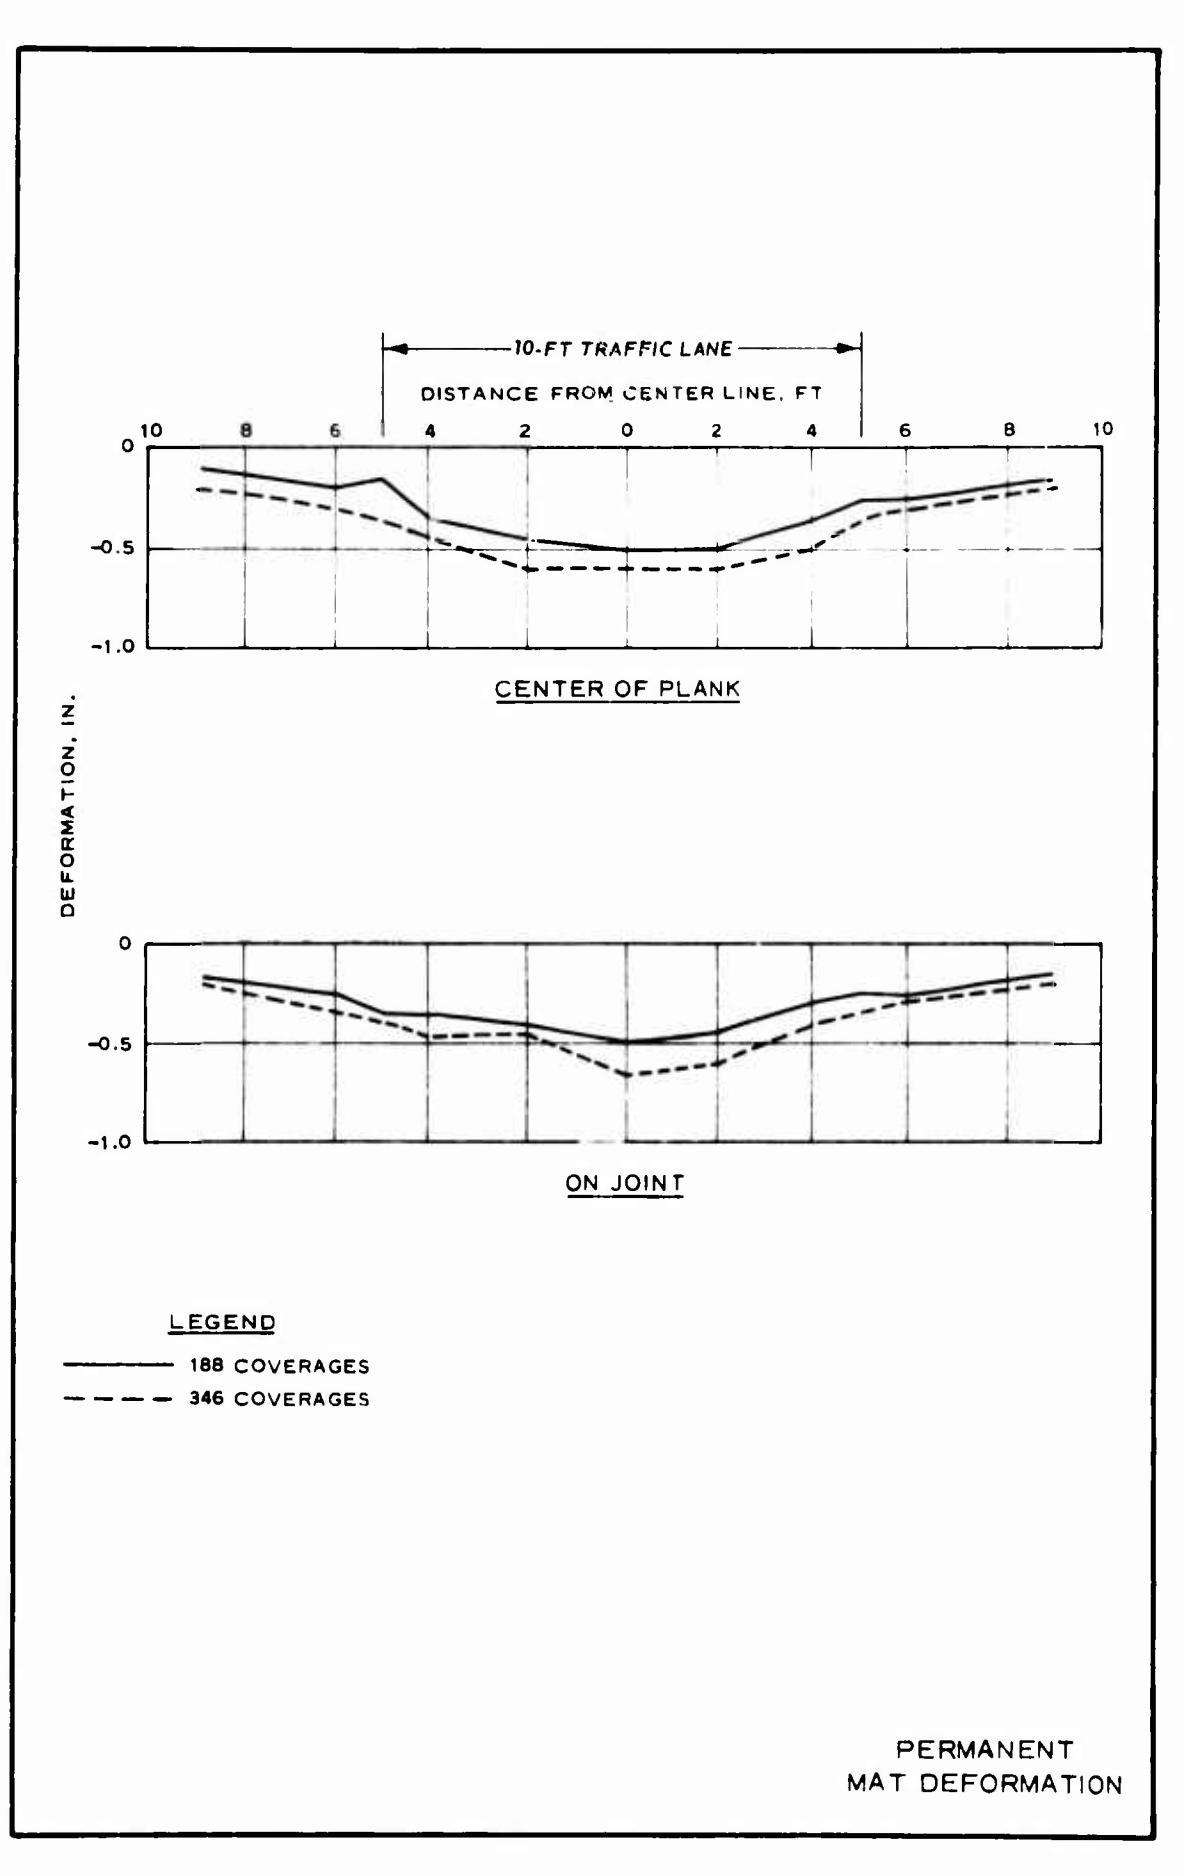
PLATE 3

21. Plots showing permanent mat deformation as determined from level readings taken prior to and at intervals during traffic are shown in plate 3. The cross sections were taken at several locations, and the results shown in plate 3 are averages of all the readings. Two types of locations were measured: one with the center of a plank at the center line of traffic, and the other with a plank joint at the center line of traffic. These data indicate that the greatest average deformation, about 0.65 in., occurred at a plank joint after 346 coverages. A plot of deformation along the center line of the traffic lane is shown in plate 4.

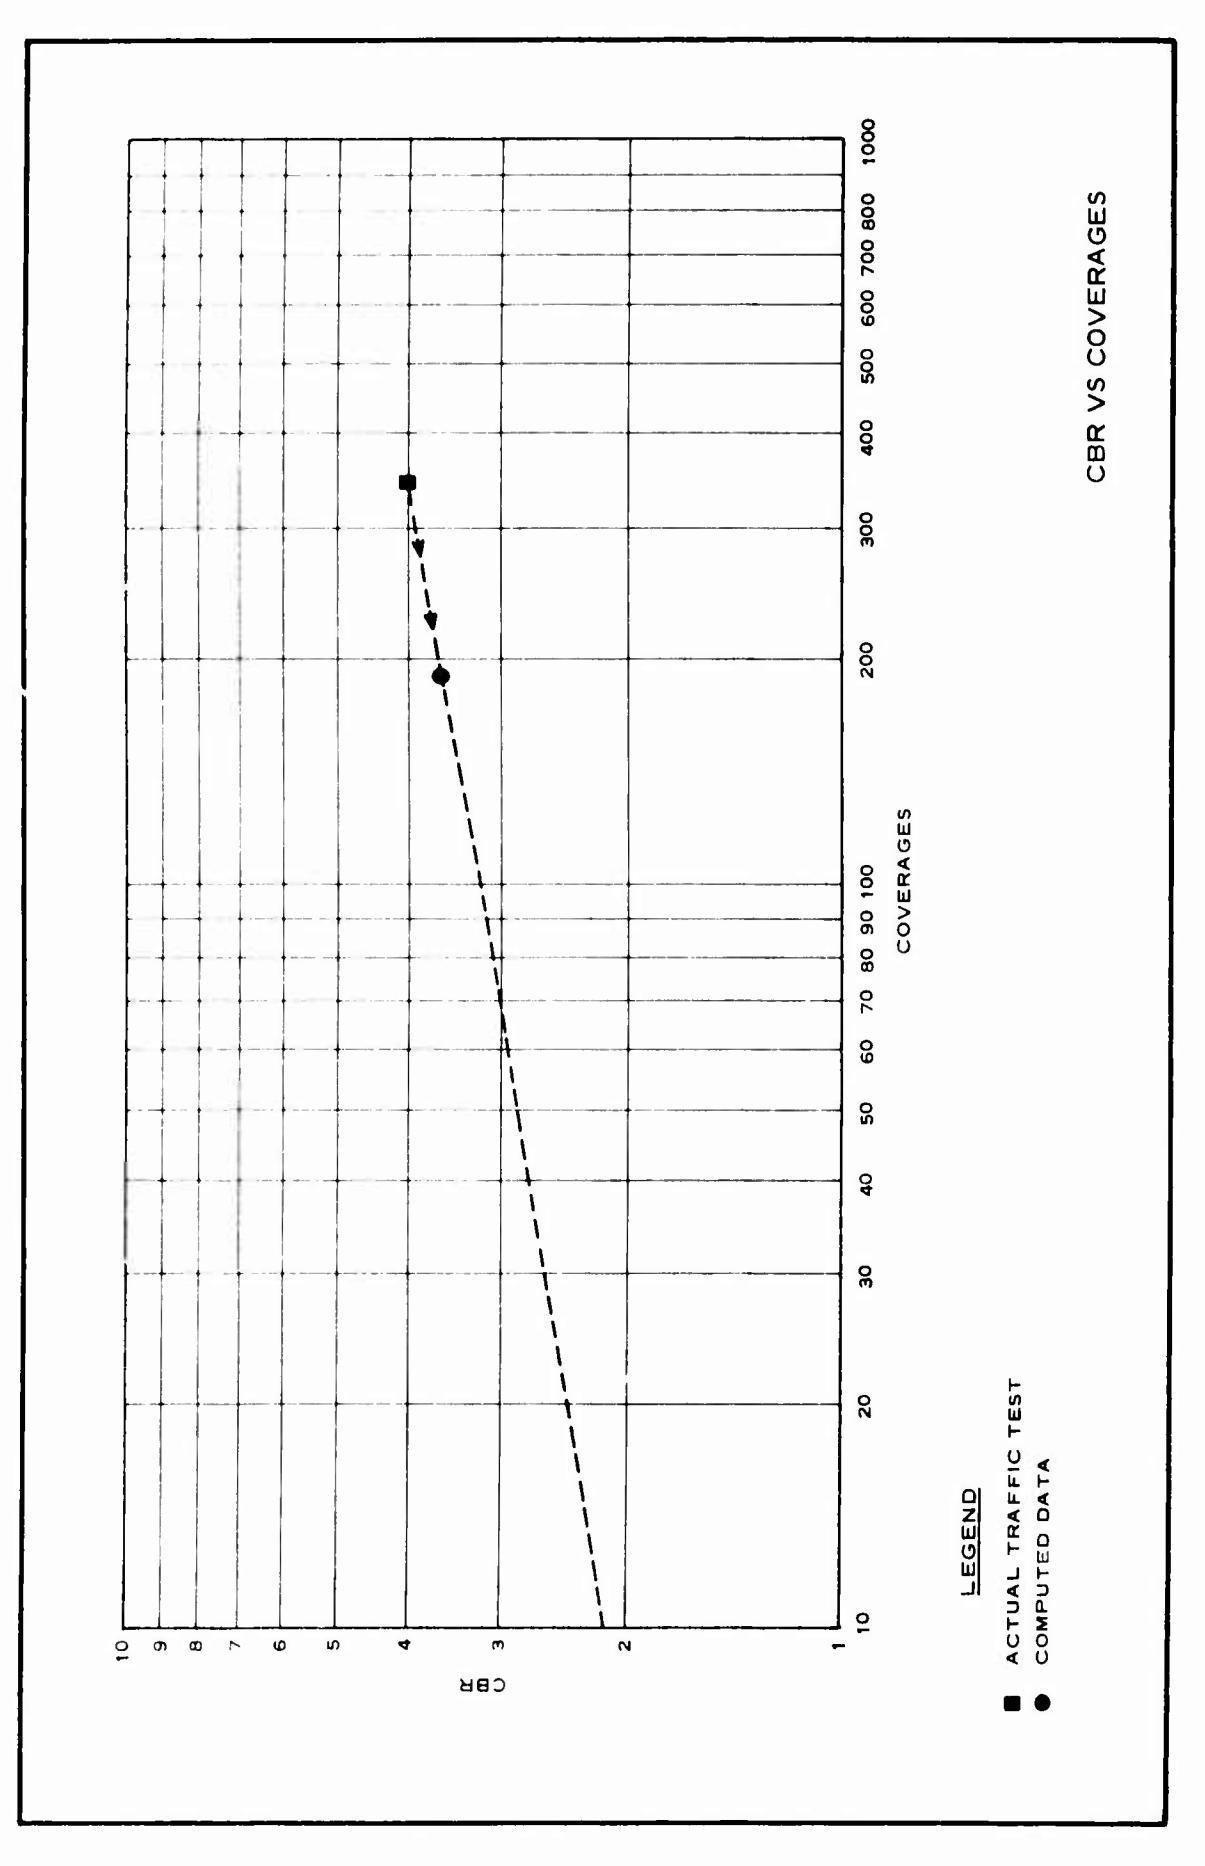
PLATE 6

26. A plot of CBR versus coverages is shown in plate 6. The rated CBR value listed in table 2 for the clay subgrade was plotted at the corresponding number of coverages at the end of traffic. From previous tests on landing mats, it has been established that the CBR-coverage relation for landing mat is essentially

a straight line when plotted to a log-log scale. By the use of the CBR equation,* the CBR versus coverages plot in plate 6 was obtained by extrapolation from the known failure point at 346 coverages. Therefore, the linear projection indicates the CBR required to support the test load for various coverage levels. The indicated CBR required to support 188 coverages is about 3.6.
