Technical Note N-1291

ZINC-RICH COATINGS FOR ALUMINUM IN SEAWATER

NAVAL CIVIL ENGINEERING LABORATORY
Port Hueneme, California 93043

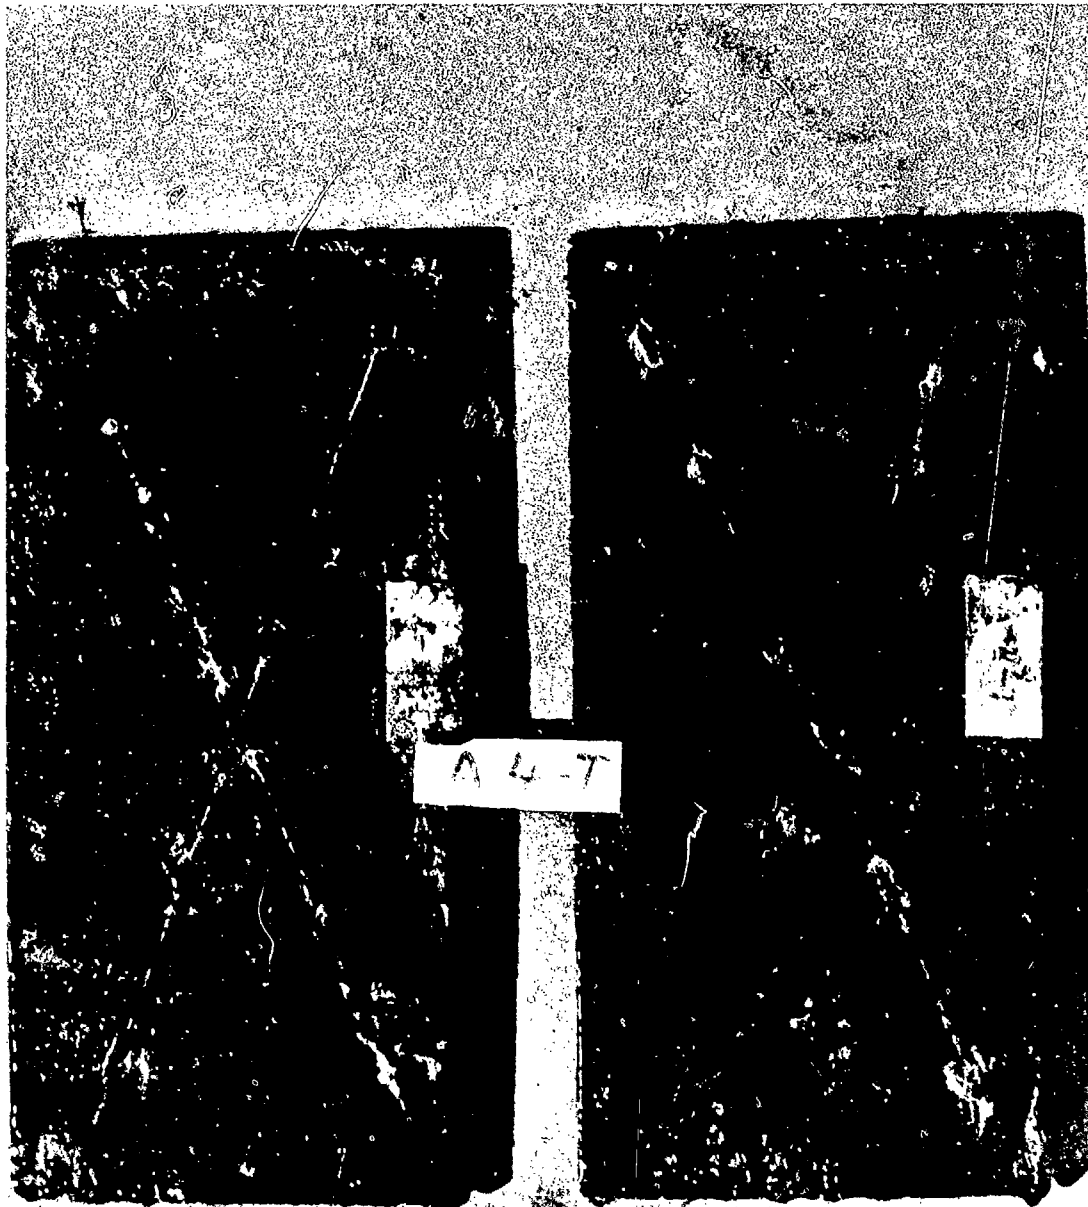
The coal-tar epoxy topcoat gave good to excellent protection for 3 years when applied over the zinc inorganic silicates of System A-4-T (Figure 10), Rust Ban 191 and System A-2-T, Dimetecote #3, as well as when applied over the Alodine 1200S anodizing treatment, System A-8-T. Only a few blisters were observed along the scribe and none on the un-scribed surfaces. Although the coal-tar epoxy was giving good protection over the zinc-rich epoxy System A-6-T and the zinc inorganic silicate Systems A-1-T, Carbo Zinc 11, and A-3-T Rust Ban 190, a few blisters along the scribe had caused flaking of the coal-tar epoxy from the primer. No blisters were observed on the un-scribed surfaces. The coal-tar epoxy topcoat over zinc inorganic silicate, System A-1-T, was giving good protection after 3 years of exposure in Port Hueneme Harbor. Blistering and undercutting along the scribe as well as blistering over the un-scribed surfaces, indicated a lessening of the protective potential for this system. The coal-tar epoxy over the zinc-rich epoxy primer Rust Ban EX6662, System A-6-T, was giving good protection after 3 years of exposure with no blistering over the un-scribed surfaces; however, considerable undercutting was initiated by a few blisters along the scribe.

Figure 10. Coal Tar Epoxy over a zinc inorganic silicate (Rust Ban 191) after 3 years in Port Hueneme Harbor.
