Report No. CG-D-02-16

# Initial Burn Pan (JMTF) Testing Results

March 2016

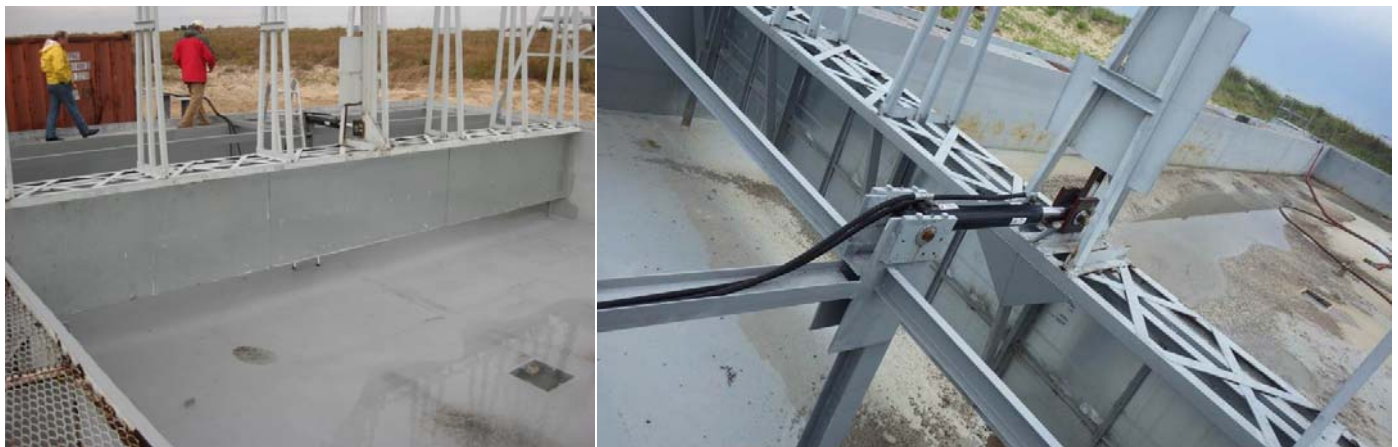
The hydraulic motor and reservoir were destroyed by Katrina and still need to be replaced. The paddle assembly and the hydraulic cylinder are shown in Figure 5. The original intent was to refurbish the wave generator and purchase a new hydraulic supply system for use during the demonstration. However, due to cost constraints, the hydraulic supply system was not purchased and thus the wave generator was not used during this test series.

Figure 5. Views of wave generator.
